Silver Bow Creek/Butte Area Superfund Site

**2022 Stormwater BMPs Repair, Inspection Report, and
Maintenance Work Plan BNSF Railway Company and Union
Pacific Railroad Company Butte Priority Soils Operable Unit KJ
2299019.00**

16 February 2023

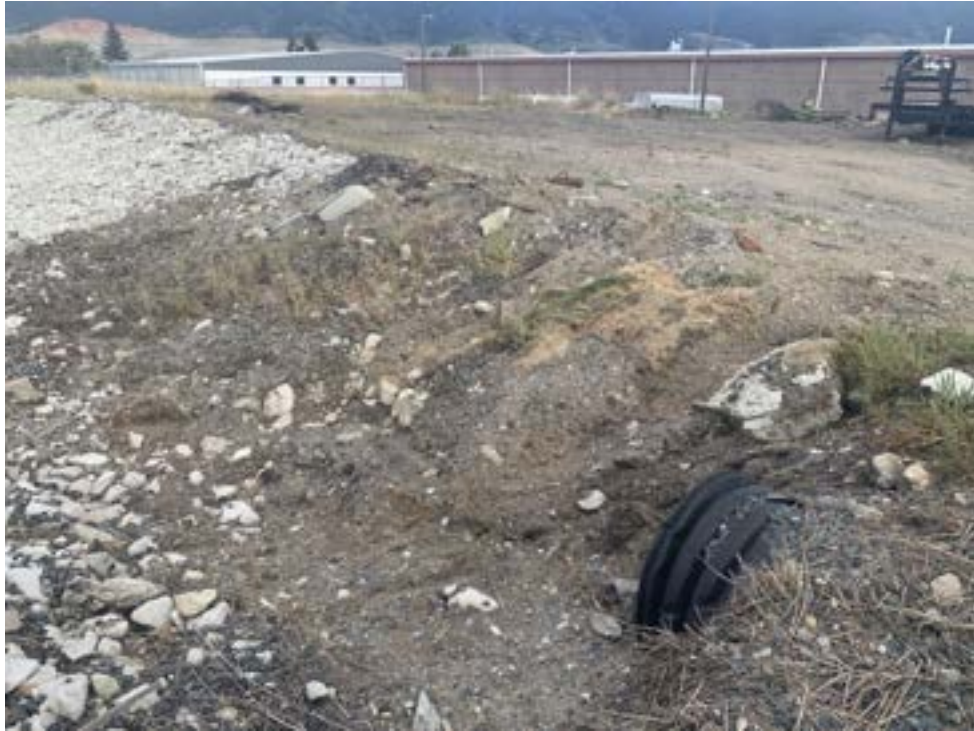
MY-D-03 (Riprap). Accumulated sediment was observed in ditch at outlet of MY-HDPE-03 (see photographs MY-D-03 in Attachment 2). Sediment has accumulated over an area of approximately 60 sq ft with a thickness of 1 to 3 inches. Remove and dispose of sediment. Potential methods of sediment removal may include one or more of the following, but are not limited to, vacuum extraction, shoveling, and brushing. This work will be completed by a contractor with engineering oversight.

MY-D-03: On the south side of the northeast ditch at MY-HDPE-03 outlet, 1-3 inches of sediment is covering rock over an approximately 60 SF area.

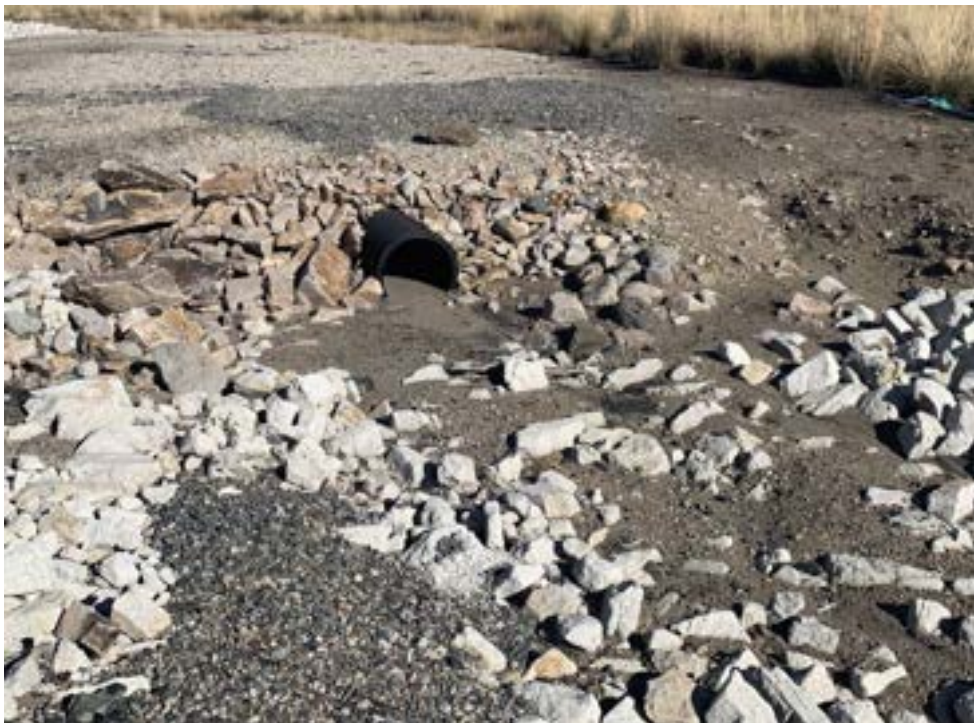
LY-D-01 (Riprap ditch). Accumulated sediment and thin rock cover was observed in ditch at the inlet and outlet of LY-HDPE-02 (see photographs LY-D-01 in Attachment 2). In the ditch, on the Southwest side of LY-HDPE-02, limited erosion is occurring, approximately 1 inch of sediment has accumulated, and rock is missing in an area of approximately 30 SF. Remove sediment from riprap ditch and cover area of thin rock cover with Type 2 Rock. Potential methods of sediment removal may include one or more of the following, but are not limited to, vacuum extraction, shoveling, and brushing. This work will be completed by a contractor with engineering oversight.

LY-D-01: Sediment accumulation and thin rock cover on the Southwest side.

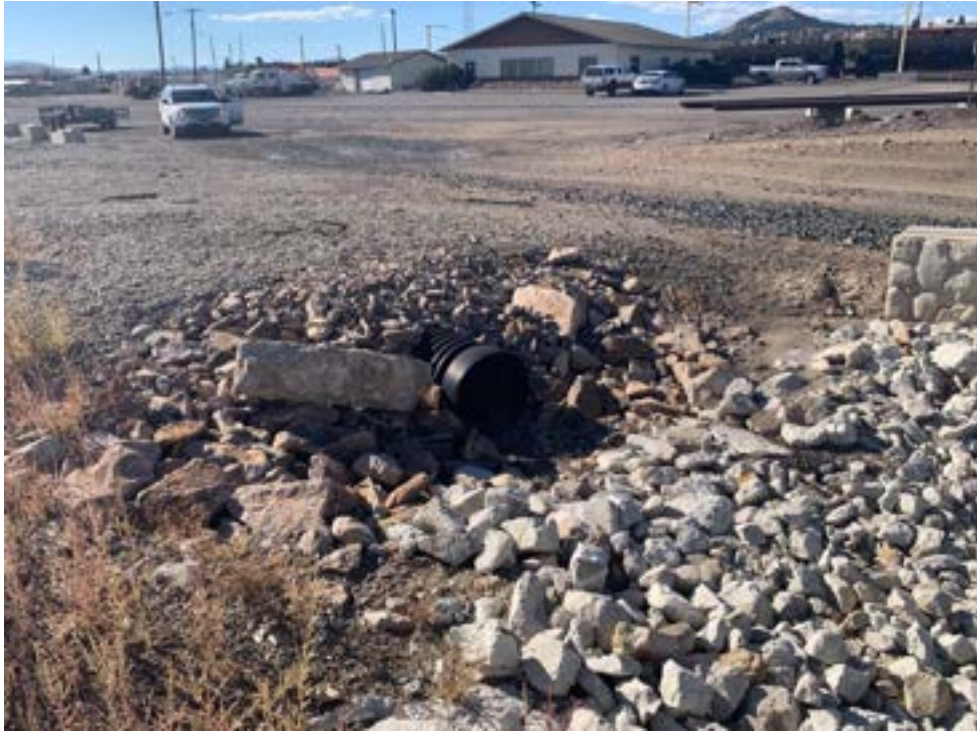
LY-D-01: Sediment accumulation.

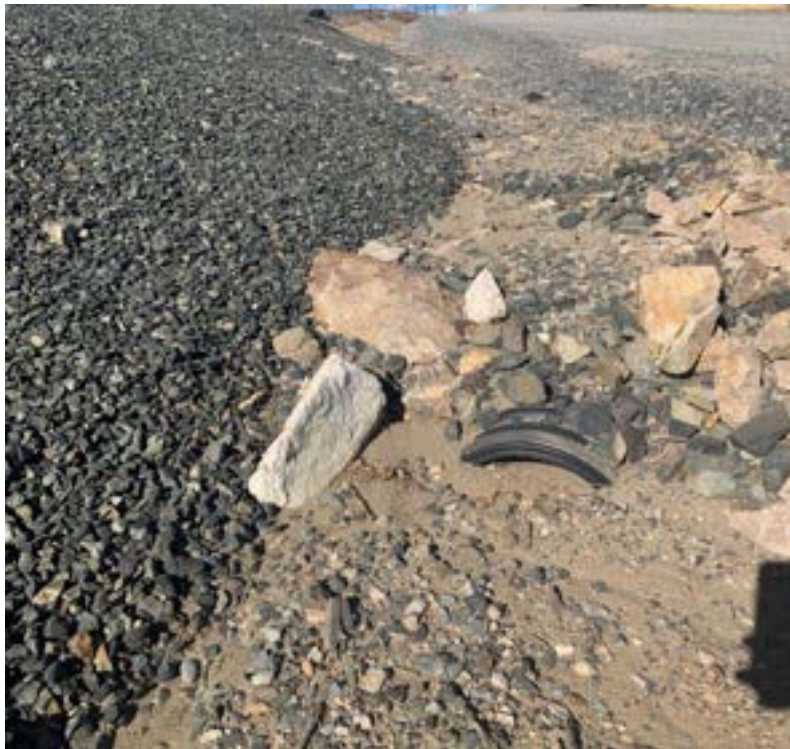
LY-HDPE-02. Accumulated sediment was observed in pipe (see photograph LY-HDPE-02 in Attachment 2). Sediment is entering pipe from the downgradient accumulation and is reducing flow through the pipe. Remove and dispose of sediment. Potential methods of sediment removal may include one or more of the following, but are not limited to, vacuum extraction, shoveling, and brushing. This work will be completed by a contractor with engineering oversight.

LY-HDPE-02: Sediment accumulated at pipe outlet. Sediment removal is part of the 2021 inspection maintenance items scheduled.

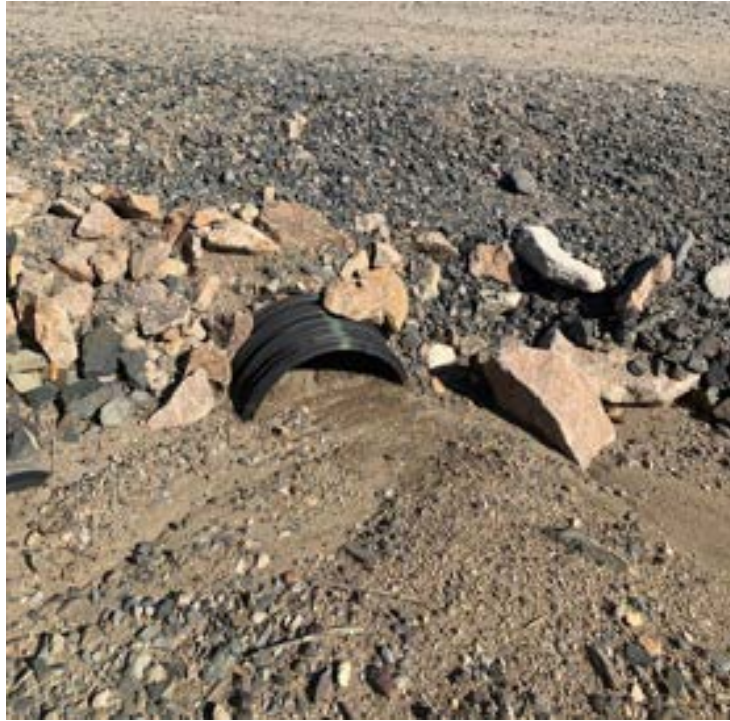
LY-HDPE-03. Accumulated sediment was observed in pipe (see photograph LY-HDPE-03 in Attachment 2). Sediment is entering pipe from the upgradient accumulation and is reducing flow through the pipe. Remove and dispose of sediment. Potential methods of sediment removal may include one or more of the following, but are not limited to, vacuum extraction, shoveling, and brushing. This work will be completed by a contractor with engineering oversight.

LY-HDPE-03: Sediment accumulation at inlet end of pipe. Sediment removal is part of the 2021 inspection maintenance items scheduled.

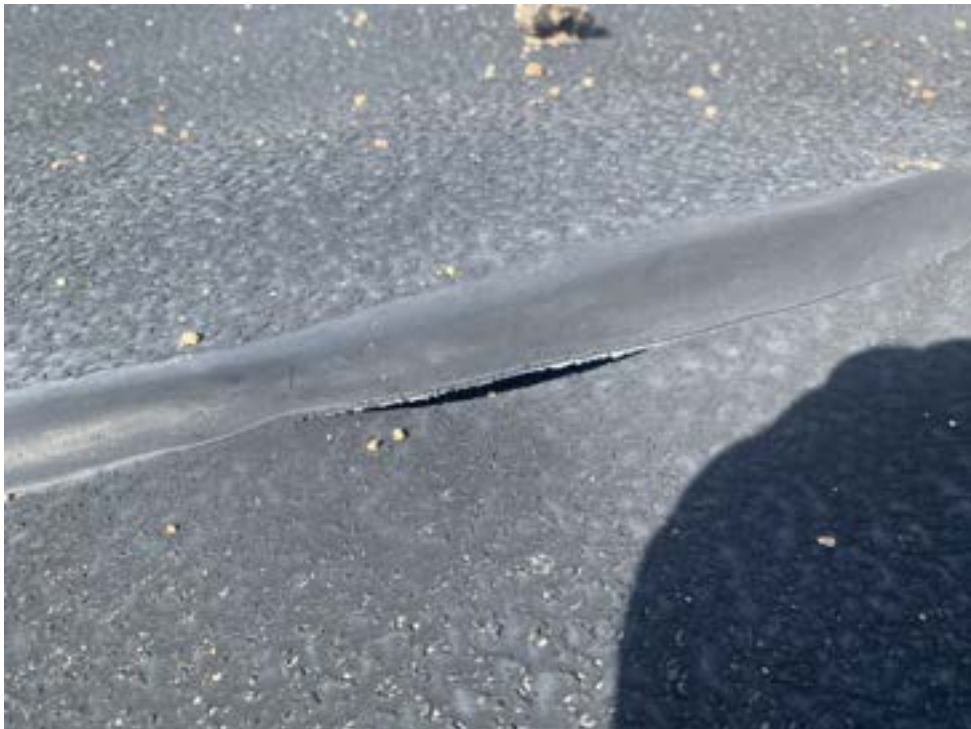
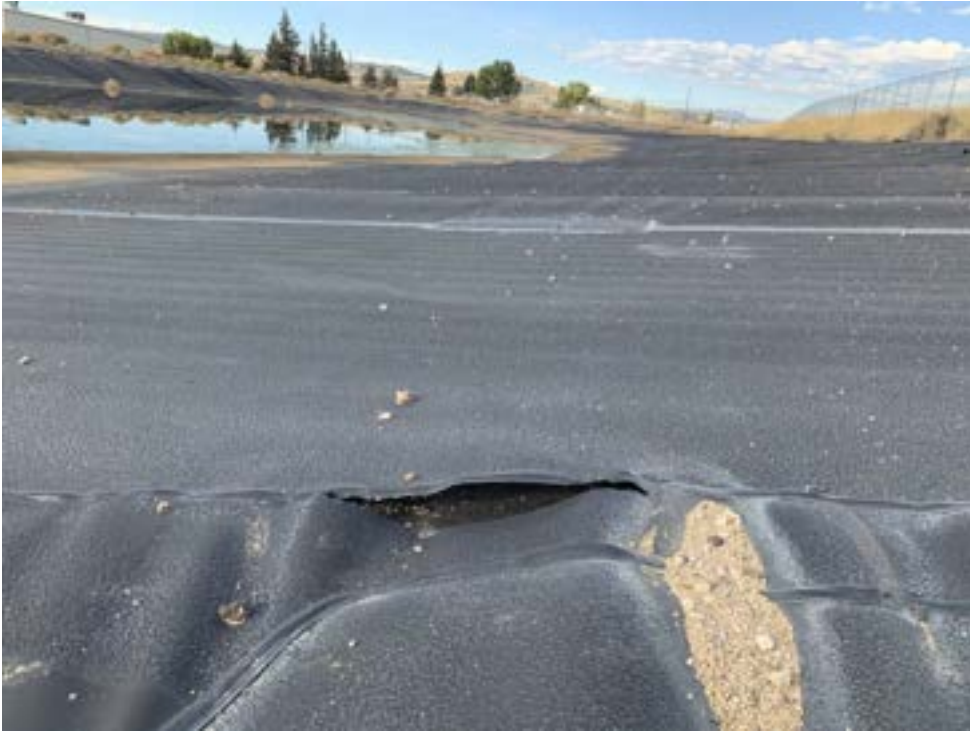
LY-PND-01. At the time of the inspection, two 1-foot-long tears remain in similar condition to observed conditions during the 2021 inspection and one 2-foot-long tear, , one 0.5 foot-long tear, and two 0.25 foot-long tears were newly observed in the sediment basin high density polyethylene (HDPE) liner; however, the sediment basin is still performing per design. Liner repairs have been added to the 2021 inspection maintenance items scheduled for repair. Undesirable vegetation growth observed in basin area at approximately 60 percent density covering 20,000 square feet (see photographs for LY-PND-01 in Attachment 2). Repair the liner tears and spot spray with limited application of herbicide as needed. This work will be completed by a contractor with engineering oversight.

LY-PND-01: New tear in liner (Two liner tears from 2021 inspection still present).

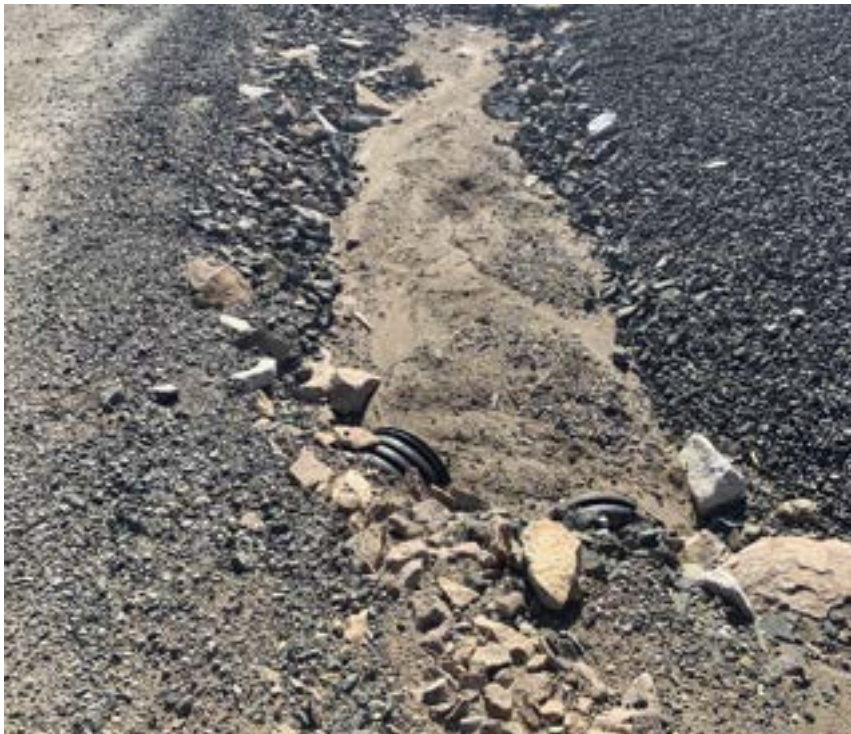
LY-RA-01a,b. Accumulated sediment was observed at inlet and outlet aprons (see photographs LY-RA-01a,b in Attachment 2). Sediment appears to be accumulating from the 1,650 sq ft barren area east of Lower Yard entrance driveway and the 2,300-square-foot barren area west of the driveway. Remove sediment from riprap aprons, regrade inlet apron to 2:1 slope, and cover barren areas in 6 inches of Type 3 Rock. Potential methods of sediment removal may include one or more of the following, but are not limited to, vacuum extraction, shoveling, and brushing. This work will be completed by a contractor with engineering oversight.

LY-RA-01a: Sediment accumulated in apron. Sediment removal is part of the 2021 inspection maintenance items scheduled.

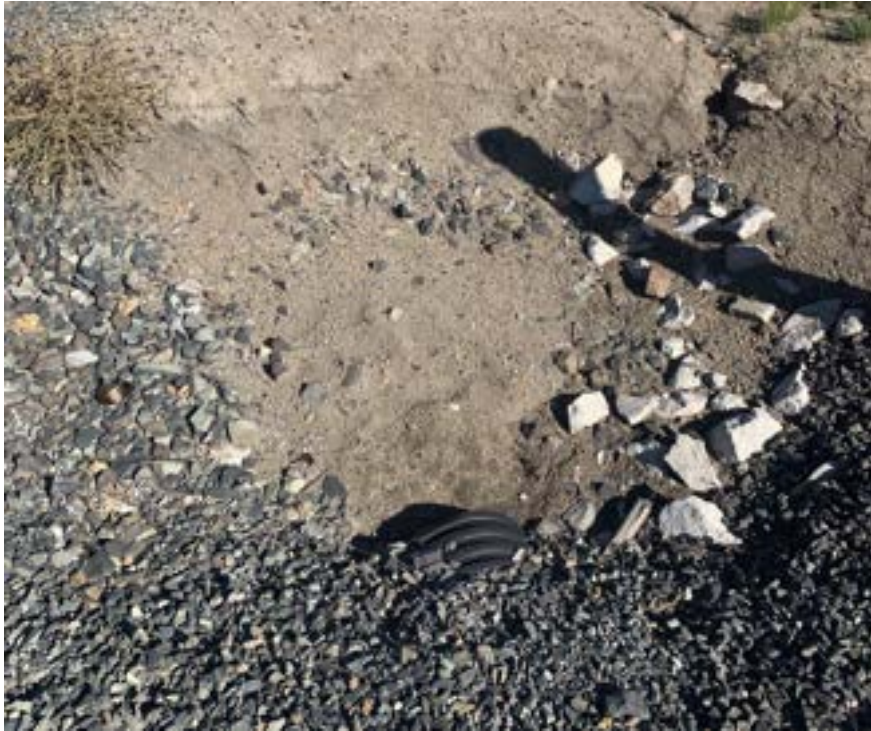
LY-RA-01b: Sediment accumulated in apron. Sediment removal is part of the 2021 inspection maintenance items scheduled.
