SILVER BOW CREEK/BUTTE AREA NPL SITE BUTTE PRIORITY SOILS OPERABLE UNIT

*Butte Reduction Works (BRW) Smelter Area Mine
Waste Remediation and Contaminated
Groundwater Hydraulic Control Site
Pre-Design Investigation (PDI) Evaluation Report*

Atlantic Richfield Company

Revision 0 May 2021

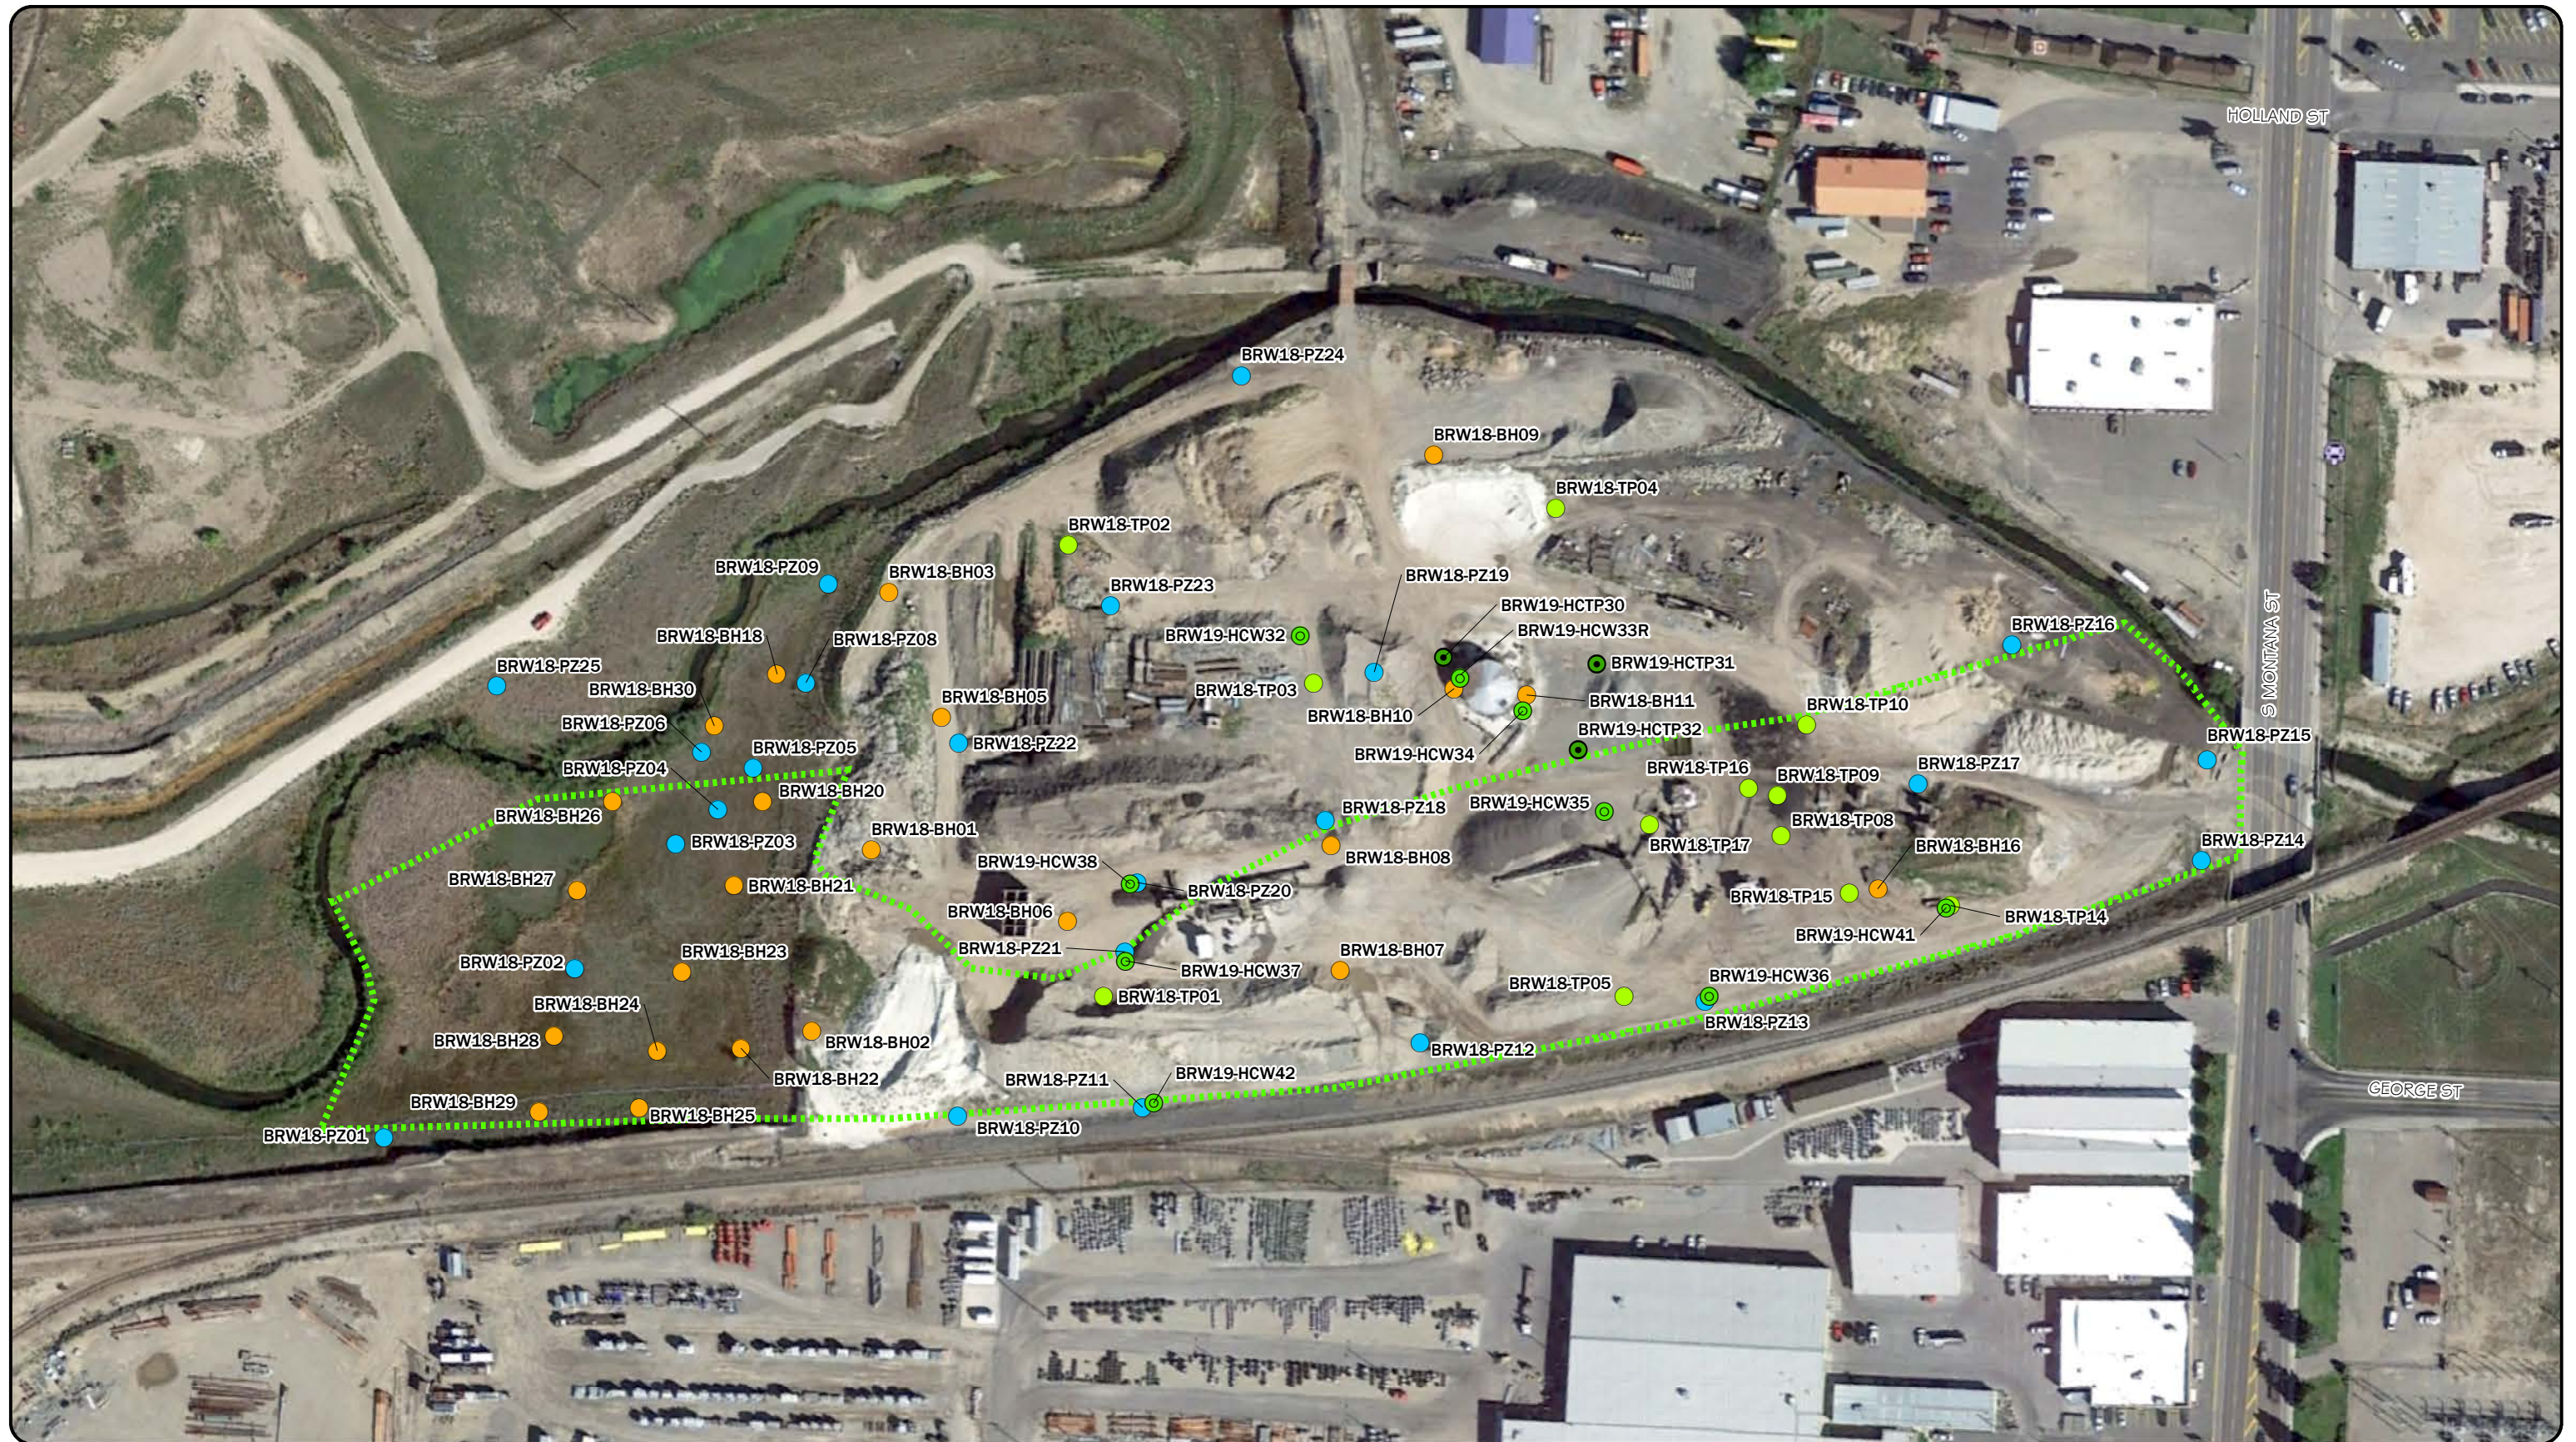
**BRW PHASE I
 SITE INVESTIGATION
 LOCATIONS**

- PHASE I LOCATIONS**
- Phase I Borehole
 - Phase I Piezometer
 - Phase I Test Pit
- HYDROCARBON INVESTIGATION**
- Hydrocarbon Piezometer
 - Hydrocarbon Test Pit
 - - - Preliminary Waste Removal Corridor

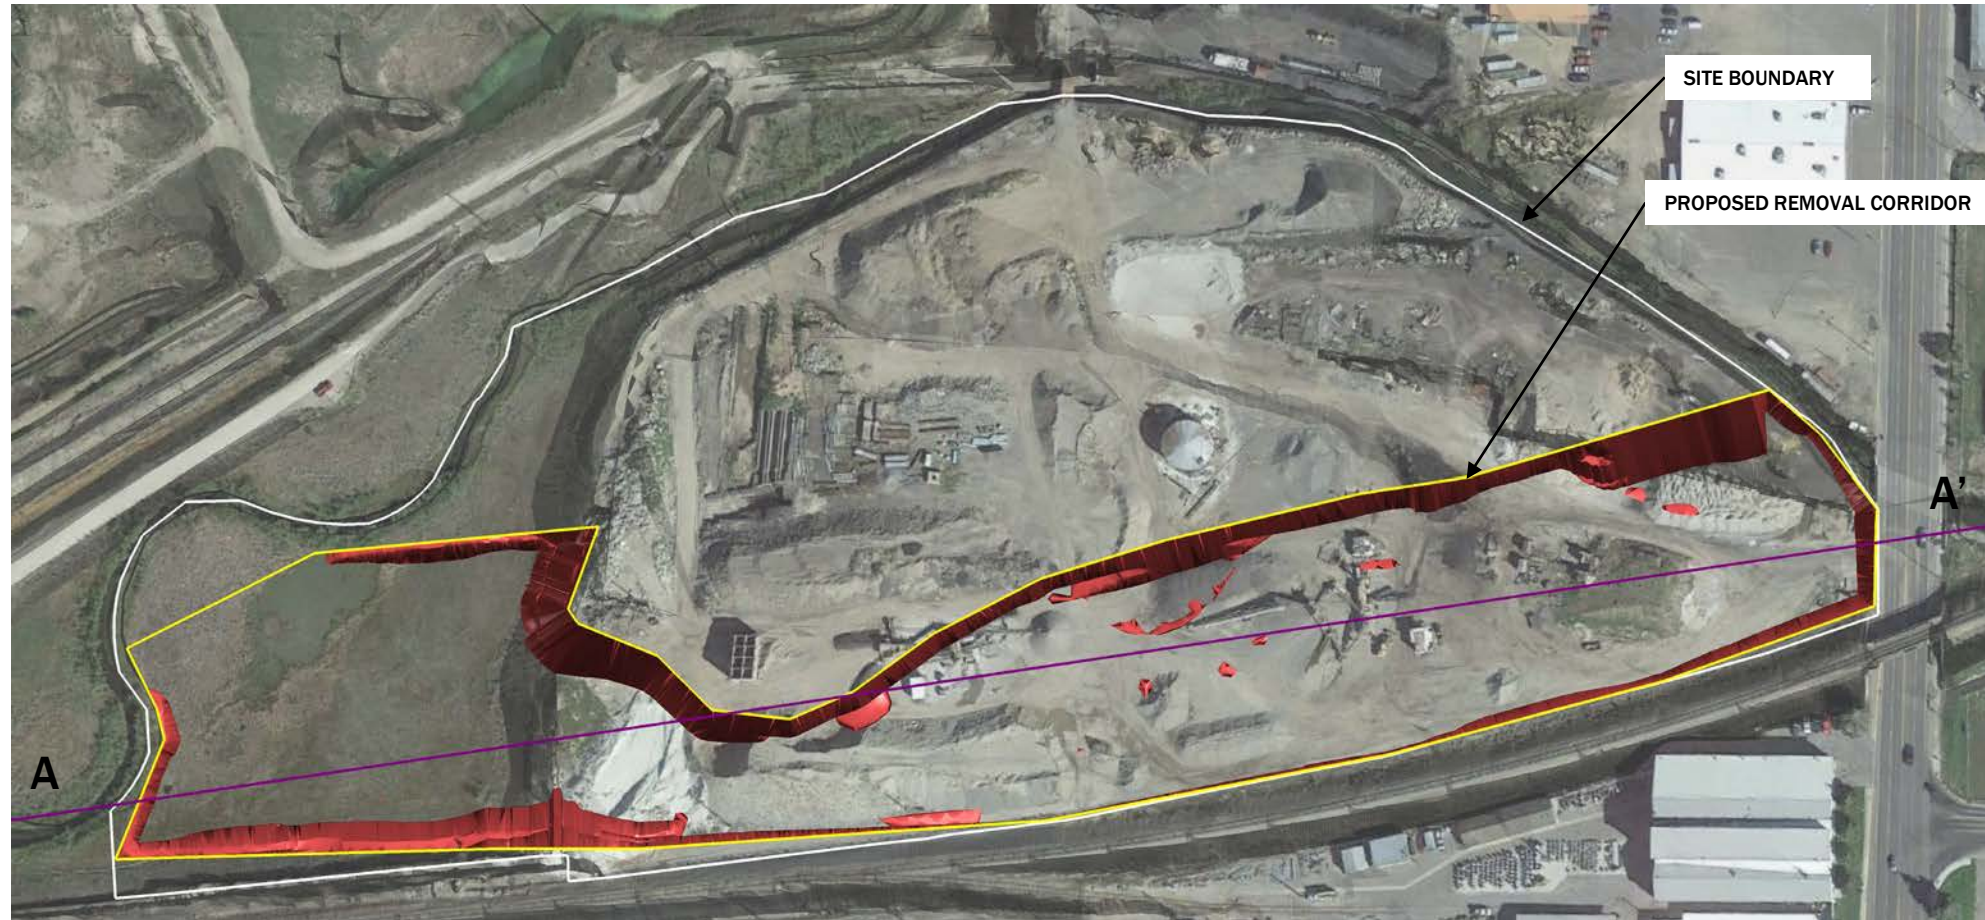
THIS FIGURE AND MODELED VOLUMES WERE GENERATED USING LEAPFROG WORKS. THE WASTE VOLUME WAS EXPORTED AND INTEGRATED INTO THE PRELIMINARY WASTE EXCAVATION SURFACE IN AUTOCAD. THE WASTE VOLUME IS A MODELED APPROXIMATION BASED ON THE BOREHOLE AND TEST PIT DATA COLLECTED DURING THE BRW PHASE I SITE INVESTIGATION AS WELL AS OBSERVATIONS FROM PREVIOUS INVESTIGATIONS AND THE INSTALLATION OF OLDER MONITORING WELLS.

THE ROTATED VIEWS HAVE BEEN SCALED SO THE ELEVATION (Z) AXIS IS 5 TIMES GREATER THAN THE NORTHING (Y) AND EASTING (X) AXES.

THE PROPOSED REMOVAL CORRIDOR SHOWN IS PRELIMINARY AND ONLY SHOWN AS A REFERENCE AT THIS POINT. THE REMOVAL CORRIDOR AND EXCAVATION SURFACE WILL BE REFINED FURTHER DURING THE REMEDIAL DESIGN AND WILL BE SUBMITTED FOR AGENCIES' REVIEW AND APPROVAL.

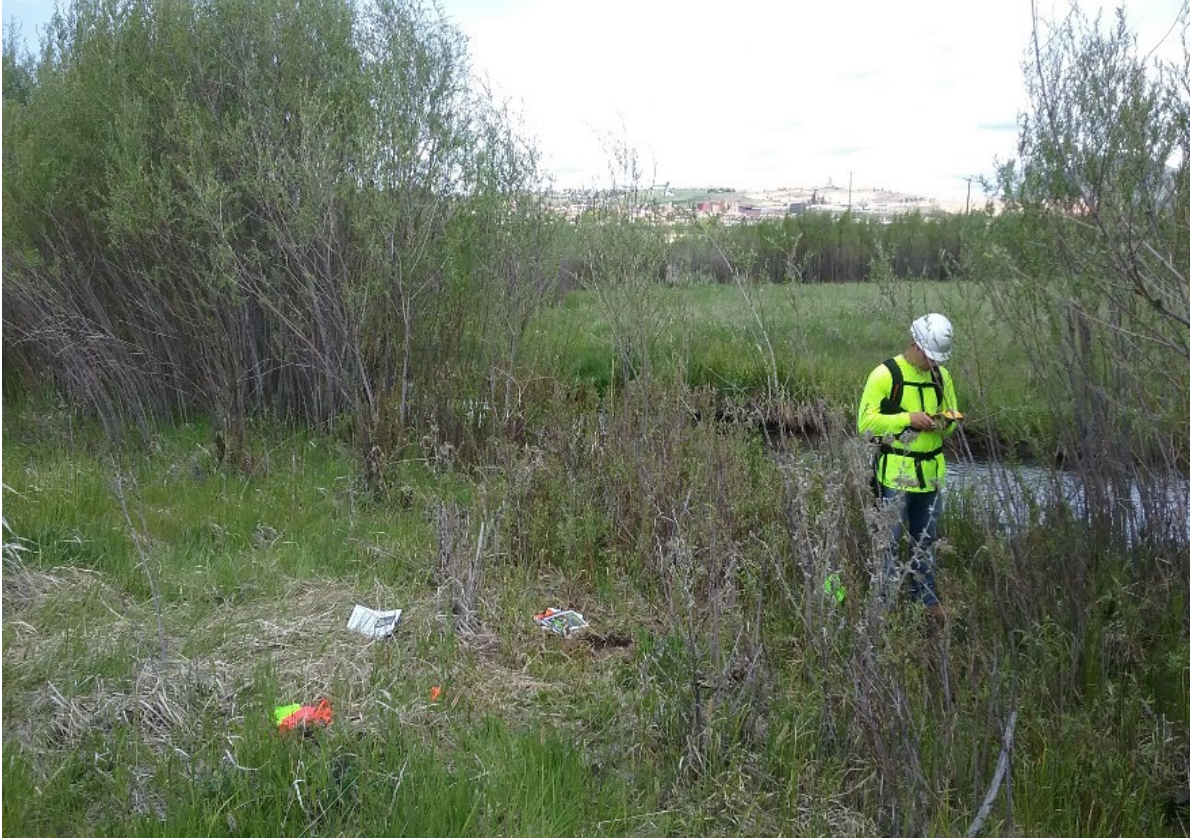
Photograph 1: Wetland along Silver Bow Creek showing both the palustrine emergent and shrub-scrub habitats.

Based on this survey, 3.2 acres of reconstructed wetland exists within the Site (Figure 2). The wetland is located along both banks of the stream channel (Photograph 1) and the terrace to the south (Photograph 2) and for all intents and purposes is a continuous feature. Wetland boundaries were not readily apparent based on vegetative and soil characteristics; therefore, depth to groundwater or soil saturation was used as the major determinant. The defined area also includes a confined area between slag walls (Photograph 3). The banks of the stream are jurisdictional wetland areas, but the stream channel itself is not. However, it is a non-wetland waters of the U.S.

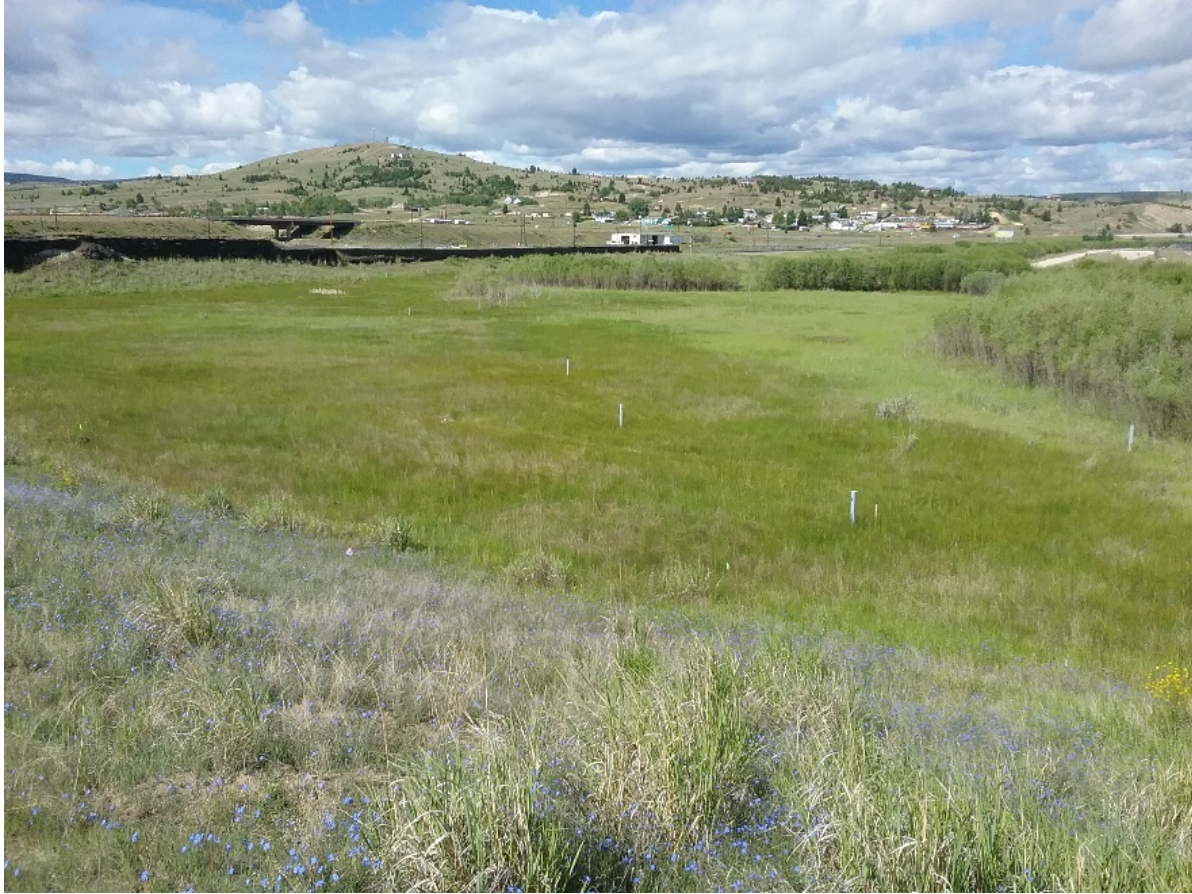
Photograph 2: Broad wetland area on south side of Silver Bow Creek.

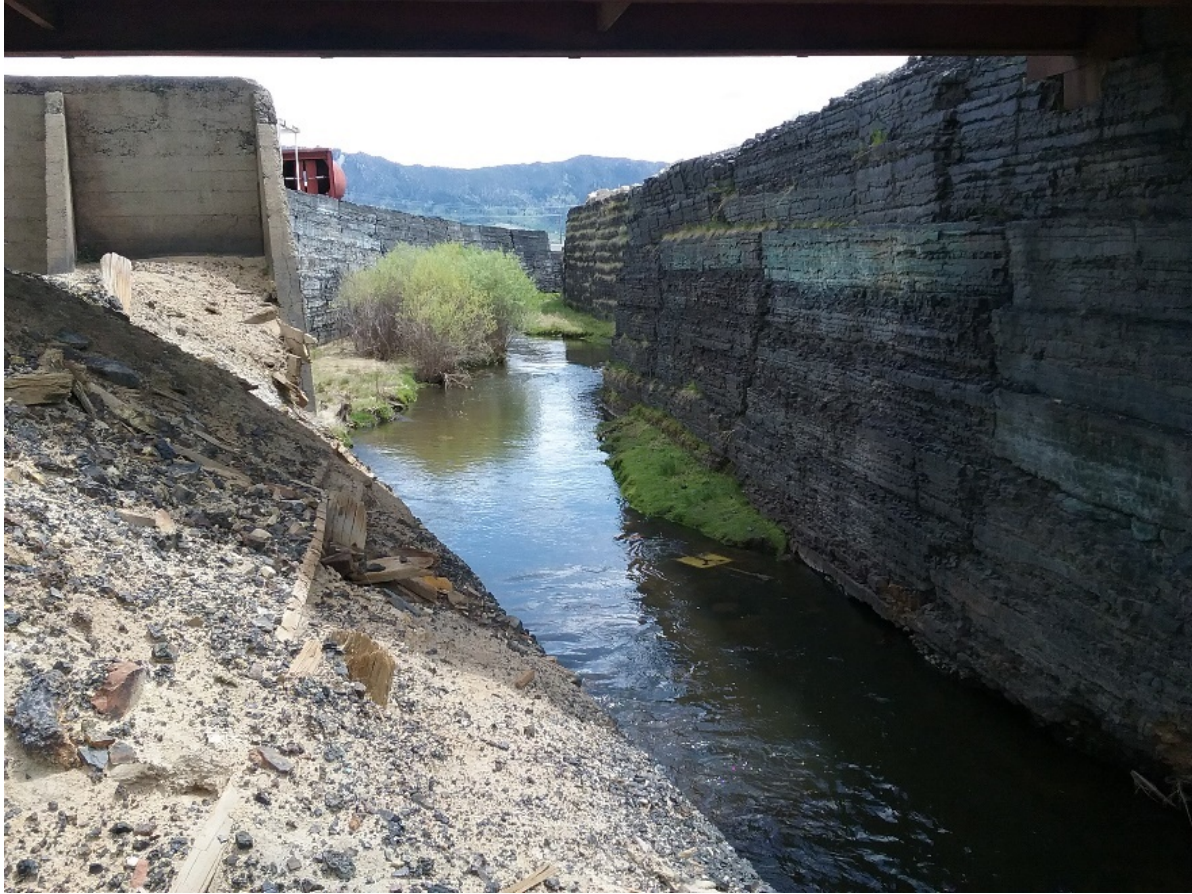
Photograph 3: Slag Canyon with limited wetland characteristics.

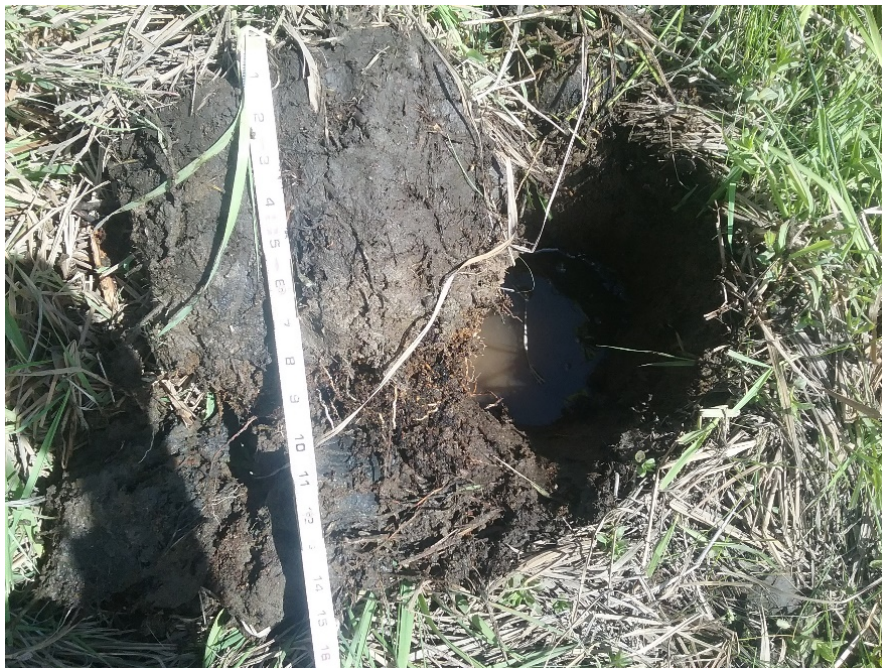
Photograph 4: Borrow material without distinct soil horizon but exhibiting a dark surface layer and groundwater near the surface.

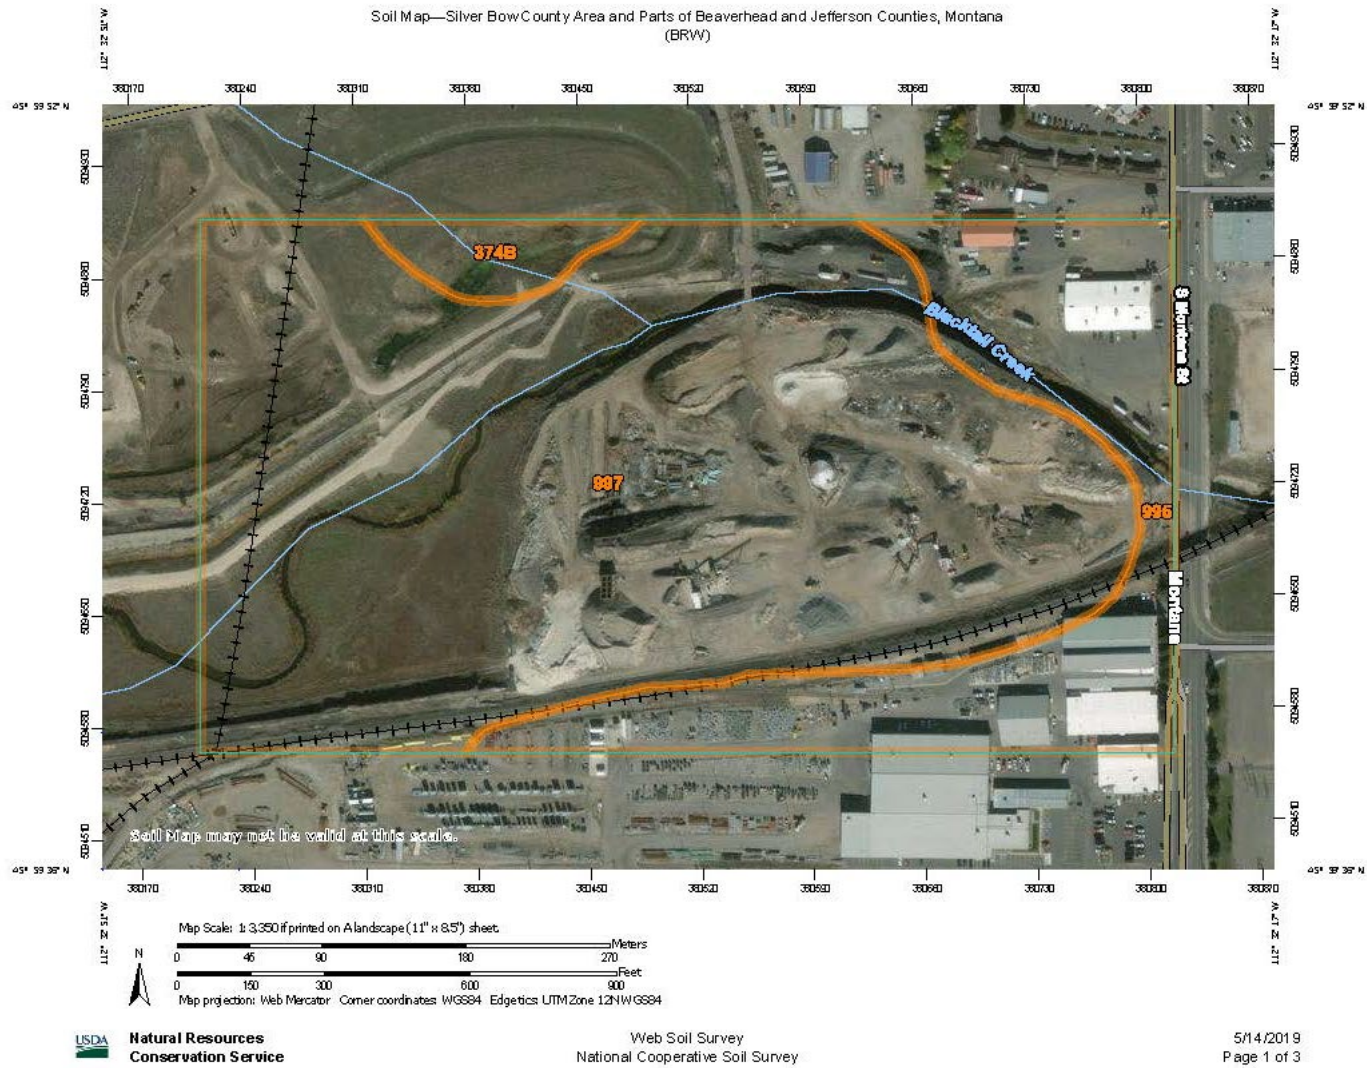
Figure 3. NRCS Soil Mapping

Soil Map—Silver Bow County Area and Parts of Beaverhead and Jefferson Counties, Montana
(BRW)

Map Unit Symbol	Map Unit Name	Acres in AOI	Percent of AOI
374B	Valleyflat sandy loam, 1 to 4 percent slopes	1.4	2.8%
995	Dumps, garbage	11.0	22.0%
997	Dumps, mine	37.7	75.2%
Totals for Area of Interest		50.1	100.0%

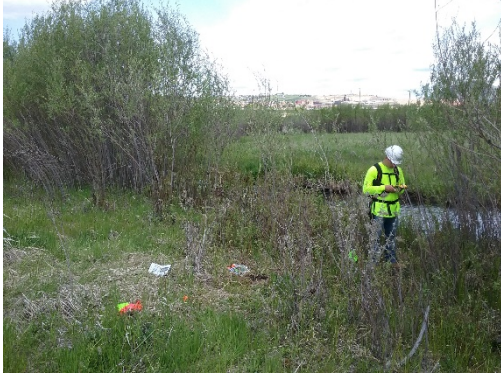
Plot 1. Green flag indicates the transition from a wetland to an upland. Groundwater influenced by streamflow.

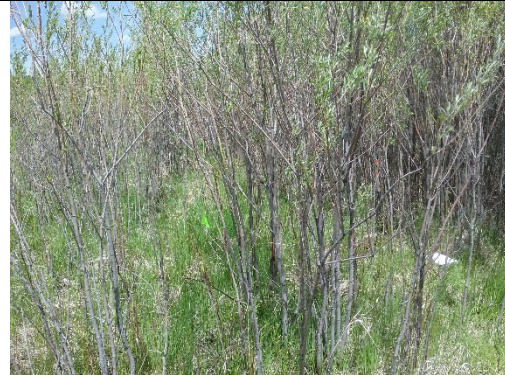
Plot 2. Green flag indicates transition from a wetland to a non-wetland riparian area based on depth to saturation. Shrub-scrub community type.

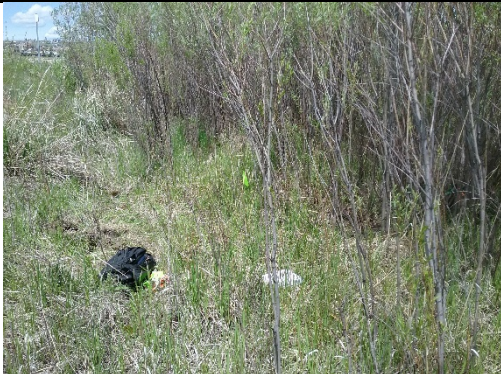
Plot 3. Green flag indicates transition from a wetland to a non-wetland riparian area. Shrub-scrub community type.

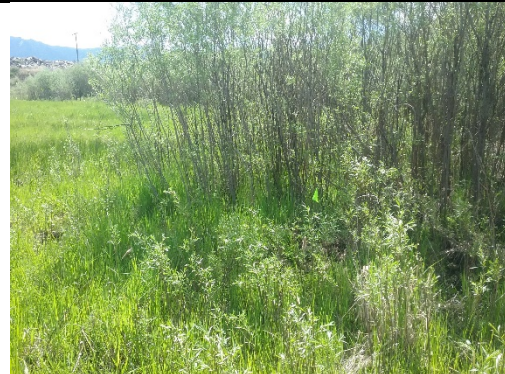
East of Plot 4. Green flag indicates transition from a wetland to a non-wetland riparian area based on depth to saturation. Shrub-scrub community type.

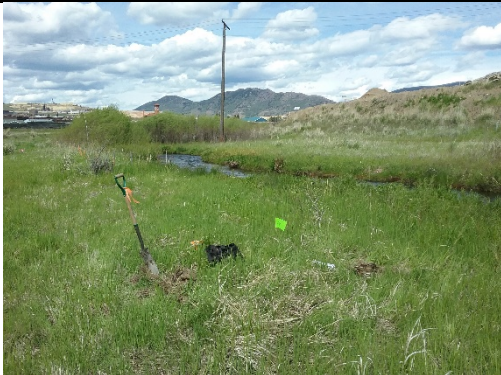
Plot 5. Green flag indicates transition from a wetland to a non-wetland riparian area based on depth to saturation. Palustrine emergent community type.

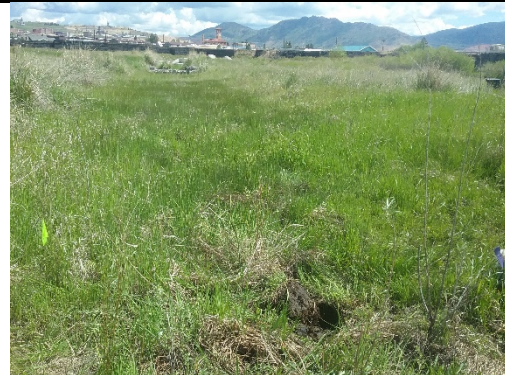
Plot 6. Green flag indicates transition from a wetland to a non-wetland riparian area (behind flag) based on depth to saturation. Palustrine emergent community type and is a low area, possibly historic channel.

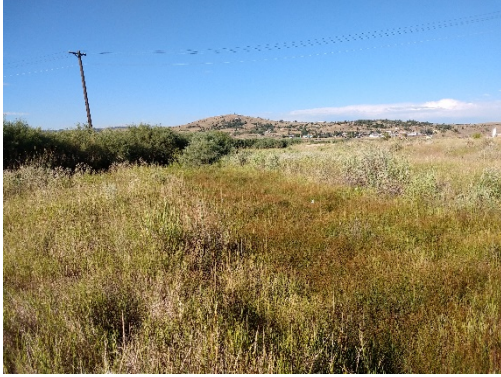
Plot 7. Transition from a non-wetland to a wetland riparian area based on depth to saturation. Palustrine emergent community type.

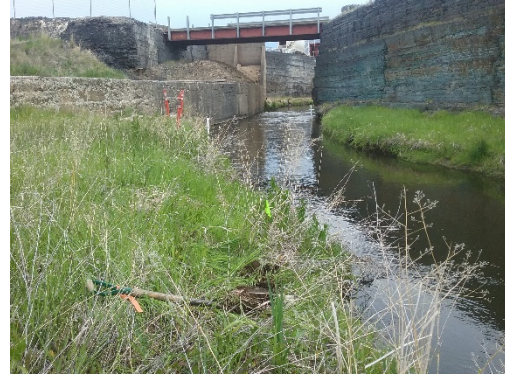
Plot 8. Green flag indicates transition from a wetland to a non-wetland riparian area. Delineation terminates against the stream area and upstream bank area is not a jurisdictional wetland area.

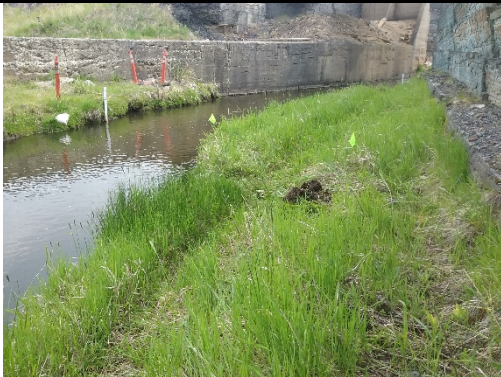
Plot 9. Green flag indicates delineation route, beginning at creek and terminating at slag pile.

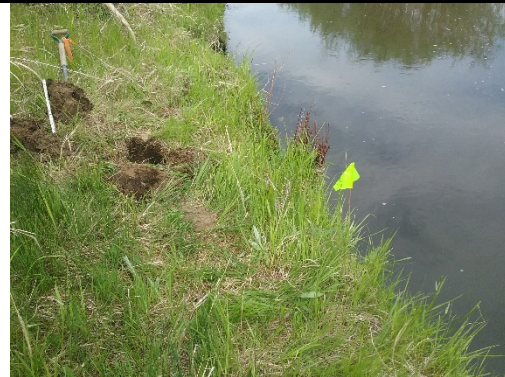
Plot 10. Green flag indicates end of delineation at stream edge. Excavation did not indicate saturation within 16 inches of surface.

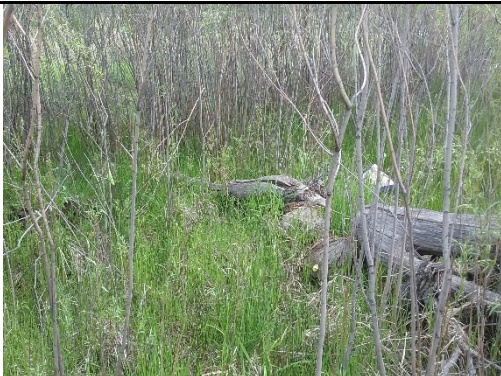
Plot 11. Green flag indicates transition from a wetland to a non-wetland riparian area based on depth to saturation. Shrub-scrub community type.

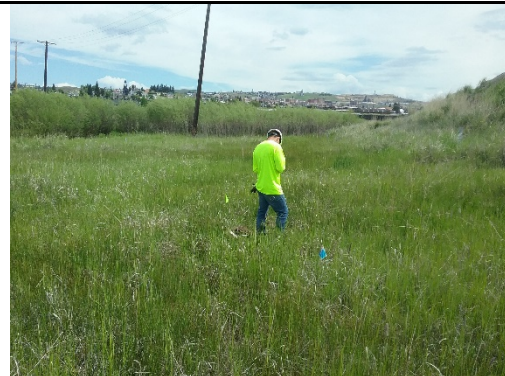
Plot 12. Green flag indicates transition from upland (right) to wetland/terrace (left). Groundwater emanating from upslope area.

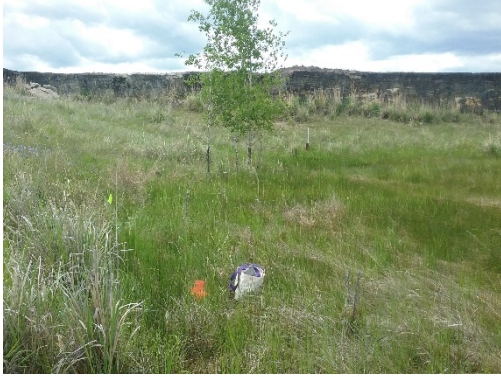
Plot 13. Southeast corner of terrace/floodplain, looking southward. Green flag indicates transition from upland (left) to wetland/terrace (right). Groundwater emanating from upslope area.

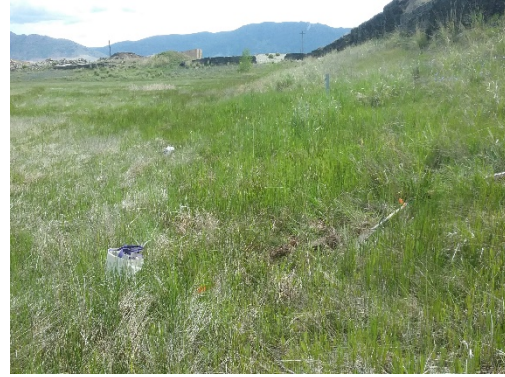
Plot 14. Southwest end of terrace/floodplain, looking eastward. Transition from upland (right) to wetland/terrace (left). Groundwater emanating from upslope area.
