**Butte Priority Soils Operable Unit (BPSOU) Insufficiently
Reclaimed Sites - Field Sampling and Investigation Plan (FSP)
BRES No. 104 - Colorado Dump**

September 29, 2021

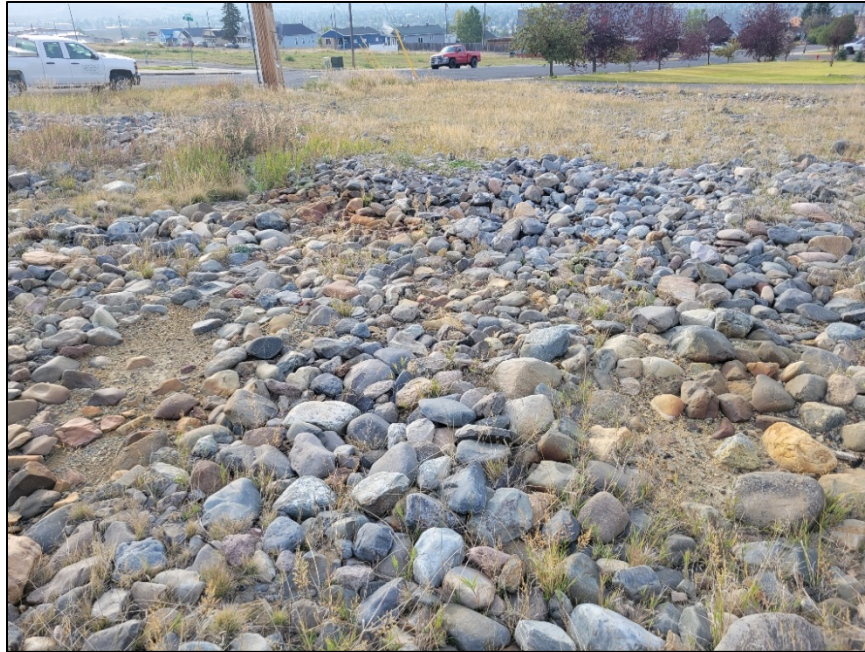
Photograph 1. Possible Mining Waste Leaching through Rock Cap

A preliminary site visit was conducted to better qualify existing site conditions and identify areas of focus for additional evaluation. The site consisted of a decomposing engineered cap that appears to have mine waste leaching through the rock cap, as shown in Photograph 1 below.

- Evaluate 2 concrete shaft caps.
- Coordinate remedy and end land use with landowner(s).
- Remove existing engineered (rock) cap.
- Evaluate adequacy of existing storm water structures to 25-year, 24-hour, Soil Conservation Service (SCS) Type I storm event requirements.
- Evaluate installation of additional storm water controls designed for a 25-year, 24-hour, SCS Type I storm event.
- Evaluate site storm water controls to mitigate run on/runoff.
- Identify remedial improvements to mitigate site erosion and vegetative areas to meet BHRS.

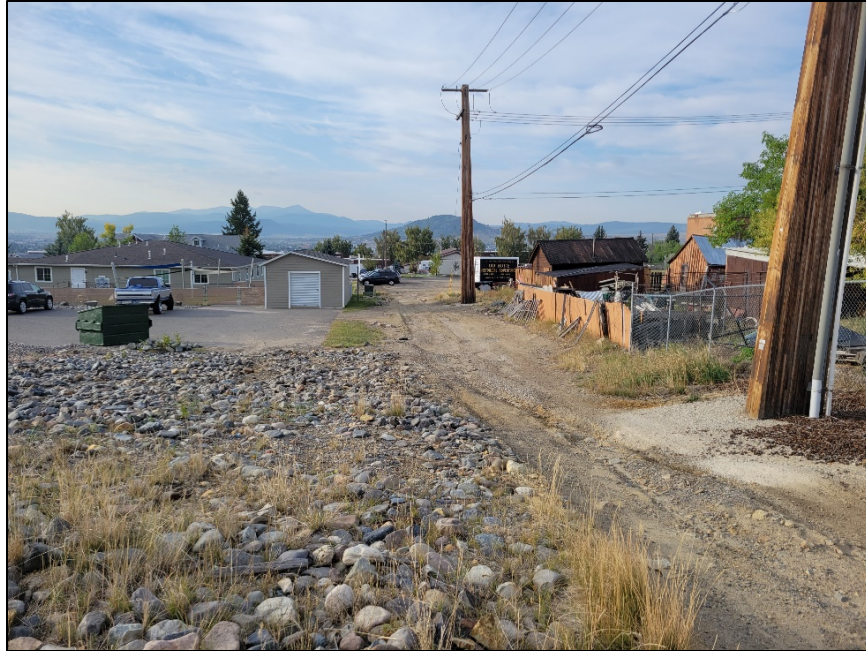
Photograph 2. Storm Water Flows Causing Rills that Transport Material to the South End of the Alleyway.

Storm water flows causing sediment conveyance into the site boundary are suspected to be originating from adjacent property located on the corner of Park and Main Street. As seen in Photograph 2 below, flows are causing rills to develop that transport materials to the south end of the alleyway.

An adjacent property owner is currently building a new parking lot that is predicted to increase flows and sediment deposition during high storm water events. There are potential measures to divert water to a manhole location (SWC AB-M-2201) located 10 feet north of the concrete foundation (shown in Photograph 3). Additional evaluation of the storm water structure is warranted.

Existing site grading will be evaluated to determine storm water flow patterns and identify potential additional storm water controls to prevent sediment migration. The location and condition of existing storm water features will be field verified and recorded for appropriate implementation into corrective actions. Upgradient and adjacent contributing sources of storm water will also be investigated.

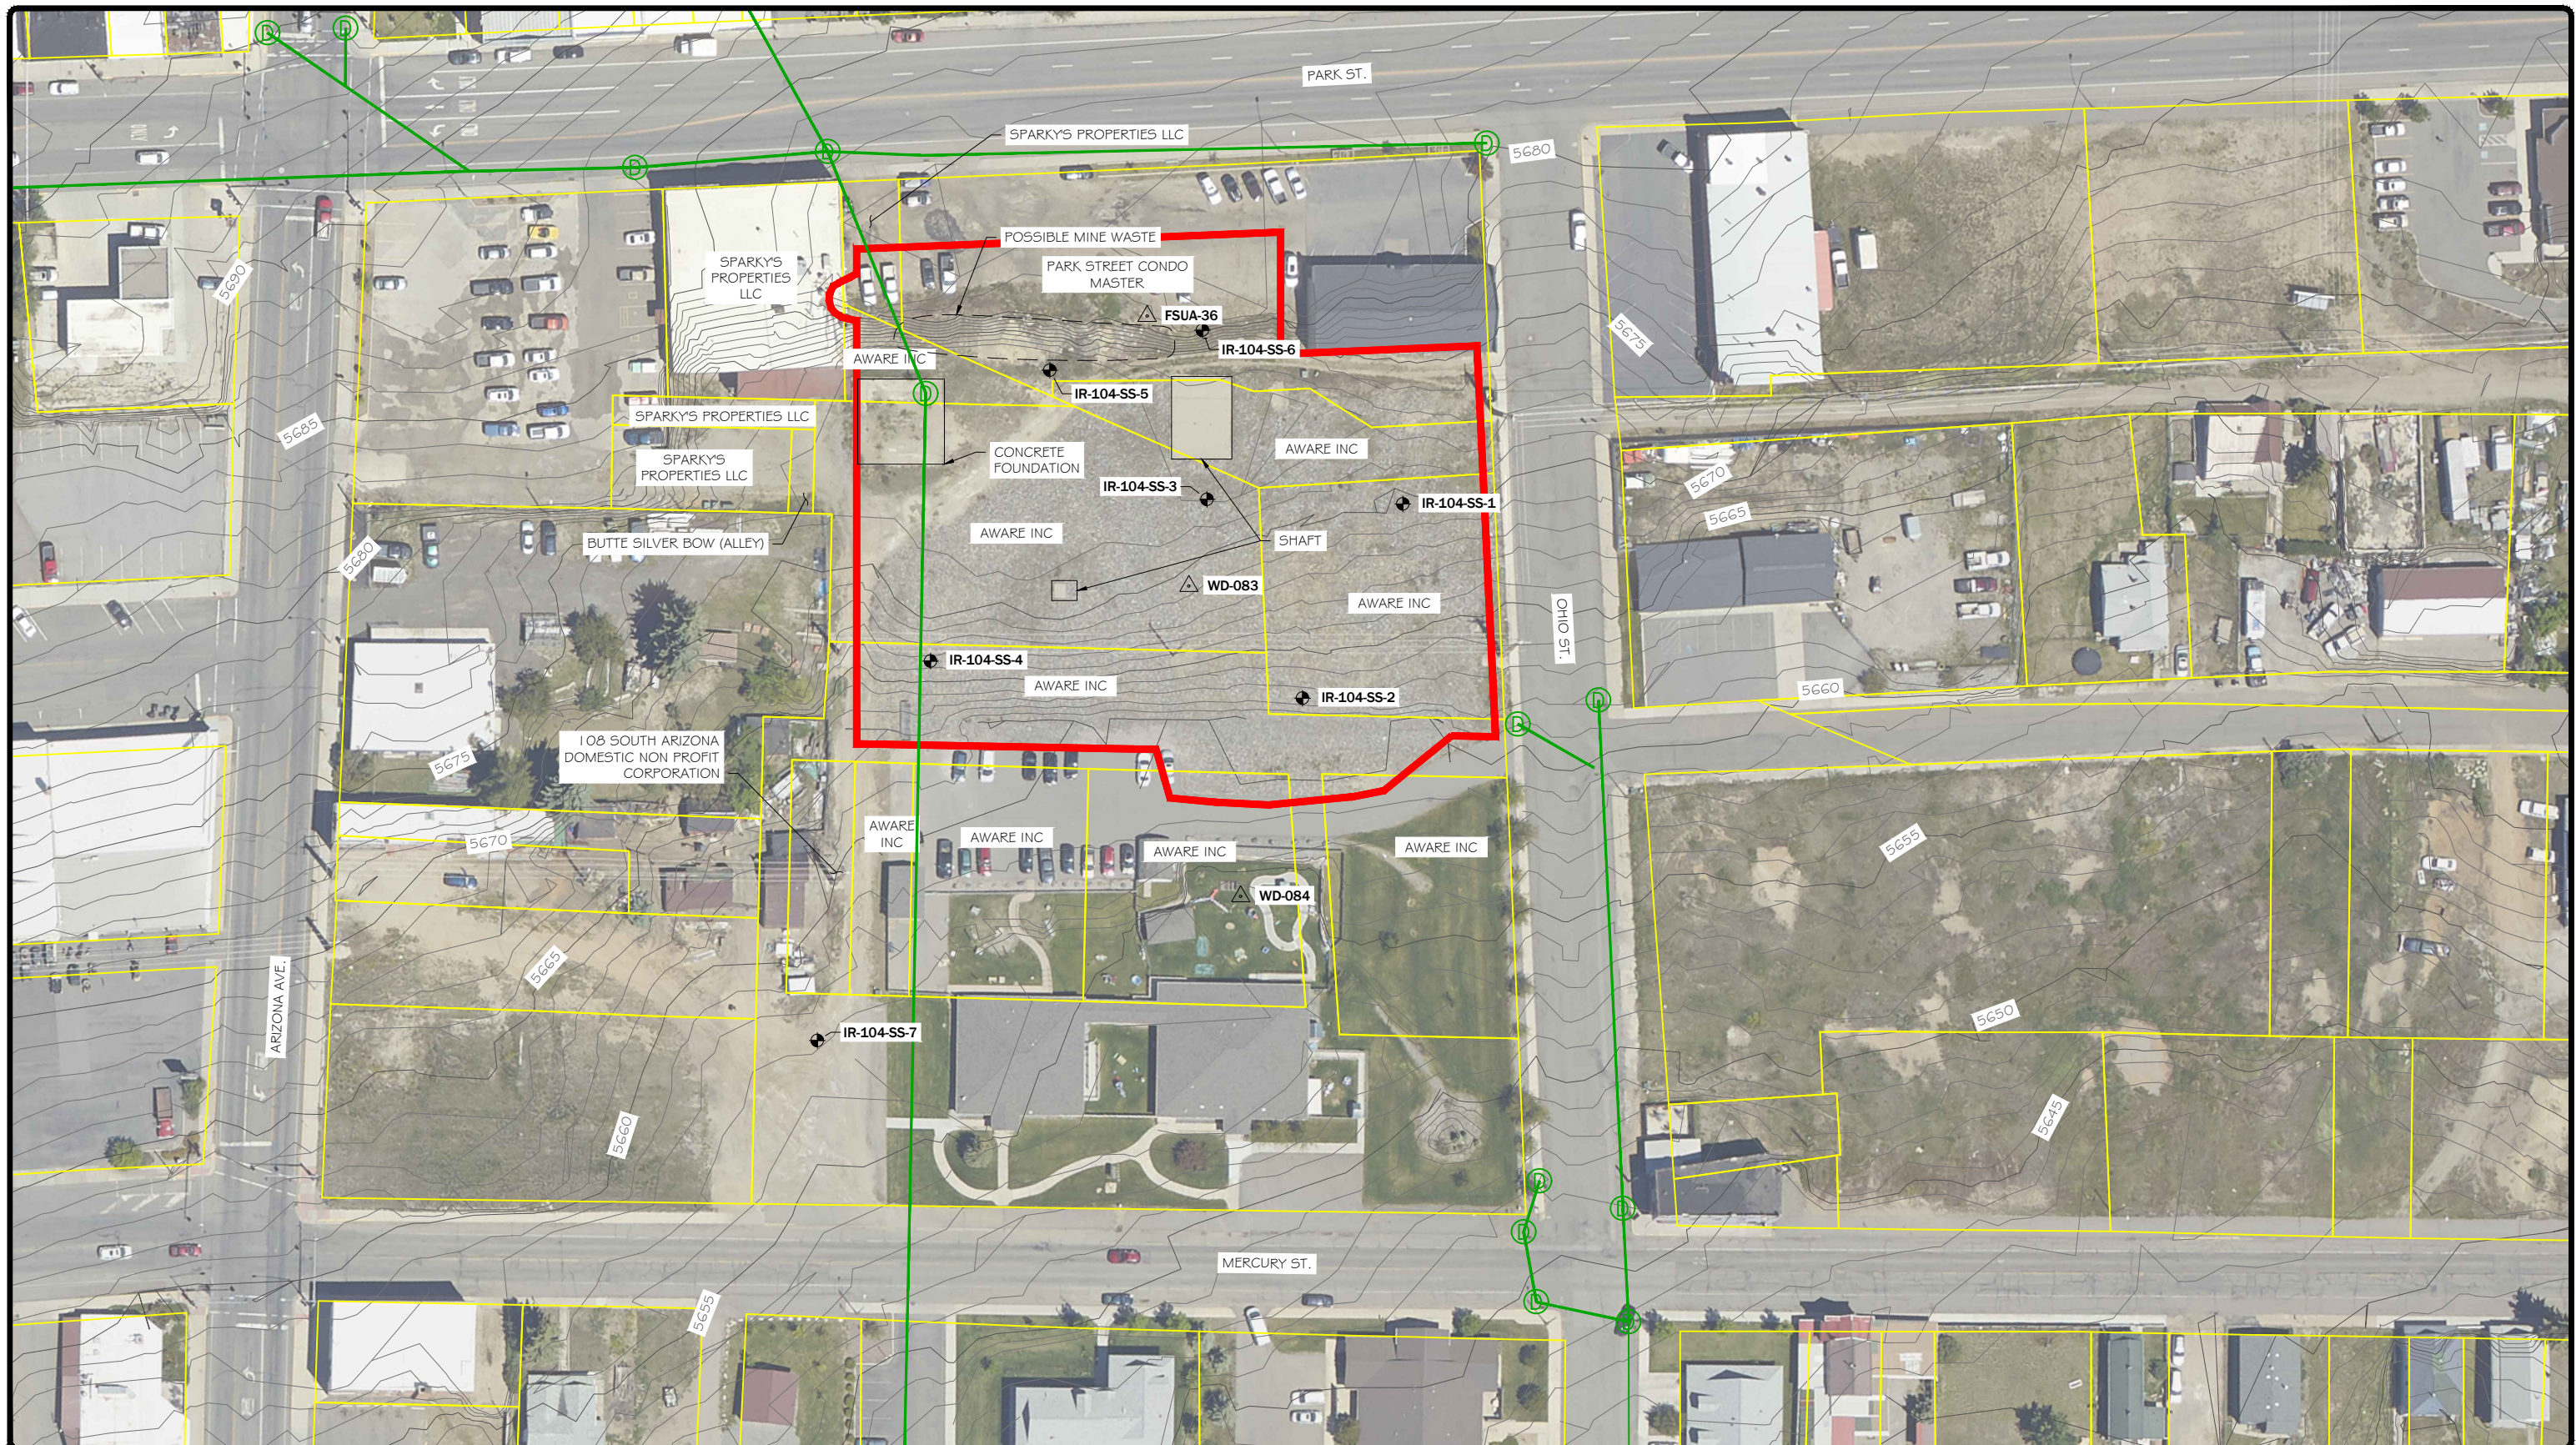
FIGURE 1 INSUFFICIENTLY RECLAIMED SITES

The site evaluation will include reviewing previous Butte Reclamation Evaluation System (BRES) field evaluations (if available), on-site evaluations, and construction completion reports if available. The site evaluation will include additional sampling performed according to the Atlantic Richfield Company 2021 Final Reclaimed Areas Maintenance and Monitoring (M&M) Quality Project Plan (QAPP) (referred to as Reclaimed Areas M&M QAPP), which is a component of the BPSOU Solid Media Management Project Plan. Field sampling will be performed to determine the presence of contaminants, adequacy of growth media, or previously unidentified sources contributing to site deficiencies. This Field Sampling and Investigation Plan (FSP) provides details related to field evaluation of the Insufficiently Reclaimed Site BRES No. 104 - Colorado Dump. Proposed soil sampling locations and areas of known deficiencies are shown on Figure 1.

Per the Reclaimed Areas M&M QAPP, the site will be sampled at 2 depth intervals (0-6 inches and 6-18 inches) to determine the presence of waste and/or confirm the depth and previous reclamation efforts. Figure 1 illustrates proposed sample locations. Opportunistic samples may be obtained in the field at the discretion of field sampling personnel or Agency oversight representative(s).

PROPOSED SAMPLE LOCATION

Data obtained from the Geocortex web-based database at <https://eis2.woodardcurran.com/Html5Viewer/index.html?viewer=BPButte.BPSOU> contains the records for previous soil samples collected near the BRES No. 104 – Colorado Dump. The approximate sample locations are shown on Figure 1 with results provided in Table 1 below. Sample results highlighted below exceed Record of Decision (ROD) Solid Media soil screening criteria. The BPSOU action levels are listed in Table 3 (Section 2.6.1) of the Reclaimed Areas M&M QAPP.
