Silver Bow Creek/Butte Area Superfund Site

Response to Comments to the Butte Priority Soils Operable Unit (BPSOU) Unreclaimed Sites Draft Final Field Sampling Plan (FSP) Package #7: UR-01, UR-12, UR-03, UR-04, UR-15, and UR-17

**Butte Priority Soils Operable Unit (BPSOU) Unreclaimed Sites Final Field Sampling Plan (FSP)
Package #7: UR-01, UR-02, UR-03, UR-04, UR-15, and UR-17**

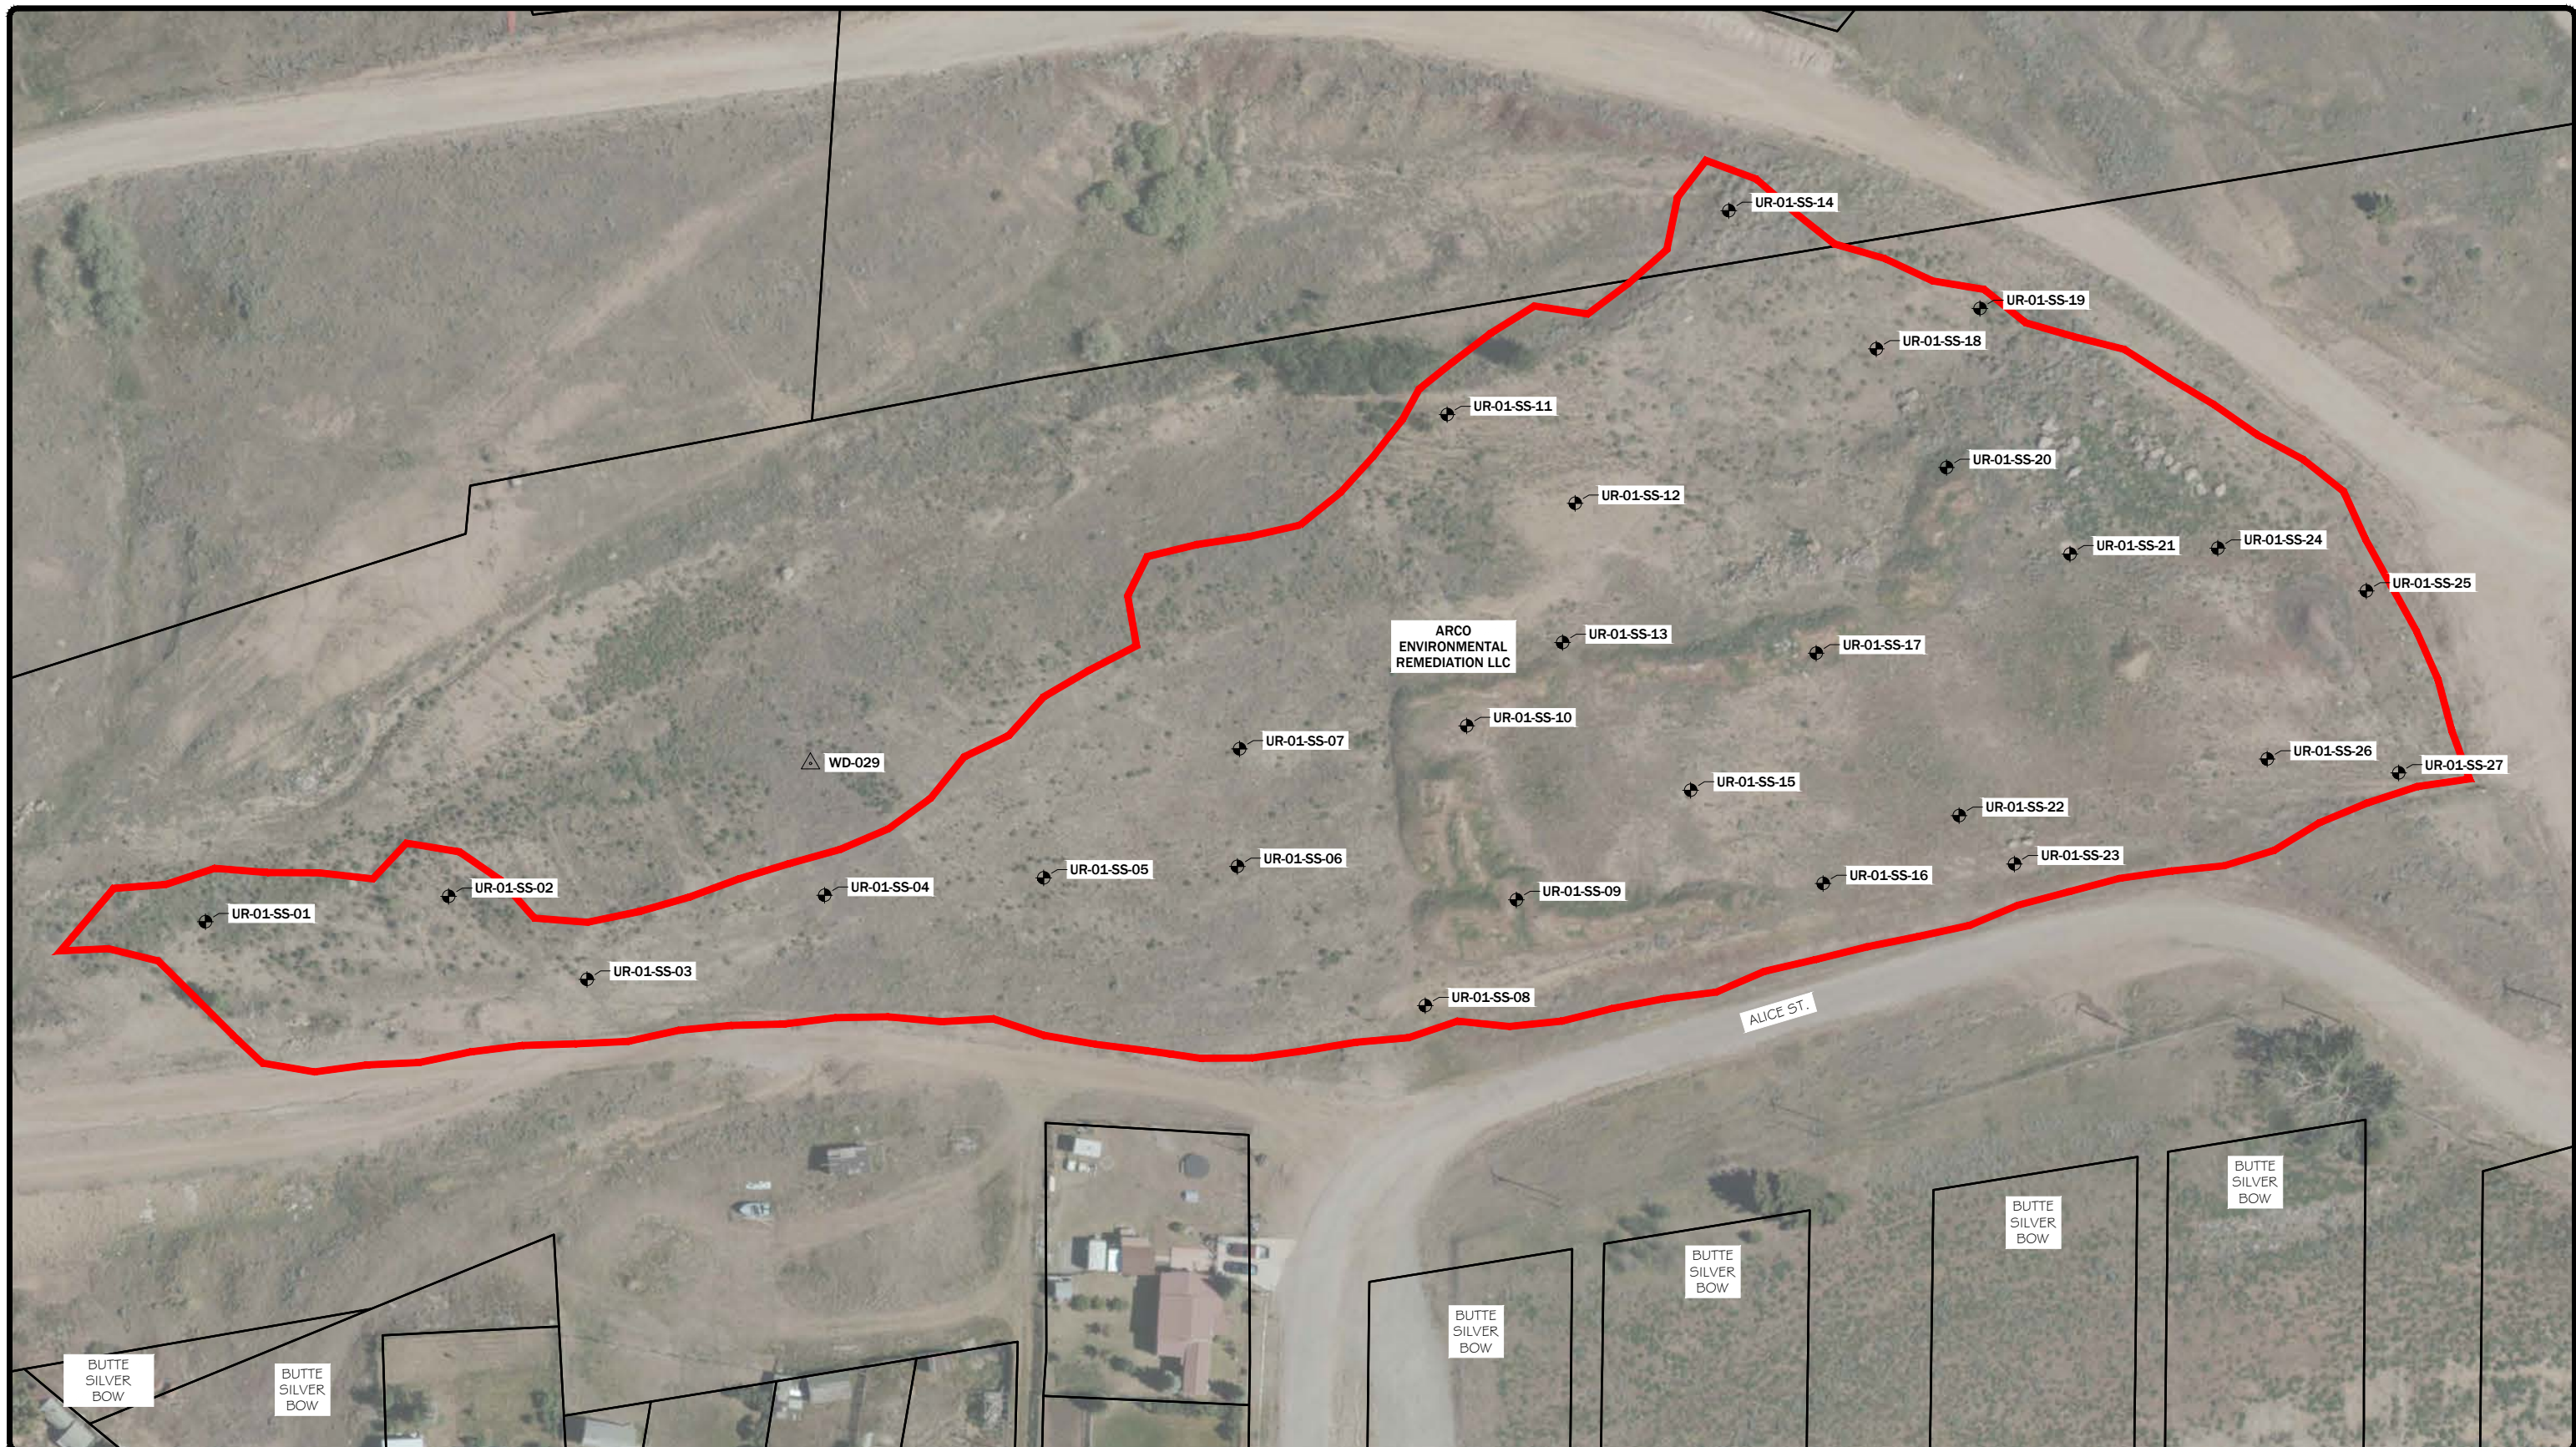
FIGURE 1 UNRECLAIMED SITE
 UR-01
 PROPOSED
 SAMPLE LOCATIONS

UR-01 IS 5.44 ACRES

Site UR-01 is approximately 9.2 acres and is located north of Walkerville and just north of the Alice Pit. Site UR-01 is bounded on the south by North Alice Street and on the north by Ryan Road (Figure 1). Ownership of Site UR-01 includes Atlantic Richfield Company and a private third party.

Site UR-01 is vacant land with well-established vegetation and several bare areas including windrows of dumped material. The dumped material is covered with established weeds and grasses. Erosion rill starting from the middle of the site running northwest into the drainage ditch appears to have iron staining and impacted soils. There are residences within 200 feet of UR-01 in several directions. Site UR-01 is in the Beef Straight Gulch drainage basin.

Data obtained from the Geocortex web-based database at <https://eis2.woodardcurran.com/Html5Viewer/index.html?viewer=BPButte.BPSOU> contain the record for one previous soil sample near Site UR-01. Arsenic sample results contain the letter “J” which is indicative of a data qualifier. The letter “J” accompanying sample results typically indicates specific criteria may not have been met when analysis was performed, and results are considered qualified. These criteria are dependent upon laboratory protocol. Laboratory data qualifiers are defined in the data deliverable provided by the laboratory which performed the analysis. The EPA 2020 National Functional Guidelines for Inorganic Superfund Methods Data Review provides the following definition for J qualified data, “*The result is an estimated quantity. The associated numerical value is the approximate concentration of the analyte in the sample.*” The approximate sample location is shown on Figure 1 with the results provided in Table 1 below. None of the results listed exceed the BPSOU action levels. The BPSOU action levels are listed in Tables 1 and 2 of the UR Sites QAPP.

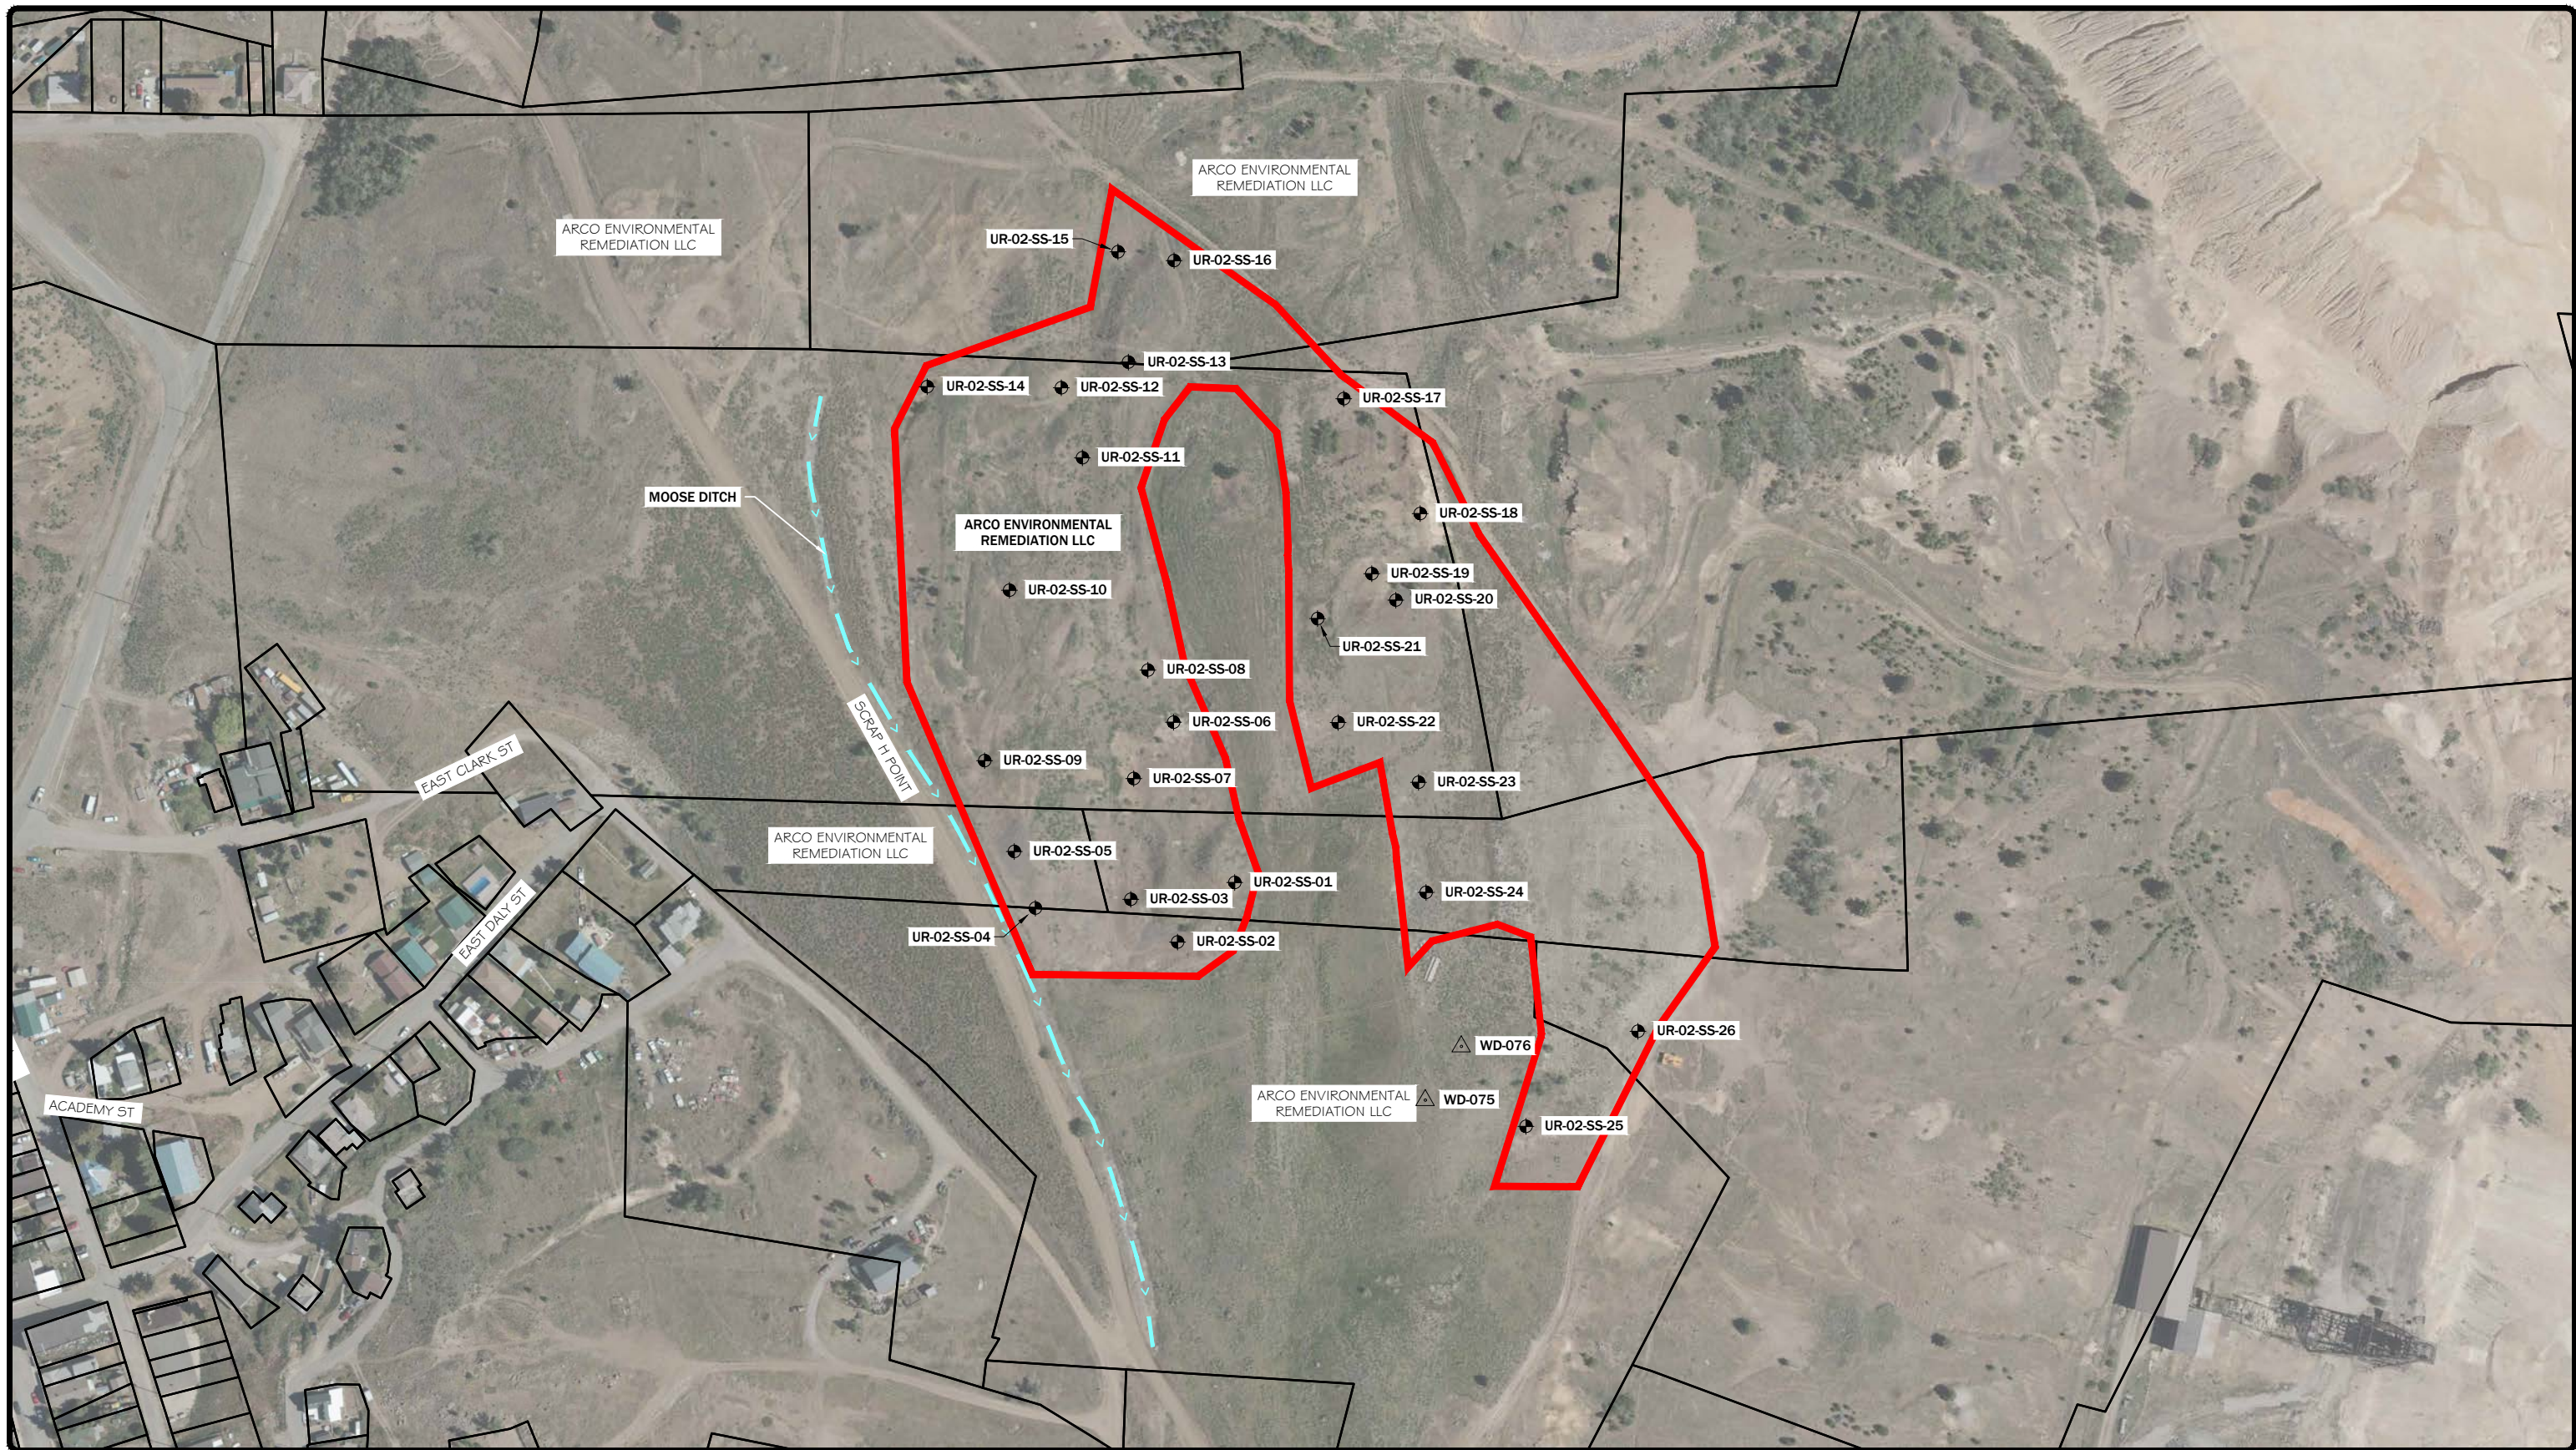
FIGURE 2 UNRECLAIMED SITE
UR-02
PROPOSED
SAMPLE LOCATIONS

UR-02 IS 12.80 ACRES

Site UR-02 is approximately 12.8 acres and is located east of Scrap H Point Road in Walkerville near Moose Dump (BRES No. 12). Site UR-02 is bounded by a 4-strand barbed wire fence on the west along Scrap H Point Road (Figure 2). Site UR-02 is located on property owned by Atlantic Richfield Company and a private third party.

Site UR-02 is vacant land with several bare areas and heavily impacted with mining waste including debris and garbage dumps. The Moose Ditch (AB-D-S001) riprap-lined drainage channel is located between the barbed fence and Scrap H point.

Data obtained from the Geocortex web-based database at <https://eis2.woodardcurran.com/Html5Viewer/index.html?viewer=BPButte.BPSOU> contain the records for previous soil samples near Site UR-02. The approximate sample locations are shown on Figure 2 with the results provided in Table 2 below. Results above BPSOU action levels are highlighted in Table 2. The BPSOU action levels are listed in Tables 1 and 2 of the UR Sites QAPP.

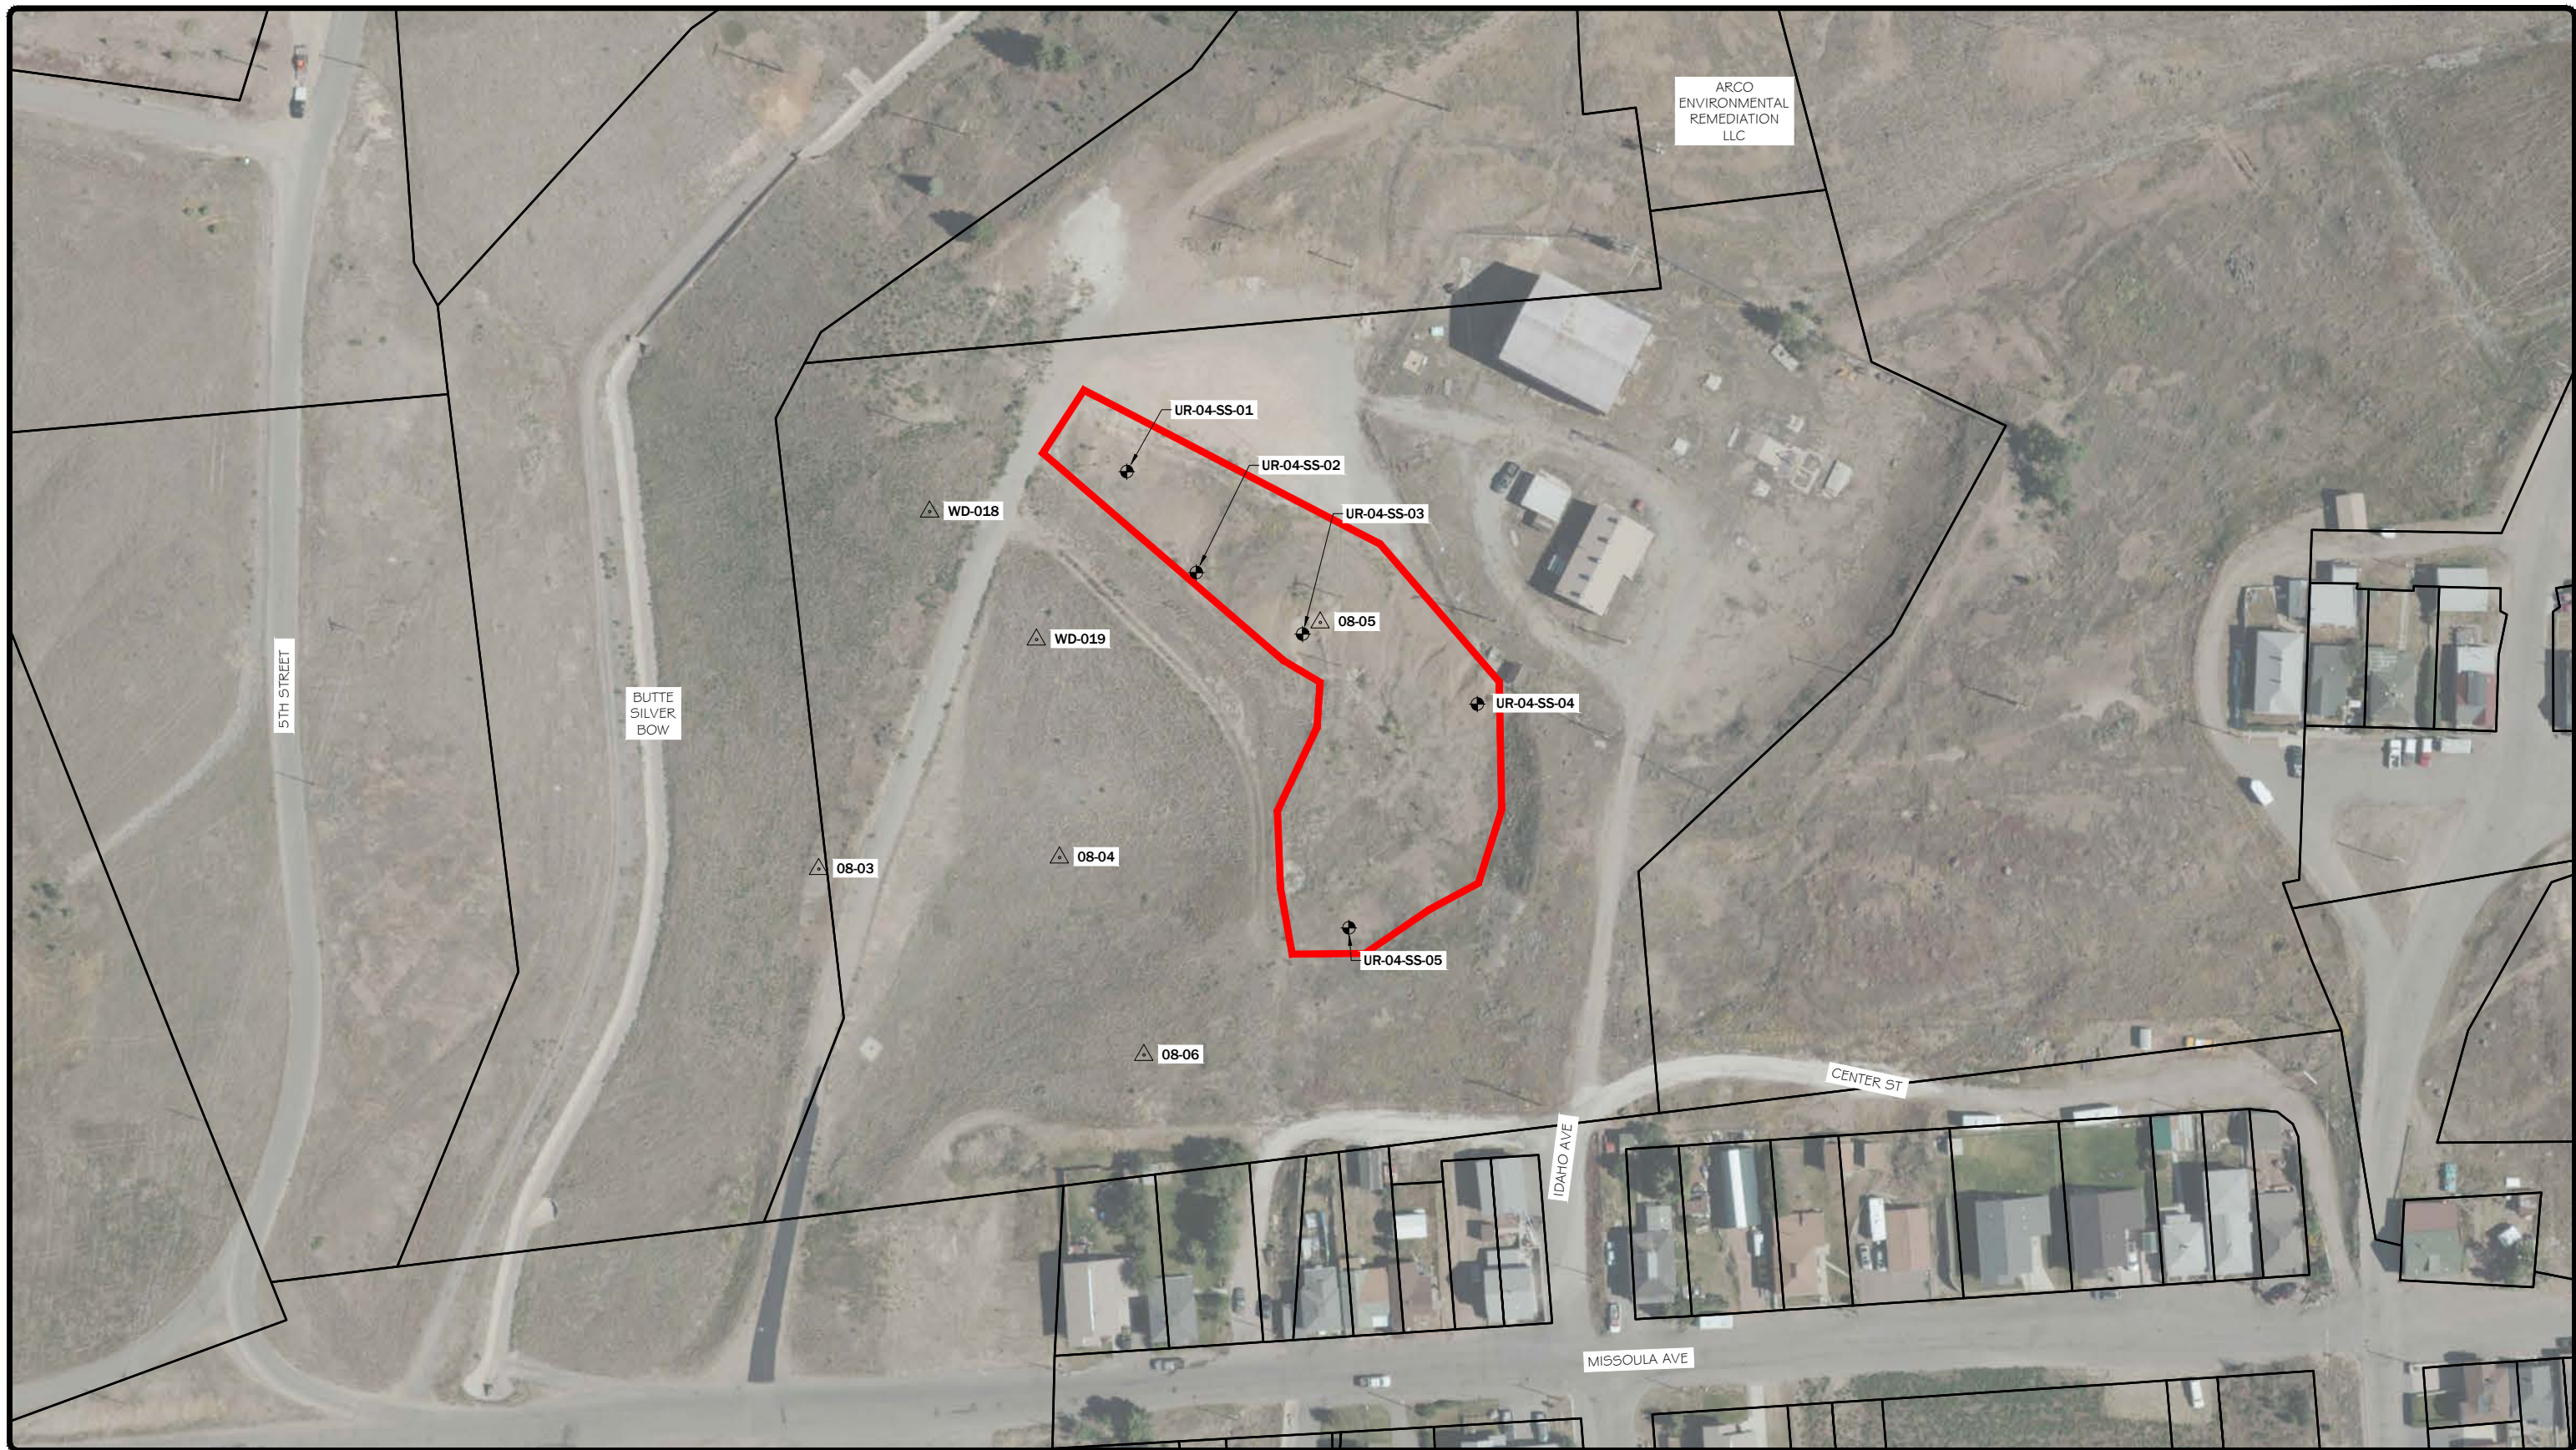
FIGURE 4 UNRECLAIMED SITE UR-04 PROPOSED SAMPLE LOCATIONS

LEGEND:
 ● PROPOSED SOIL SAMPLE LOCATION
 ▲ PREVIOUS SOIL SAMPLE LOCATION
 UR-04 IS 0.9 ACRES

Site UR-04 is approximately 0.9 acres. It is located slightly south of Walkerville and just northwest of the intersection of North Idaho and Center Streets (Figure 4), on the east side of the Missoula Gulch drainage. Site UR-04 consists of a poorly vegetated, southwest facing slope that is immediately southwest of the former Missoula Mine yard. An especially steep area in the middle of the site appears to consist of mine waste, based on yellow color and clayey texture of the soil. The south lobe of site UR-04 has better vegetation than the rest of the site, but there are still bare areas and a dump area that may contain waste rock.

Site UR-04 is owned by a private third-party. Site UR-04 is vacant land in a largely open-space area. There are several residences about 150 feet south of Site UR-04 along Missoula Avenue. Site UR-04 is in the Missoula Gulch drainage basin.

Data obtained from the Geocortex web-based database at <https://eis2.woodardcurran.com/Html5Viewer/index.html?viewer=BPButte.BPSOU> contain the record for previous soil samples within or near Site UR-04. Some sample results contain the letter “J” which is indicative of a data qualifier. The letter “J” accompanying sample results typically indicates specific criteria may not have been met when analysis was performed, and results are considered qualified. These criteria are dependent upon laboratory protocol. Laboratory data qualifiers are defined in the data deliverable provided by the laboratory which performed the analysis. The EPA 2020 National Functional Guidelines for Inorganic Superfund Methods Data Review provides the following definition for J qualified data, “*The result is an estimated quantity. The associated numerical value is the approximate concentration of the analyte in the sample.*” The approximate sample locations are shown on Figure 4 with the results provided in Table 3 below. Some of the results listed show exceedances of BPSOU action levels for lead and zinc (highlighted in yellow). The BPSOU action levels are listed in Tables 1 and 2 of the UR Sites QAPP.

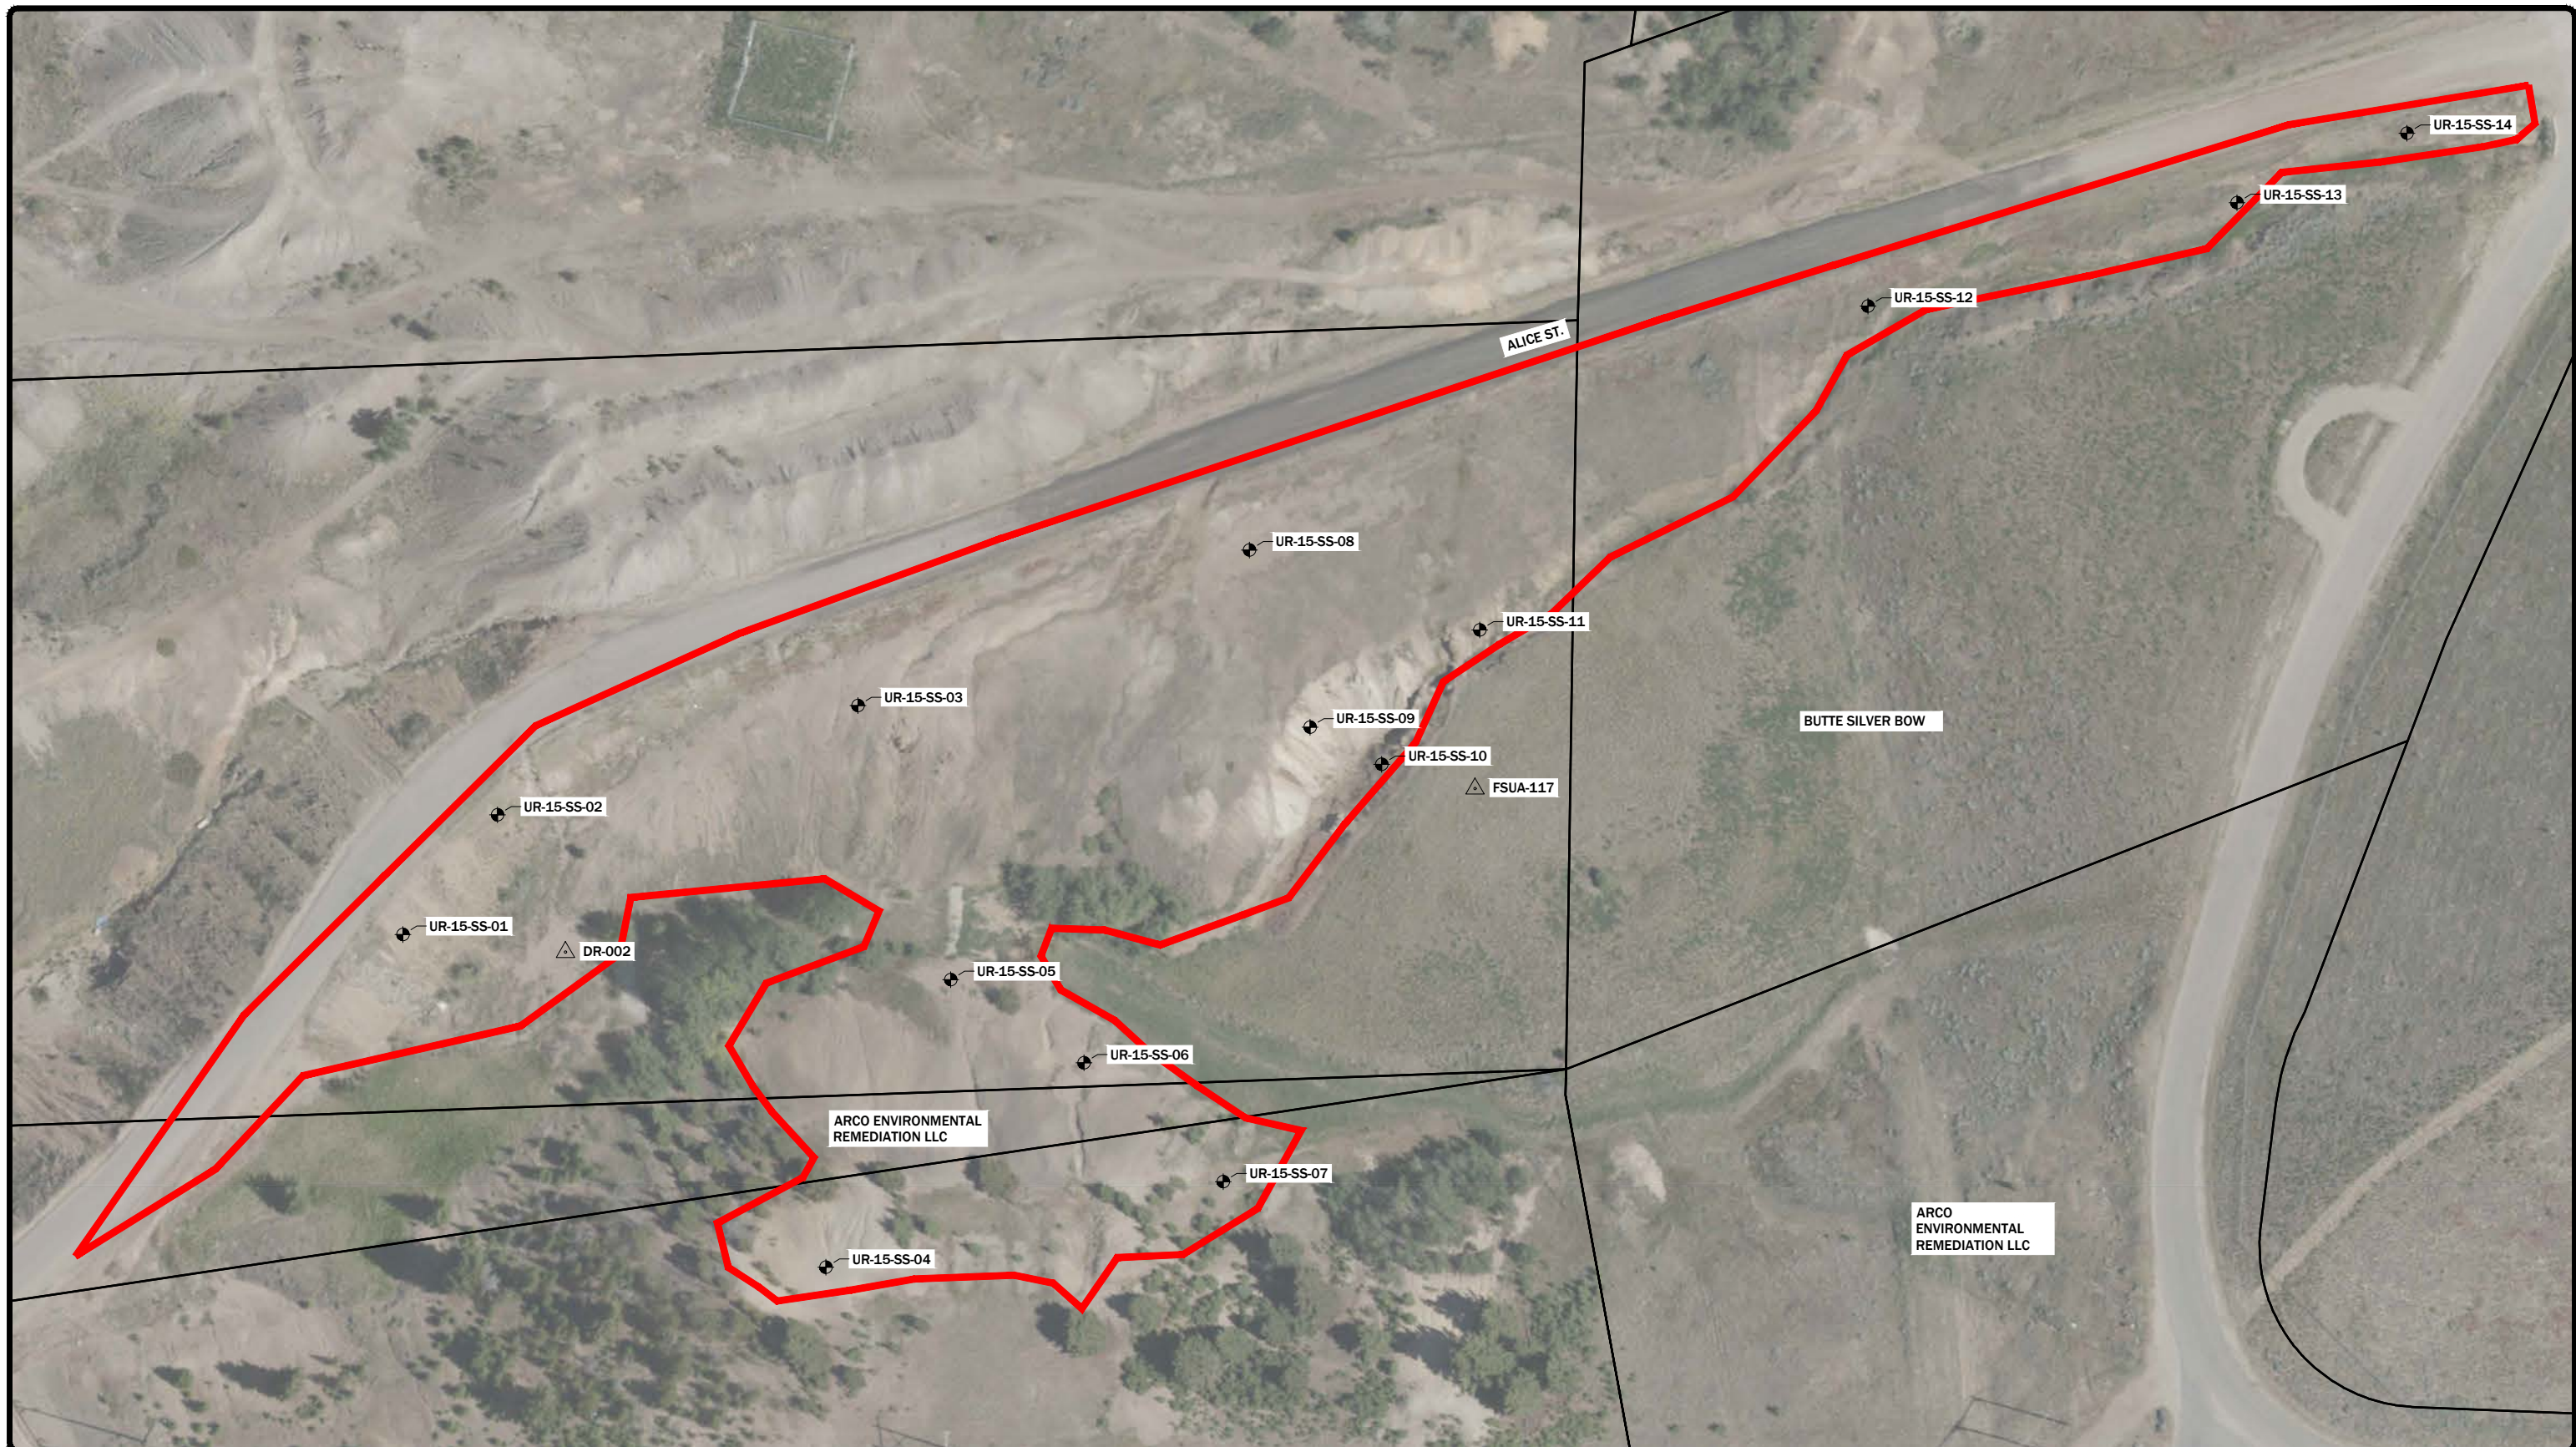
FIGURE 5 UNRECLAIMED SITE UR-15 PROPOSED SAMPLE LOCATIONS

LEGEND:
 ● PROPOSED SOIL SAMPLE LOCATION
 ▲ PREVIOUS SOIL SAMPLE LOCATION
 UR-15 IS 3.82 ACRES

Site UR-15 is approximately 3.8 acres and is located north of Walkerville and south of Ryan Road. The east end of Site UR-15 is at the southwest intersection of Ryan Road and Fourth Street (Figure 5). The site extends about 1,000 feet to the west of the intersection and is totally on the south side of Ryan Road. The site consists mostly of waste rock dumps that are bare. Beef Straight Creek forms part of the south border of Site UR-15 and also cuts through a portion of it. Ownership of Site UR-15 includes Butte-Silver Bow, Atlantic Richfield Company, and private third-party owners.

Site UR-15 is vacant land that has poor vegetation. The nearest residences are about 600 feet to the north and to the south. Site UR-15 is in the Beef Straight Gulch drainage basin.

Data obtained from the Geocortex web-based database at <https://eis2.woodardcurran.com/Html5Viewer/index.html?viewer=BPButte.BPSOU> contain the records for previous soil samples within or near Site UR-15. The approximate sample locations are shown on Figure 5 with the results listed in Table 4 below. Some of the results listed show exceedances of the BPSOU action levels for lead and zinc (highlighted in yellow). The BPSOU action levels are listed in Tables 1 and 2 of the UR Sites QAPP.

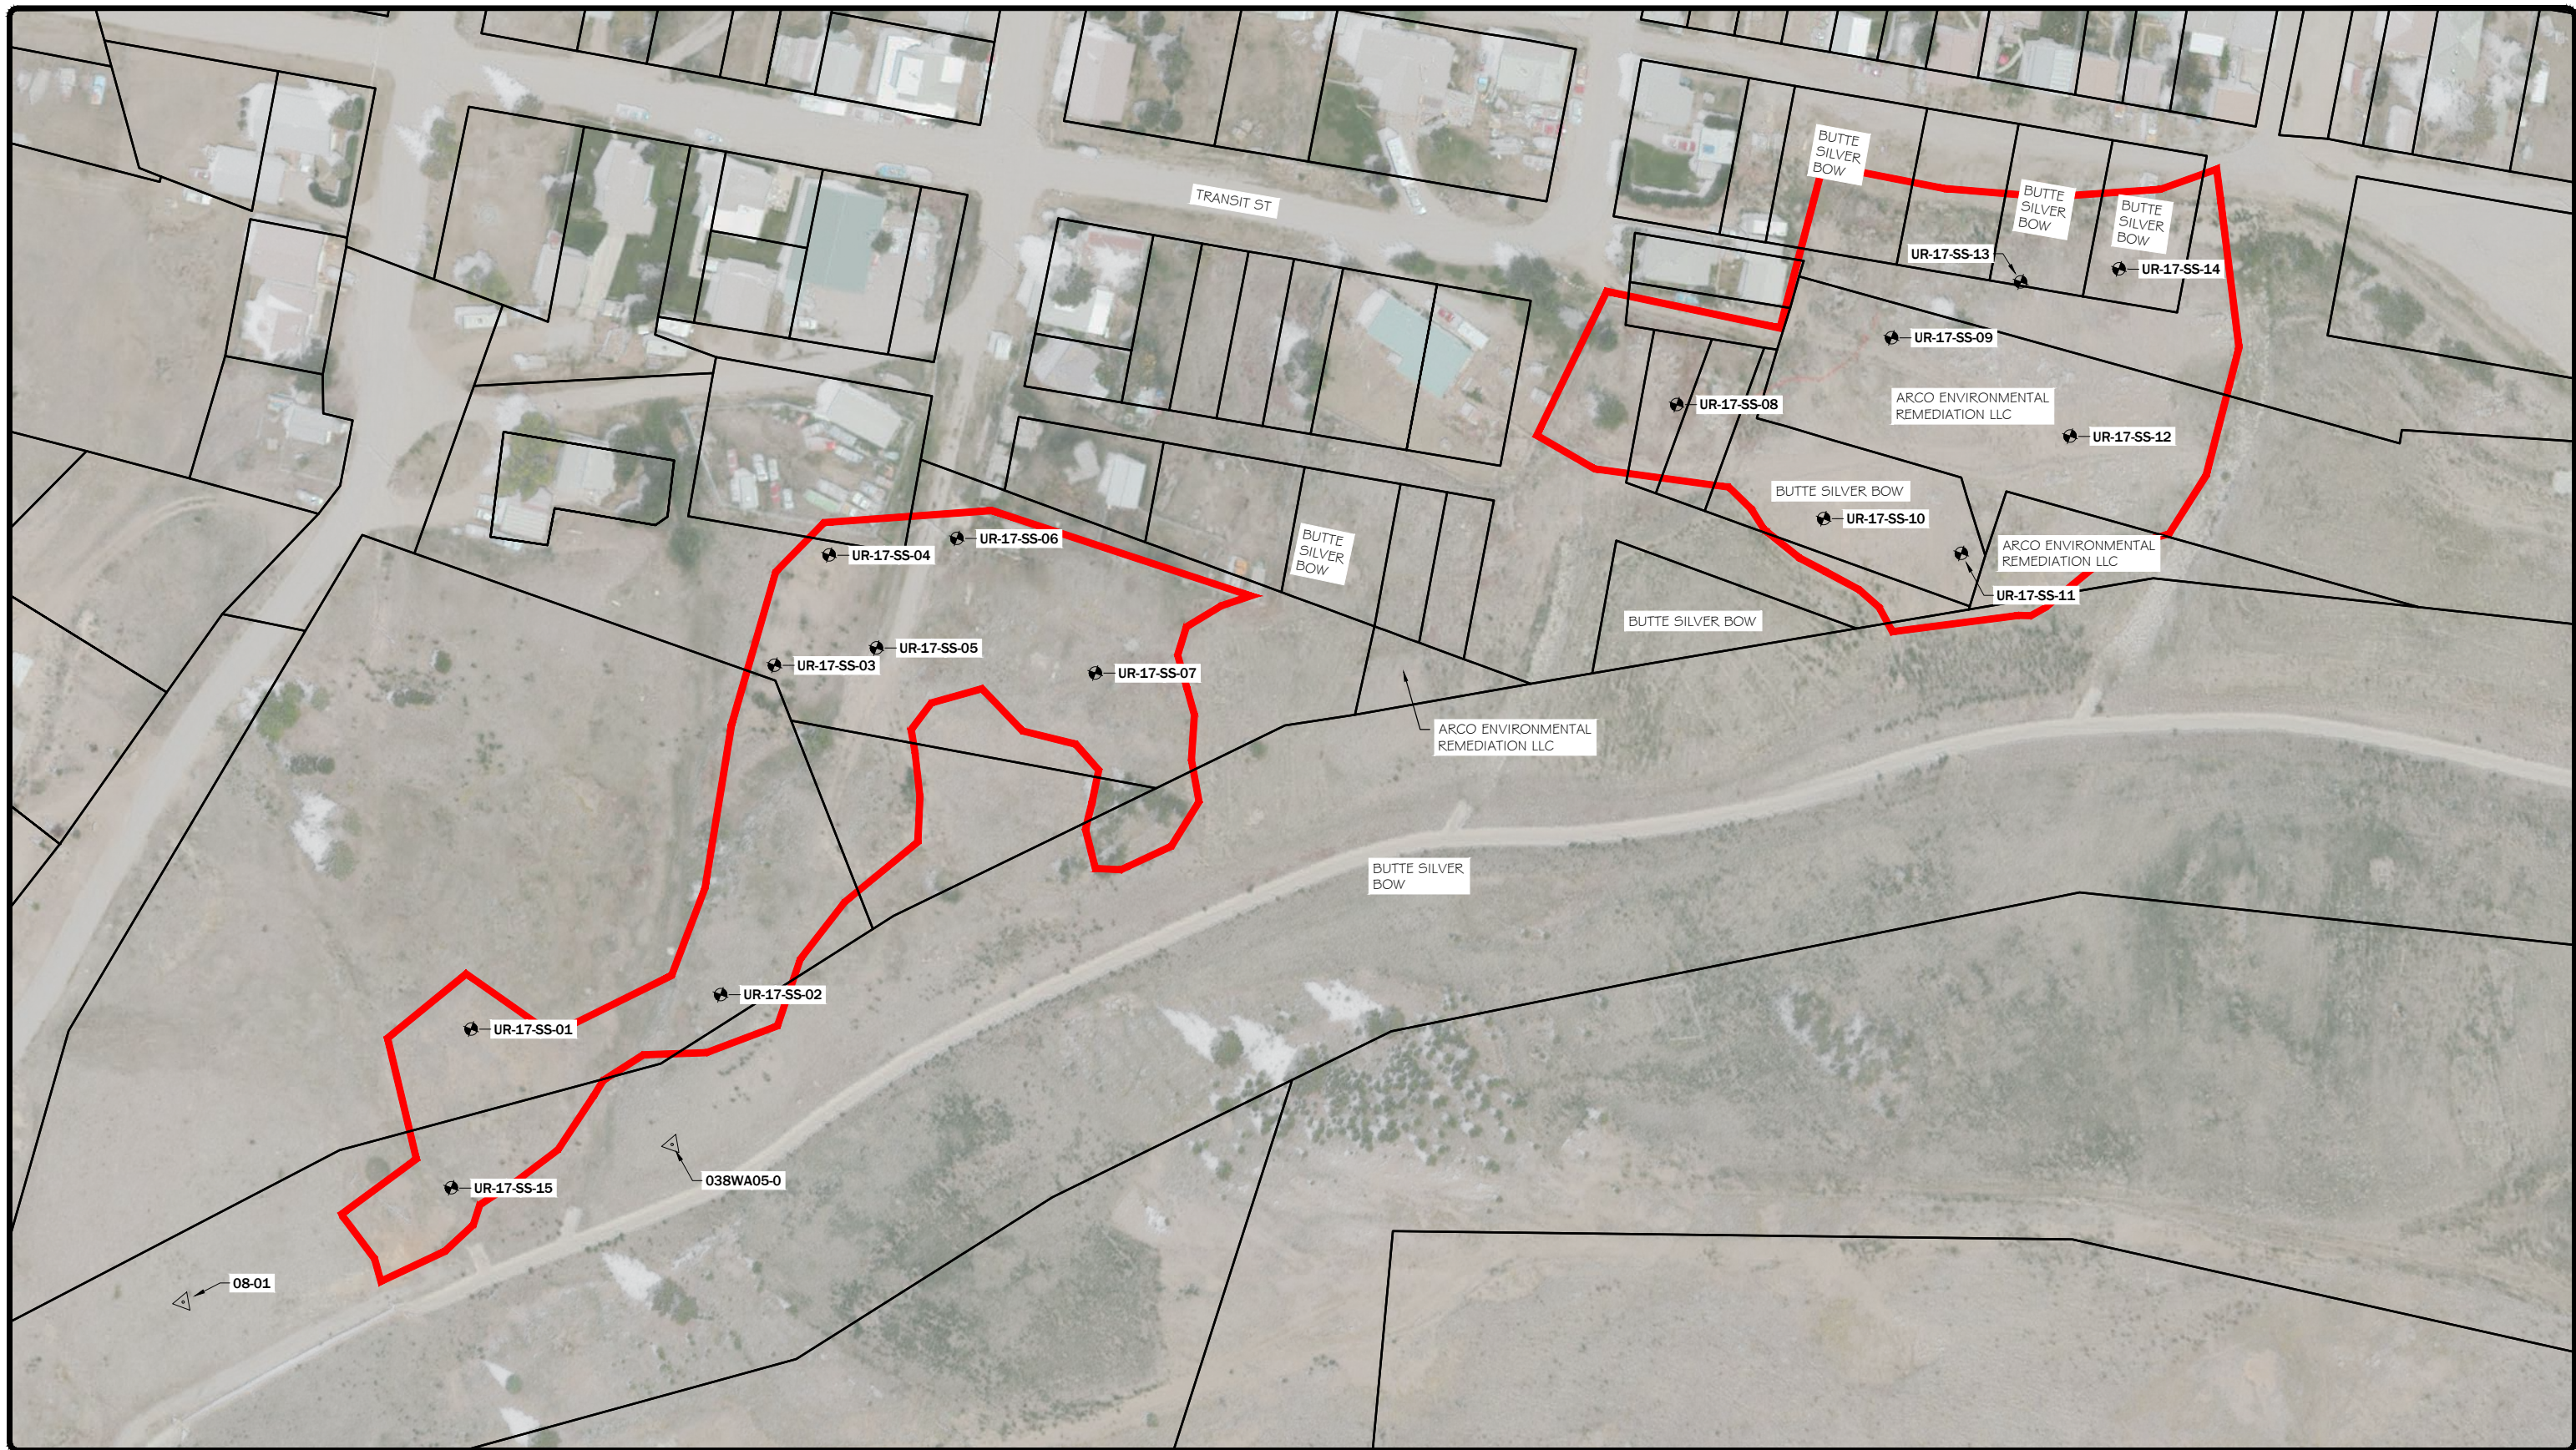
FIGURE 6 UNRECLAIMED SITE
 UR-17
 PROPOSED
 SAMPLE LOCATIONS

LEGEND:
 ● PROPOSED SOIL SAMPLE LOCATION
 ▲ PREVIOUS SOIL SAMPLE LOCATION
 UR-17 IS 3.60 ACRES

Site UR-17 is approximately 5.0 acres and is located in the upper reaches of the Missoula Gulch drainage on the south side of Walkerville (Figure 6) and consists of two non-contiguous UR areas to be evaluated. The site occupies a south-facing slope between a residential part of Walkerville and the bottom of Missoula Gulch. Ownership of Site UR-17 includes Atlantic Richfield Company, Butte-Silver Bow, and private third parties.

Areas comprising Site UR-17 are vacant land near residential areas with relatively good vegetation throughout the southwest section. There is an access road from 4th Street that contains a small gully and apparent impacted soils. The northeast section of the site has large bare areas with high manganese and iron staining. There are cars on top of the steep slopes that appear to have oil leaks running down the slope. Scrap metal and glass are found through the section with variants of soil colors and erosion. Site UR-17 is in the Missoula Gulch drainage basin.

Data obtained from the Geocortex web-based database at <https://eis2.woodardcurran.com/Html5Viewer/index.html?viewer=BPButte.BPSOU> contain the records for previous soil samples within Site UR-17. The approximate sample locations are shown on Figure 6 with the results listed in Table 5 below. Some of the results listed show exceedances of the BPSOU action levels for lead and zinc (highlighted in yellow). The BPSOU action levels are listed in Tables 1 and 2 of the UR Sites QAPP.
