Butte Priority Soils Operable Unit (BPSOU) Insufficiently Reclaimed Sites - Field Sampling and Investigation Plan (FSP) BRES No. 104 - Colorado Dump – Final

Butte Priority Soils Operable Unit (BPSOU) Insufficiently Reclaimed Sites - Field Sampling and Investigation Plan (FSP) BRES No. 104 - Colorado Dump - Final

INSUFFICIENTLY RECLAIMED SITES BRES-104 COLORADO DUMP PROPOSED SAMPLE LOCATIONS

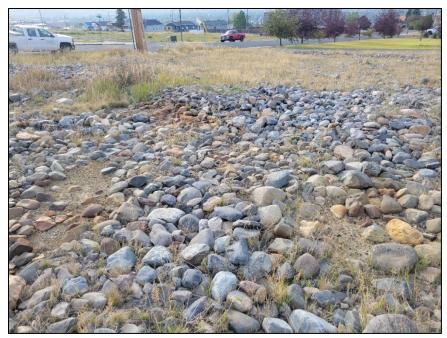
A preliminary site visit was conducted to better qualify existing site conditions and identify areas of focus for additional evaluation. The site consisted of a decomposing engineered cap that appears to have mine waste leaching through the rock cap, as shown in Photograph 1 below.

Photograph 1. Possible Mining Waste Leaching through Rock Cap

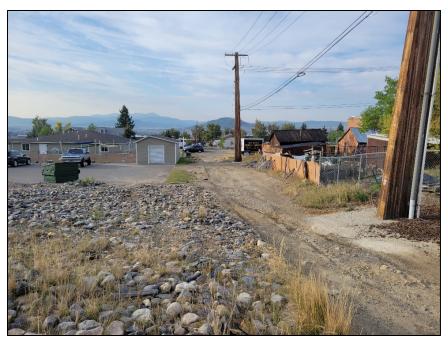
Storm water flows causing sediment conveyance into the site boundary are suspected to be originating from adjacent property located on the corner of Park and Main Street. As seen in Photograph 2 below, flows are causing rills to develop that transport materials to the south end of the alleyway.

Photograph 2. Storm Water Flows Causing Rills that Transport Material to the South End of the Alleyway.

An adjacent property owner is currently building a new parking lot that is predicted to increase flows and sediment deposition during high storm water events. There are potential measures to divert water to a manhole location (SWC AB-M-2201) located 10 feet north of the concrete foundation (shown in Photograph 3). Additional evaluation of the storm water structure is warranted.

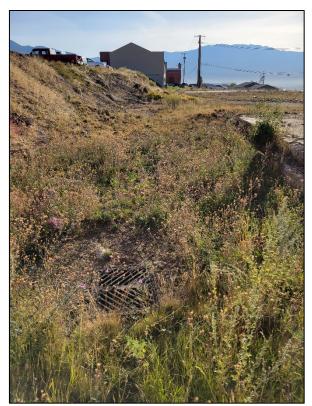
Photograph 3. Manhole AB-M-2201 Located North of Concrete Foundation

Existing site grading will be evaluated to determine storm water flow patterns and identify potential additional storm water controls to prevent sediment migration. The location and condition of existing storm water features will be field verified and recorded for appropriate implementation into corrective actions. Upgradient and adjacent contributing sources of storm water will also be investigated.

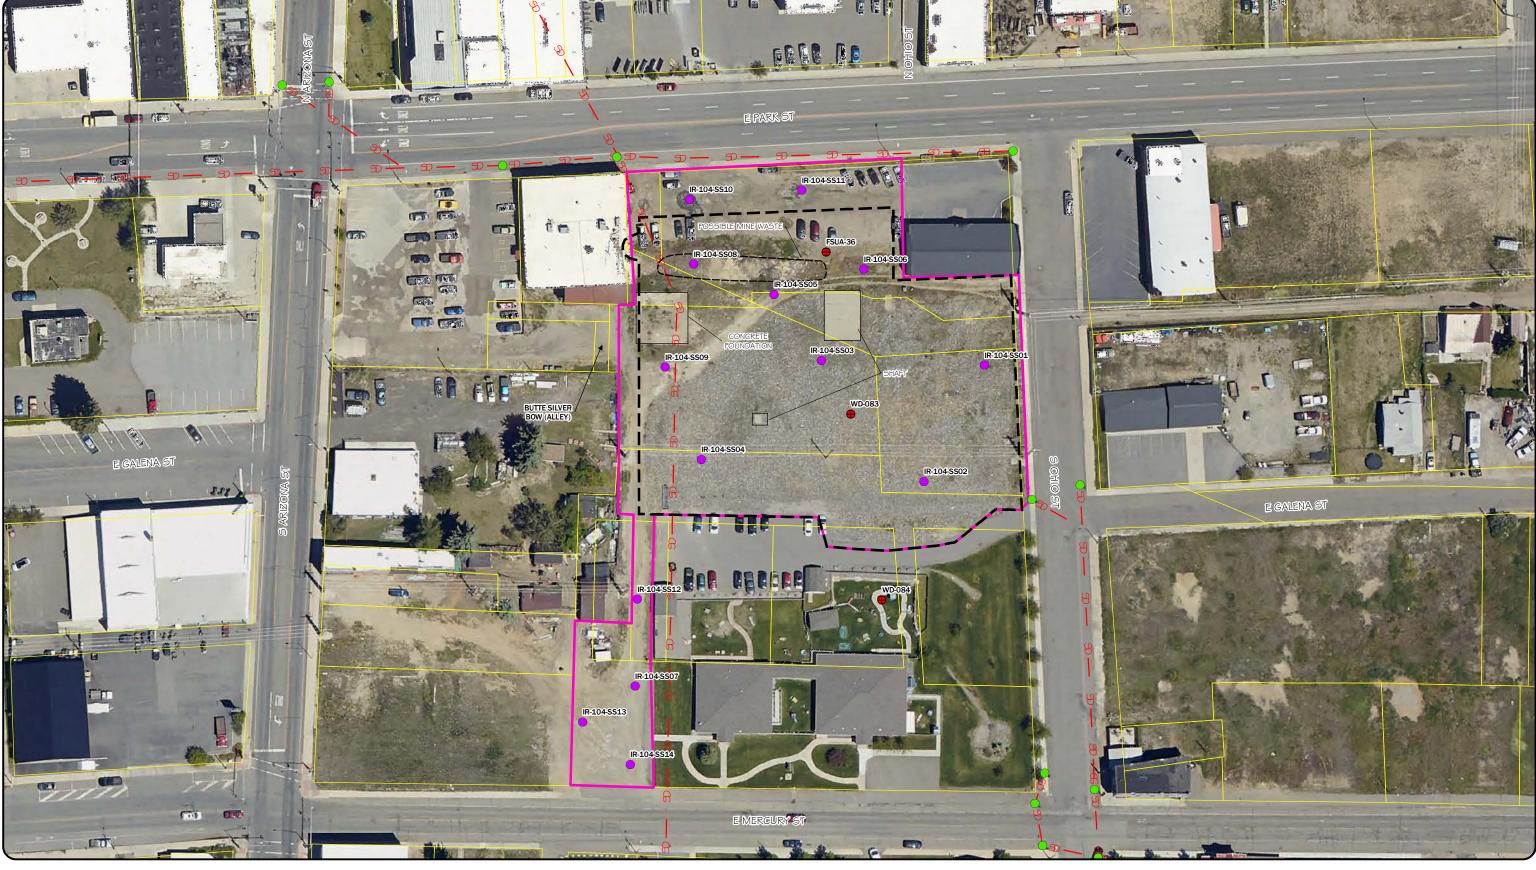
The site evaluation will include reviewing previous Butte Reclamation Evaluation System (BRES) field evaluations (if available), on-site evaluations, and construction completion reports if available. The site evaluation will include additional sampling performed according to the Atlantic Richfield Company 2021-2022 Final Reclaimed Areas Maintenance and Monitoring (M&M) Quality Project Plan (QAPP) (referred to as Reclaimed Areas M&M QAPP and available at <a href="https://pioneertechnicalservices.sharepoint.com/:b:/s/submitted/Ebj\_4MWC5ENErHdG89yMF6QBl\_viK5T1dpsi483fuVSAQWg1">https://pioneertechnicalservices.sharepoint.com/:b:/s/submitted/Ebj\_4MWC5ENErHdG89yMF6QBl\_viK5T1dpsi483fuVSAQWg1</a>), which is a component of the BPSOU Solid Media Management Project Plan. Field sampling will be performed to determine the presence of contaminants, adequacy of growth media, or previously unidentified sources contributing to site deficiencies. This Field Sampling and Investigation Plan (FSP) provides details related to field evaluation of the Insufficiently Reclaimed Site BRES No. 104 - Colorado Dump. Proposed soil sampling locations and areas of known deficiencies are shown on Figure 1.

Per the Reclaimed Areas M&M QAPP, the site will be sampled at 2 depth intervals (0-6 inches and 6-18 inches) to determine the presence of waste and/or confirm the depth and previous reclamation efforts. Figure 1 illustrates proposed sample locations. Opportunistic samples may be obtained in the field at the discretion of field sampling personnel or Agency oversight representative(s).

Results will be used to prepare the site declaration and prescribe site remedial improvements. Sampling along the north slope and western alleyway will be conducted to determine the extent of waste impact and soil preparation needed to meet the BHRS criteria. Following procedures in the Reclaimed Areas M&M QAPP, the overall site will be sampled through a systematic procedure to determine spatial characterization of waste, previous reclamation, and extent of transient material.
