Butte Priority Soils Operable Unit (BPSOU) Draft Final Insufficiently Reclaimed Sites - Field Sampling Plan (FSP) BRES No. 96 – Washoe Dump

Re: Butte Priority Soils Operable Unit (BPSOU) Draft Final Insufficiently Reclaimed Sites - Field Sampling Plan (FSP) BRES No. 96 – Washoe Dump.

Background

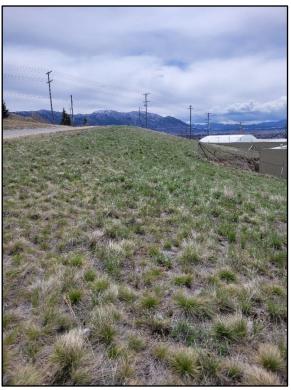
A preliminary site visit was conducted to better qualify existing site conditions and identify areas of focus for additional evaluation. Site photographs from the site investigation in the spring of 2022 are included in this section for reference. The site has a good vegetative cover with strong establishment throughout the entire area. Strom water run-on from nearby building rooftops and sediment moving along the east boundary to the north can be seen in Photograph 2 and Photograph 3. The east boundary along Copper Street has gravel material with one area containing different colored material, which may be iron staining (Photograph 4). The previous evaluation findings suggested that Montana Tech was going to plant forbs and shrubs on Site; however, there was no evidence that the work has been conducted.

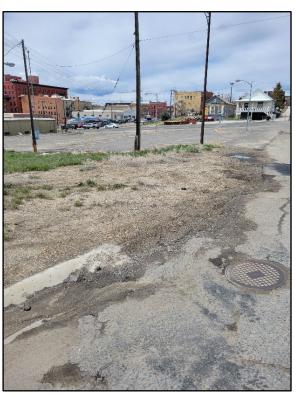
Photograph 2: Sediment Transporting along the North Boundary

Existing site grading will be evaluated to determine storm water flow patterns and identify whether additional storm water controls are necessary to prevent sediment migration. The location and condition of existing storm water features will be field-verified and recorded so appropriate corrective actions can be implemented. Upgradient and adjacent contributing sources of storm water will also be investigated.

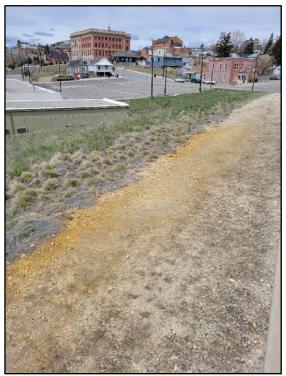
Photograph 4: Staining Along the Walking Pathway.

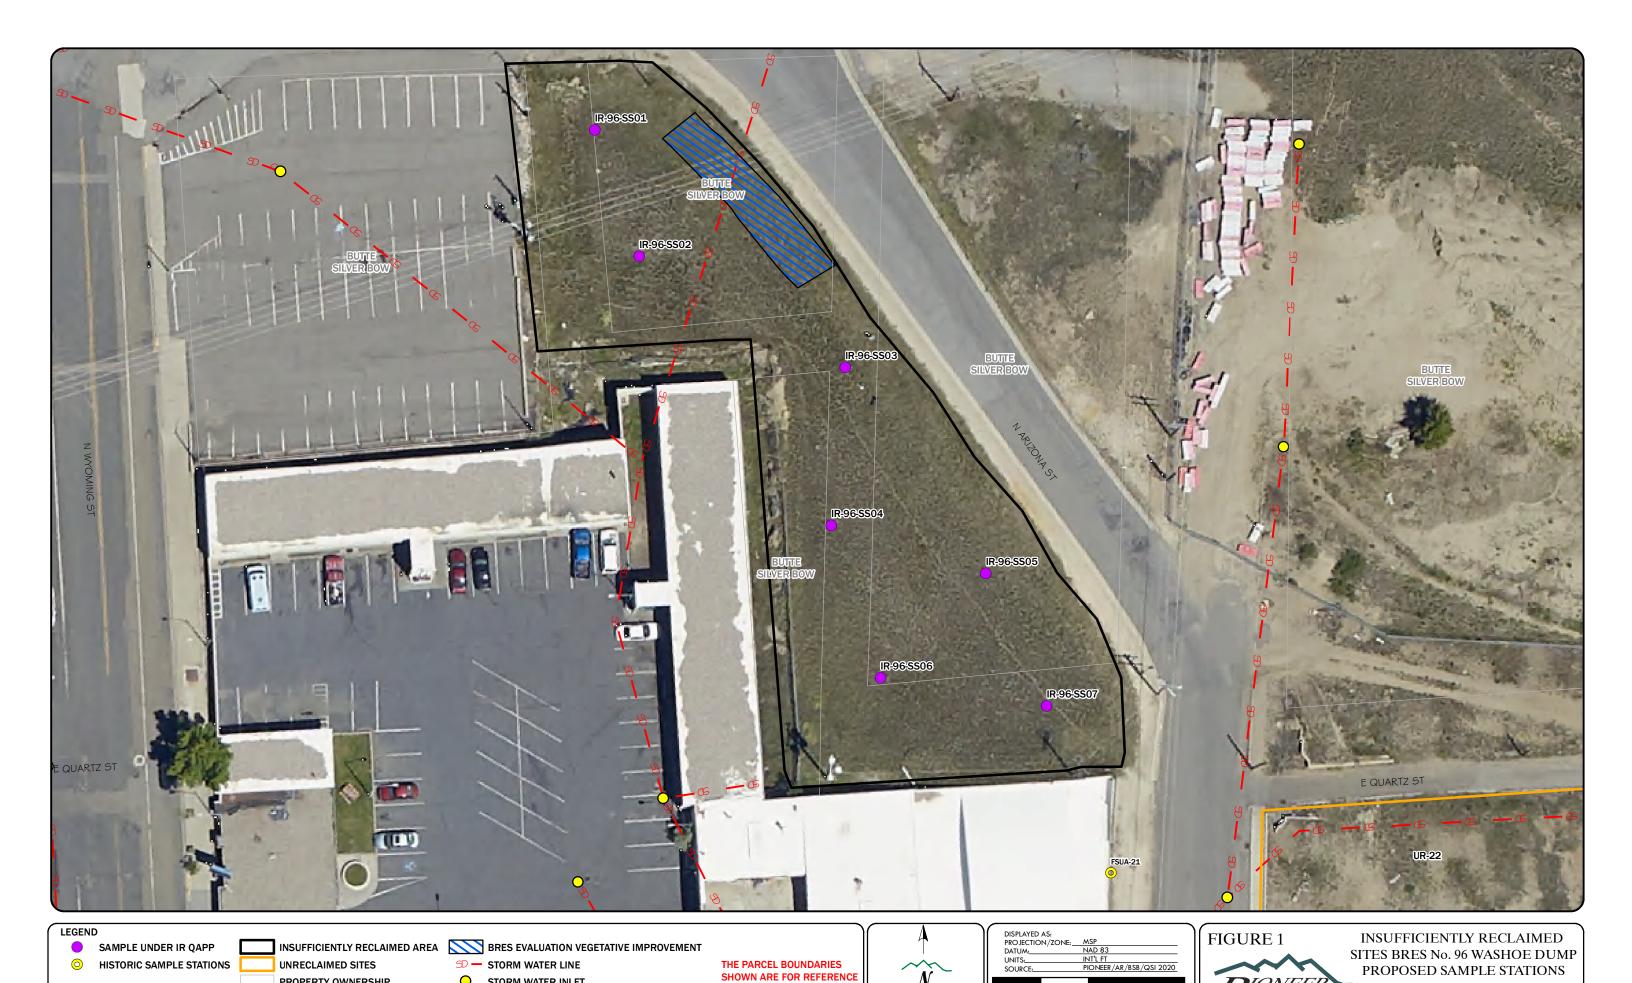
Figure 1 – Insufficiently Reclaimed Sites BRES No. 96 Washoe Dump Proposed Sample

This FSP provides details related to the field evaluation of the IR Site BRES No. 96 – Washoe Dump. Proposed soil sampling stations and areas of known deficiencies are shown on Figure 1. The site will be evaluated following the Commercial Land Use Waste Identification and Action Level Criteria provided in the IR QAPP. The site evaluation is anticipated to be completed in 2022.

Per the IR Sites QAPP, the site will be sampled at 2 depth intervals (0 to 6 inches and 6 to 18 inches) to determine the presence of waste and/or confirm the depth of previous reclamation efforts. Figure 1 illustrates the proposed sample stations. Opportunistic samples may be obtained in the field at the discretion of field sampling personnel or Agency oversight representative(s).

Sample Station	2 Depth Intervals (inches)
IR-96-SS01	(1) 0-6, (2) 6-18
IR-96-SS02	(1) 0-6, (2) 6-18
IR-96-SS03	(1) 0-6, (2) 6-18
IR-96-SS04	(1) 0-6, (2) 6-18
IR-96-SS05	(1) 0-6, (2) 6-18
IR-96-SS06	(1) 0-6, (2) 6-18
IR-96-SS07	(1) 0-6, (2) 6-18
