**Draft Final Revised Butte Reduction Works (BRW) Smelter Area  
Mine Waste Remediation and Contaminated Groundwater  
Hydraulic Control Site Pre-Design Investigation (PDI) Evaluation  
Report**

Atlantic Richfield Company

June 10, 2022

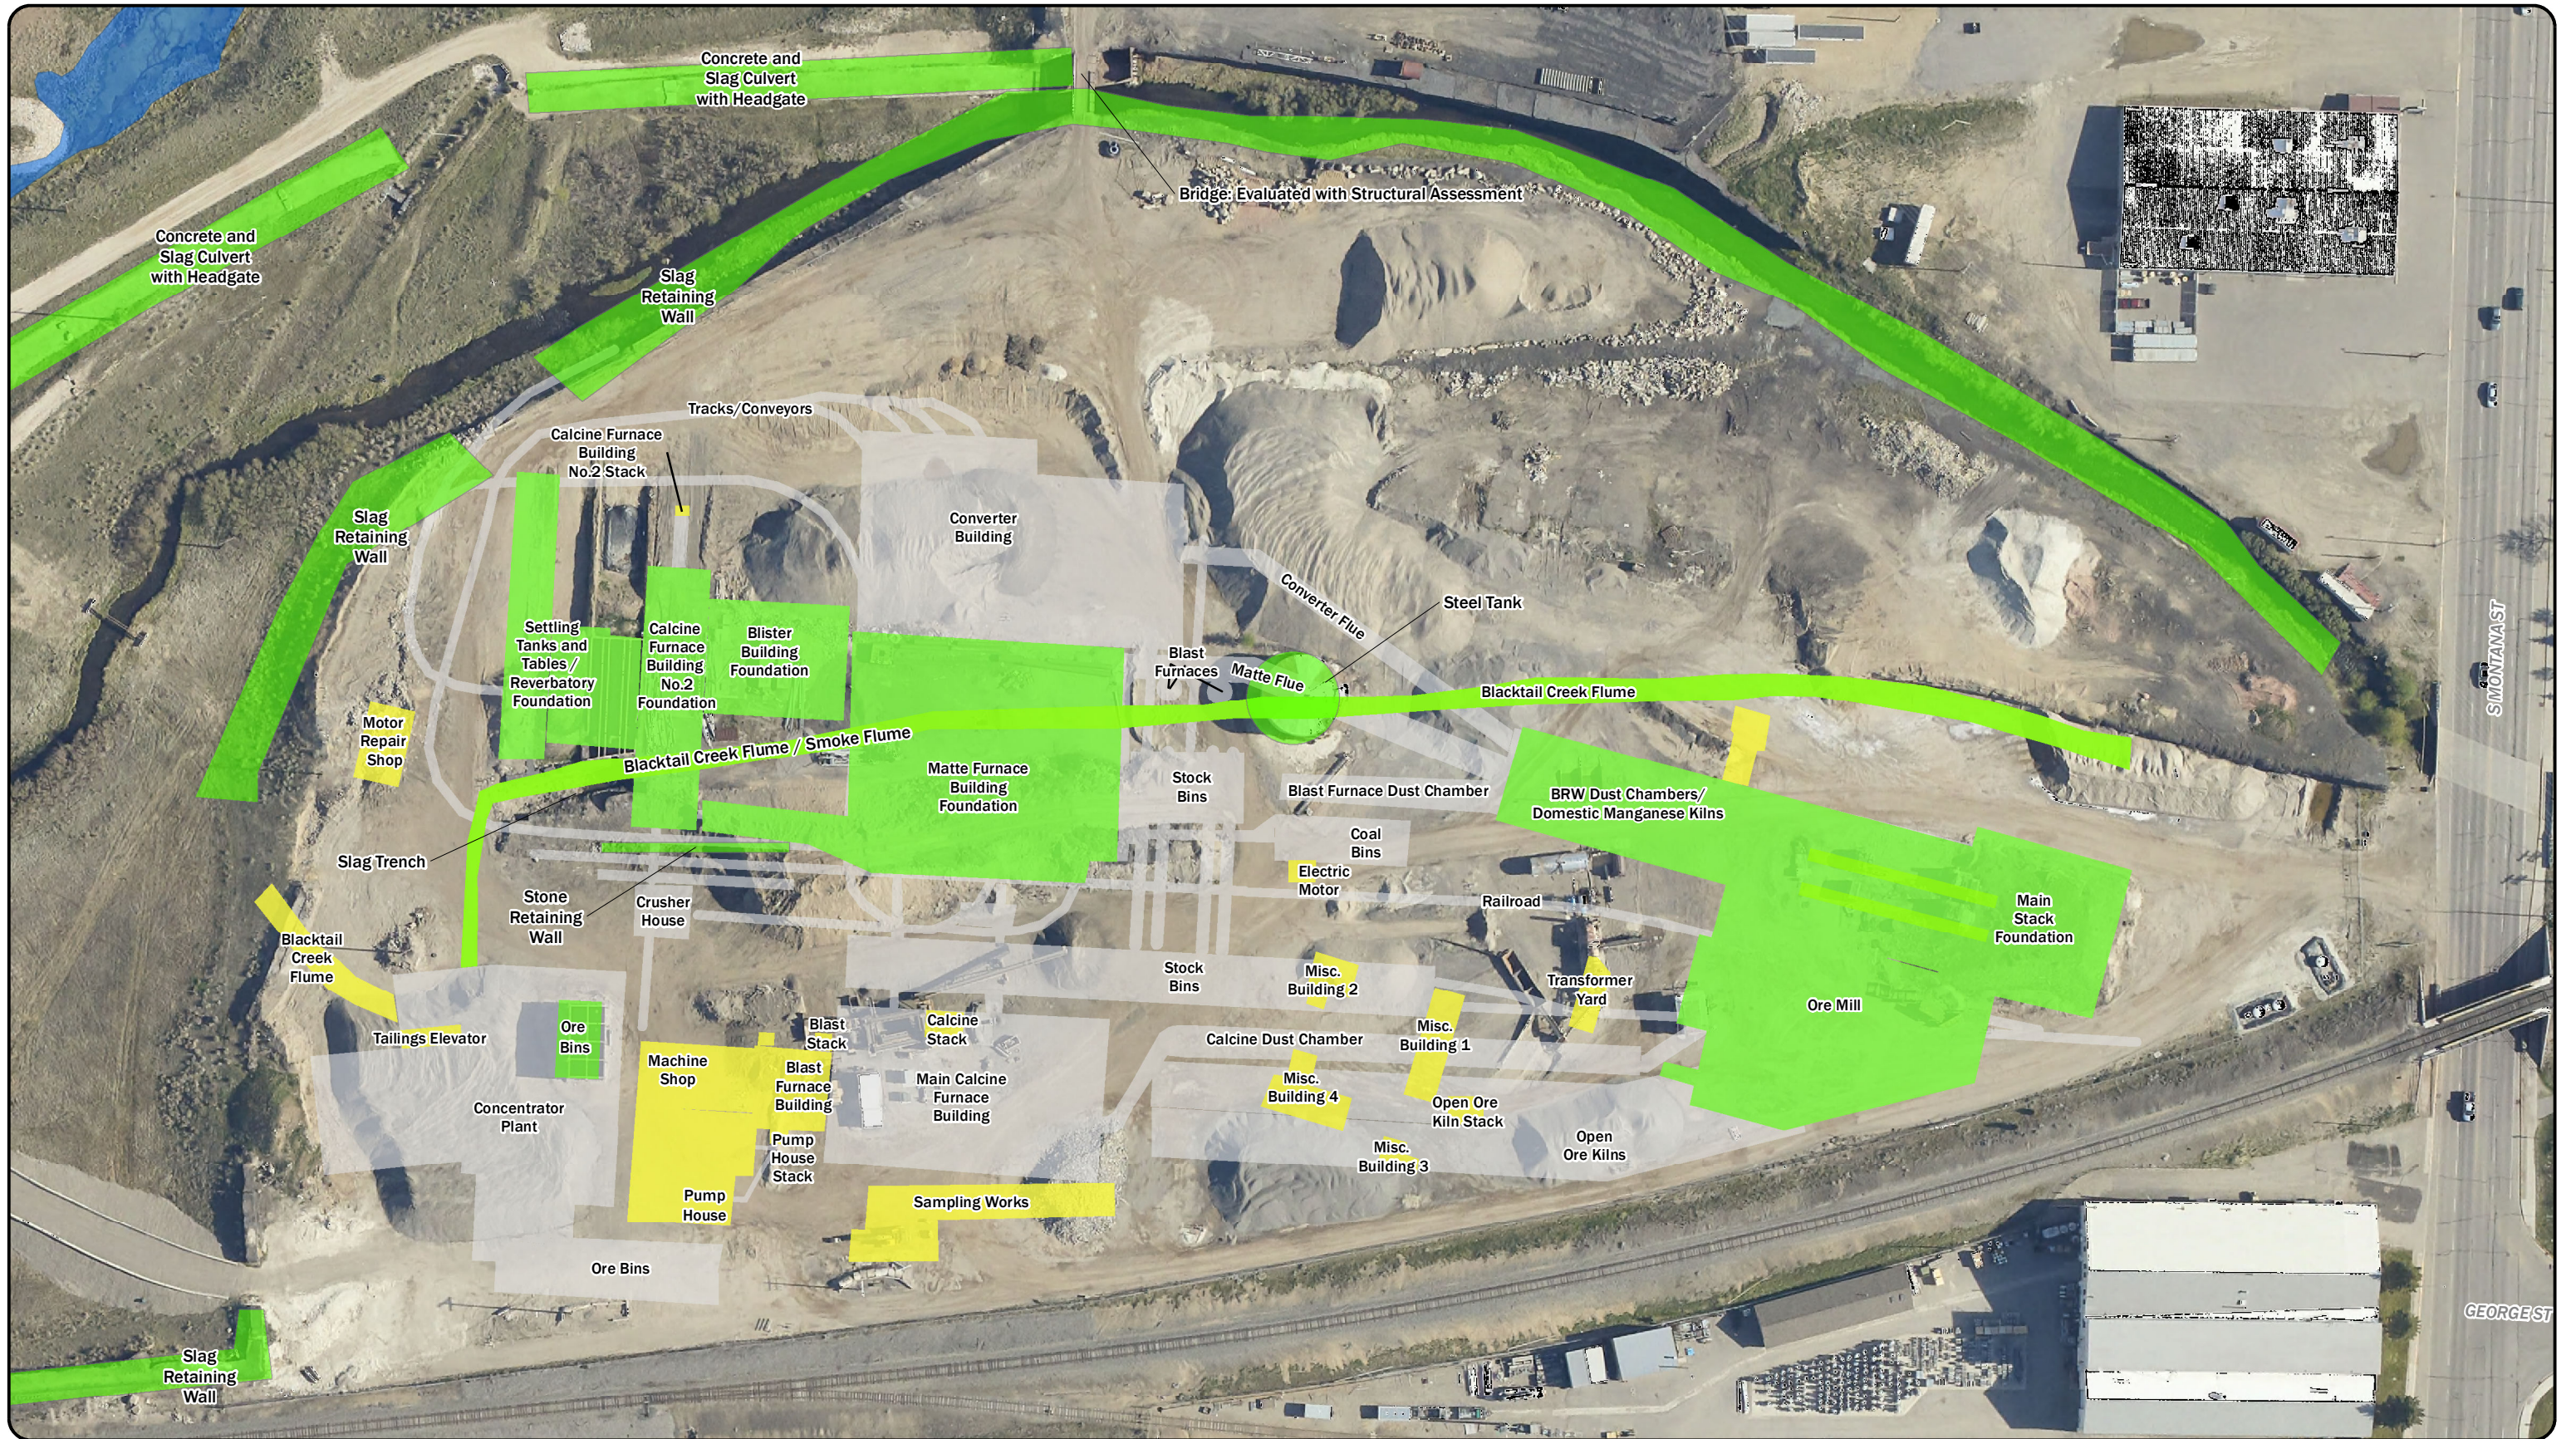
Potentially Remaining Infrastructure	  0 50 100 200 Feet	<b>FIGURE 6</b>  <b>EXISTENCE OF DURABLE HISTORIC INFRASTRUCTURE WITHIN BUTTE REDUCTION WORKS SITE</b> DATE: 3/23/2022
	Demolished Historic Infrastructure		
	Confirmed Remaining Infrastructure

flume(s) and to cross as much of the southern part of the Site as possible. The Middle Transect was positioned near an exposed brick roof of one flume or culvert. Based on the analysis of the MASW survey and background information, the historic flume can be traced across the Site, as shown on Figure 7, from the exposed brick and slag tunnel near the west end of the Site through a void identified in the Middle Transect, the exposed brick roof of the flume in the middle of the Site, and finally the void identified in the East Transect. Additional detail on this investigation can be found in Appendix D.

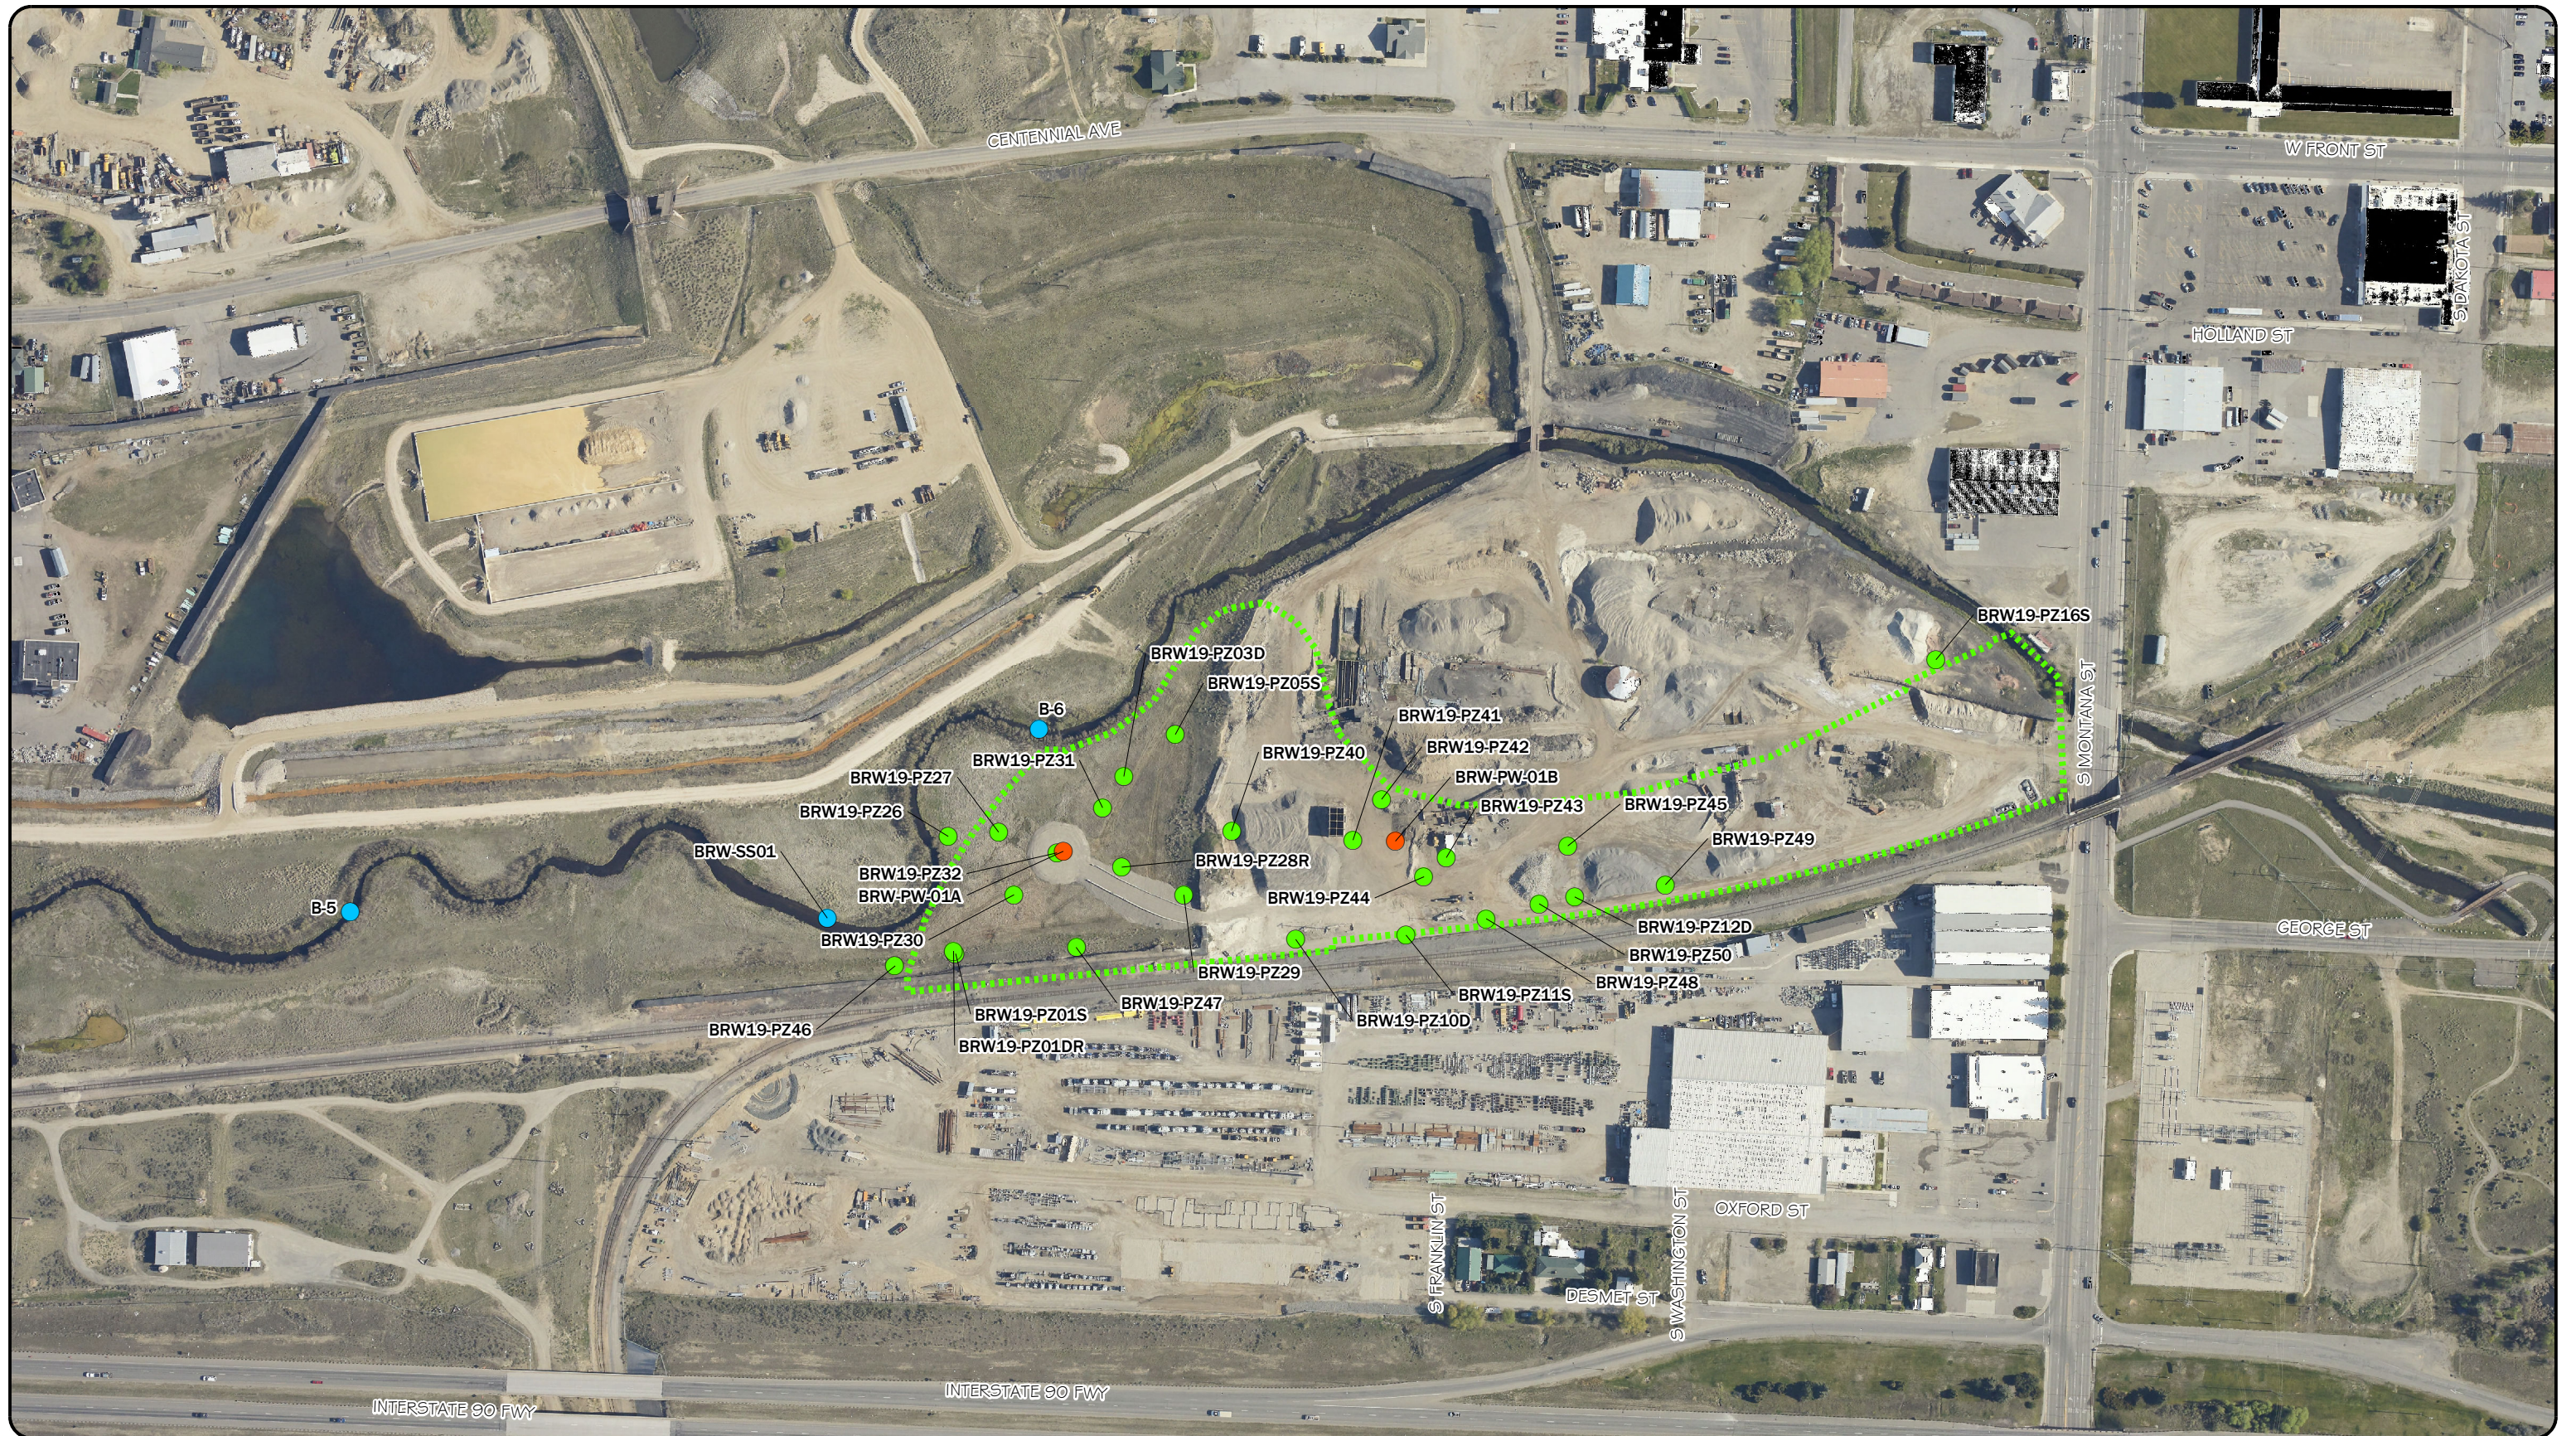
**FIGURE 8**  
**PHASE II**  
**SLAG INVESTIGATION**  
**STAGES 1-3**  
 DATE: 3/15/2022

During Stage 2 of the Slag Investigation, 5 boreholes were drilled to collect samples for laboratory tests to determine the tensile strength, compressive strength, and fracture toughness of slag throughout the Site. Test pit results from Stage 1 informed borehole locations for Stage 2 (Figure 8).

Boreholes were drilled using a sonic drill rig, capable of drilling both by traditional (i.e., rotating drill bit) and sonic methods. The borehole locations are shown on Figure 8 and detailed in Table 3. The extracted slag cores were fragile, and lengths were insufficient for laboratory analysis. As a result, no samples were submitted for laboratory testing. Without laboratory analysis, expandable grout could not be specified for the planned field test (Stage 4); however, boreholes were completed to observe physical properties of the slag and to determine potential heavy equipment needed for removal in Stage 3.

- Excavated 44 test pits and drilled 5 boreholes for the Slag Investigation and documented information (i.e., physical properties of the slag, equipment production rates, etc.) to inform the potential effectiveness of methods that may be employed to remove the slag (Section 2.2.1.1 and Figure 8).

During the Stage 1 of the Slag Investigation, 39 test pits were excavated and sampled to refine the extent and characteristics of slag in areas where slag is planned to be removed during RA activities. One additional test pit was excavated to determine the extents of the slag foundation base. The location of each test pit is shown on Figure 8. In accordance with the Phase II QAPP, all test pits were logged, and opportunistic soil samples were collected from select test pits within the waste removal corridor for analysis of metals and/or hydrocarbon compounds. Additional details on the soil samples collected are included in Section 2.2.1.3.

The specific constraint for each location is shown on Figure 8, and additional details on the constraints for each test pit (including the final depths of each test pit) are documented in logbook entries; field logs note the final depths of each test pit.

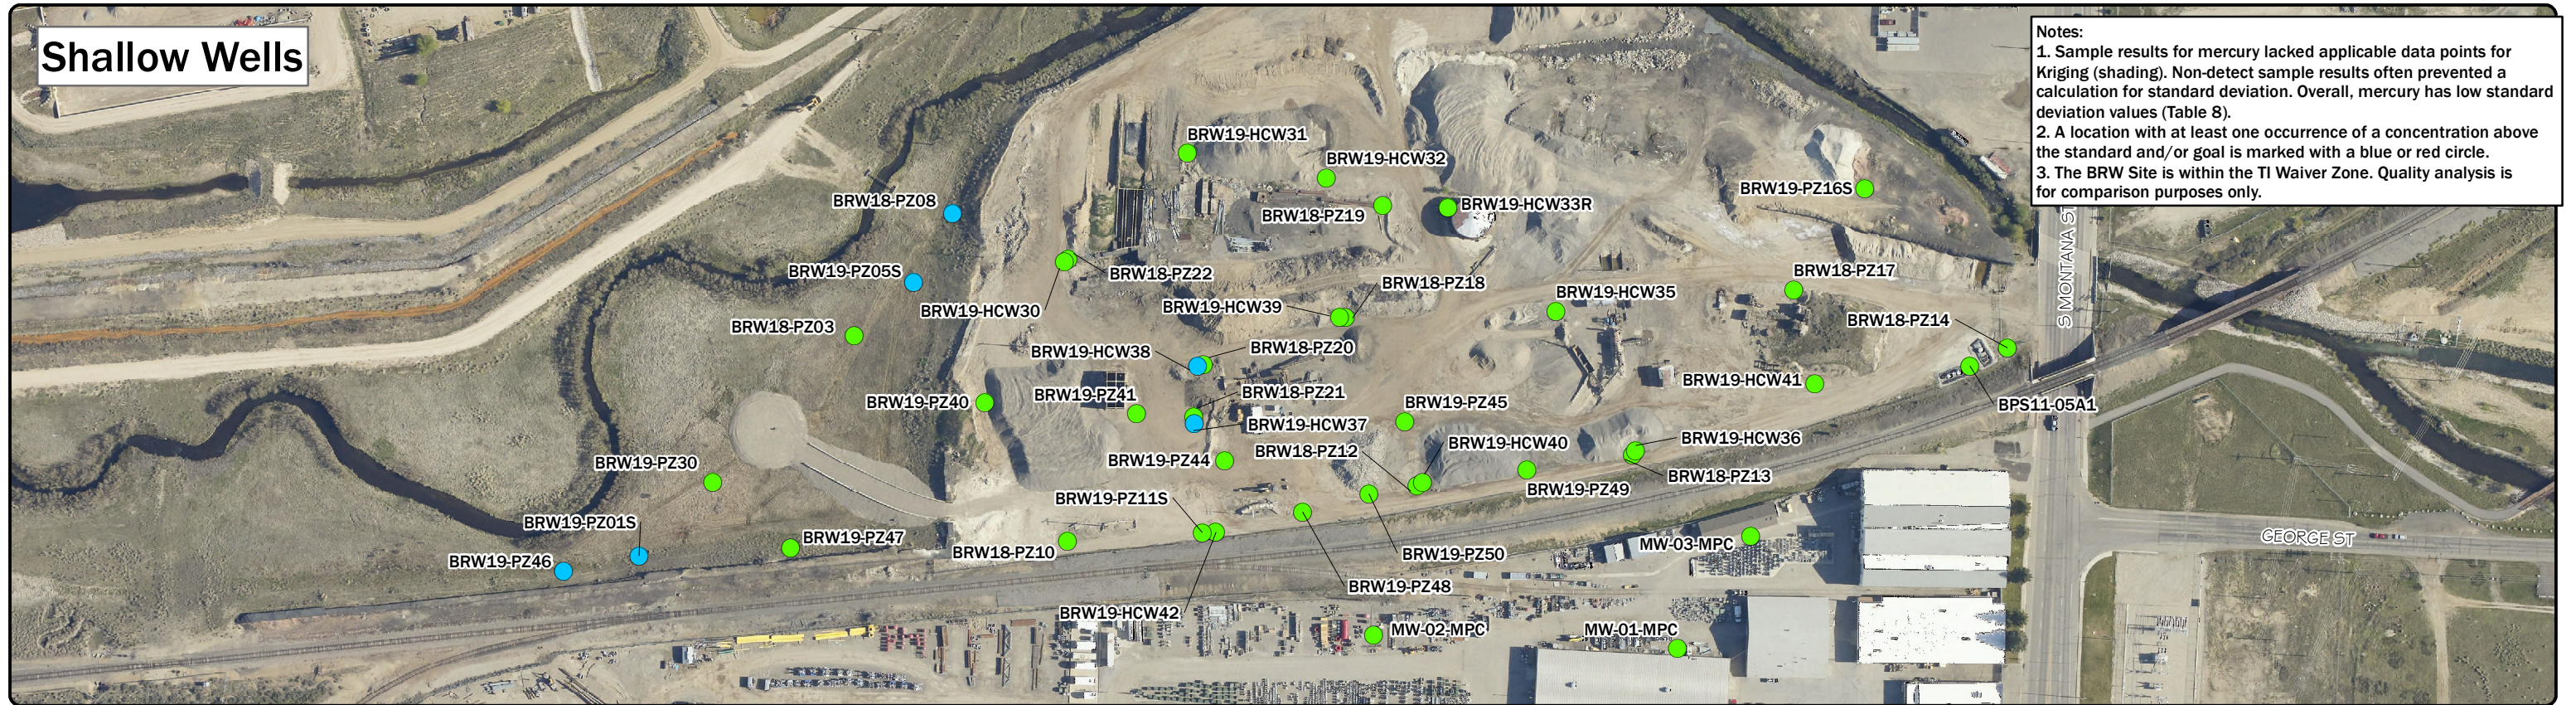
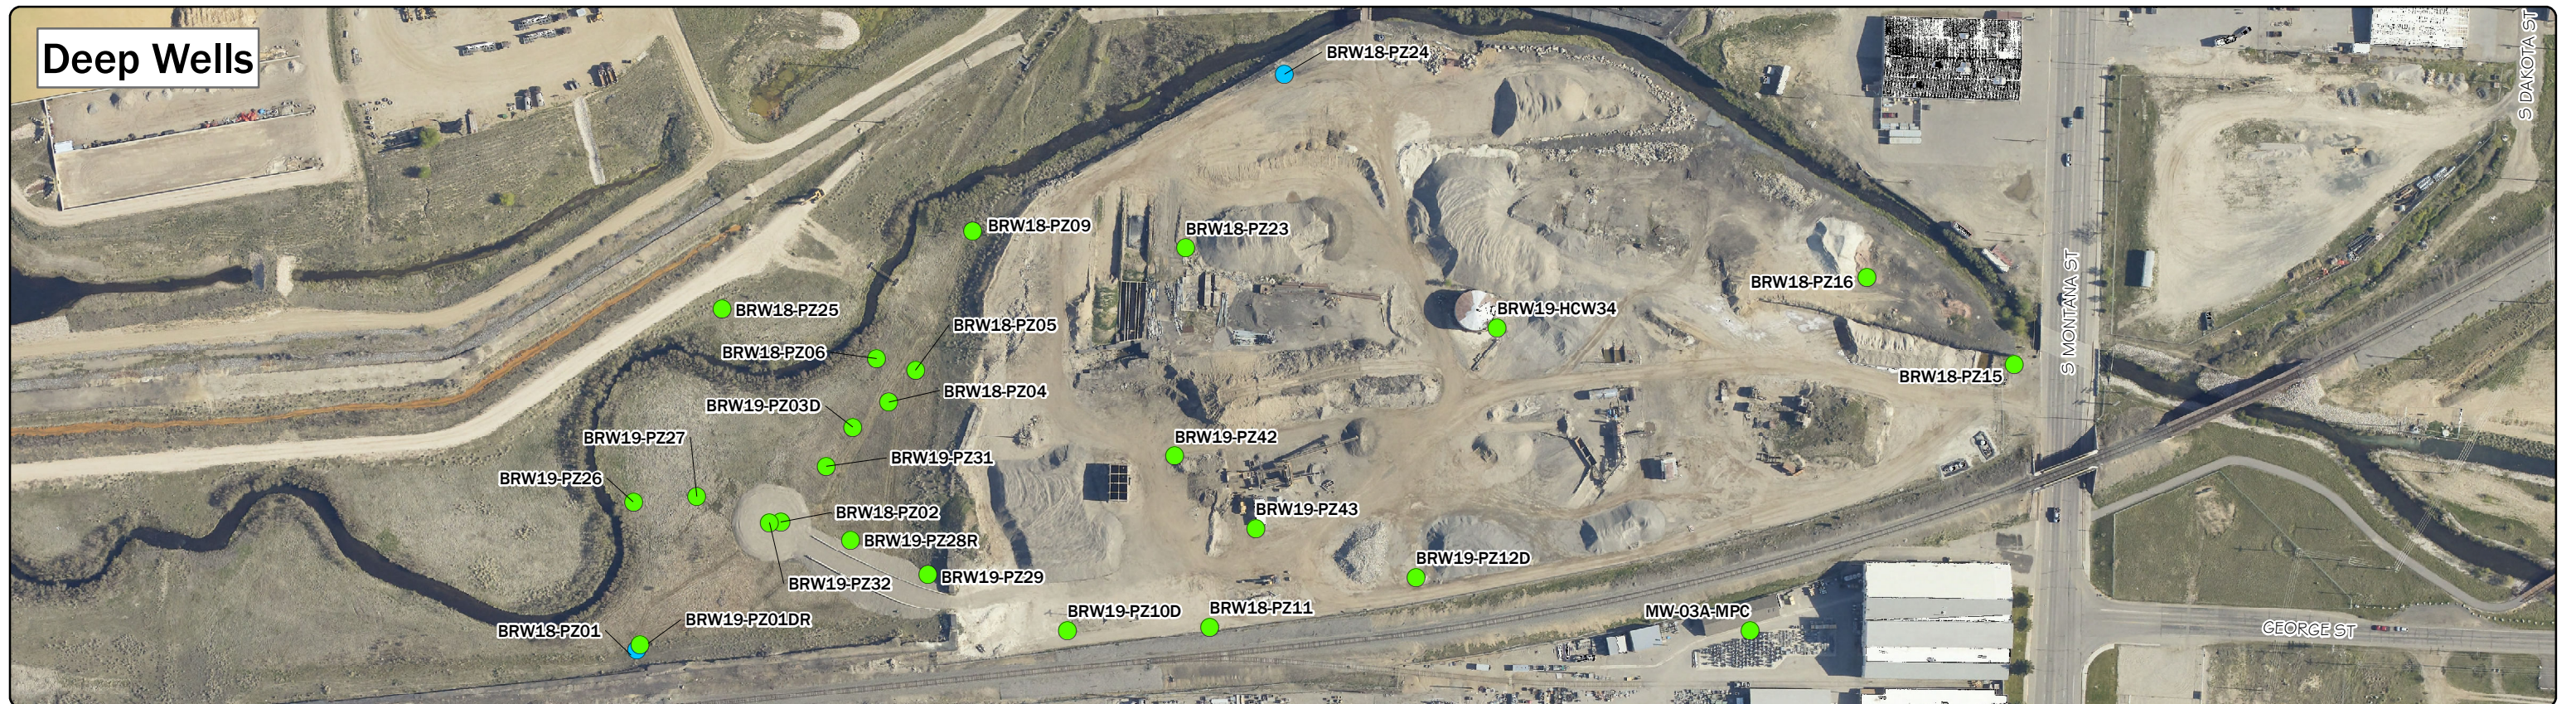
**FIGURE 16**  
**PIONEER**  
 TECHNICAL SERVICES, INC.  
 DATE: 6/6/2022  
**GW QUALITY ANALYSIS OF MERCURY COMPARED TO CD PERFORMANCE STANDARDS**

Notes:  
 1. Sample results for mercury lacked applicable data points for Kriging (shading). Non-detect sample results often prevented a calculation for standard deviation. Overall, mercury has low standard deviation values (Table 8).  
 2. A location with at least one occurrence of a concentration above the standard and/or goal is marked with a blue or red circle.  
 3. The BRW Site is within the TI Waiver Zone. Quality analysis is for comparison purposes only.

- LEGEND**
- Below Mercury CD Chronic Surface Water Standard (0.05 µg/L - Total Recoverable)
  - Above Mercury CD Chronic Surface Water Standard and Below Groundwater Remedial Goal (2 µg/L - Dissolved)
  - Above Mercury CD Chronic Surface Water Standard and Groundwater Remedial Goal (2 µg/L - Dissolved)

Note: There is no hardness calculation for Mercury.

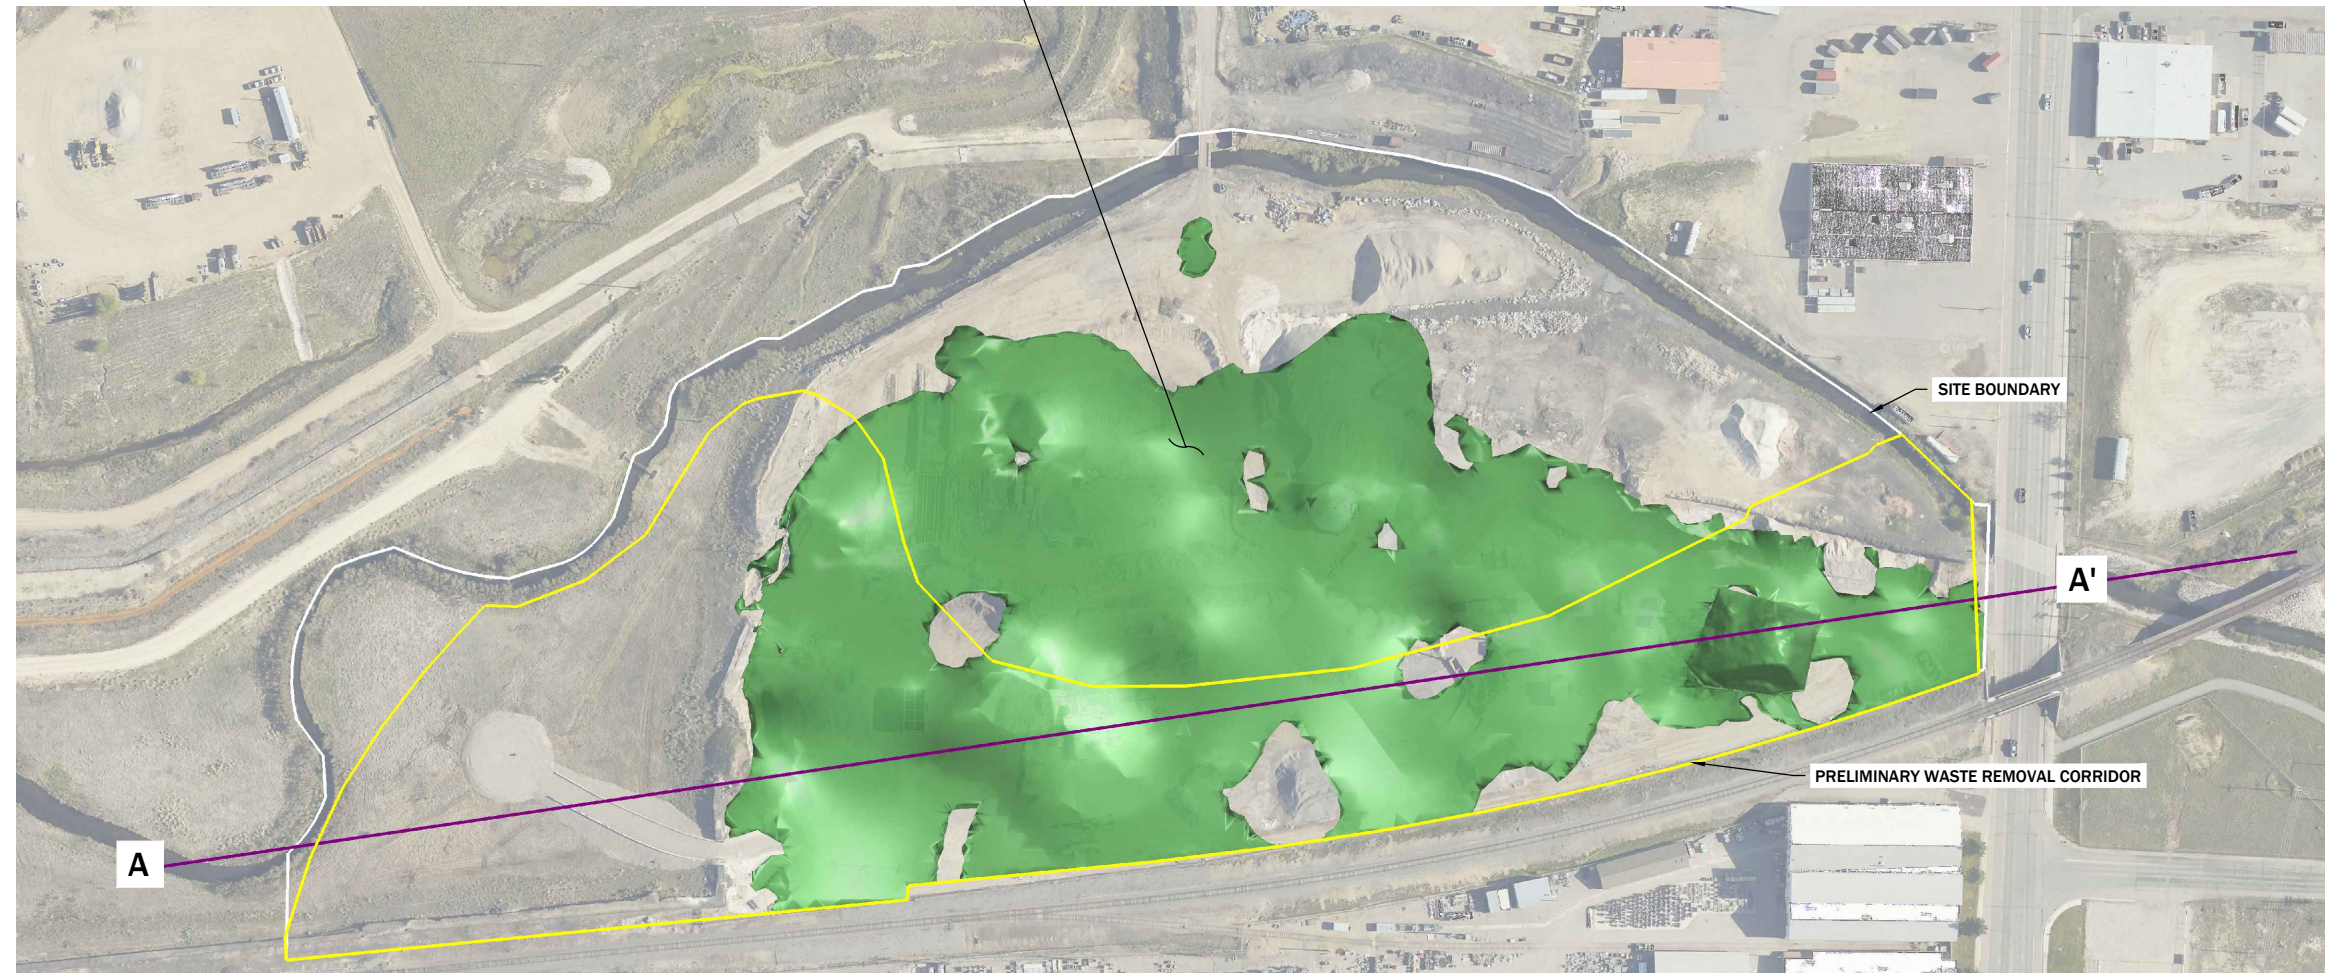
DEMOLITION DEBRIS VOLUME

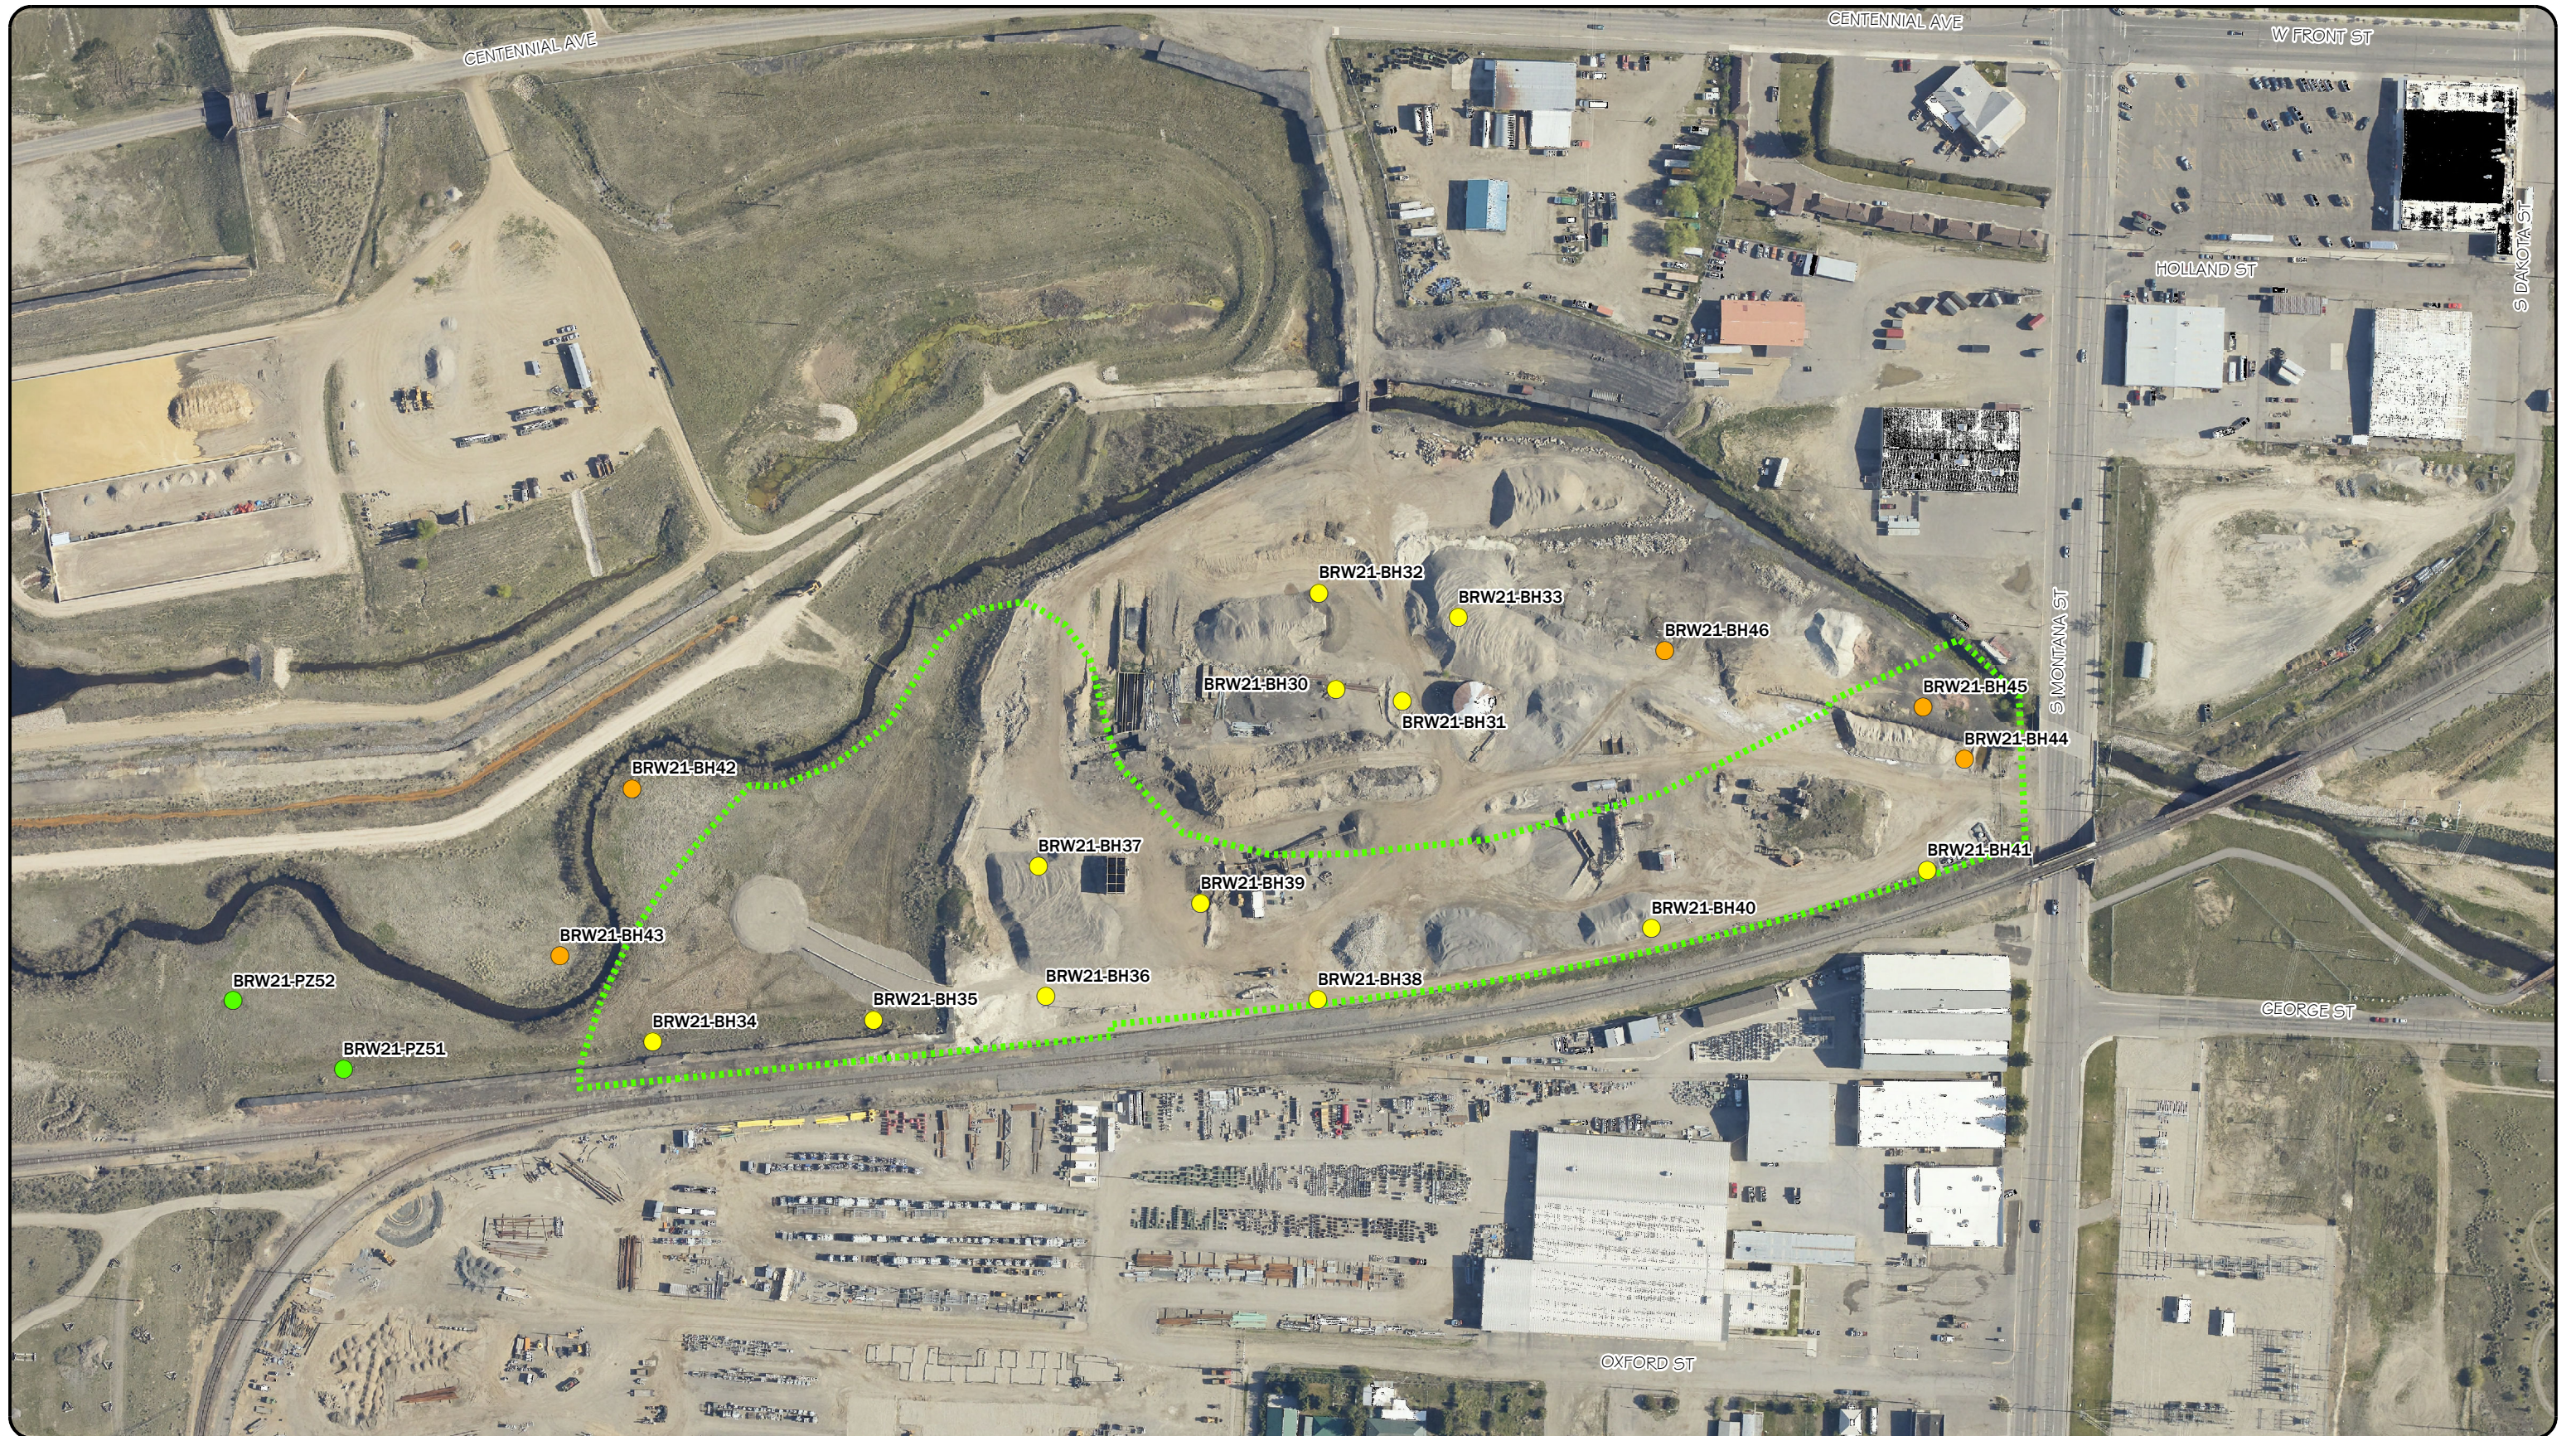
- Preliminary Waste Removal Corridor
- EXISTING PHASE III LOCATIONS**
- Phase III Waste Characterization Boreholes
- Geotech Analysis Boreholes
- Phase III Piezometers

**Note:**  
 Phase III locations were installed according to the Phase III QAPP. Data collected has not yet been validated. Once data has been reviewed and validated it will be included in PDI Evaluation Report
