Silver Bow Creek/Butte Area Superfund Site

Butte Priority Soils Operable Unit (BPSOU) Draft Final Insufficiently Reclaimed Sites - Field Sampling Plan (FSP) BRES No. 32 – Corra-2 Dumps.

INSUFFICIENTLY RECLAIMED SITES BRES No. 32 CORRA-2 DUMPS PROPOSED SAMPLE STATIONS

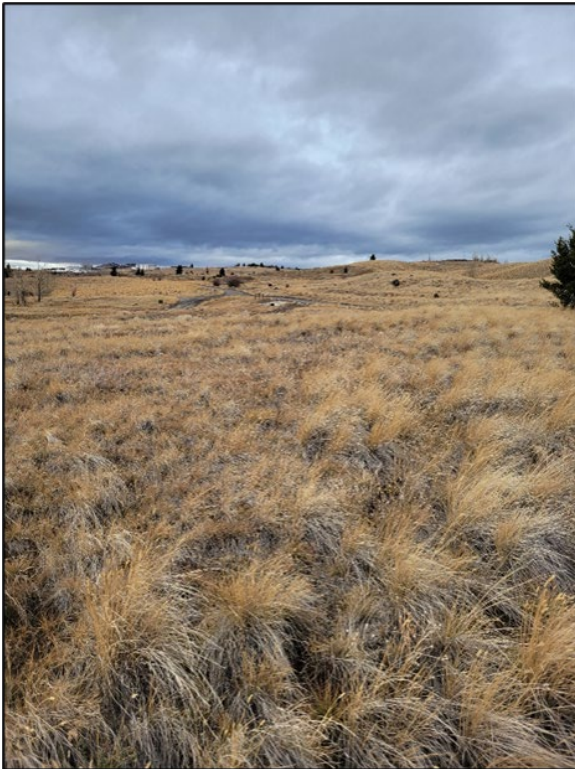
Photograph 1: Site is Well Vegetated East of the Channel

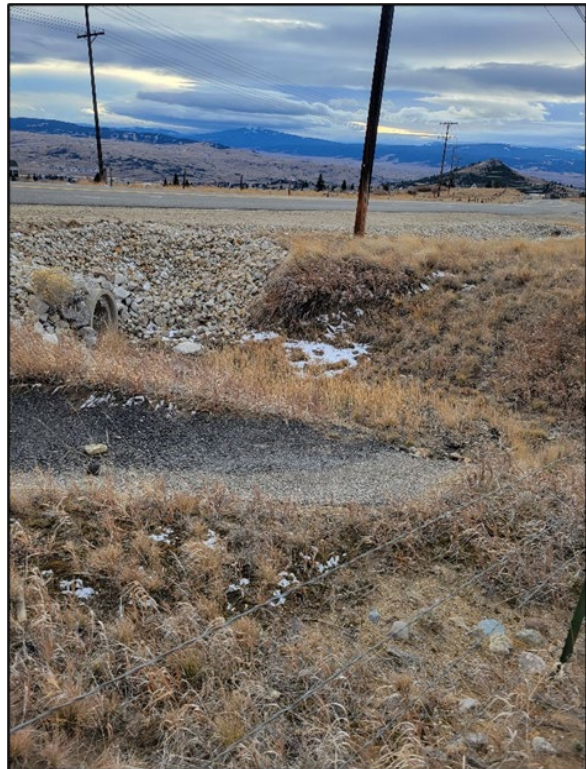
Photograph 2: Storm Water Inlet on Southwest Corner of Site

Existing storm water controls include rock and grass lined ditches located through the center of the site running north to south (Photograph 4 and Photograph 5), and two outlet structures at the south end of the ditch and in the southwest corner of the site (Photograph 2). These will be evaluated to determine their effectiveness and identify additional Best Management Practices or potential maintenance items.

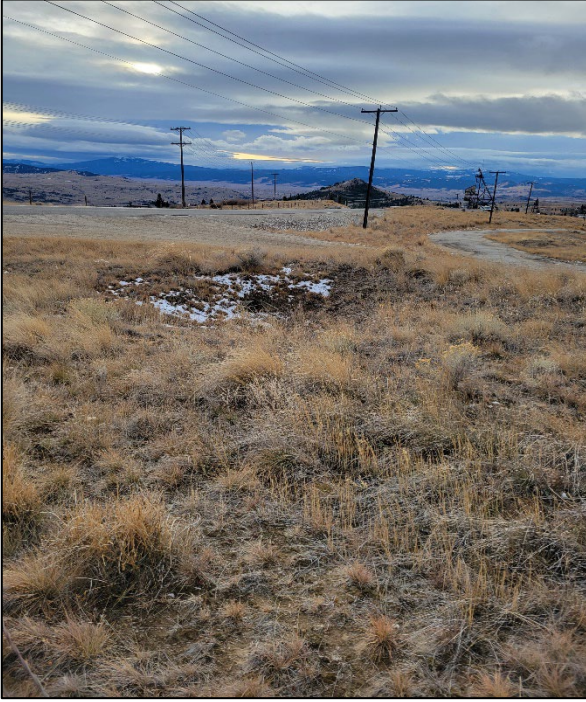
Photograph 3: Asphalt and Concrete Storm Water Features-South

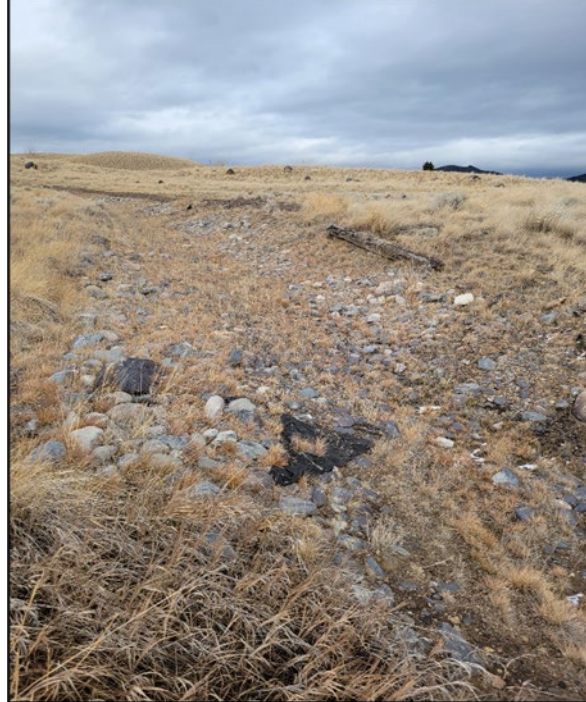
Photograph 4: Rock Lined Storm Channel Through Middle of Site

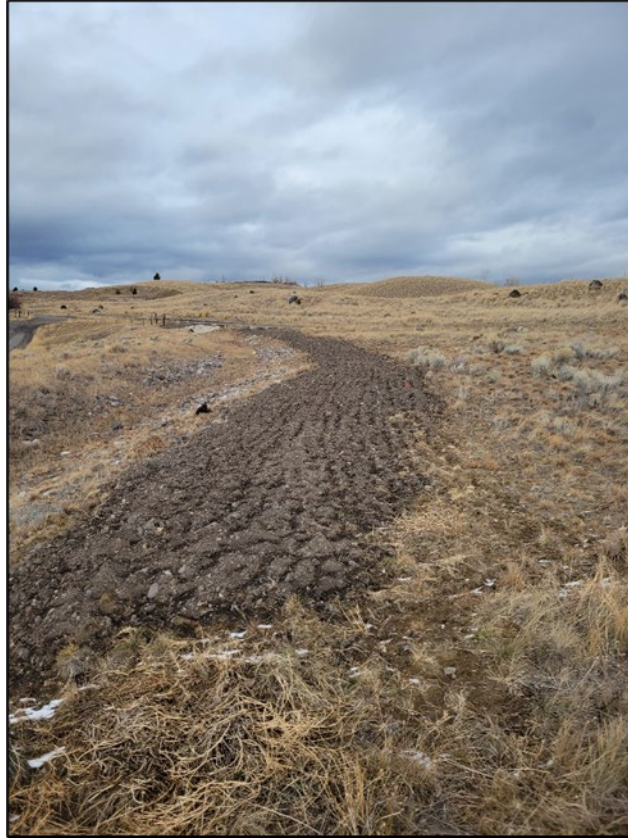
A preliminary site visit was conducted to qualify existing site conditions and identify areas of focus that need additional evaluation. Site photographs were taken during the preliminary site evaluation to capture site conditions. The photographs are included in this section for reference. The site appears to be well vegetated with minor areas of bare ground. Although weed detection is difficult in winter months, it appears the site has limited weed establishment. Remediation efforts were conducted by Butte-Silver Bow (BSB) in 2021 addressing previous barren areas and vegetative improvement. EPA approved cover soil was placed in areas of repair as seen on Photograph 5.

Photograph 5: BSB Remediation Efforts Along Storm Water Channel

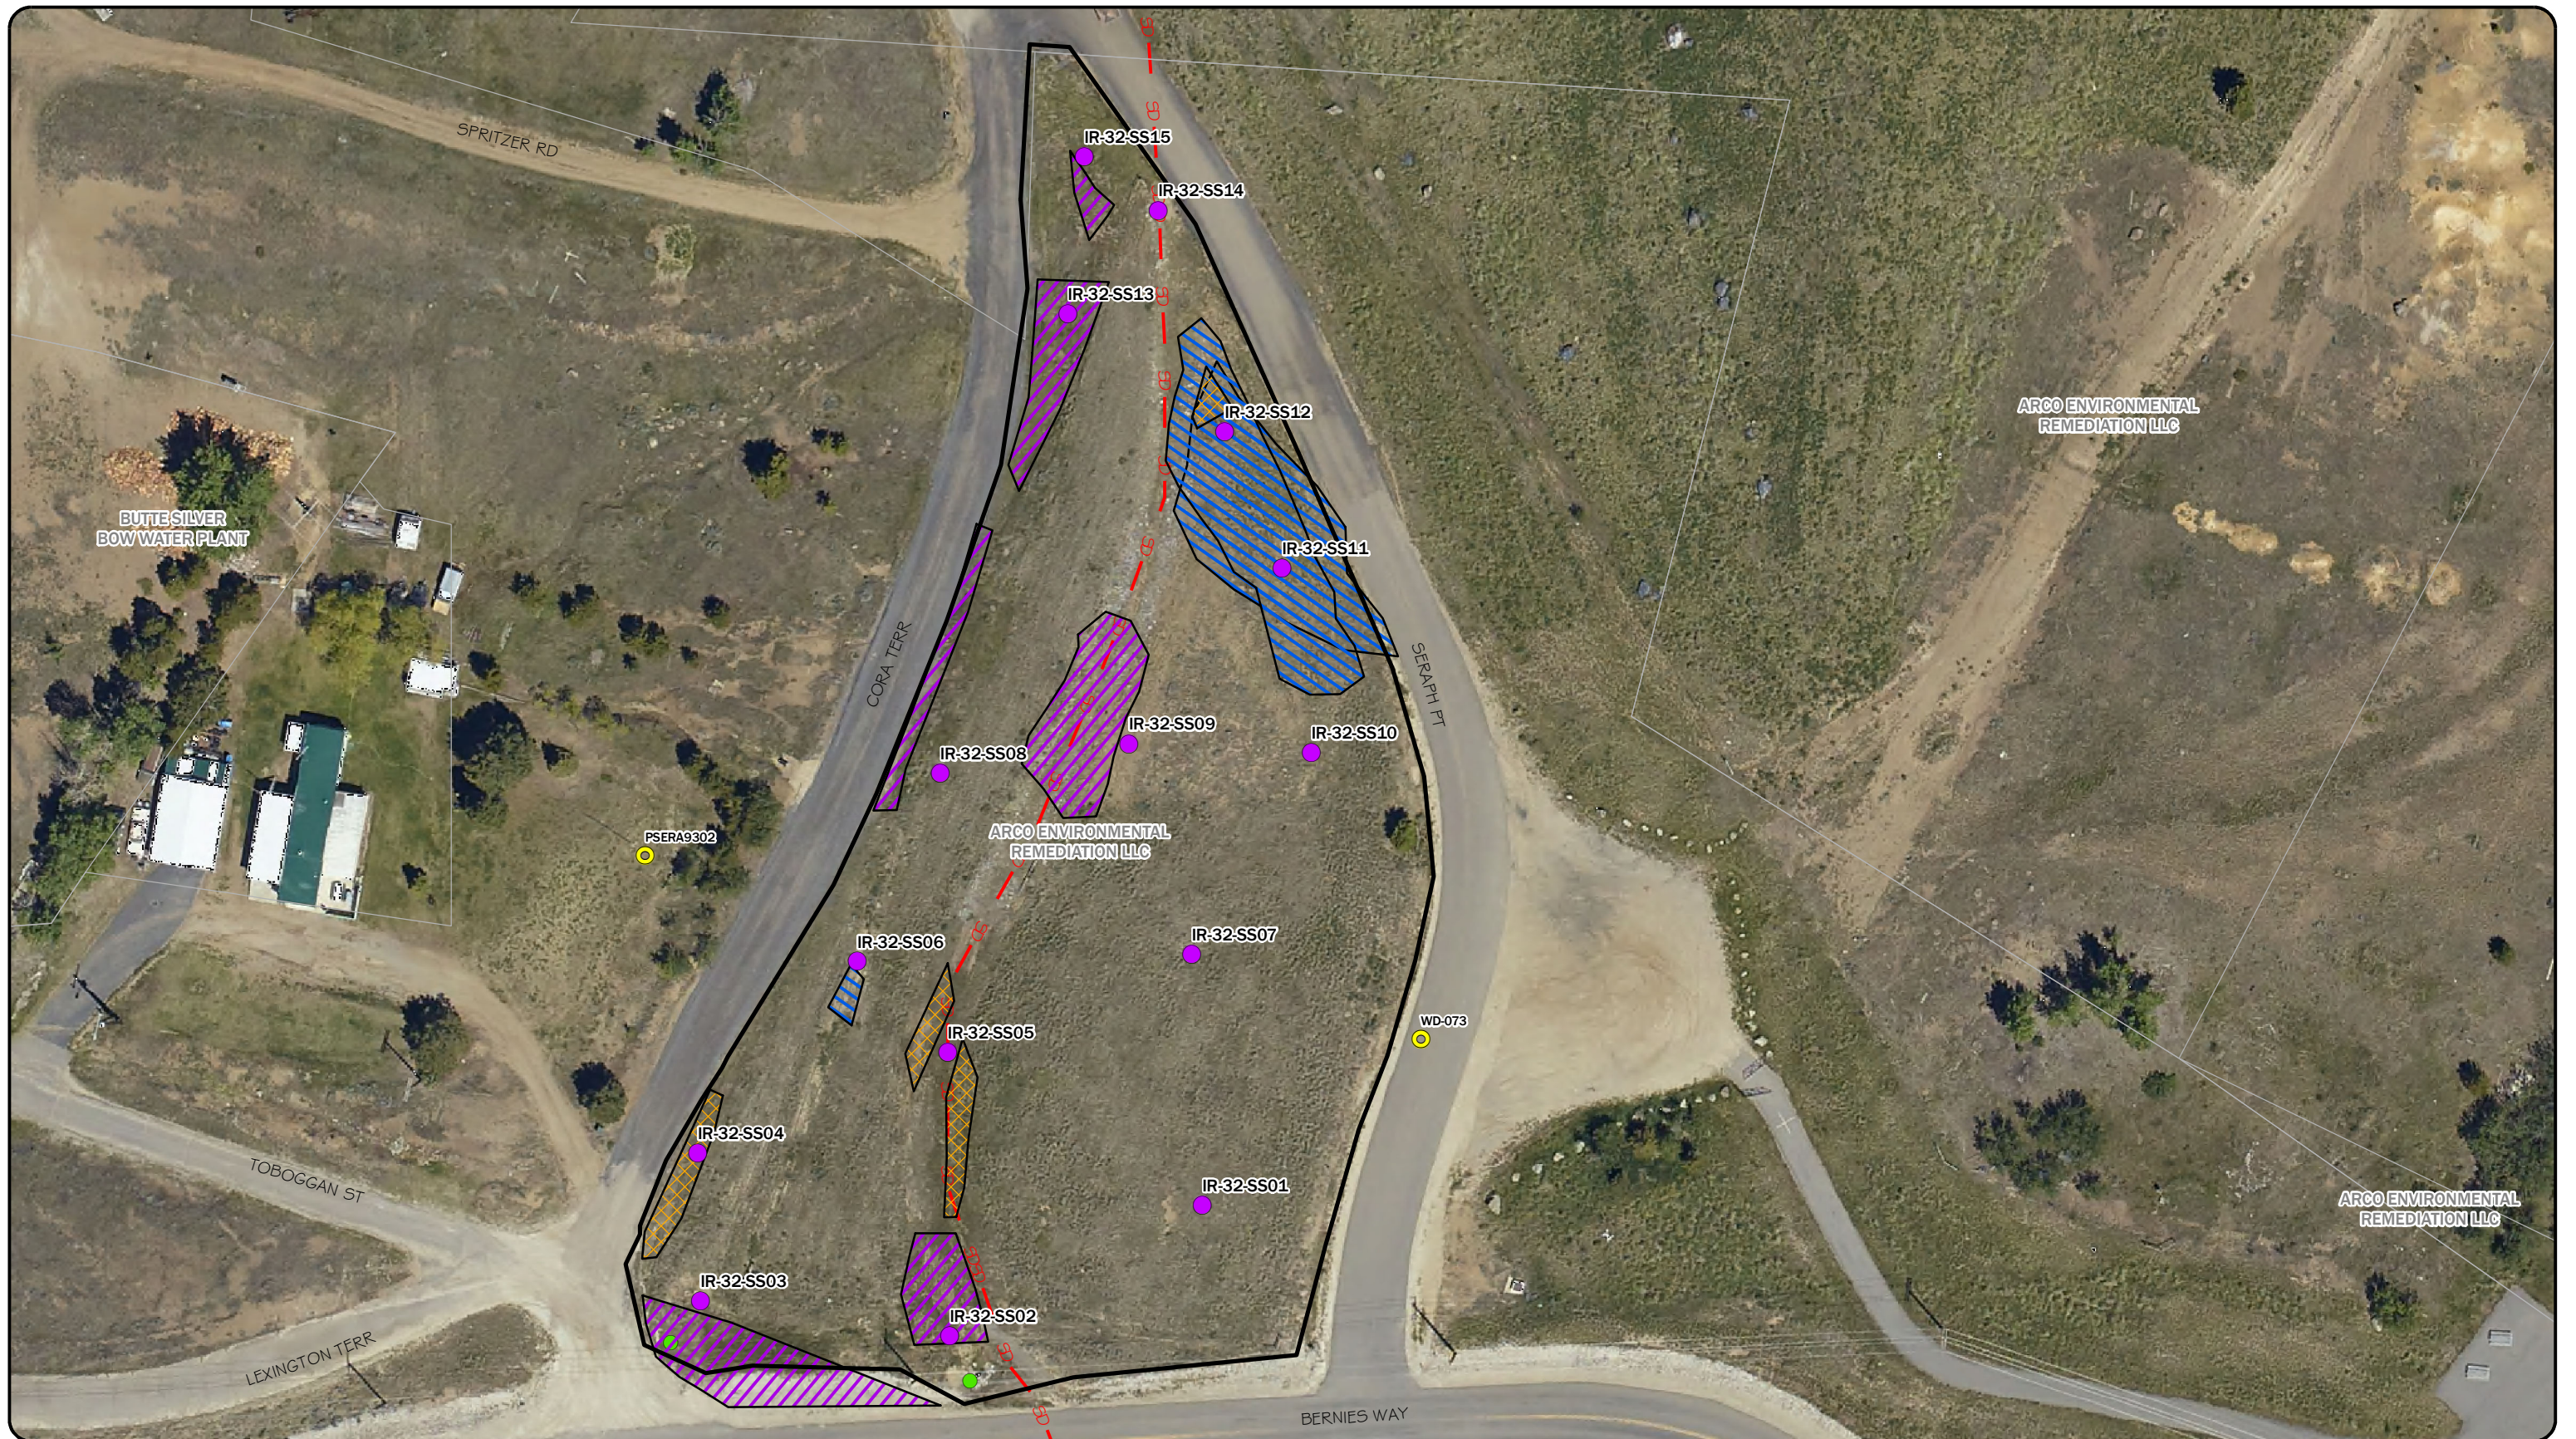
FIGURE 1

This FSP provides details related to the field evaluation of the IR Site BRES No. 32 – Corra-2 Dumps. Proposed soil sampling stations and areas of known deficiencies are shown on Figure 1.

Per the IR Sites QAPP, the site will be sampled at 2 depth intervals (0 to 6 inches and 6 to 18 inches) to determine the presence of waste and/or confirm the depth of previous reclamation efforts. Figure 1 illustrates the proposed sample stations. Opportunistic samples may be obtained in the field at the discretion of field sampling personnel or Agency oversight representative(s).
