**AN EXAMINATION OF THE IMPACTS OF BEAVER DAM MIMICRY
STRUCTURES ON GROUNDWATER SURFACE-WATER
INTERACTIONS IN LOWER MOUNTAIN RIPARIAN SYSTEMS**

Master of Science in Geology with an Emphasis in Hydrogeology
and a Certificate in Ecological Restoration

Montana Tech
2022

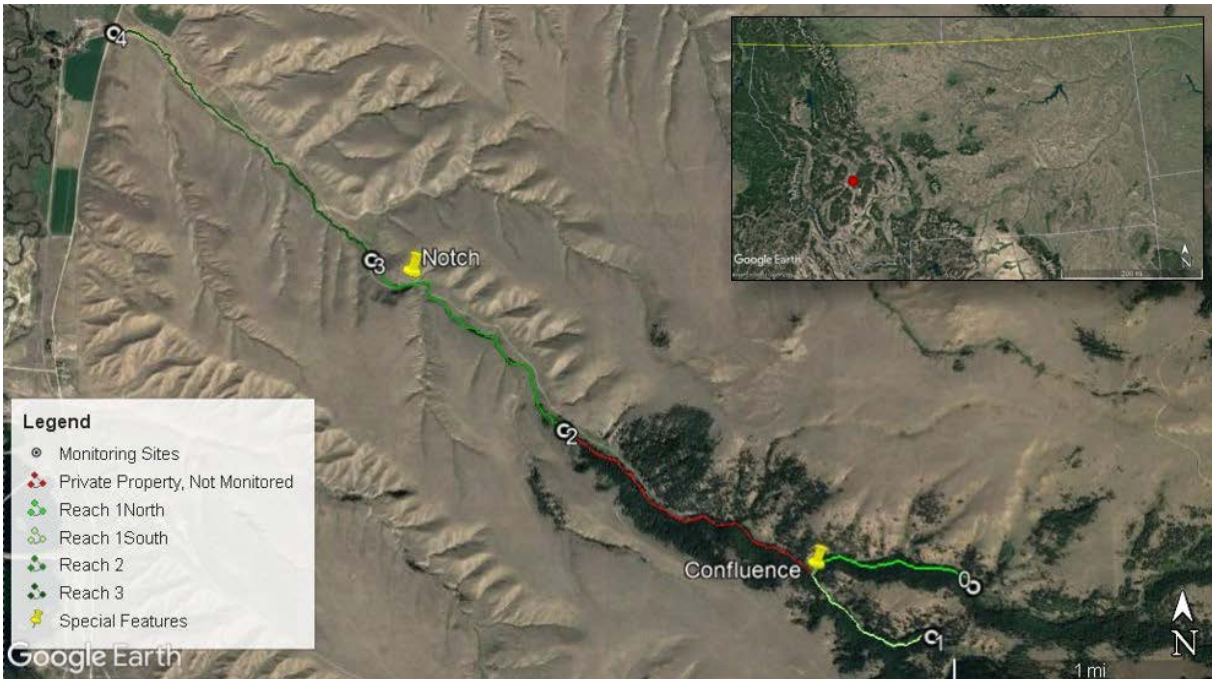
Figure 3: The Perkins Gulch field area covers roughly 6.4 km of stream spanning from the northernmost extent of the Warm Springs Wildlife Management Area to United States Forest Service stations.

The study area can be summarized by five gauging sites that delineate three monitored reaches along the creek (Figure 3). Each site is coupled with a stilling well/staff gauge in the creek and one or two piezometers located on the creek bank.

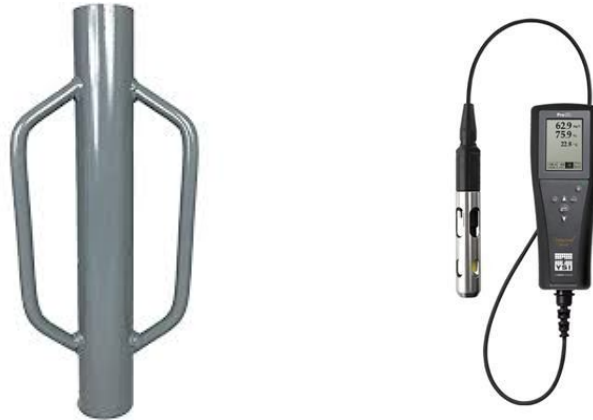
Figure 5: Hand held post pounder used to install shallow wells at sites 4-1 (right) and YSI Pro30 conductivity meter used to determine specific conductivity, conductivity, and temperature.

Groundwater and surface-water monitoring instruments were installed during August 2020. Shallow wells at monitoring sites 3, 2, and 1S consisted of 1.5 m long, 2.5 cm diameter PVC pipes which were manually driven into the ground using a metal fence post pounder (Figure 5), with a metal drive rod inserted into the PVC. These shallow installations provide an open bottom completion approximately 1 m below ground surface. Wells at sites 3, 2, and 1S range from 0.74 m to 1.1 m belowground surface. At site 3 (Figure 6) three shallow wells were installed. The first two wells were too shallow to reach water and so a third was installed to supplement data.

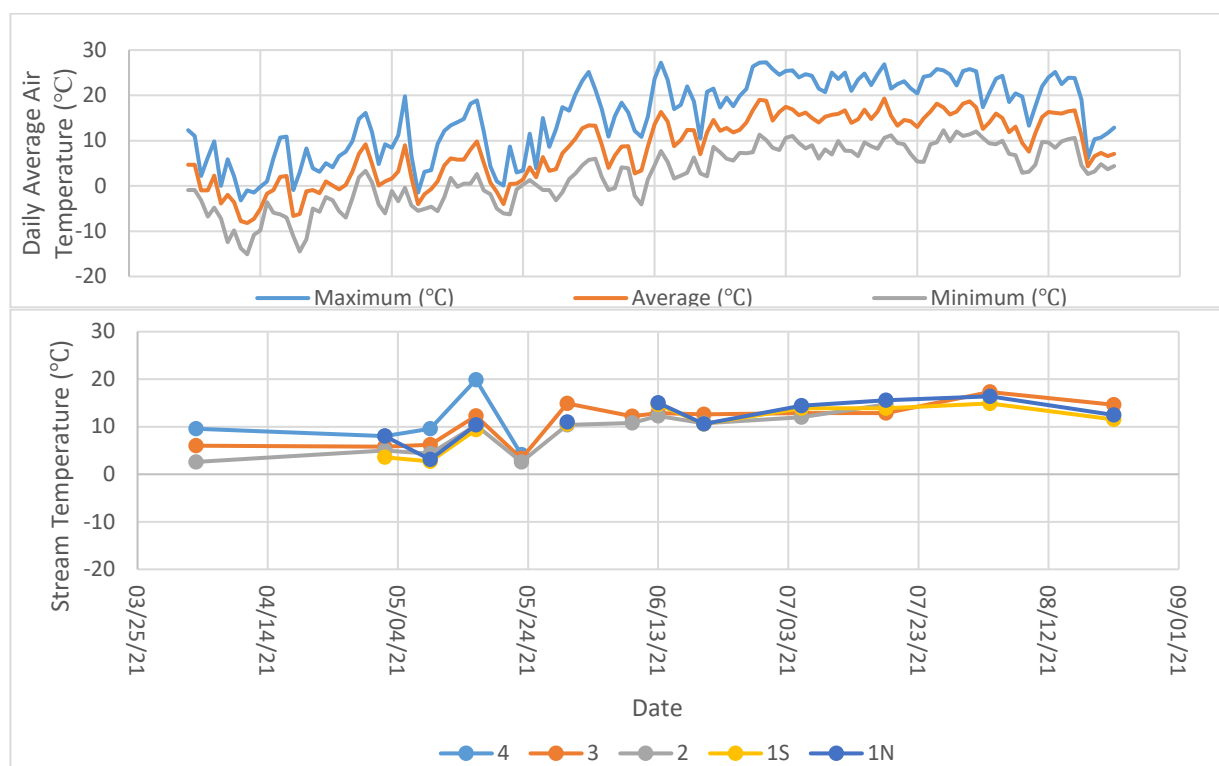
Figure 8: Air temperature at the Warm Springs USGS weather station (top) compared to surface flow temperature at monitoring sites 4-0 (bottom) over the course of the 5-month field study.

Surface flow temperature generally trended upwards over the 5-month field study with the exception of two outliers at 19.9 °C on May 16th and 2.6 °C on May 23rd. Maximum and minimum recorded surface flow temperatures are congruent with daily average air temperatures on those days, which were recorded at Warm Springs as 18.9 °C and -0.8 °C, respectively. Despite these outliers, surface flow temperature generally increased from about 6 °C in early April to about 16 °C in early August., From April to August the daily average air temperature increased from 0 °C to 18 °C (Figure 8). The last surface flow temperature at Perkins Gulch was recorded on August 22nd but daily average air temperature did not drop below freezing until October 9th.

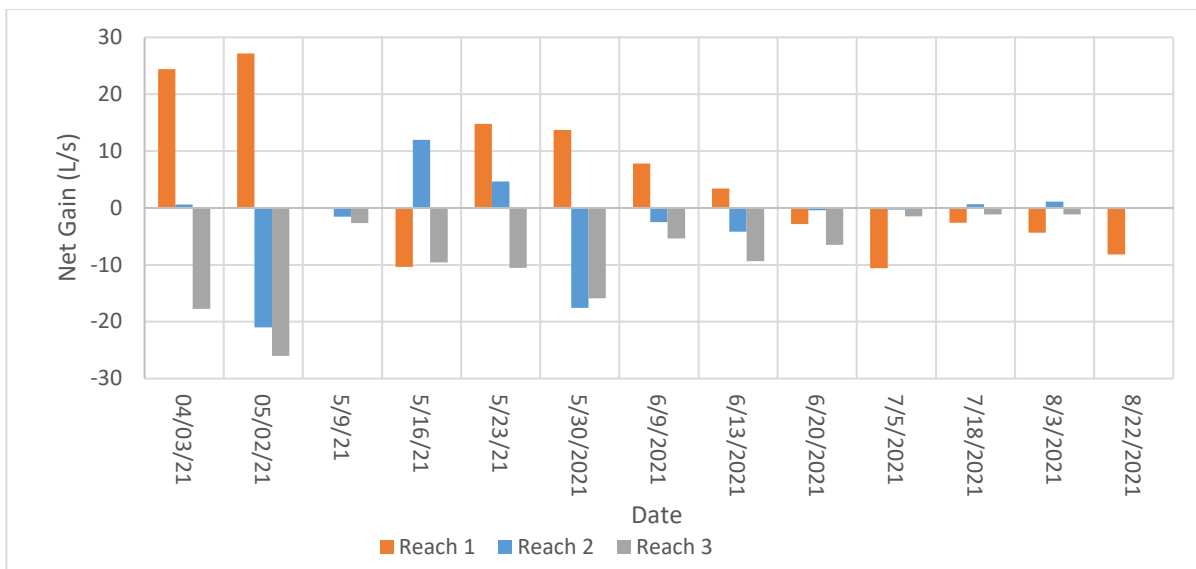
Figure 11: Net gain/loss as calculated from the surface balance over the 5-month study period. Negative values indicate that the stream is losing, while positive values indicate gaining.

In reach 1 the maximum measured stream gain was 27.2 L/s, and the maximum loss was 10.4 L/s. At reach 2 maximum gain was 12 L/s and loss was 21 L/s. Reach 3 was losing for the entire study with minimum loss of 1.1 L/s and a maximum loss of 26 L/s (Figure 11). Since flow was zero at the lower end of reach 3 after mid-June, losses after that time are limited by the amount of water flowing into the upstream end of the reach.

Reach 1 was strongly gaining from early April to mid-June, with a brief losing period from early to mid-May. Reach 1 showed net losses from mid-June through the end of August. Reach 2 was a losing system but briefly transitioned to show a net gain from early to mid-May, and weakly gained after mid-July. Reach 3 was a losing system throughout the study period. Overall, groundwater systems at all three reaches converged on a neutral gaining/losing status. Reduced groundwater contribution in the reaches is likely partly due to dryer summer conditions over the course of the study (Figure 7).

The temporal surface balance (Figure 11) established reach 2 as losing throughout the study season. However, the reach transitioned from gaining to losing, and flowing to zero flow, several times from subsite 1 to 11 (Reach 2, Figure 18). The greatest gain in surface flow was noted at subsite 9, which is immediately upstream of the Tlc bedrock notch. Stream flow increased by over

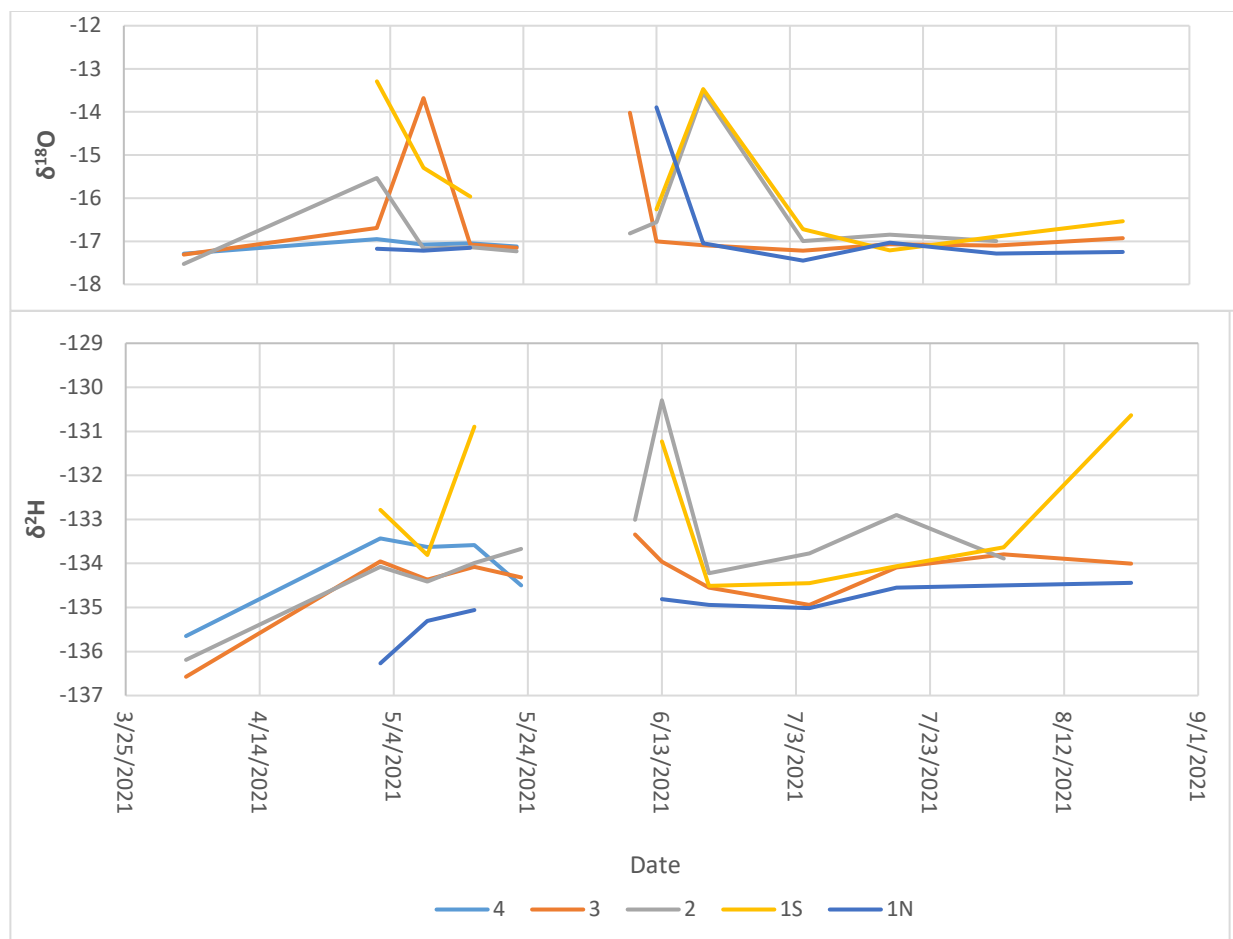
Figure 15: Surface water O18 and Deuterium over time

$\delta^{18}\text{O}$ and $\delta^2\text{H}$ values were also compared over time. In general, $\delta^{18}\text{O}$ of all monitoring sites remained constant over time at roughly -17‰ . However, all five monitoring sites increased to -14‰ at some point between early May and early July (Figure 15).

In contrast, deuterium values trended generally upward from -136 ‰ in early April to 134‰ in mid-August. The maximum deuterium value observed was -129‰ at site 2 on June 13th.

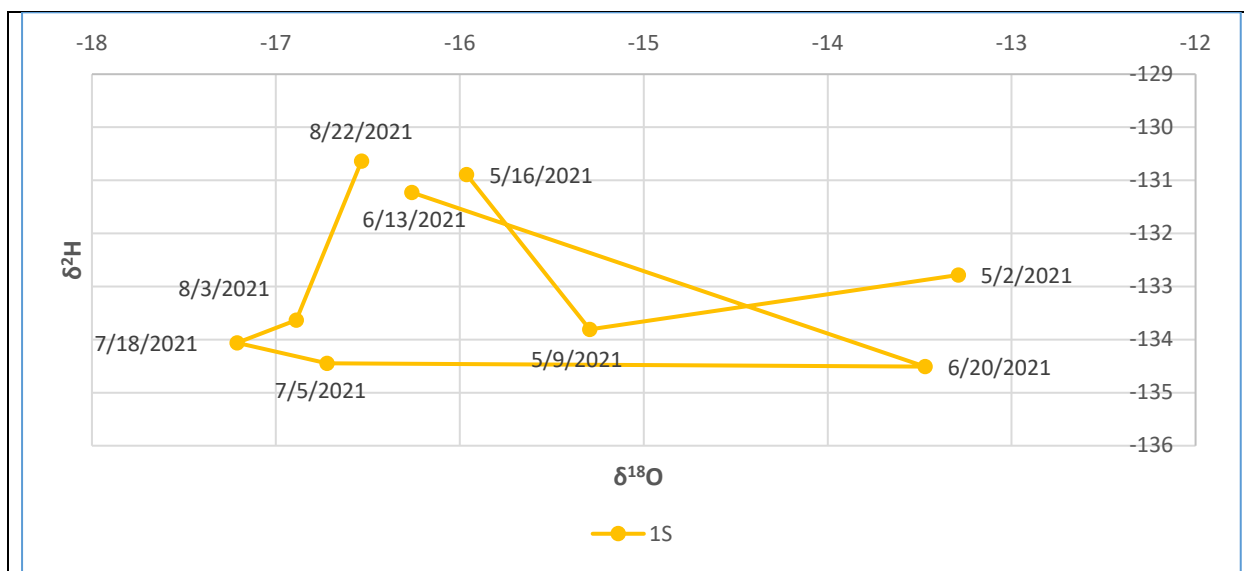
Figure 16: Variation of $\delta^{18}\text{O}$ and $\delta^2\text{H}$ values at site 1S over time

When compared over time, $\delta^{18}\text{O}$ and $\delta^2\text{H}$ values at site 1S behaved in a cyclical pattern (Figure 16). Over the study period surface water at site 1S swung between less negative to more negative $\delta^{18}\text{O}$ and $\delta^2\text{H}$ values several times.

Minute changes in local climate or surface water/ groundwater interactions into the late season may be responsible for the cyclical trends in isotopic makeup at site 1S.

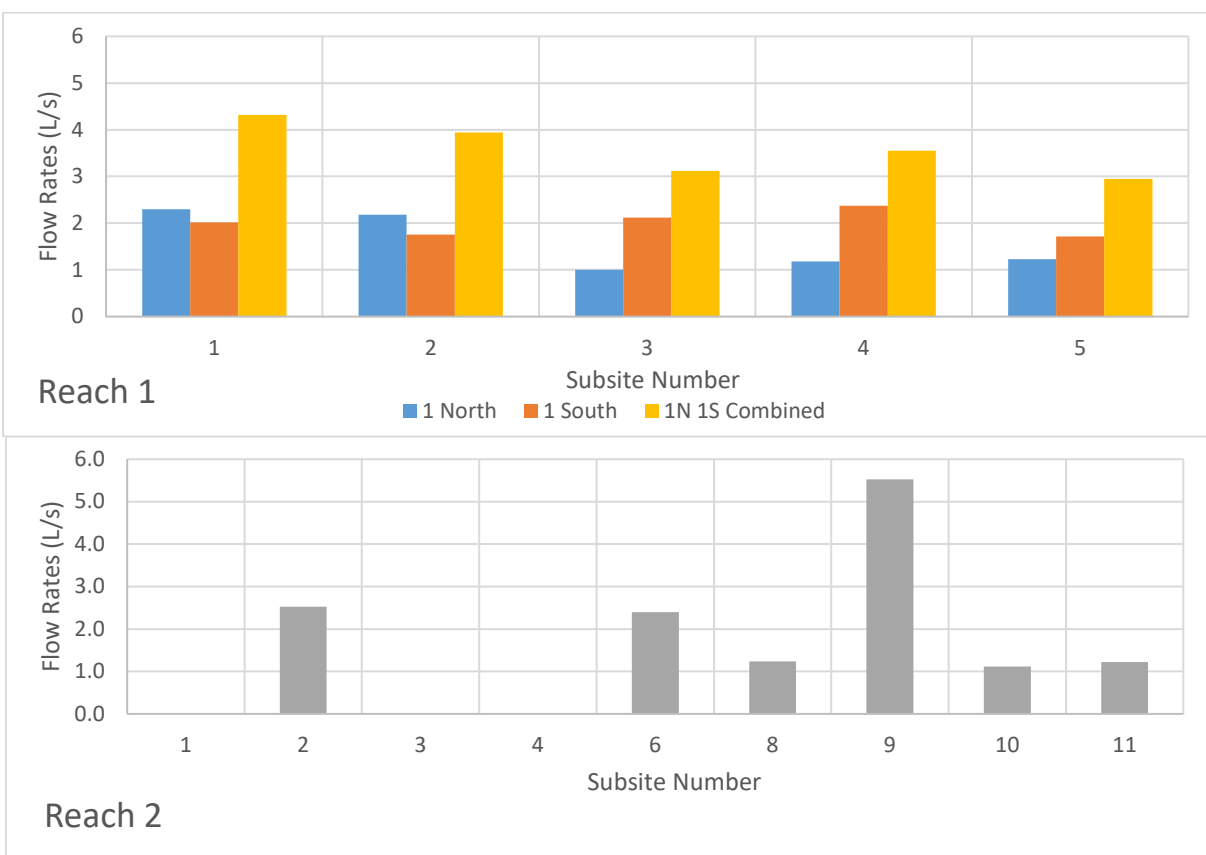
Figure 18: Stream flow rates at late-season subsites in reach 1 (combined 1N and 1S) and reach 2.

A water balance was completed to supplement the observations of changes in flow status (Figure 18). From upstream to downstream (subsites 1 to 5) surface flows in reach 1 combined declined from over 4L/s at subsite 1 to less than 3 L/s at subsite 5 with a brief increase in flow at subsite 4. No trends in stream flow rate in reaches 1N and 1S were noted (Reach 1, Figure18).
