## Butte Priority Soils Operable Unit (BPSOU) Final Insufficiently Reclaimed Sites - Field Sampling Plan (FSP) BRES No. 32 – Corra-2 Dumps

# **Atlantic Richfield Company**

#### July 29, 2022

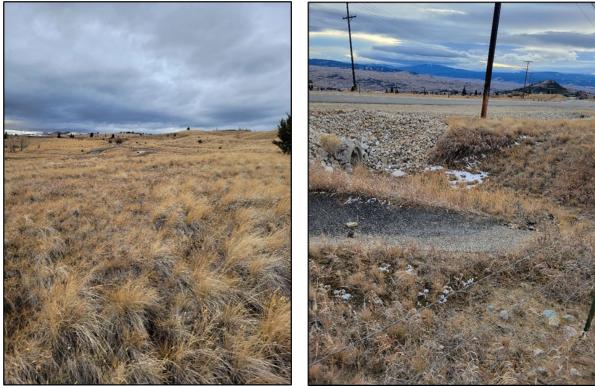
Photograph 1: Site is Well Vegetated East of the Channel

A preliminary site visit was conducted to qualify existing site conditions and identify areas of focus that need additional evaluation. Site photographs were taken during the preliminary site evaluation to capture site conditions. The photographs are included in this section for reference. The site appears to be well vegetated with minor areas of bare ground. Although weed detection is difficult in winter months, it appears the site has limited weed establishment. Remediation efforts were conducted by Butte-Silver Bow (BSB) in 2021 addressing previous barren areas and vegetative improvement. EPA approved cover soil was placed in areas of repair as seen on Photograph 5.

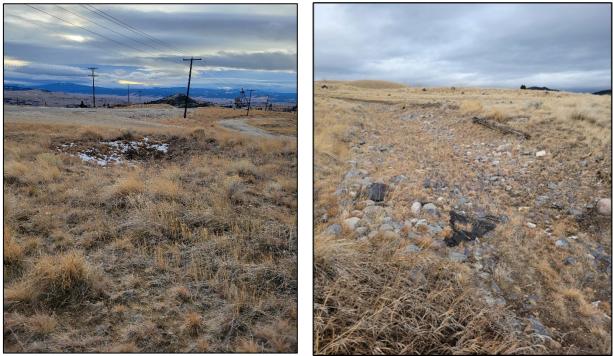
Photograph 3: Asphalt and Concrete Storm Water Features-South

Photograph 4: Rock Lined Storm Channel Through Middle of Site

Existing storm water controls include rock and grass lined ditches located through the center of the site running north to south (Photograph 4 and Photograph 5), and two outlet structures at the south end of the ditch and in the southwest corner of the site (Photograph 2). These will be evaluated to determine their effectiveness and identify additional Best Management Practices or potential maintenance items.

Existing site grading will be evaluated to determine storm water flow patterns and identify whether additional storm water controls are necessary to prevent sediment migration. The location and condition of existing storm water features will be field-verified and recorded so appropriate corrective actions can be implemented. Upgradient and adjacent contributing sources of storm water will also be investigated.
