**SURFACE WATER/GROUNDWATER INTERACTIONS AND
HYDROGEOCHEMICAL CHARACTERIZATION OF THE ELKHORN
MINE AND MILL, BEAVERHEAD COUNTY, MONTANA**

SURFACE WATER/GROUNDWATER
INTERACTIONS AND HYDROGEOCHEMICAL
CHARACTERIZATION OF THE ELKHORN MINE
AND MILL, BEAVERHEAD COUNTY, MONTANA

Masters of Science Degree in Geoscience
Hydrogeology Option

Montana Technological University

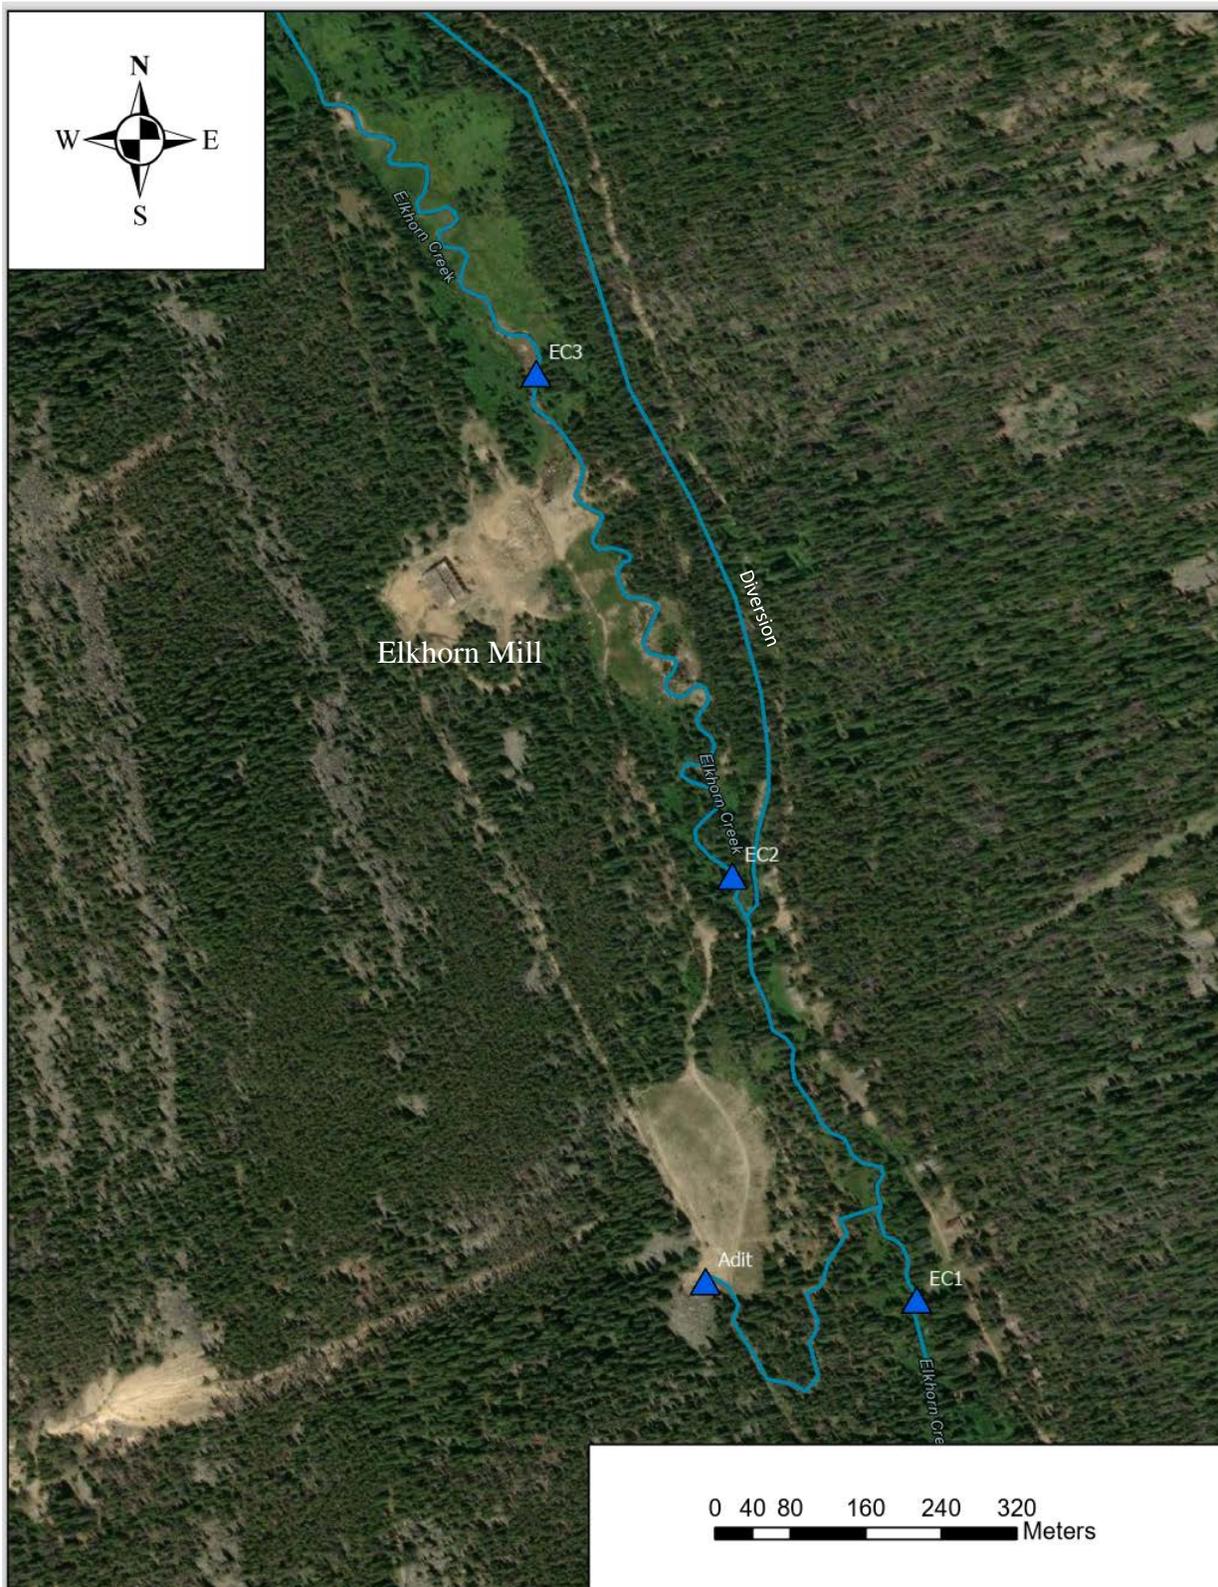
Figure 6: Map of stilling well locations at the Elkhorn site

Three staff gages and stilling wells were implemented along Elkhorn Creek (Figures 6 and 7). Stilling well/staff gage number one (EC1) was placed in Elkhorn Creek above the mine to capture all incoming flows to the system. EC2 was placed below the diversion culvert on the Elkhorn Creek side to capture water entering the creek and, by interpolation, how much the diversion is taking. Finally, EC3 was placed in Elkhorn Creek below the mill to capture influxes coming from the mill. The Elkhorn Creek diversion, referred to as the “diversion”, was measured twice in June and not at all in July. By August 2nd, zero flow was observed in the diversion and water was stagnant.

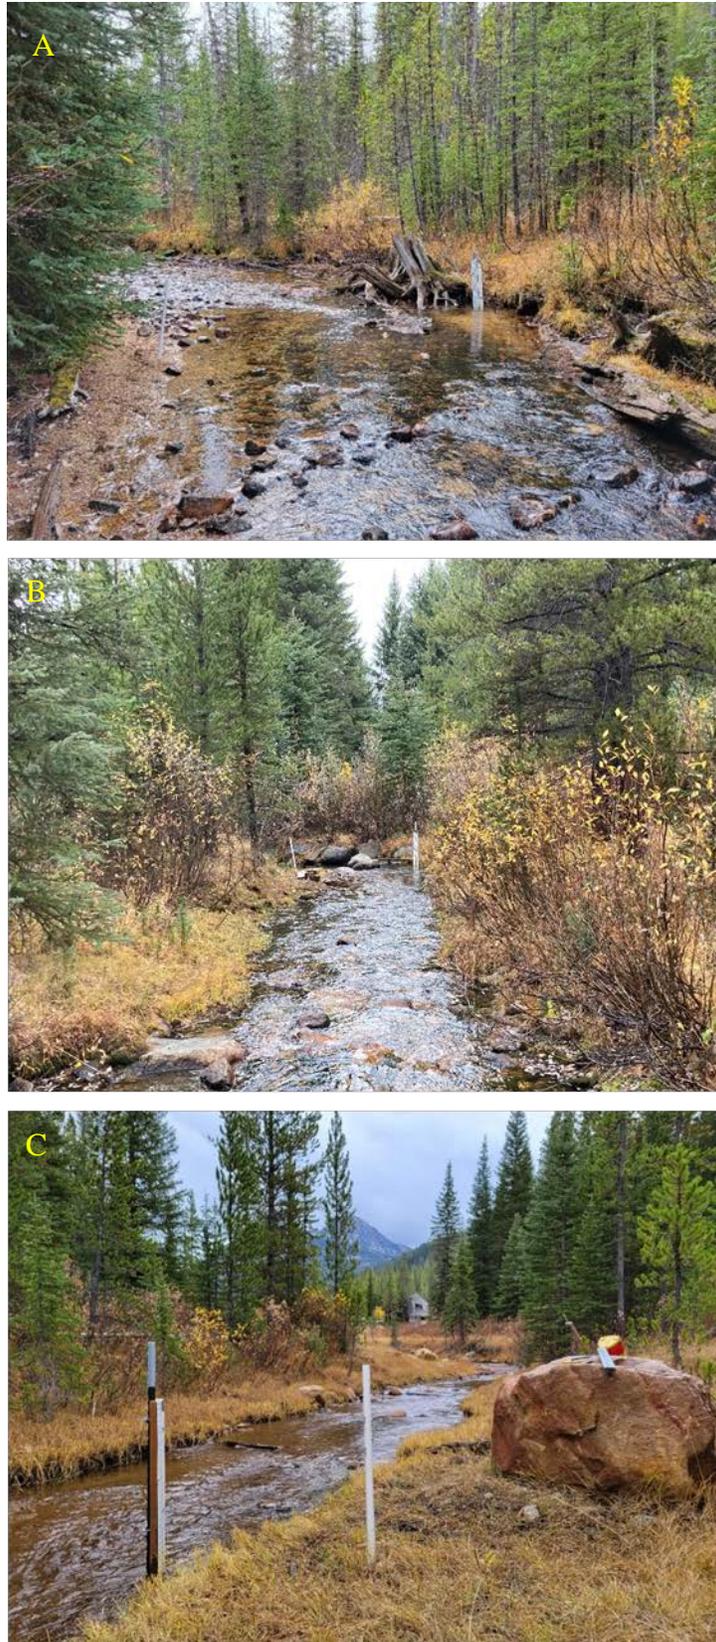
Figure 7: Photos of staff gages and stilling wells in place at EC1 (A), EC2 (B), and EC3 (C)

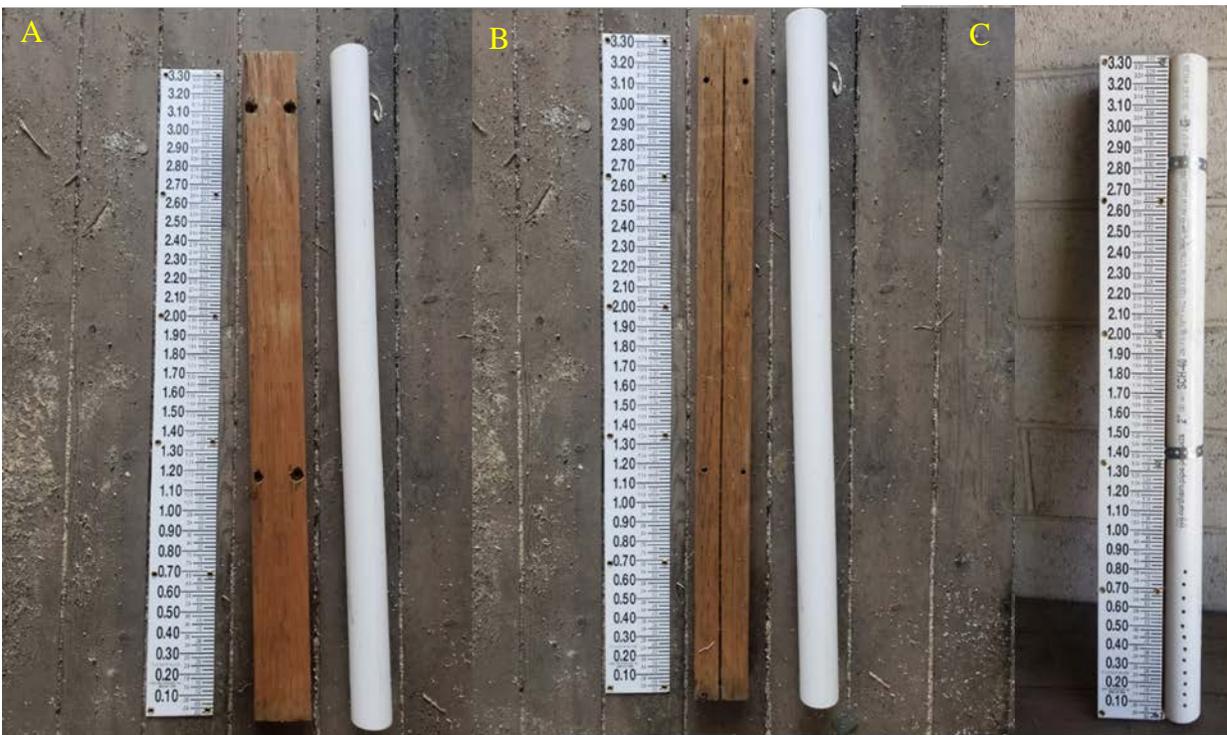
Staff gages were created by hand based on the Montana Bureau of Mines and Geology's (MBMG) standard operating procedure on staff gage creation (figure 8). A treated 2x4 wood plank was used as the support for the staff gage and stilling well. Inset holes were drilled in the plank to allow the carriage bolts to be flush with the board. A seam was cut on the back of the board to allow easier attachment to the tee-post. A 2-inch, schedule 40, PVC pipe was used as the stilling well. Holes were drilled in the pipe from the bottom to about a foot up. The pipe was attached using metal pipe straps screwed into the board. The type C staff gage was then screwed into the board, covering the carriage bolts and strapping.

Figure 8: Assembling the staff gage, inset for carriage bolt (A), seam for T-post alignment (B) and all together (C)

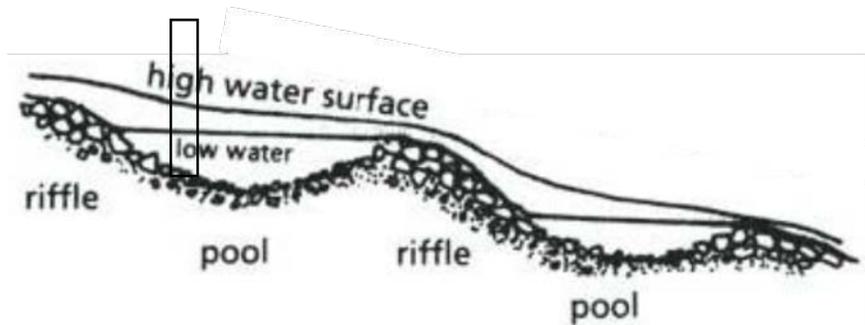
Site selection for the staff gage/stilling well is based on stream morphology and in-stream structures. Consideration must be taken for potential blowouts, wash-outs, or debris accumulation. In the case of Elkhorn Creek, these in-stream structures were natural. The staff gages must be placed in a pool (Figures 9 and 10) upstream of a control structure (riffles). The site must also be compatible with flow data collection.

Figure 9: Diagram of staff gage placement structures taken from the National Park Service

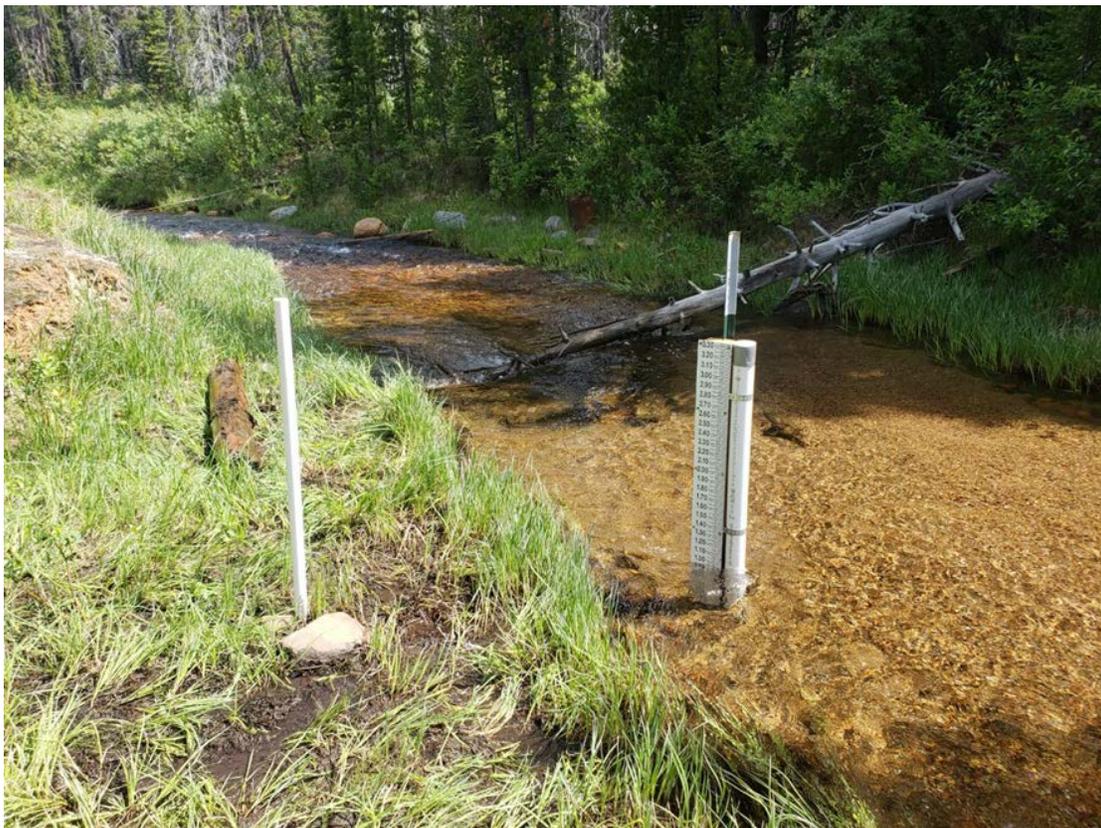
Figure 10: Photo of staff gage/stilling well and piezometer placement at EC3

One PZ was also installed next to each of the three staff gages (Figure 10). The PZ at EC3 was installed on 6-28-2021, while those at EC2 and EC1 were installed on 8-9-2021. EC2 and EC1 PZs broke on the initial try in June. A new tool was fabricated for their installation in August to prevent breaking.

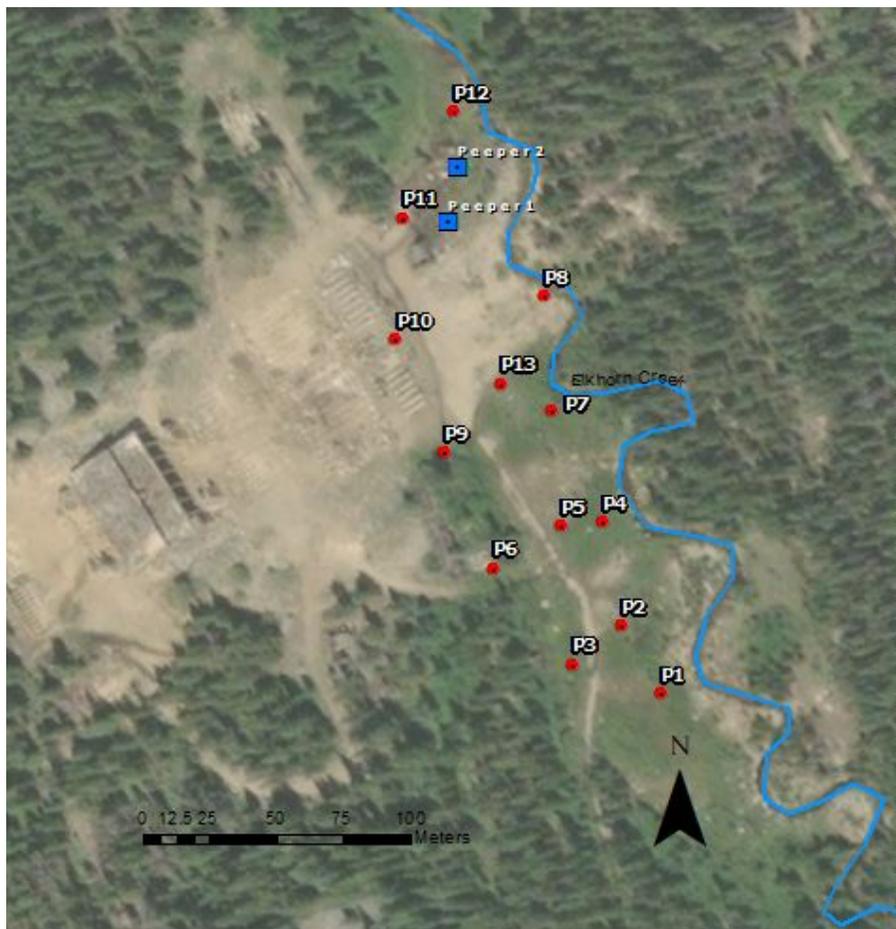
On June 28th, 2021, 13 nested Piezometers (PZ) were implemented surrounding the mill area (Figure 11). The PZs were created by hand and manually installed. The chosen material was one-inch, schedule 40 PVC pipe cut into 5-foot sections. 7/64-inch holes were drilled every inch from the bottom for a total screen length of 1 foot, and then the bottom was capped (Figure 12). A 6-foot iron spud bar was used as a pilot and pounded in with a post pounder until the proper depth was reached or could no longer move. When hand pulling was not possible, a chain and lift jack was used to break the suction. The PZ was placed in the hole and pounded in with the back of an axe. Depths of PZs ranged from 0.59 meters to 0.96 meters below the surface (Table I).

Figure 11: Map of transect piezometers and peeper locations

The peepers were deployed in the bog between PZ 11 and 12 (Figure 11) and left for two weeks. Peeper 1 encountered rocks and therefore had ten rows of cells sticking up. Peeper 2 was able to be fully submerged. Upon site visit the next week, most of the standing water in the pool had drained. Peeper 1 was now exposed to row 12 (Figure 14), and peeper 2 was exposed to row 8 (Figure 15).

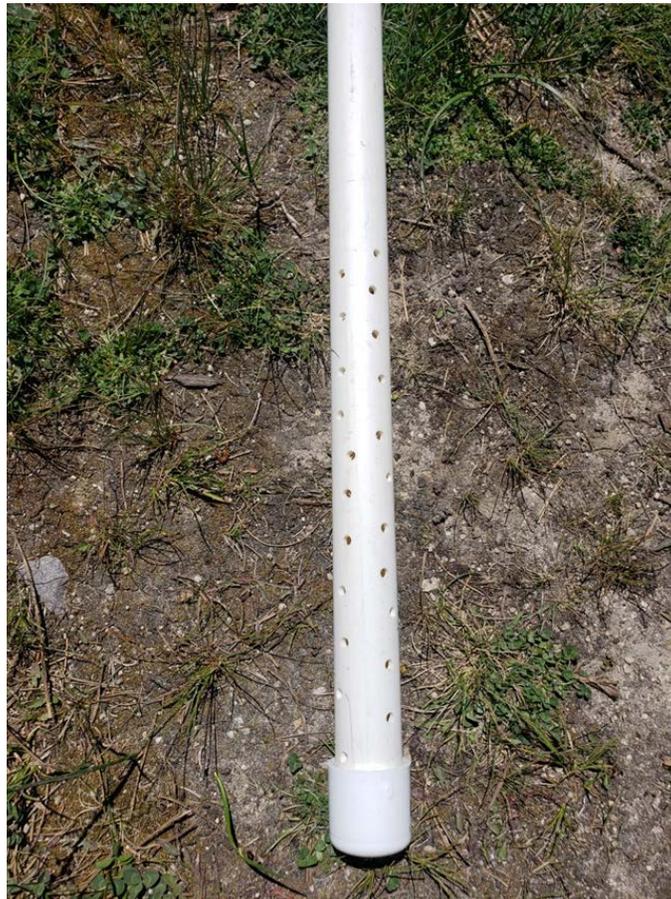
Figure 12: Picture of capped piezometer base

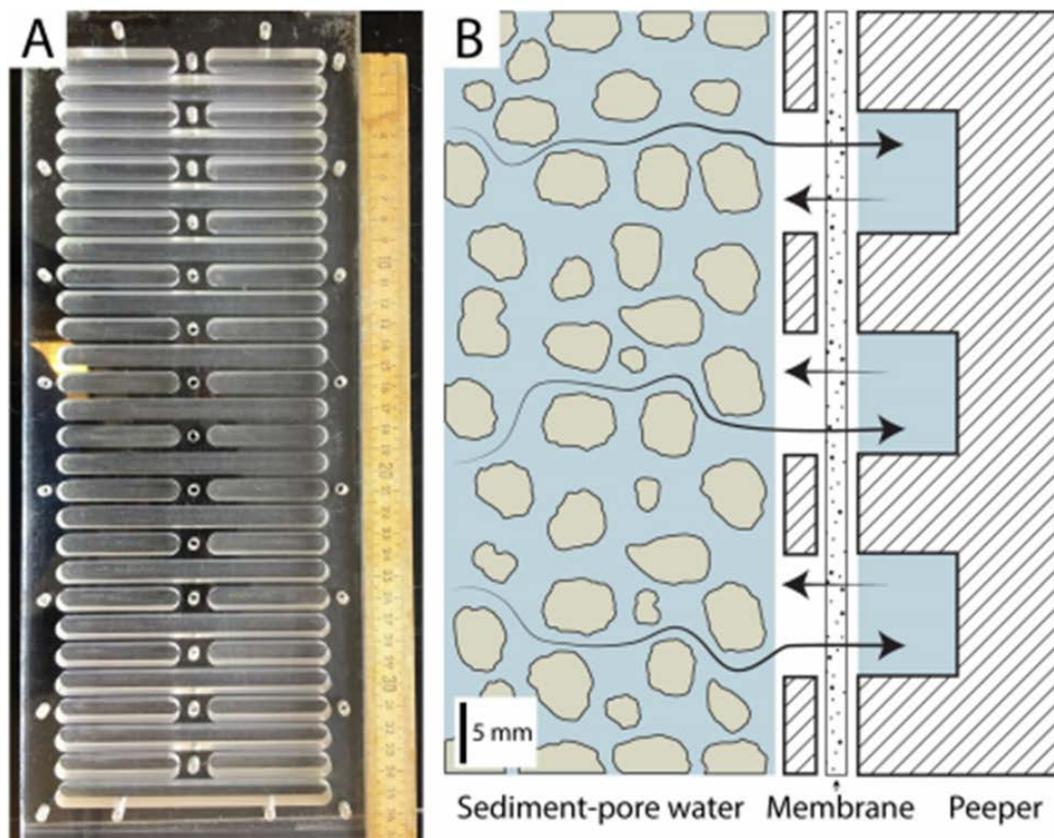
Soil pore-water chemistry down gradient of the old mill was monitored using dialysis arrays, also known as peepers. The peepers allow in-situ pore-water sampling by diffusion of solutes across a membrane (Hesslein, 1976) (Figure 13). The instrument is made of acrylic, 30 cm long, with 14 x 10-ml cells and 28 x 5-ml cells. A nylon membrane (5 μm pore size) is laid in between the acrylic layers. The peeper is assembled in a cooler filled with deoxygenated, deionized water. The deoxygenation of water was done by bubbling nitrogen gas through it for approximately 1 hour. This step is crucial to ensure pore water does not become oxidized in the field (Carignan, 1984). Deoxygenation was done again, in the field, on the day of installation. Argon gas was bubbled through water in the cooler, and the peeper was then placed in the water to fill the cells. The top was attached in the cooler as well.

Figure 13: Picture of a peeper (A), and illustration of pore water diffusion (B)

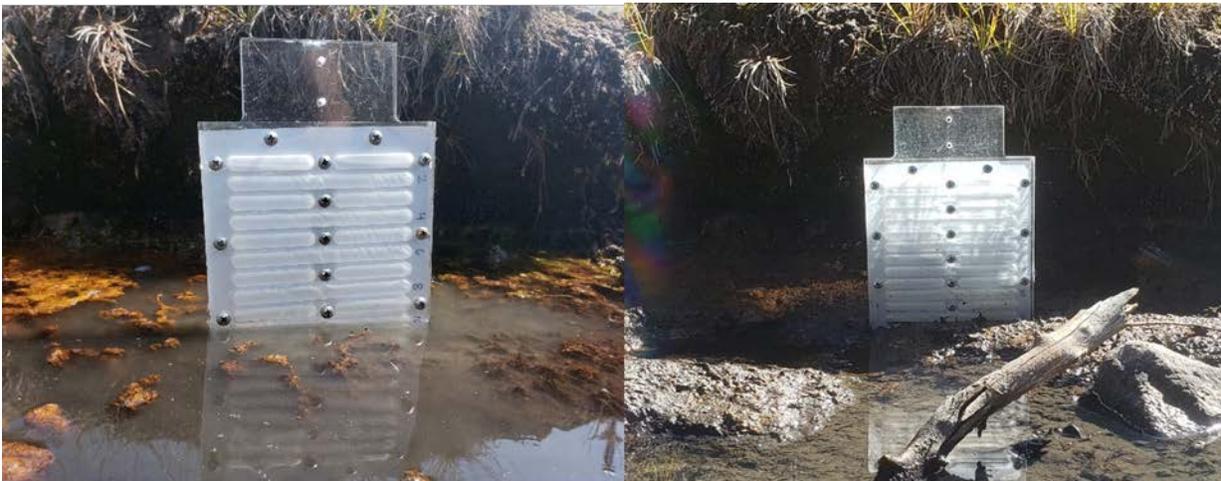
Figure 14: Peeper 1 on September 5th (left) and on September 14th (right)

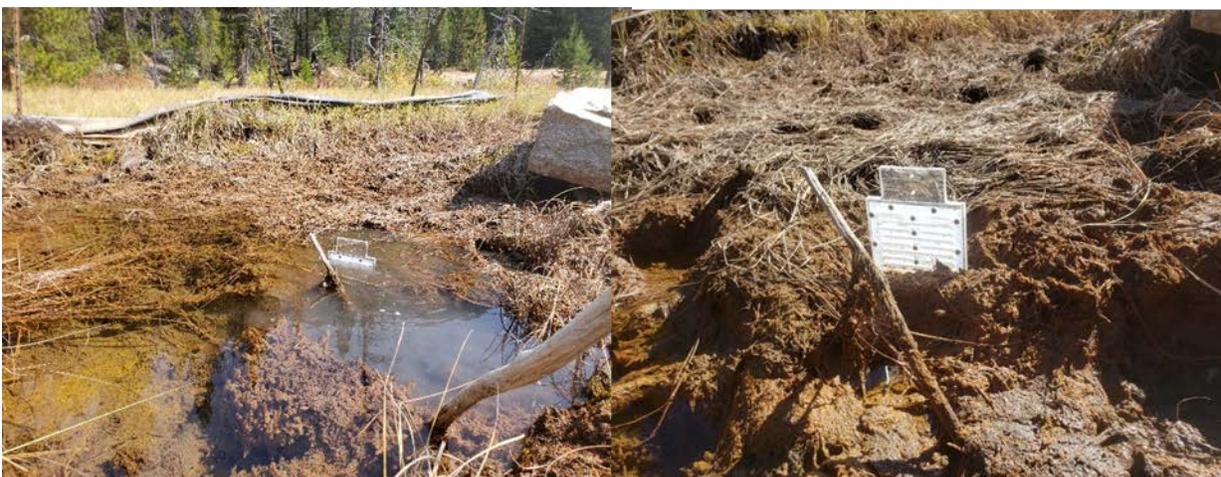
Figure 15: Peeper 2 on September 5th (left) and on September 14th (right)

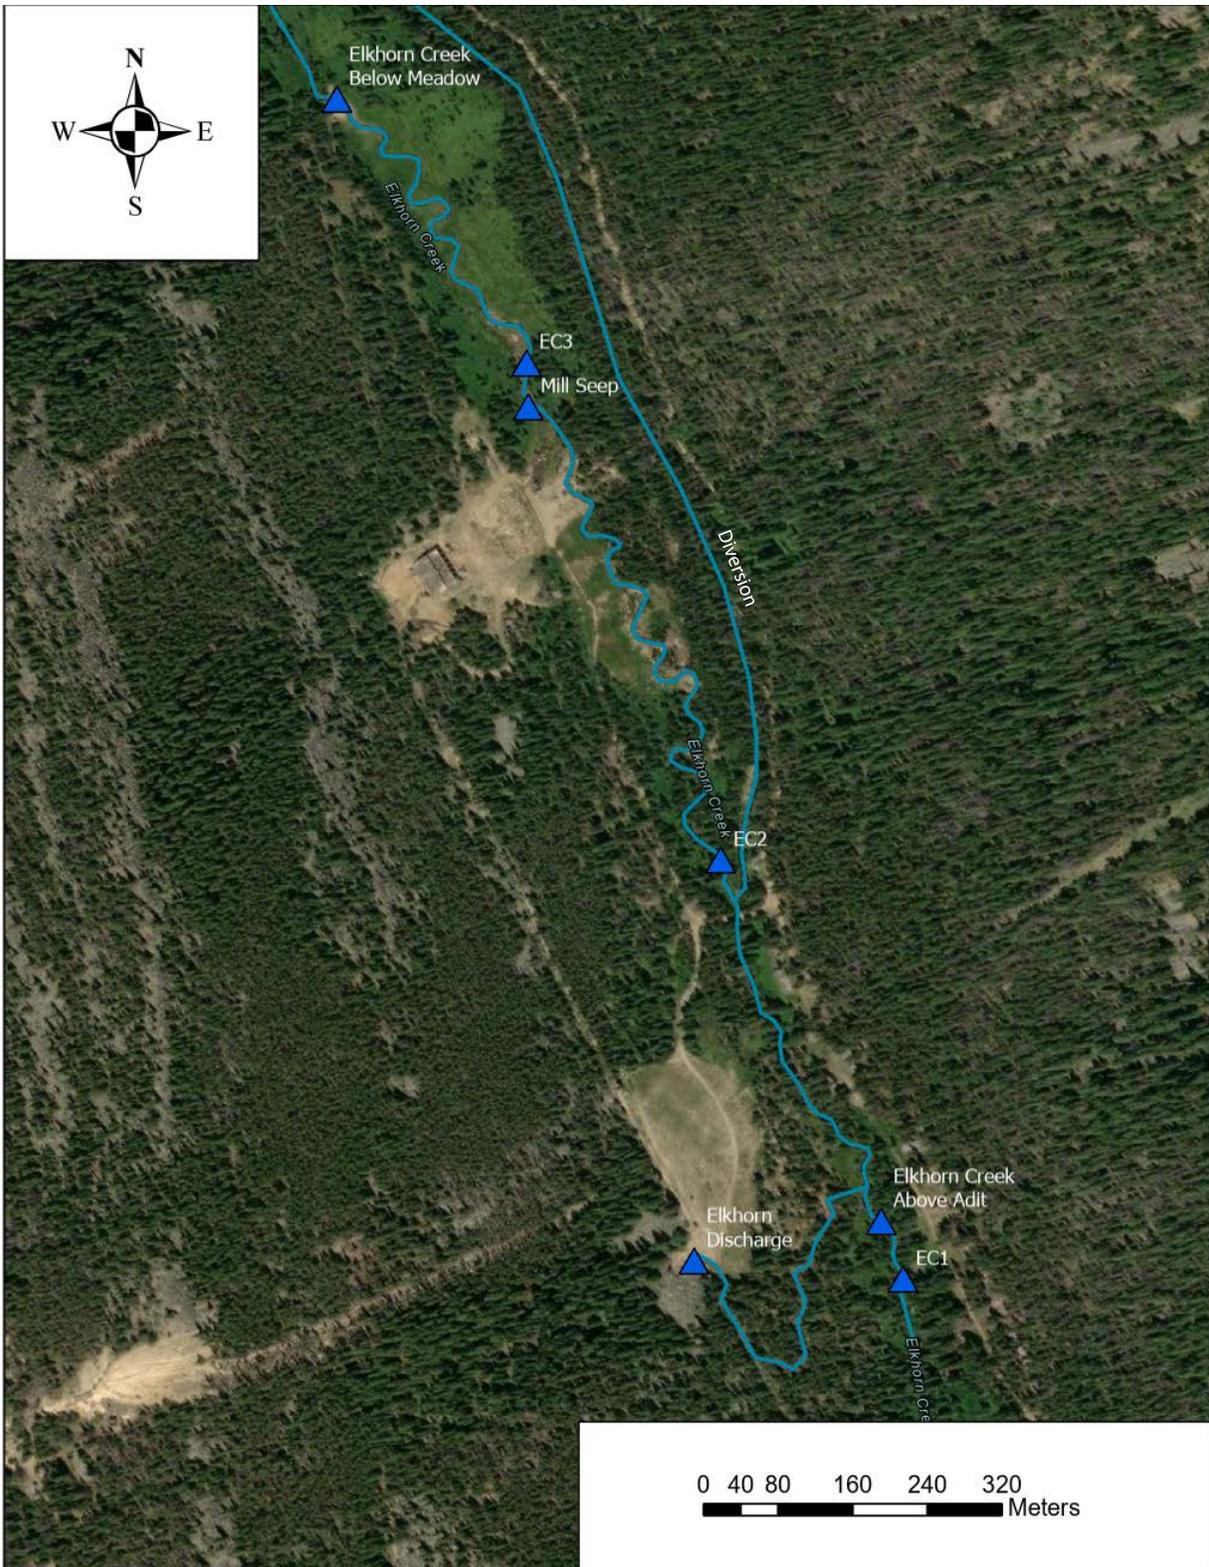
Figure 16: Map of additional sample run locations

Water quality samples were taken periodically throughout the field season. Twenty-two surface water samples were taken from the stream using a 60mL syringe between June 6th and August 29th (Table II). In addition to sampling the stilling well sites, one round of sampling was done at the following sites (Figure 16): the mouth of the adit (“Elkhorn Discharge”), Elkhorn Creek above adit confluence with Elkhorn Creek (“Elkhorn Creek above Adit”), a groundwater seep below transect wells (“Mill Seep”) and above EC3, and in the restored meadow below EC3 (“Elkhorn Creek Below Meadow”) (Table XIV). A Hydrolab MS5 was used for the above samples only. Water collected was sampled for anions, cations, trace metals, and water isotopes. Anion and cation samples were filtered, using a Corning 0.2 micron PES filter, into a 30mL bottle and stored at 4° C. Full-suite analysis samples were filtered into a 250mL bottle and preserved with 1% nitric acid and stored at 4° C. Part of the full-suite analysis also included a “raw” sample (unfiltered and unacidified), which the lab uses to perform pH and alkalinity measurements. Sulfur and Oxygen isotopes ($\delta^{34}\text{S}$ and $\delta^{18}\text{O}$) were also collected from several sites to analyze the sulfate molecule.

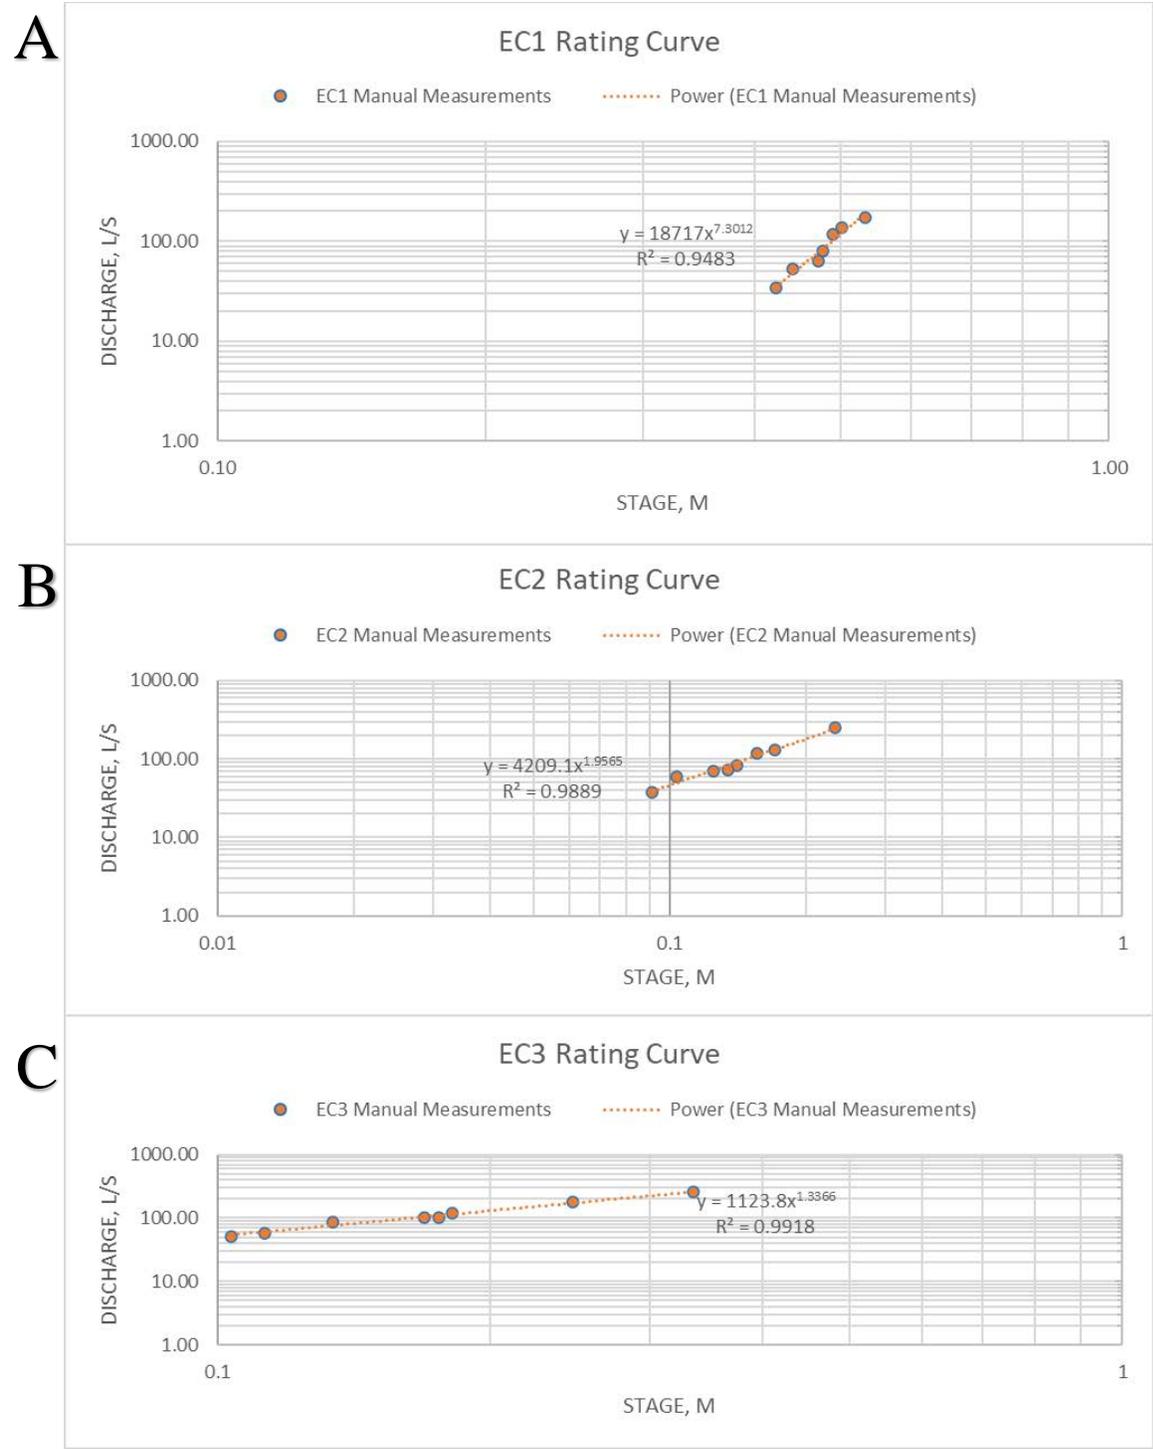
The following results were compiled from the staff gage/stilling wells and the corresponding Solinst data logger. Manual FlowTracker discharge measurements were plotted against manual stream stage readings on a log/log scale to produce a rating curve at each of the monitoring sites (Figure 17). The power curve of the plots yielded an equation for which discharge was calculated. The “X” in the equation is the stream stage measured from the pressure transducer (Figure 18) and the “Y” values of stream discharge were calculated using the power curve. Hydrographs show that high flows occurred during snowmelt in June and July, but flows decreased during baseflow in August and September (Figure 19). Flows ranged from 1809.6 L/s during snowmelt and decreased to 34.10 L/s during baseflow. The highest average flows occurred at EC1, and the lowest average flows occurred at EC2. Recall that the diversion’s flow was only measured twice in June and not at all in July. By August, the diversion had stopped flowing. This could explain some of the differences in flow between sites at EC2 and EC3. Periodic jumps in stage data, as seen near July 23rd, August 2nd, and August 22nd, correspond with large rain events.

Figure 17: Rating Curve of EC1 (A), EC2 (B), and EC3 (C) on a log/log scale showing stage vs discharge

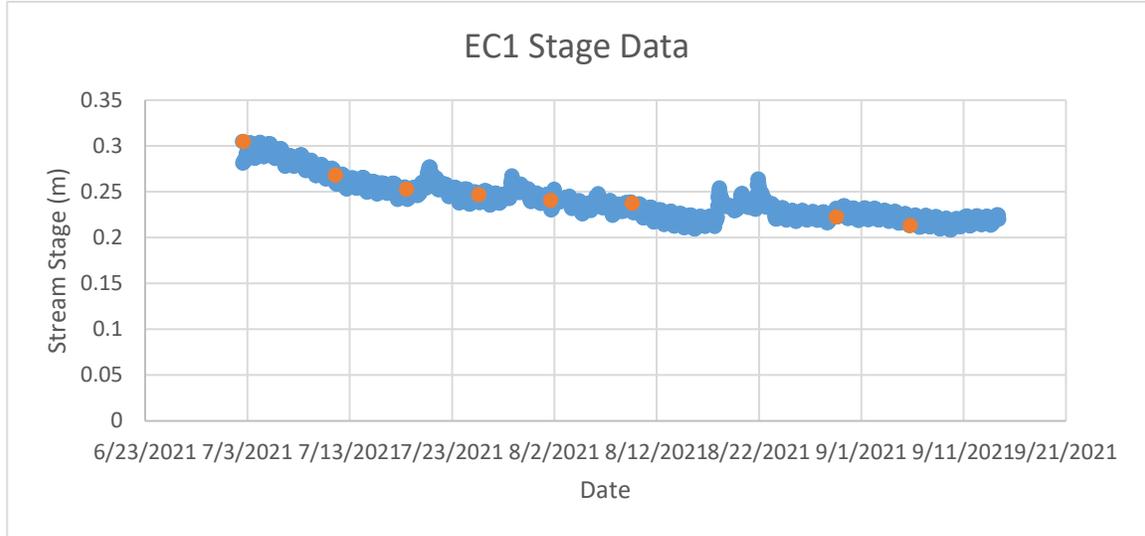
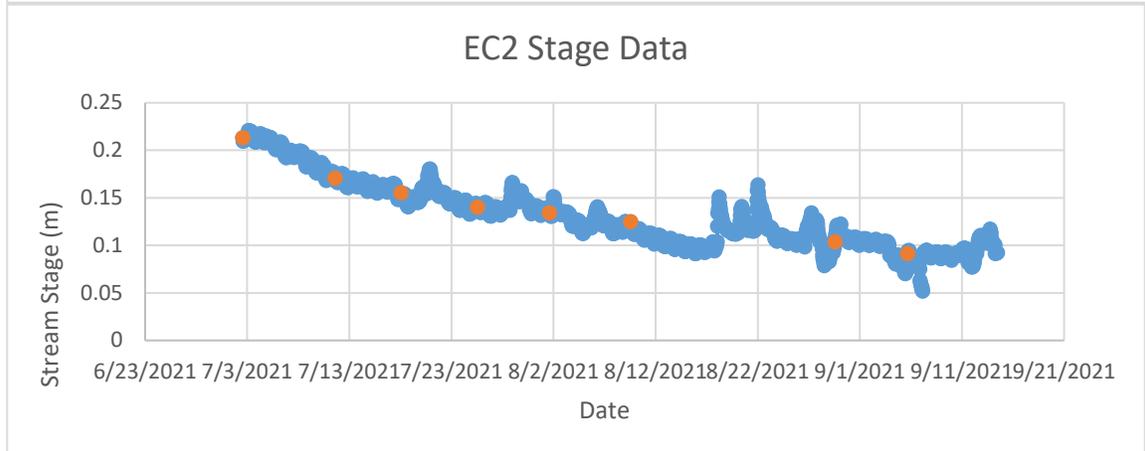
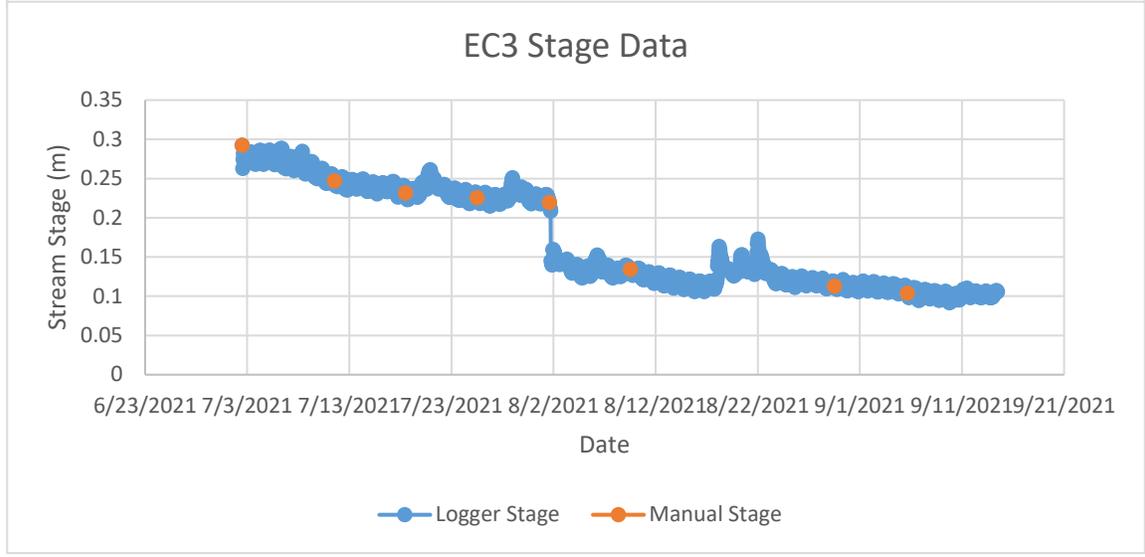
Figure 18: Hourly stage data for EC1(A), EC2(B), and EC3(C) from Solinst data logger showing stream stage over time

It should be noted that in both Figures 18 and 19, a substantial drop in EC3 stage and flow occurs on August 2nd, 2021. Manual measurements, of both stage and flow, also confirm the drop at the same time. While the diversion flows were not measured in July, it is known that by August 2nd, the diversion was not flowing. The lack of flow in the diversion is unlikely to be the reason for the sudden drop. It is more likely to either be a small blowout of the log dam downstream or the staff gage was moved through human or animal interference.

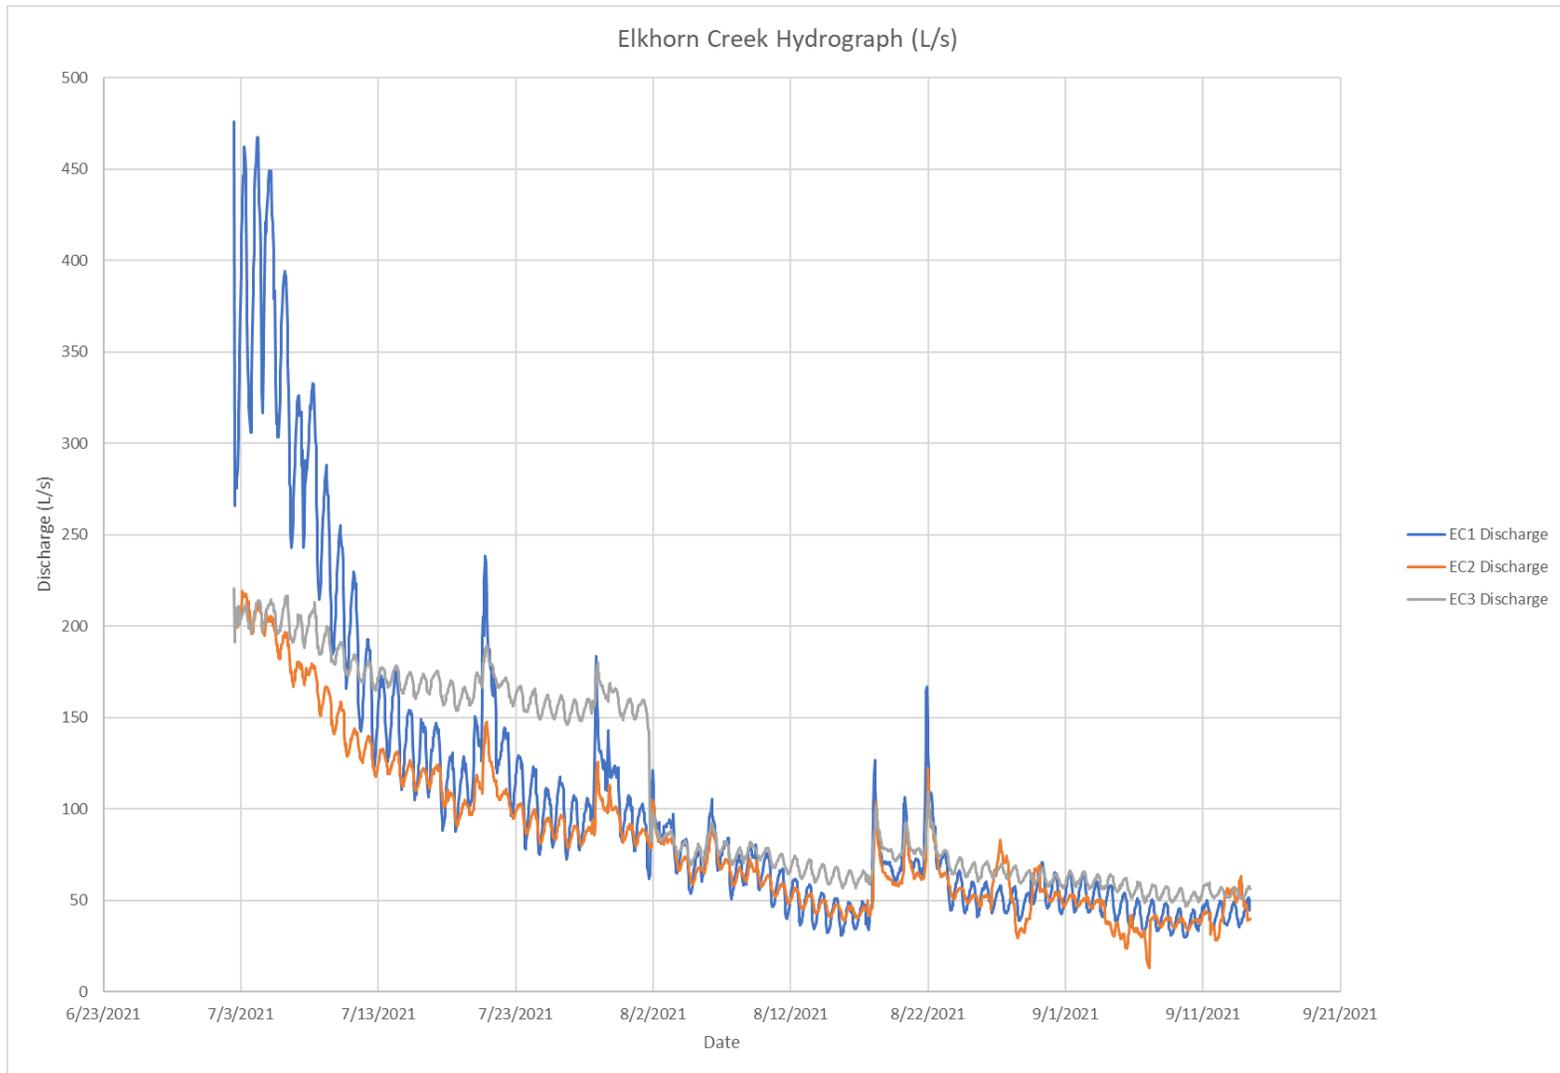
Figure 19: Hydrographs in Liters per second, created from rating curve equation and stage data

The beginning of field data (end of June) caught the very end of the snowmelt runoff, as seen in Figure 19 and supported by Figure 35. Snowmelt had the greatest effect at EC1, where higher flows and greater fluctuations were evident (Figure 19). On July 6th, 2021, for example, flow was at 390 L/s and 12 hours later at 250L/s, then after another 12 hours was at 315 L/s. EC2 and EC3 flows up to August should be higher, but flow is split between the diversion and the creek. In August, however, EC3 is observed to have higher flows than the other sites. This can be interpreted as either continued groundwater inputs or groundwater being released from storage in the meadow.

Elkhorn Creek at and before EC1 runs through steep, loose rock, hillsides, while EC3 enters a flatter valley bottom with wide meadows. Compared to gentle slopes, steep slope runoff has a shorter yield time, meaning the time between rainfall and flow increases, and flows are more turbulent (Li et al., 2020). Similarly, runoff decreases in meadows due to their intercepting quality (Jeffery et al., 2014). Exemplified in the flashier flow peaks (Figure 19) in EC1 and, to a lesser degree, EC2 during storm events compared to EC3.

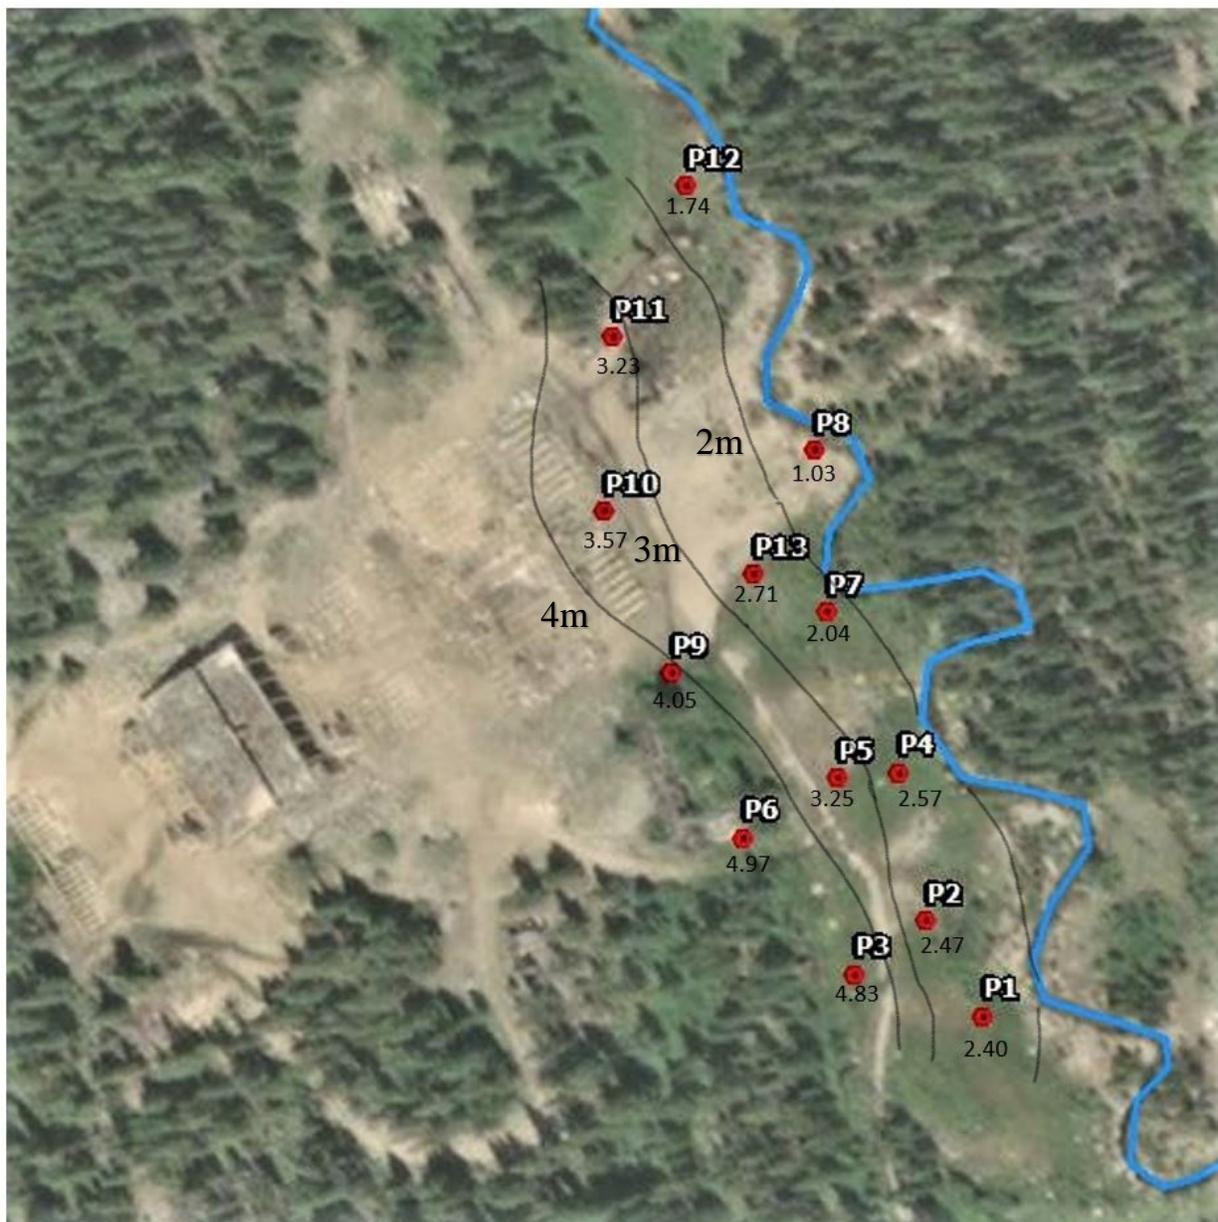
Figure 20: Hand drawn groundwater contour map for July 2nd, where P10 is '0'

Specific conductivity values ranged from 233 $\mu\text{S}/\text{cm}$ at P6 to 1269 $\mu\text{S}/\text{cm}$ at P5 (Table IX). Groundwater temperatures ranged from 10.7 °C to 19.11 °C, with the warmest at well P6 and coldest at P9. A general warming trend is observed as the season progresses (Table X). Groundwater averaged 0.27 m below the ground surface, ranging from 0.6 m below the surface at P7 to above the surface at P11.

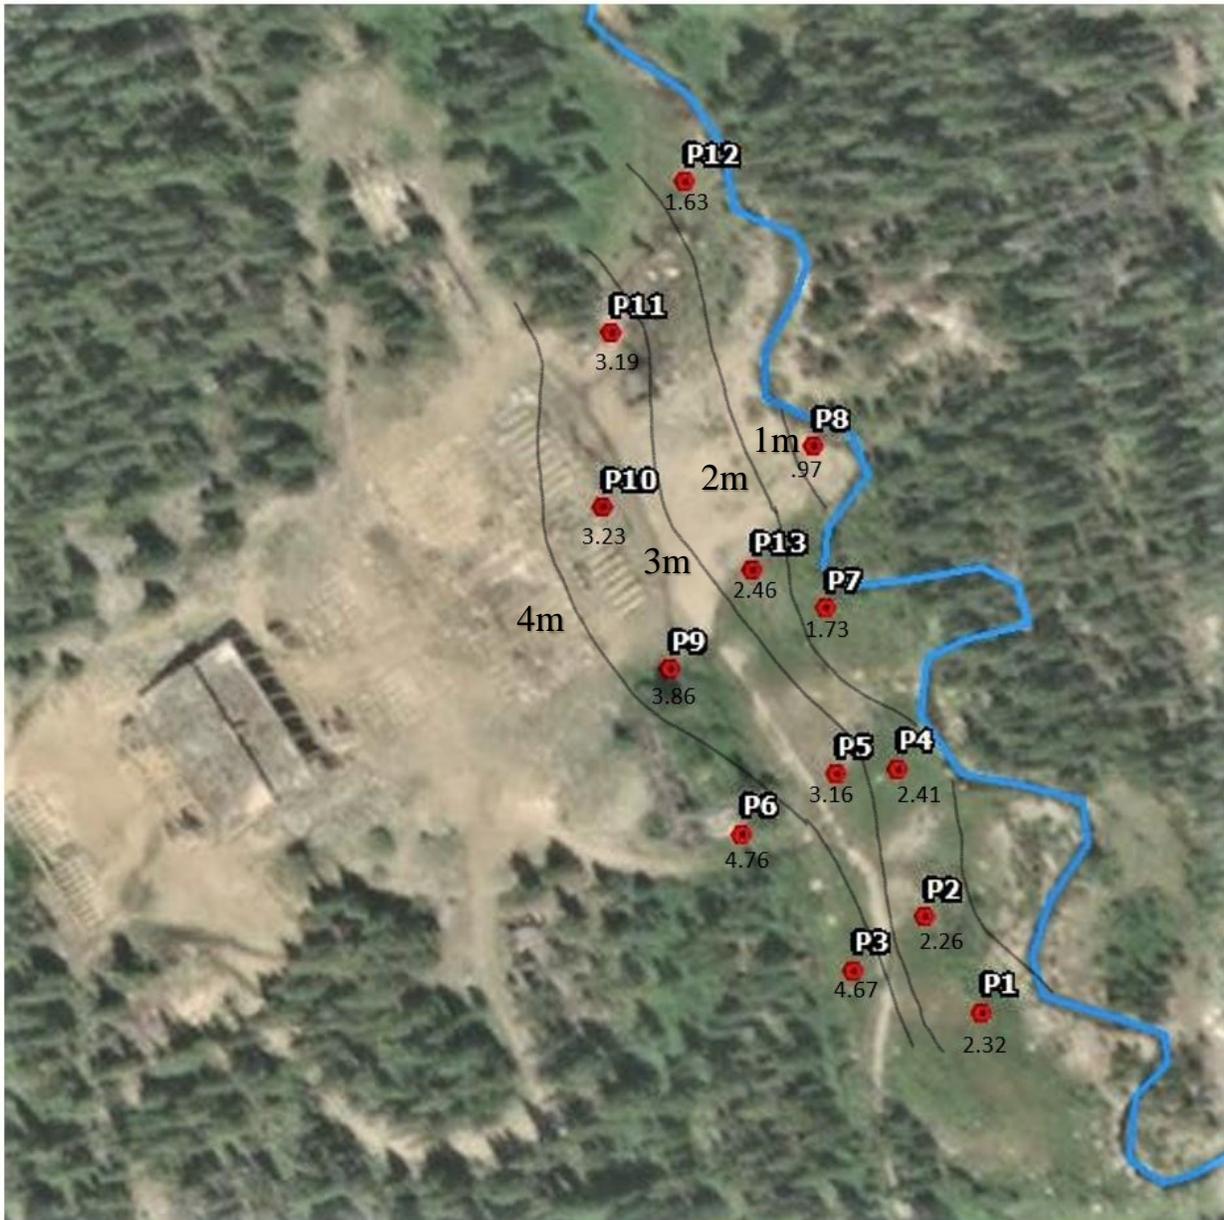
Figure 21: Hand drawn groundwater contour map for August 9th where P10 is '0'

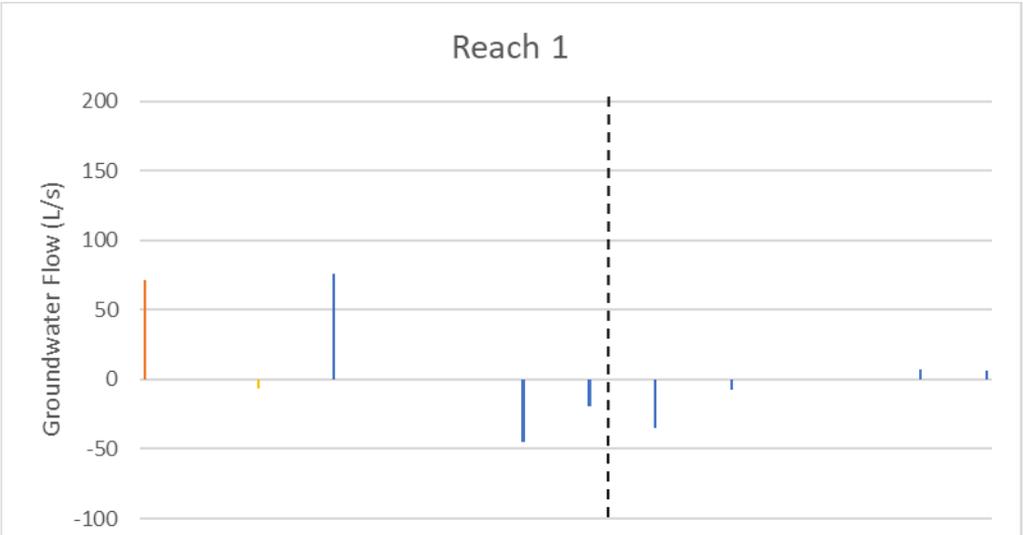
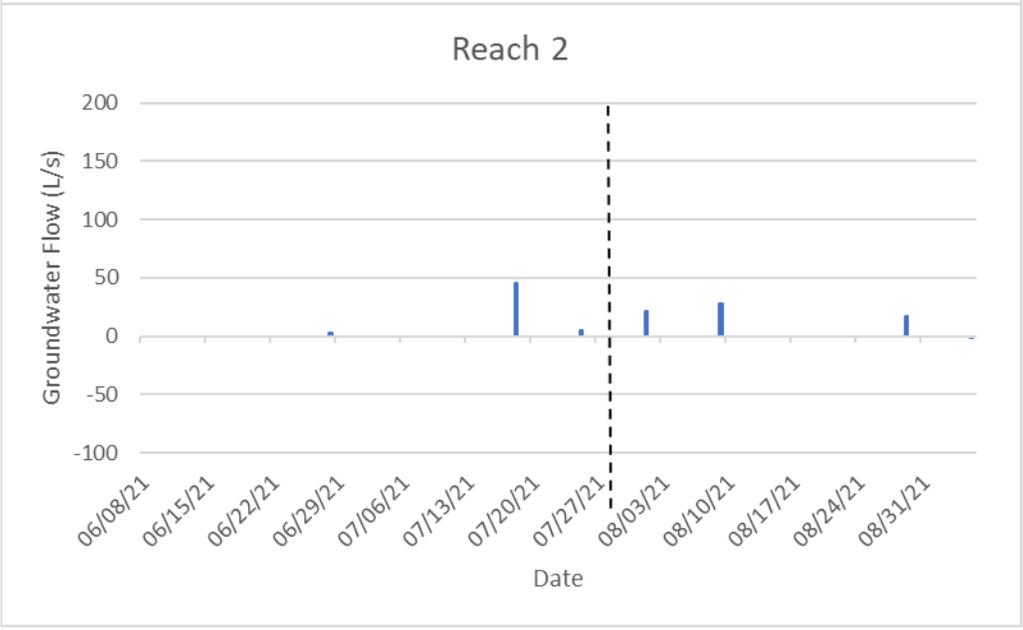
Reach 2, however, was observed to be a gaining reach throughout the whole study. Gains in the dry season (after August) were approximately twice as much as gains in Reach 1.

Figure 22: Chart of surface water balances for reach 1 (EC1 to EC2) and reach2 (EC2 to EC3) throughout the season, calculated using equation 1, The orange bars represent balances between EC1 to EC3, where the diversion had flow measurements. The dashed line represents the time at which the diversion had no more flows.
