**SURFACE WATER/GROUNDWATER INTERACTIONS AND
HYDROGEOCHEMICAL CHARACTERIZATION OF THE ELKHORN
MINE AND MILL, BEAVERHEAD COUNTY, MONTANA**

SURFACE WATER/GROUNDWATER
INTERACTIONS AND HYDROGEOCHEMICAL
CHARACTERIZATION OF THE ELKHORN MINE
AND MILL, BEAVERHEAD COUNTY, MONTANA

Masters of Science Degree in Geoscience
Hydrogeology Option

Montana Technological University

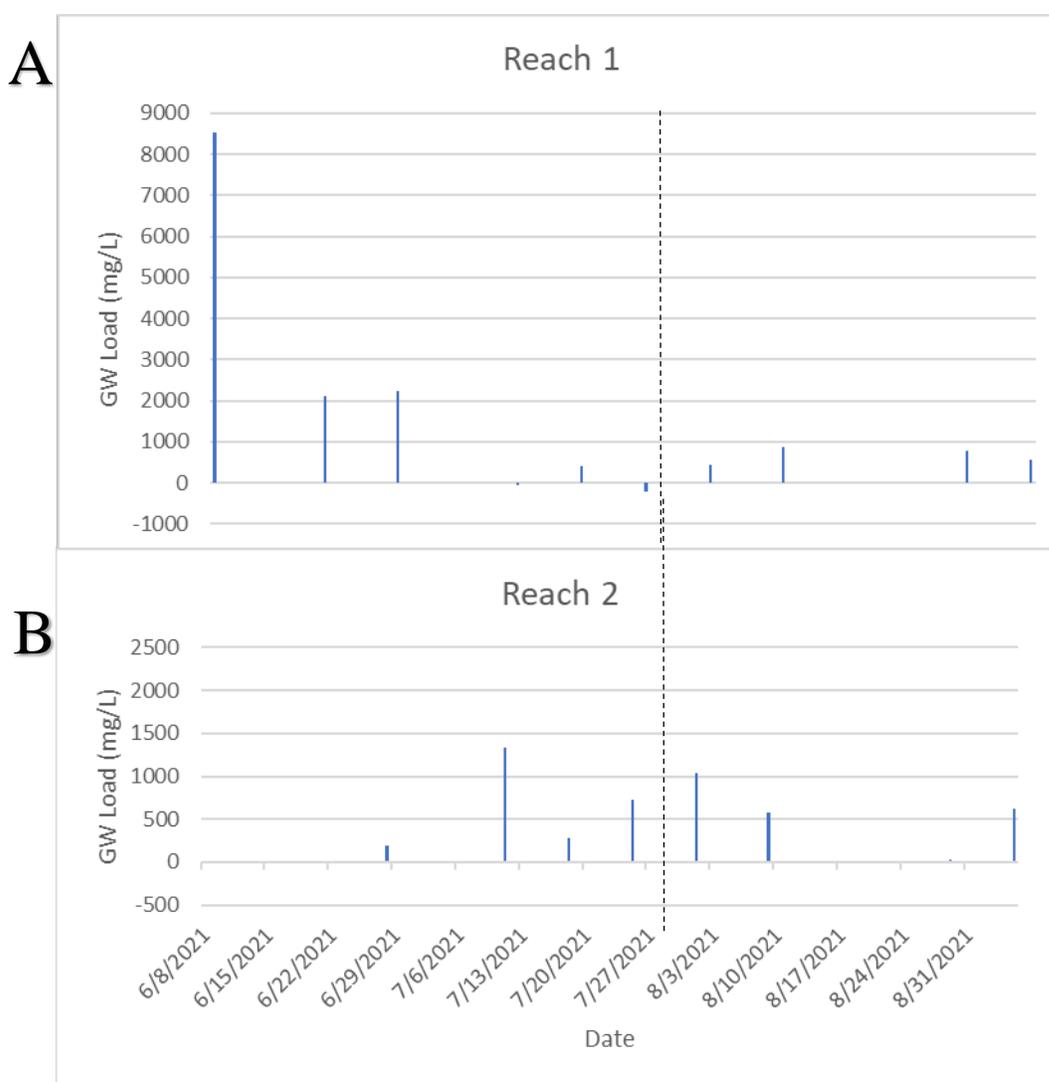
Groundwater load balance results (Figure 23) show that there is positive loading into the dry season. The change in load in June represent the entire reach (EC1 to EC3) and show generally a loss of loading. During high flow, there are several tributaries and overland flow that could be diluting the SC values with distance. In general, during July, loads increased from Reach 1 to 2 by approximately 45 $\mu\text{S}/\text{cm}$. Then, in August, Reach 1 has higher loads.

Figure 23: Chart showing load balances for each reach throughout the field season, calculated using equation 2, dashed line represents time at which diversion has no flows

From Figure 23, load balances in Reach 1 are mostly inconclusive due to the lack of diversion flows. Losses seen while the diversion is flowing could be a combination of groundwater and lost diversion flows. However, once the diversion dries up in August, the reach is observed to have positive influx of groundwater loads. Reach 1 is not as easily explained, again, due to a lack of diversion flow measurements. The negative loads indicated are not necessarily a loss of groundwater load, the difference could have been found in the diversion. Groundwater loads were positive when diversion measurements were made (June 8th and June 20th, 2021). Surface water balances also support a groundwater-fed reach. In August, Reach 1 surface water losses are a quarter of what they were previously. Then, by mid-August, Reach 1 changed to a gaining system. One interpretation may be that losses before August could be attributed to the diversion and indicate a losing system.

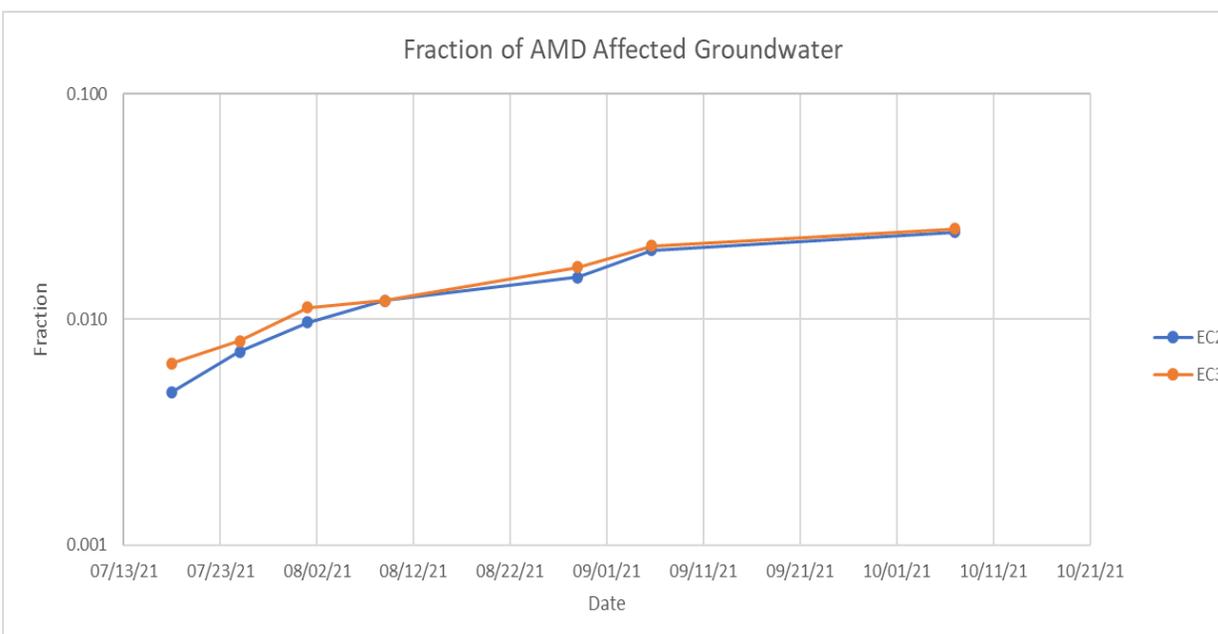
The two components of regional specific conductivity and heavy metal contaminated groundwater (AMD) specific conductivity yielded a general trend of an increasing proportion of AMD affected groundwater as the season progresses (Figure 24). The lower percent of AMD water in July can be attributed to the higher flows of snowmelt diluting the concentrations. During the latter part of the season, AMD contributions result in an increase of approximately 2% to 5%, with percent increase from decreasing total stream flow.

Figure 24: Chart showing the fraction of acid mine affected groundwater entering the system

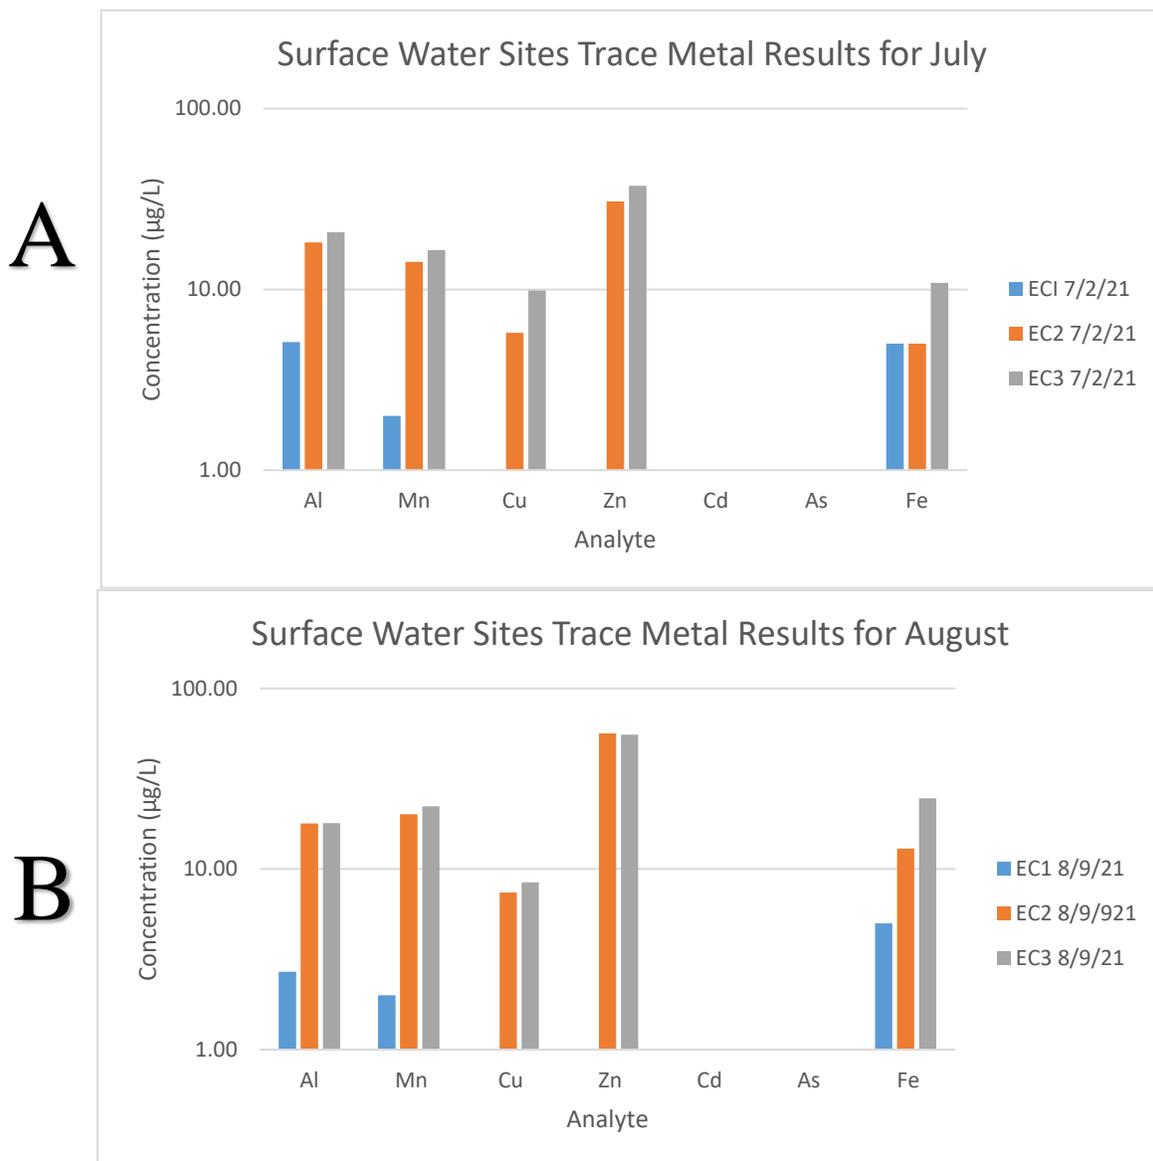
Generally, concentrations of trace metals increase with distance downstream through the study area. However, of note, dramatic increases are seen just below the adit discharge (EC2). Minor increases are observed again below the mill (EC3) (Figure 25). Figure 26 shows the trace metal concentrations of the surface water sites and the other sampling event, depicted in order of upstream to downstream. Concentrations from the adit are the highest (e.g. over 1000 $\mu\text{g/L}$ for Mn), then drop by several orders of magnitude (to 2 $\mu\text{g/L}$ for Mn) by EC1. An important note, in the restored reach, concentrations continued the trend seen from EC1 to EC3, which continues to increase. This sampling run observed two water quality exceedances in both chronic and acute standards for protection of aquatic life (Table XII). Hardness had to be calculated before exact exceedance levels could be known. Zinc was in exceedance at EC2 only in August, and EC3 was in exceedance in July and August.

Figure 25: Trace metal concentrations from surface water sites taken in July (A) and August (B)

Surface water trace metal results show a clear indication that contamination picked up after the confluence of the adit discharge (between EC1 and EC2 in Figure 25), and again picked up below the mill (EC3 in Figure 25). Figure 4-26, which includes the additional sampling results, indicates that the adit added a great deal of contamination. However, by the time water reached Elkhorn Creek (EC2), concentrations are less. This may indicate that the settling ponds are working, to a degree, but contamination above standards are still observed. Note that, while other metals are very high, there is almost no iron found in the adit sample (Figure 4-26), there were, however, ferricrete lining the adit stream bed. It could be reasoned that the ferricretes are taking the iron up (Church et al., 2007), evident from EC1 results taken above the confluence, showing very low Iron concentrations. Seasonal differences of the chemistry of the adit discharge is also possible. The “Mill Seep” portion, considered a groundwater spring, adds its contamination, which shows up at EC3. Elkhorn Meadow and EC3 results show that contamination continued to pick up through the restored section, at least. Further support was found in the 2-Component mixing model (Figure 24), which suggests that by late season approximately, 4.5% of flows is AMD affected water. Surface water balances, load balances, and water tables maps indicate groundwater inputs through the system. Given that the mill area was a short portion of the reach but sees significant contamination inputs to the creek, it suggests the area is highly contaminated.

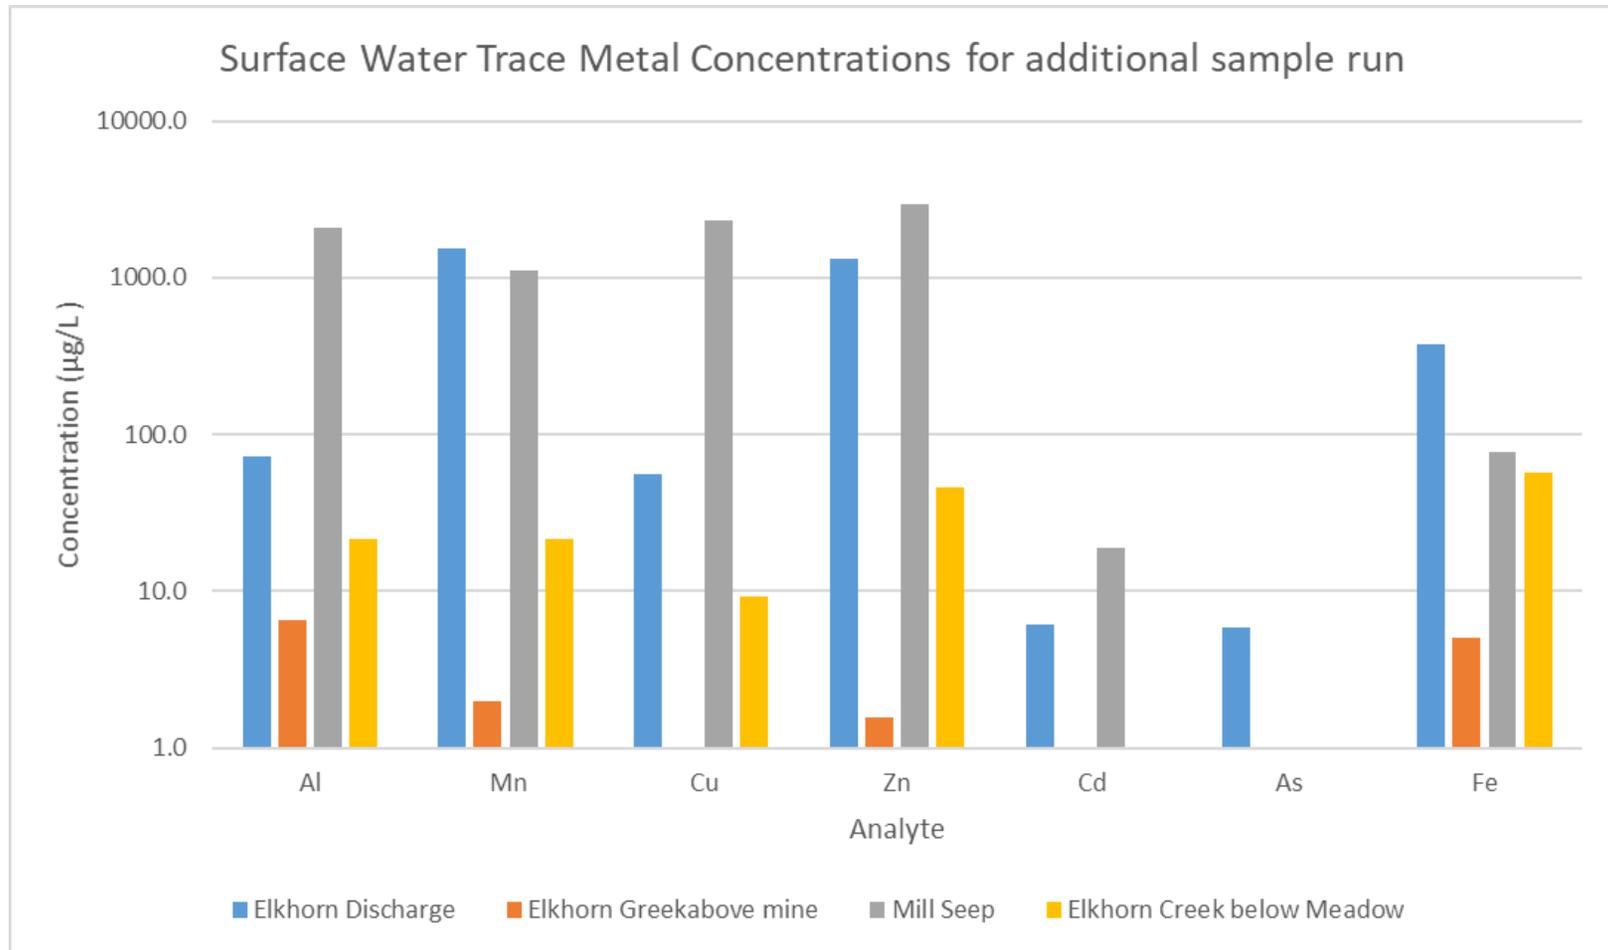
Figure 26: Trace metal concentrations for additional July sample run

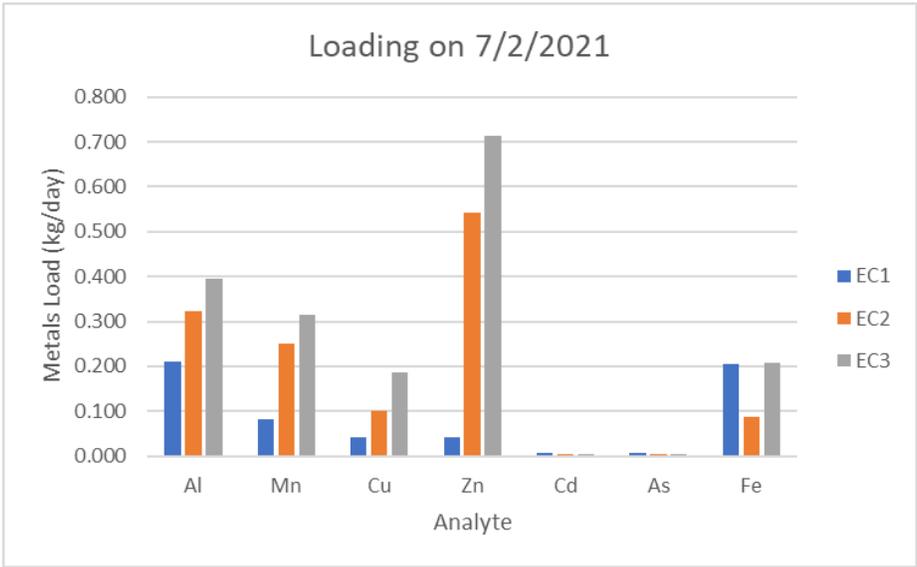
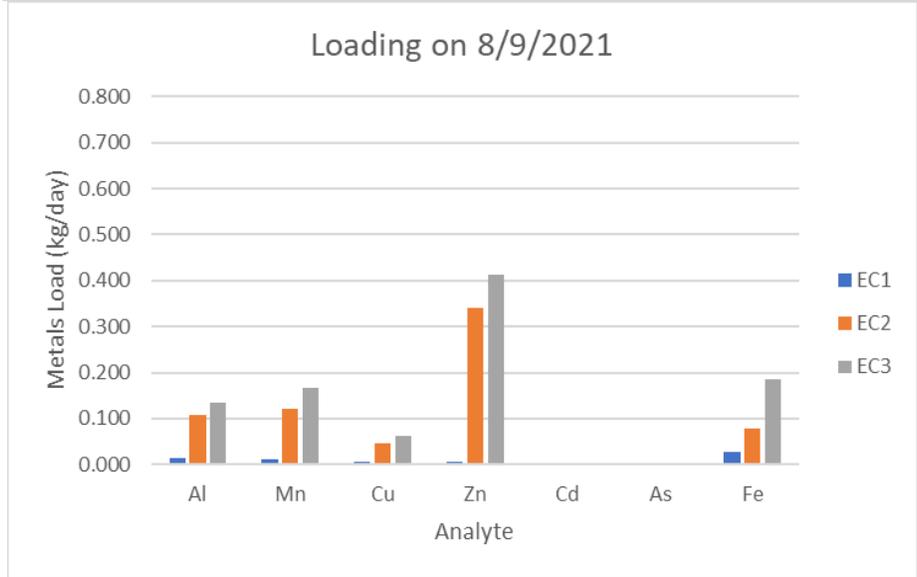
Figure 27: Metal loading from surface water sites on 7/2/2021 (A) and 8/9/2021 (B).

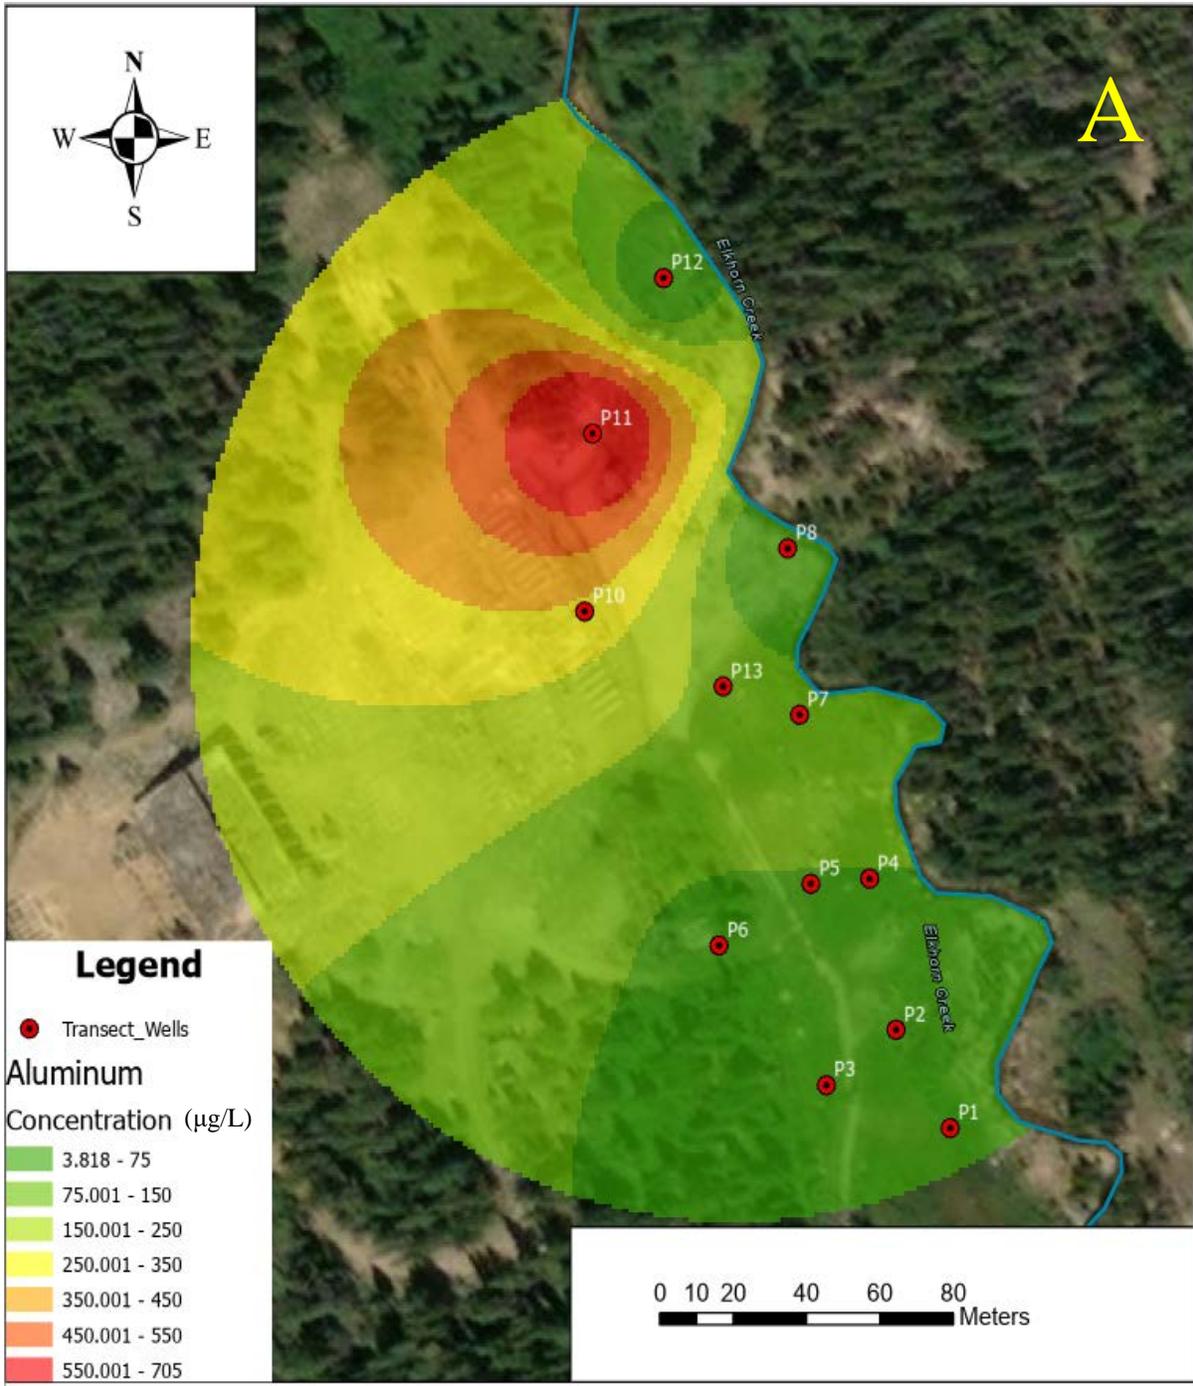
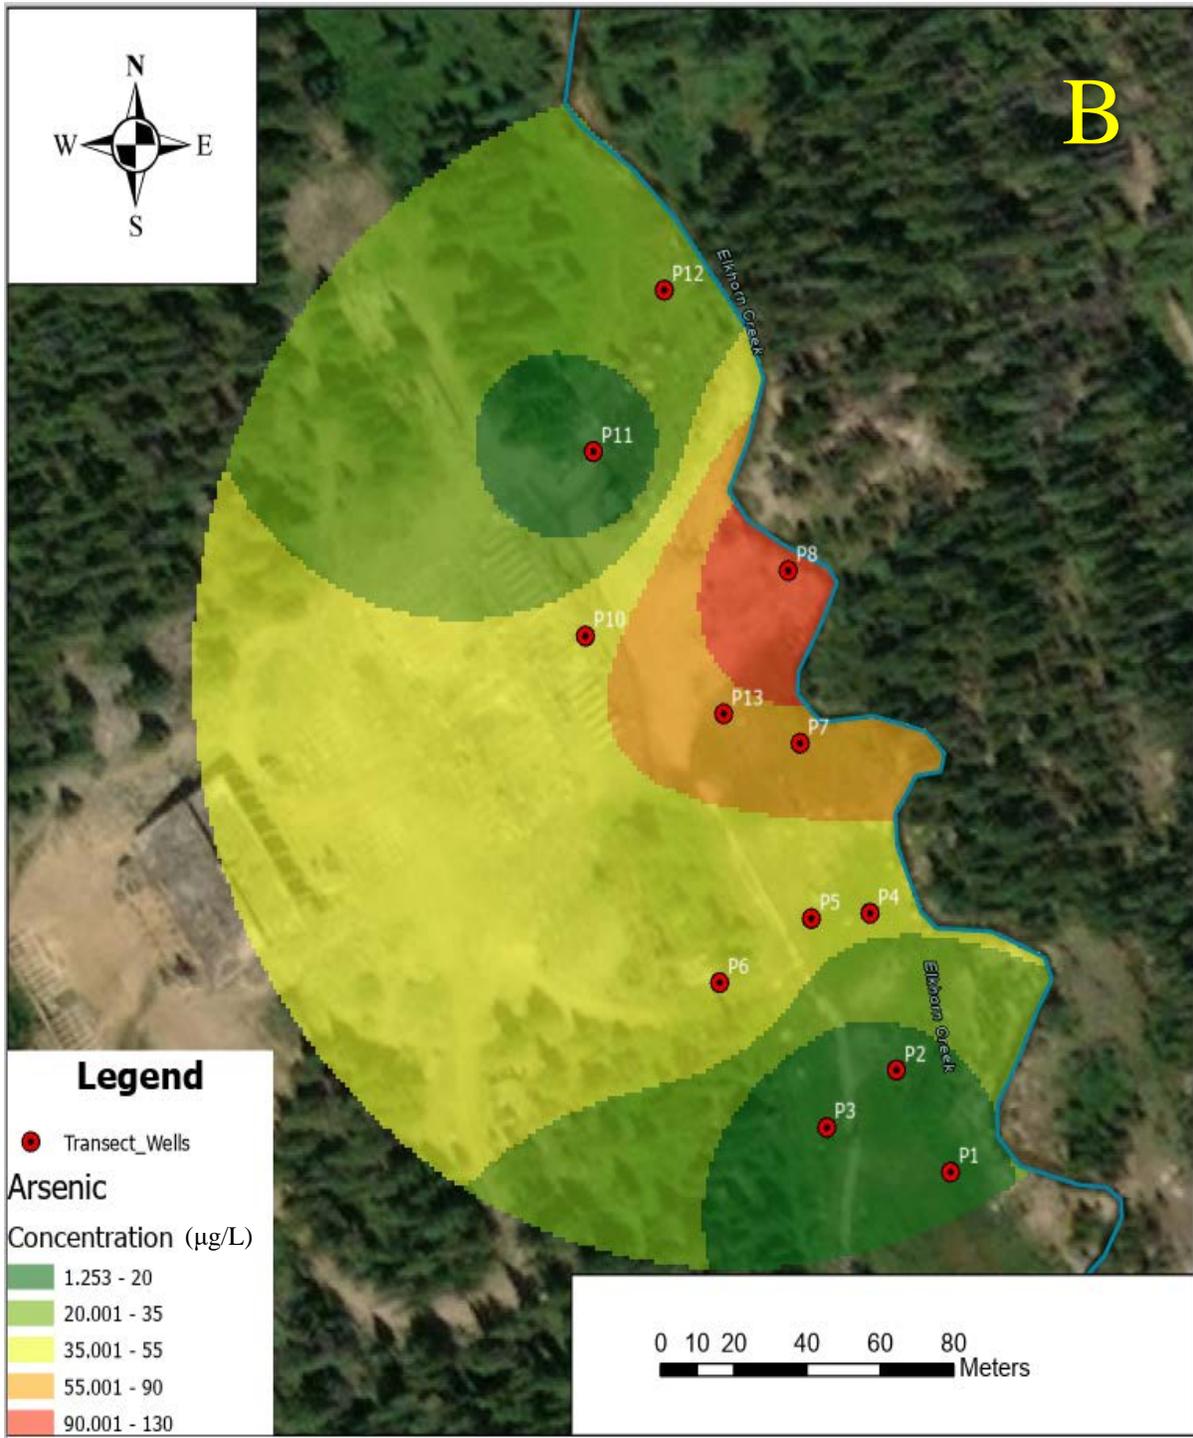
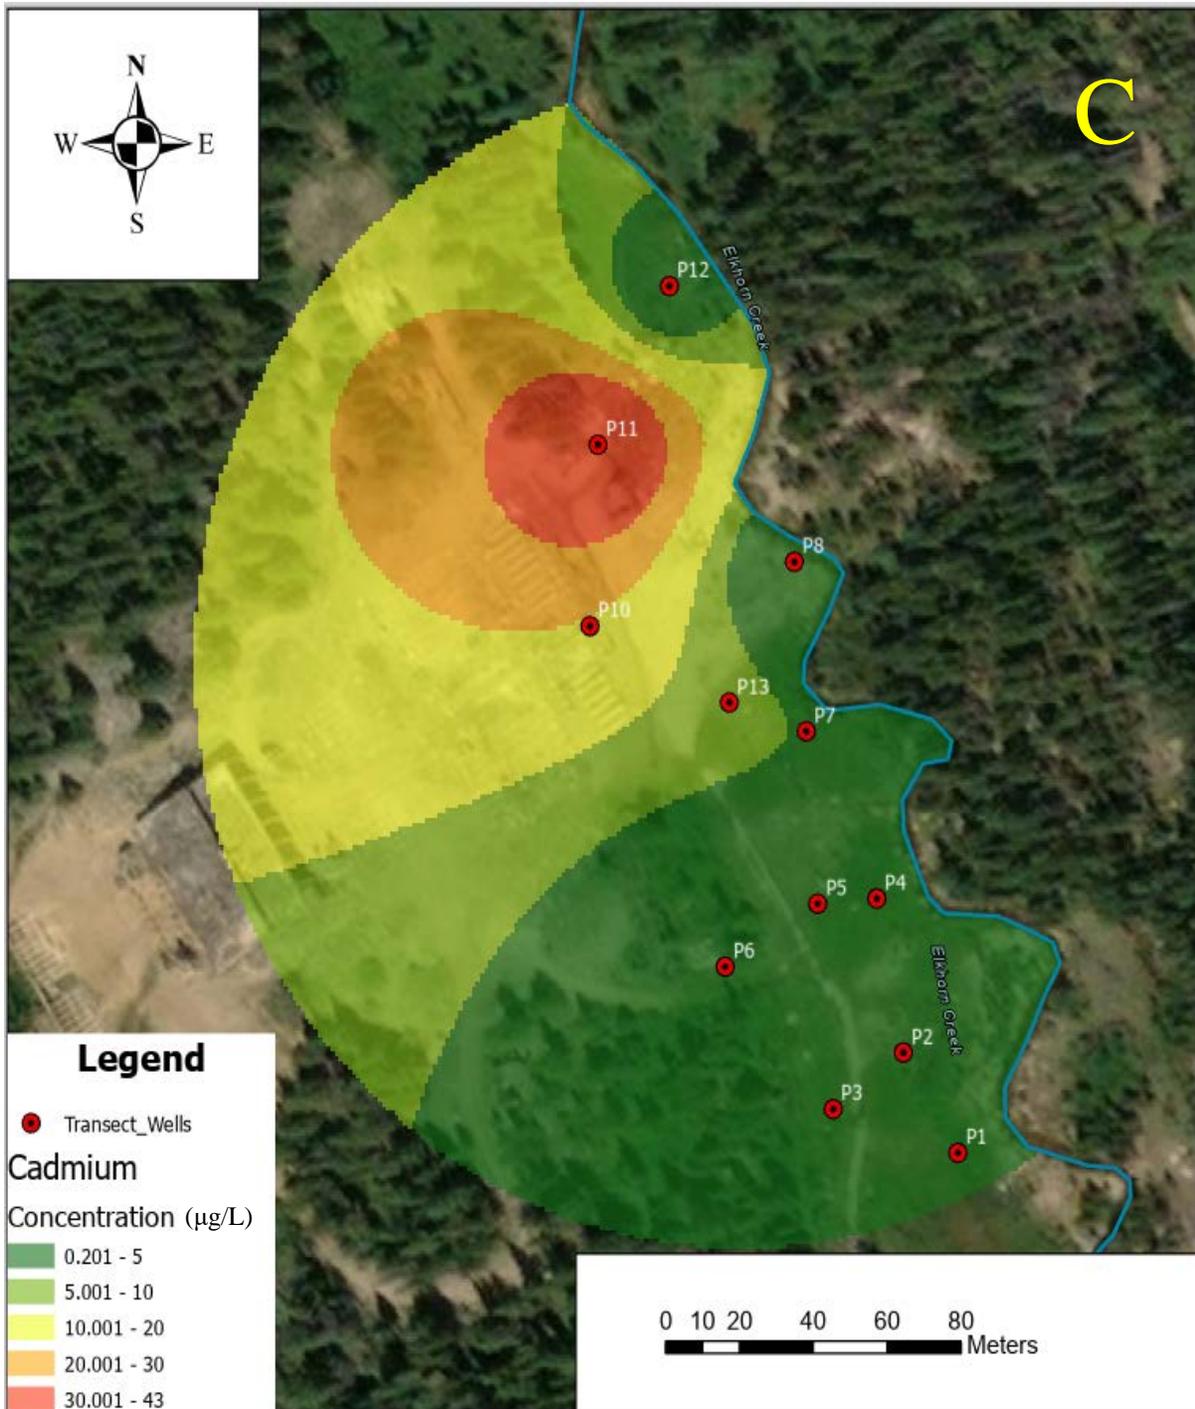
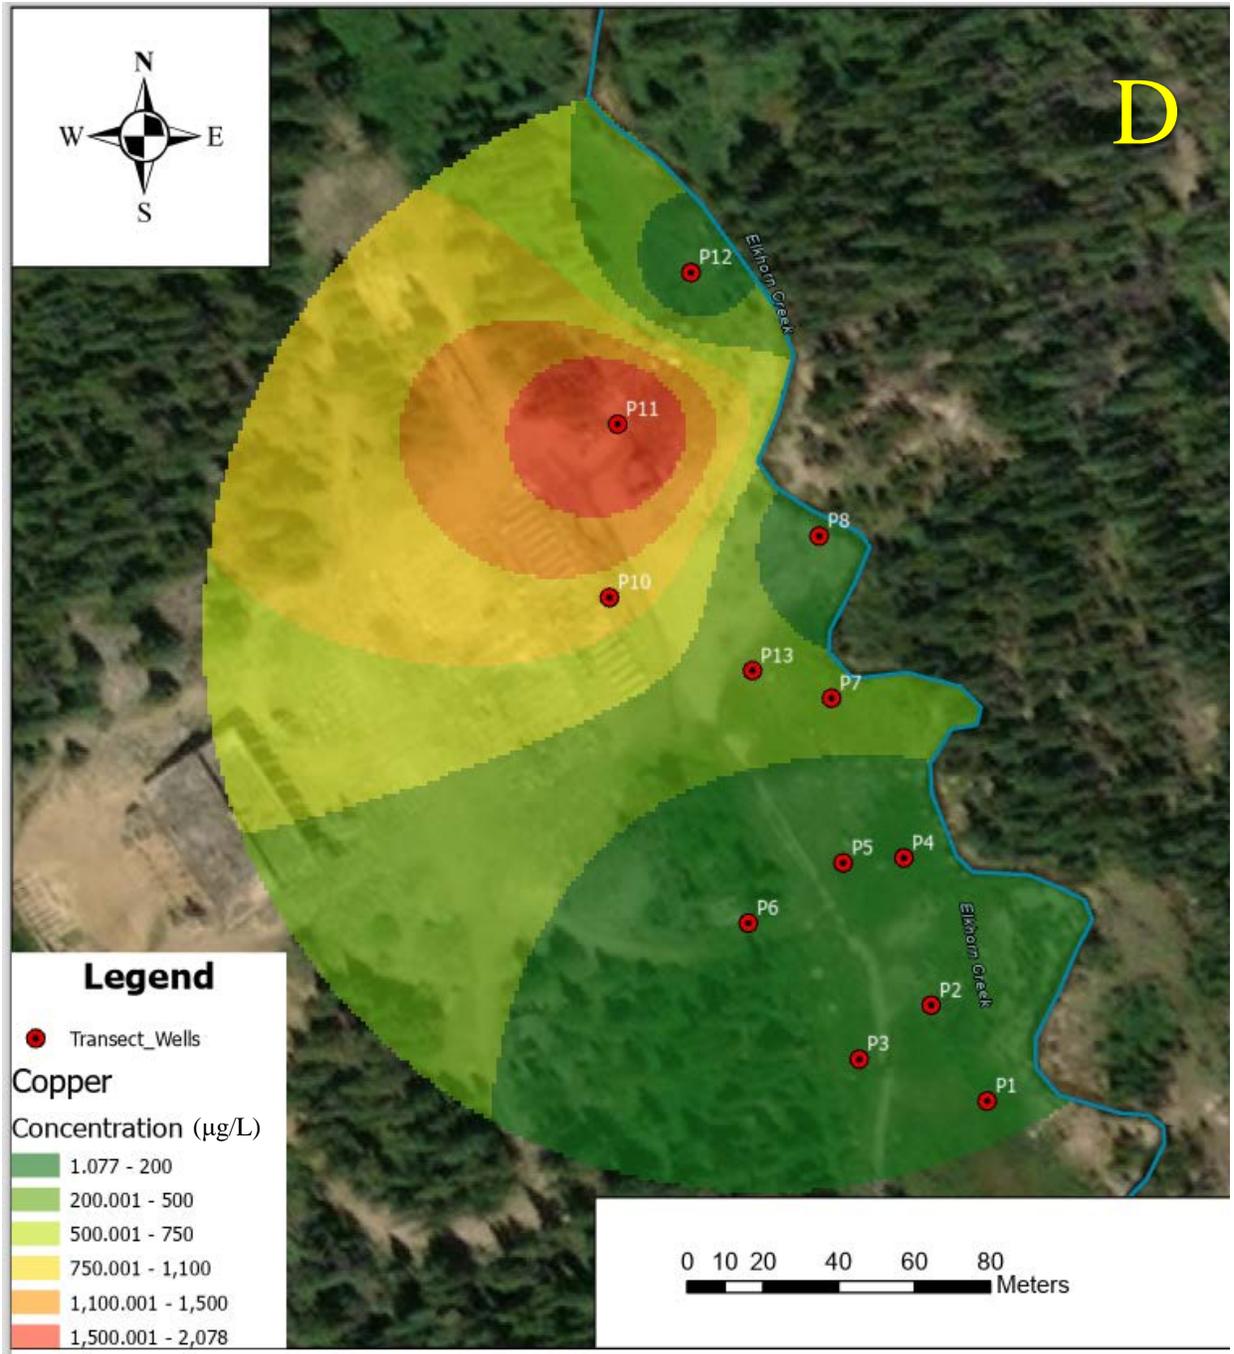
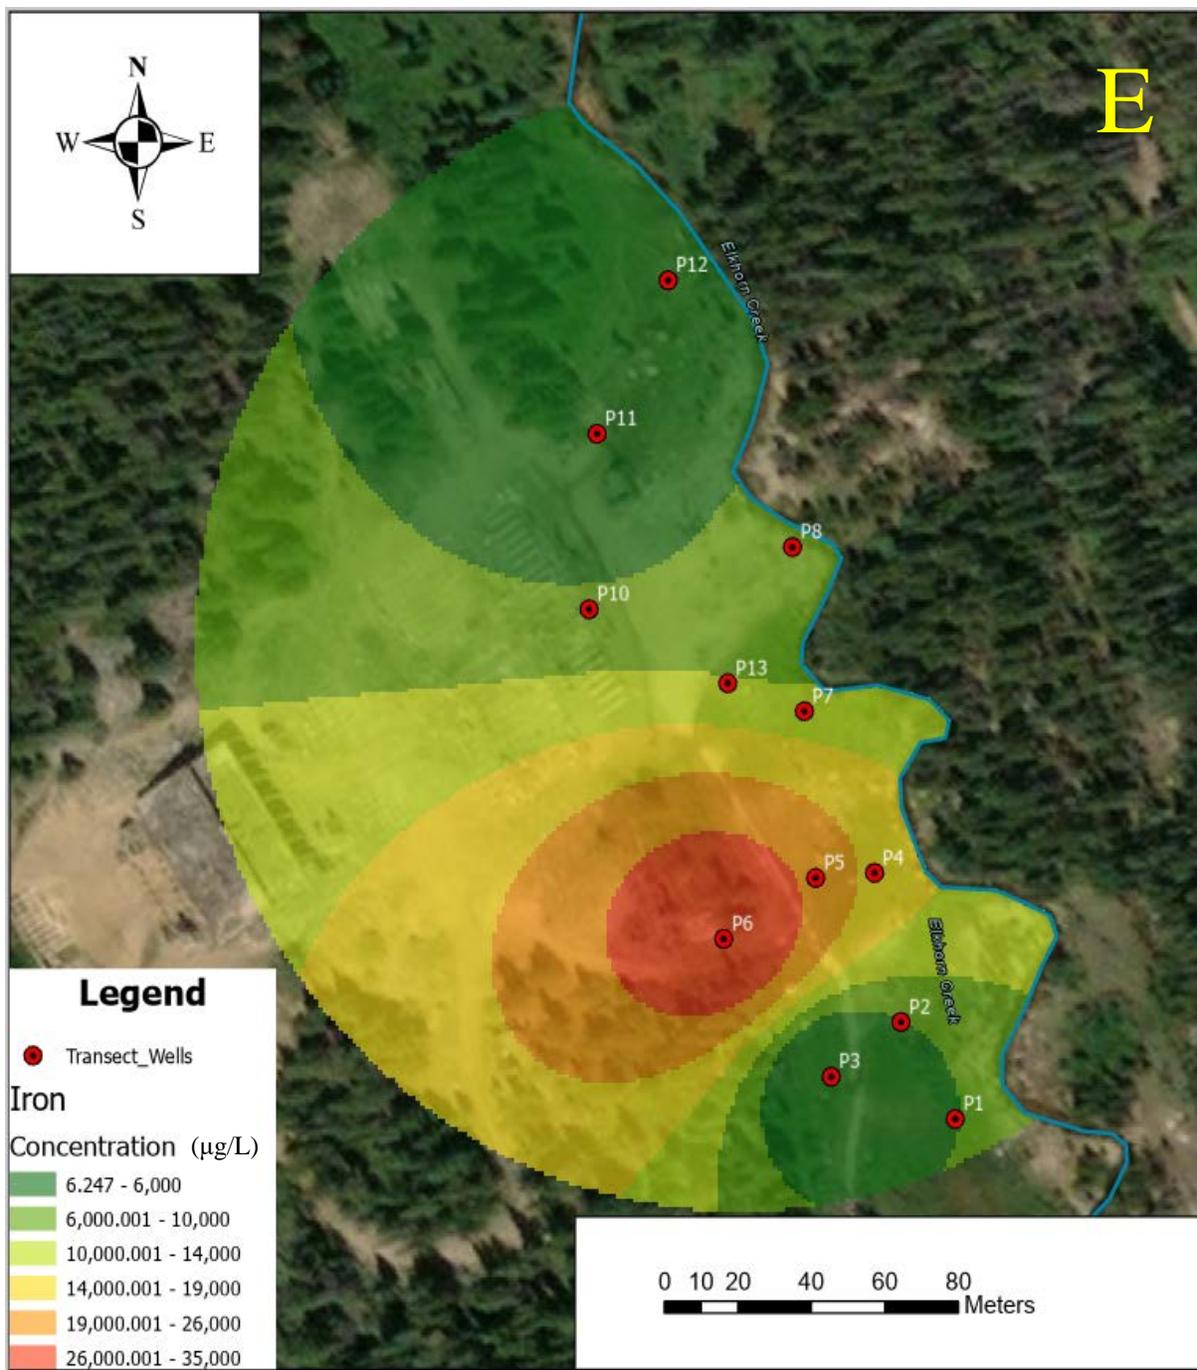
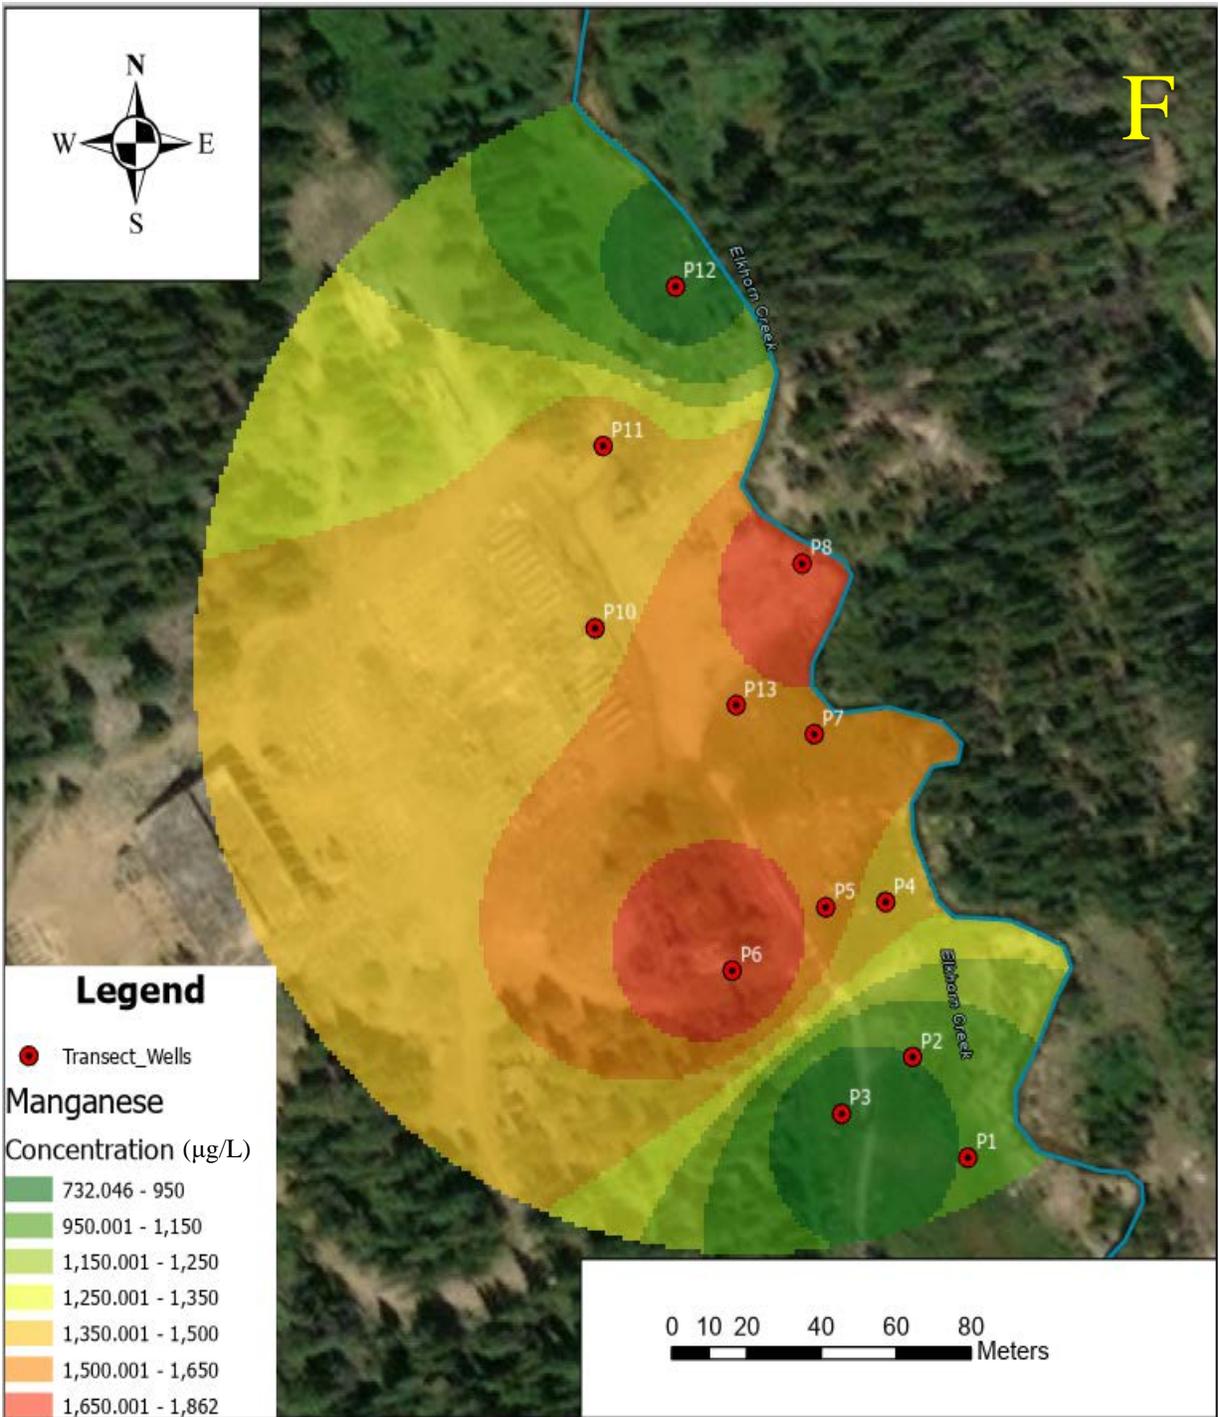
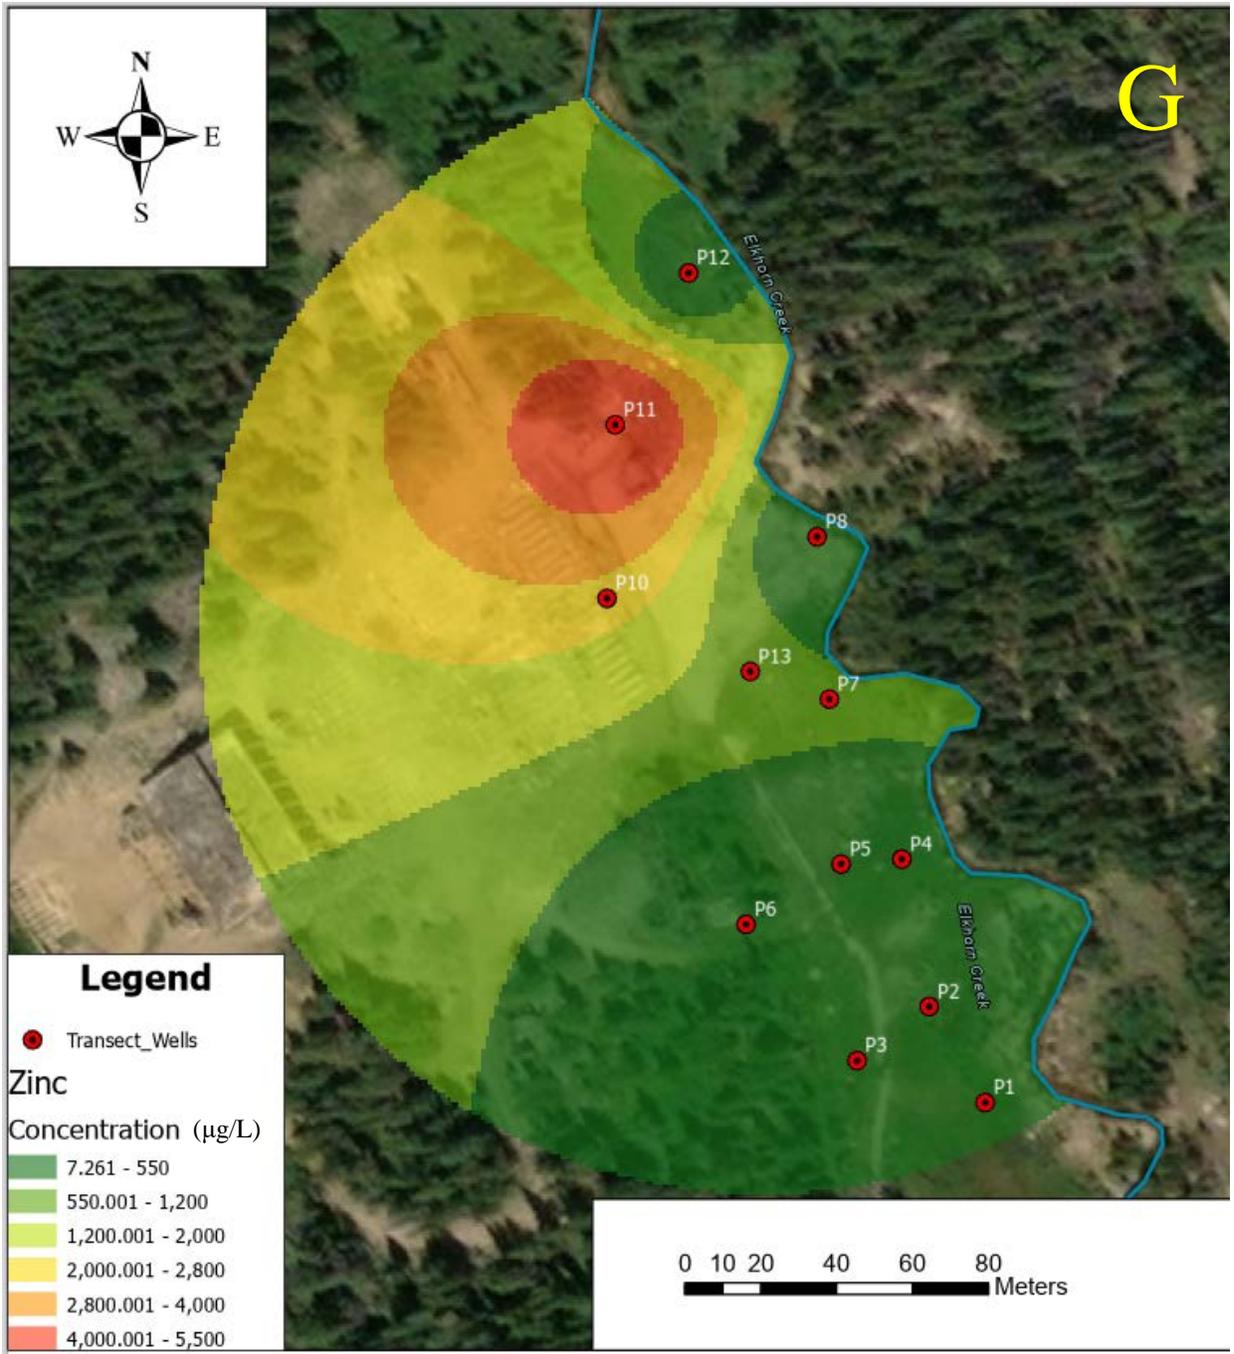
Two patterns emerge in groundwater metals concentrations (Figure 28 A-G). For Al, Cd, Cu, and Zn, the highest concentrations were centered around P11 and mainly originated in the bare tailings sediment. P11 being the PZ just south of the wetland/bog, while the PZs with lower concentration for those same metals are located in more grassy areas. The differences in concentration from P11 to P12 was important. P12, being the bottom (north) of the bog, shows

concentrations much lower, sometimes several orders of magnitude. Aluminum at P11 was 705 $\mu\text{g/L}$, and by P12 drops to below 75 $\mu\text{g/L}$ not 20 meters away. Copper has concentrations above 2000 $\mu\text{g/L}$ at P11 and dropped to below 200 $\mu\text{g/L}$ at P12. The peeper results in the following section touches more on possible reasons for this concentration gradient.

Figure 28: Groundwater trace metal heat maps for Al (A), As (B), Cd (C), Cu (D), Fe (E), Mn (F), Zn (G)

Trace metal results from the mill PZ transects (Figure 28 A-G) indicate a clear concentration of metal contamination around the bare mill soils. The greatest concentration of contamination was observed around P11, which was primarily the bare tailings by the mill. P11 was right before the wetlands and directly below a toe seep at the base of the mill. The seep ditch and wetlands may funnel some of the contaminated groundwater. Contaminated soils around the mill and a shallow groundwater table running through the soils indicate that Elkhorn Creek at that portion picks up contamination. The mill seep contamination was most likely seen at EC3 (Figure 25). Removal of the surface tailings would have some impact on cleaning the water in the area. While groundwater would not be immediately clean, the major metal source may be removed.

Concentrations of dissolved Mn, Fe, and As showed concentrations more centered around P6. P6 was chosen as a PZ location for its proximity to the old assay house directly uphill of it. These metals concentrations may have something to do with the remnant assay sediments. Arsenic far exceeds human health standards (10 ppb), while concentrations of zinc and iron are also very high. Microbial decay of organic matter turns groundwater anoxic (Drever, 1997), and when the dissolved oxygen (DO) is gone, bacteria begin to dissolve the Mn-oxide and Fe-oxide minerals (Langmuir, 1997). This process of dissolving Mn- and Fe-oxides causes the concentrations of both dissolved Mn^{2+} and Fe^{2+} to increase. Also, because arsenic tends to adsorb onto Fe-oxides (Langmuir, 1997), dissolution of Fe-oxides often results in a coupled increase in dissolved As. Previous work using peepers in the Warm Springs settling ponds near the tail end of Silver Bow Creek showed sharp increases in the concentrations of Fe, Mn, and As in the shallow sediment (Lee, 2012; Boese, 2015).

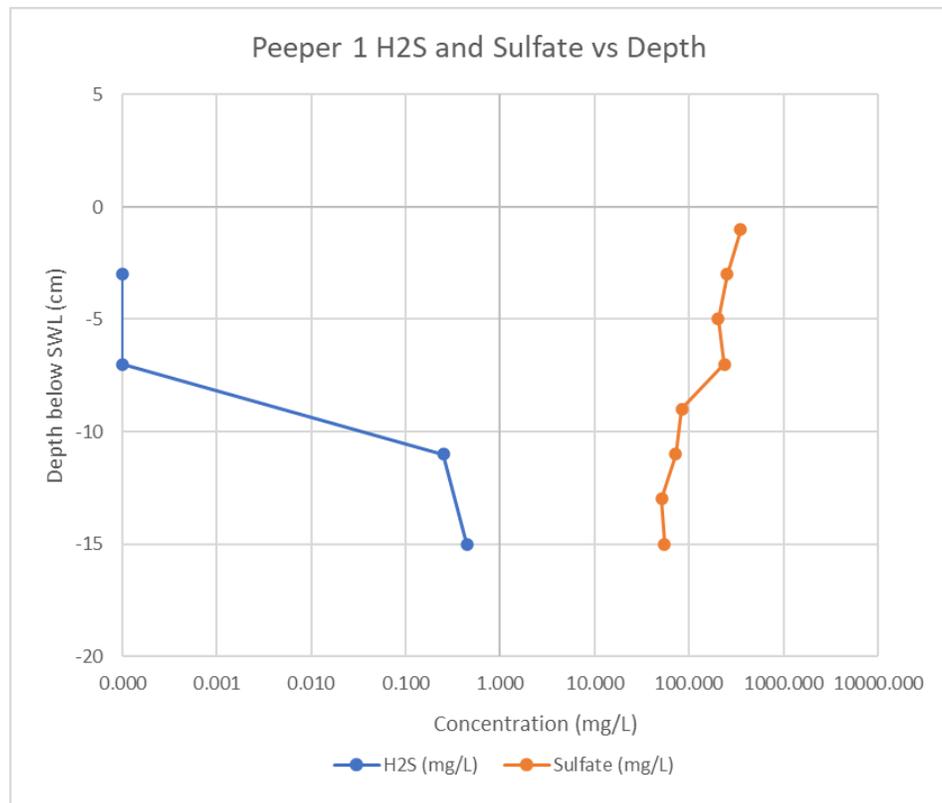
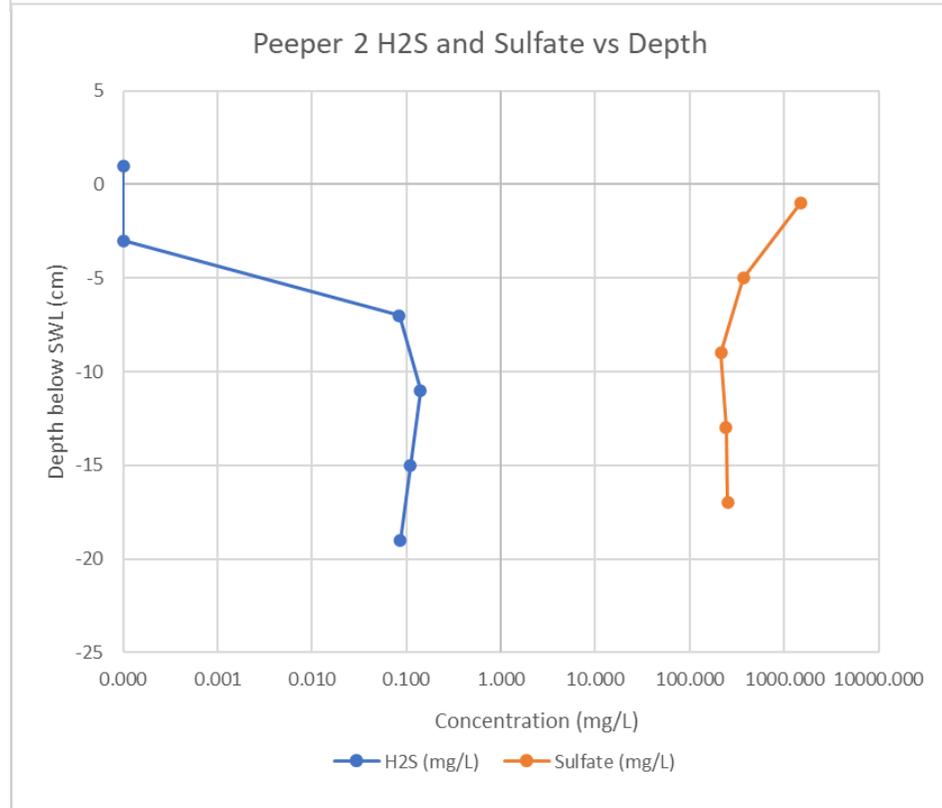
Figure 29: Graph of H₂S and Sulfate for Peeper 1 (A) and Peeper 2 (B) plotted against depth.

Peepers results in the wetlands below the mill suggest that sulfate-reducing bacteria (SRB) are present and working. In anaerobic conditions, dissolved sulfate is reduced to hydrogen sulfide by SRB. H_2S concentrations never get greater than 1 ppm (mg/L) because H_2S reacts with Fe and other metals to form metal sulfides. Formation of sulfide minerals is the best explanation for the sharp decreases in concentrations of Cd, Cu, and Zn with depth in the peeper profiles (Figure 4-14). In contrast, sulfides of Fe, Mn, and As are more soluble (Langmuir, 1997), allowing these metals to have higher concentrations at the low levels of H_2S present.

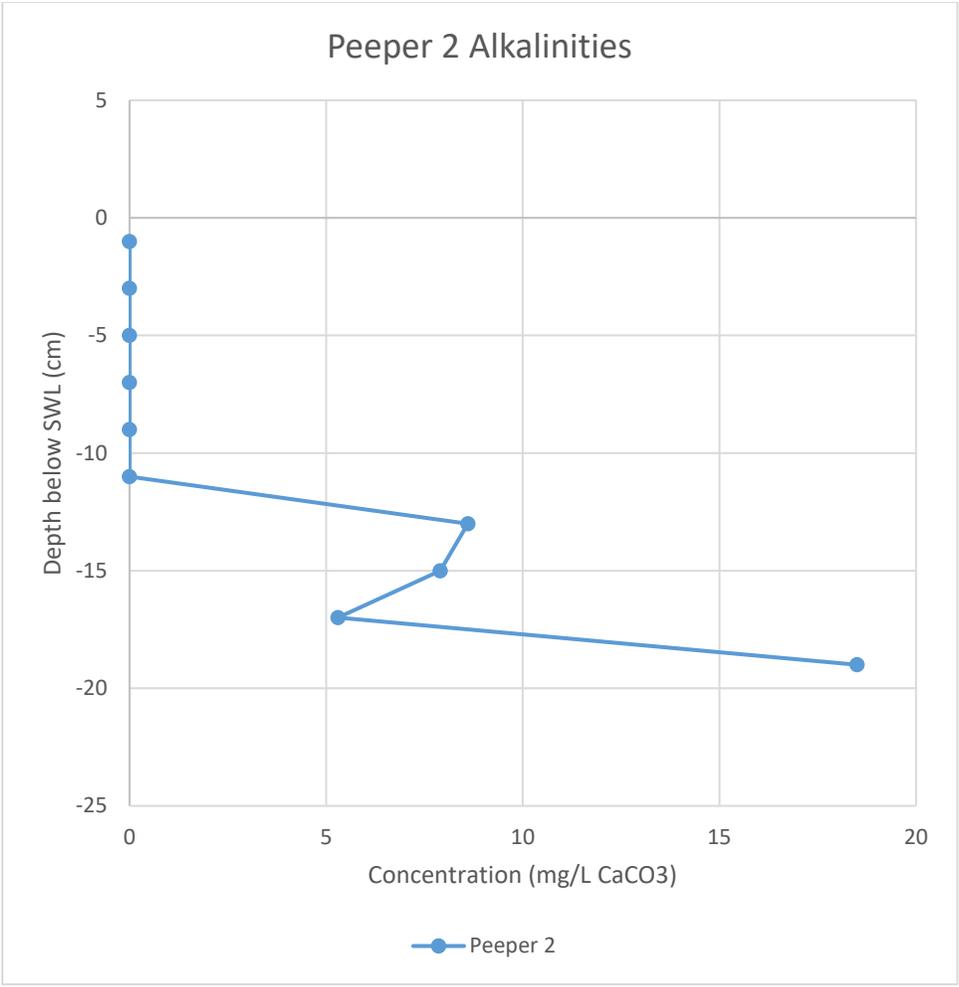
Figure 30: Alkalinity results for Peeper 2 against depth
