**SURFACE WATER/GROUNDWATER INTERACTIONS AND
HYDROGEOCHEMICAL CHARACTERIZATION OF THE ELKHORN
MINE AND MILL, BEAVERHEAD COUNTY, MONTANA**

SURFACE WATER/GROUNDWATER
INTERACTIONS AND HYDROGEOCHEMICAL
CHARACTERIZATION OF THE ELKHORN MINE
AND MILL, BEAVERHEAD COUNTY, MONTANA

Masters of Science Degree in Geoscience
Hydrogeology Option

Montana Technological University

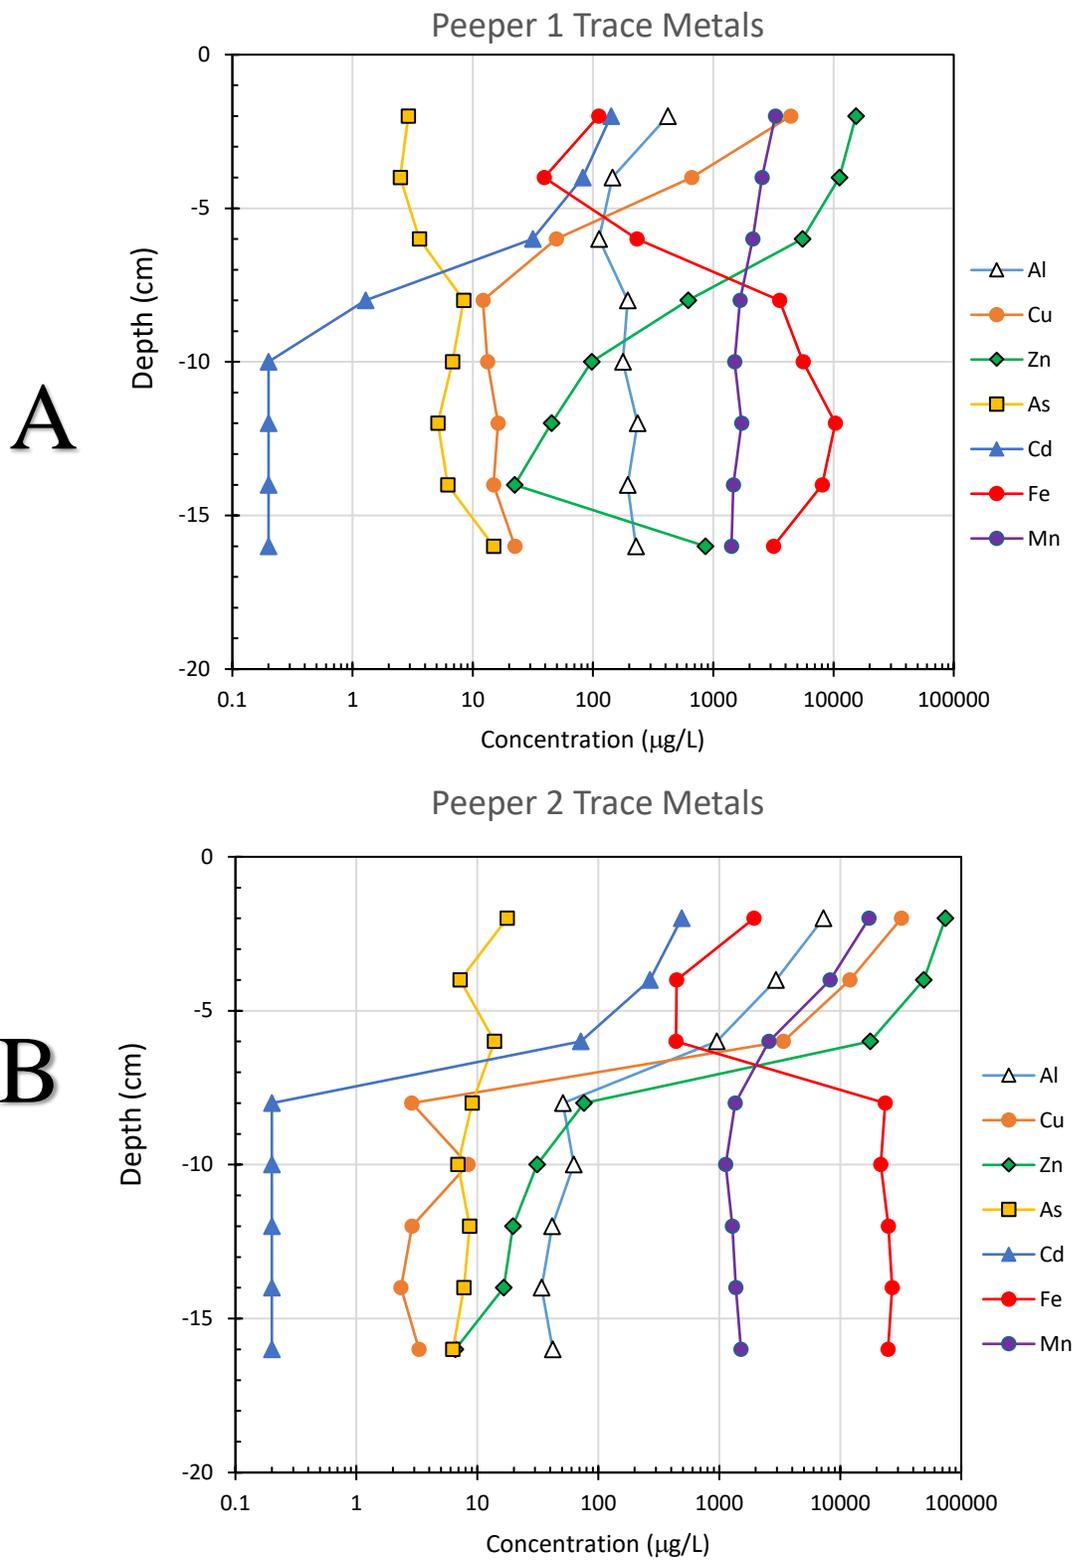
Trace metals (Figure 31) also showed an overall decreasing trend with depth below the surface, often by several orders of magnitude (e.g., Cu with 4391µg/L at 2 cm below the surface to 22.3 µg/L at 16 cm below the surface). Iron, however, increased with depth. In Peepers 1, Fe started with 111 µg/L at 2 cm below the surface and ended with 3160 µg/L 16 cm below the surface. In peeper 2, Fe started with 444 µg/L at 2 cm below the surface and ended at 26,902 µg/L at 20 cm below the surface.

Figure 31: Concentrations of contaminants of interest in Peeper 1 (A) and Peeper 2 (B) vs. depth

Peepers results in the wetlands below the mill suggest that sulfate-reducing bacteria (SRB) are present and working. In anaerobic conditions, dissolved sulfate is reduced to hydrogen sulfide by SRB. H_2S concentrations never get greater than 1 ppm (mg/L) because H_2S reacts with Fe and other metals to form metal sulfides. Formation of sulfide minerals is the best explanation for the sharp decreases in concentrations of Cd, Cu, and Zn with depth in the peeper profiles (Figure 4-14). In contrast, sulfides of Fe, Mn, and As are more soluble (Langmuir, 1997), allowing these metals to have higher concentrations at the low levels of H_2S present.

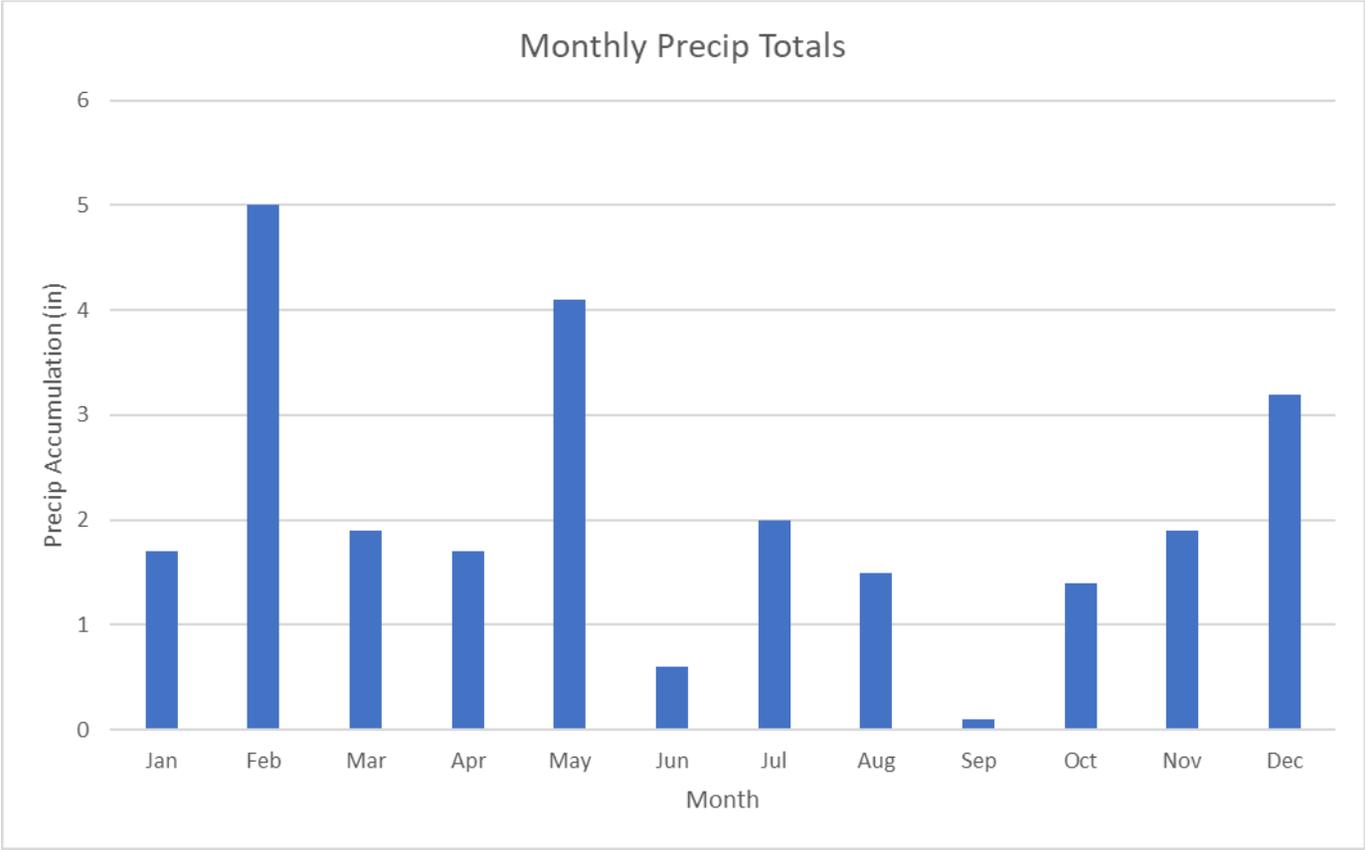
Figure 32: Chart of monthly precipitation totals for the study year

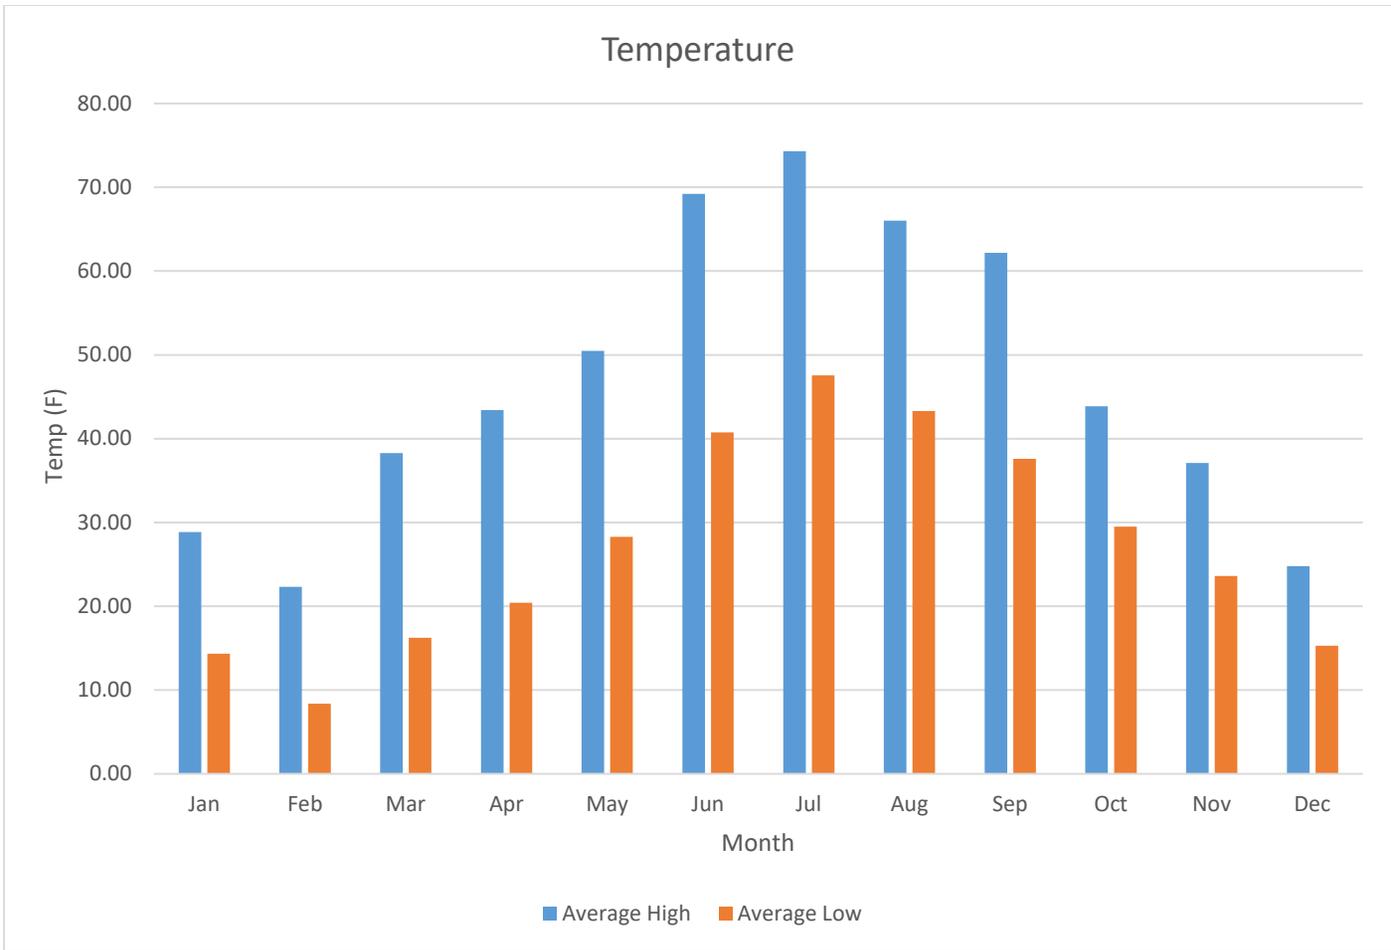
Figure 33: Chart of monthly average high and low temperatures for the study year

Monthly precipitation, snowpack, and temperature data were gathered from the Mule Creek SNOTEL site in the Pioneer Mountains. During the study period (June to September), an approximate total of 4.2 in of rain (Figure 32) fell on the area. Temperatures ranged from an average high of 67F to an average low of 42F (Figure 33).

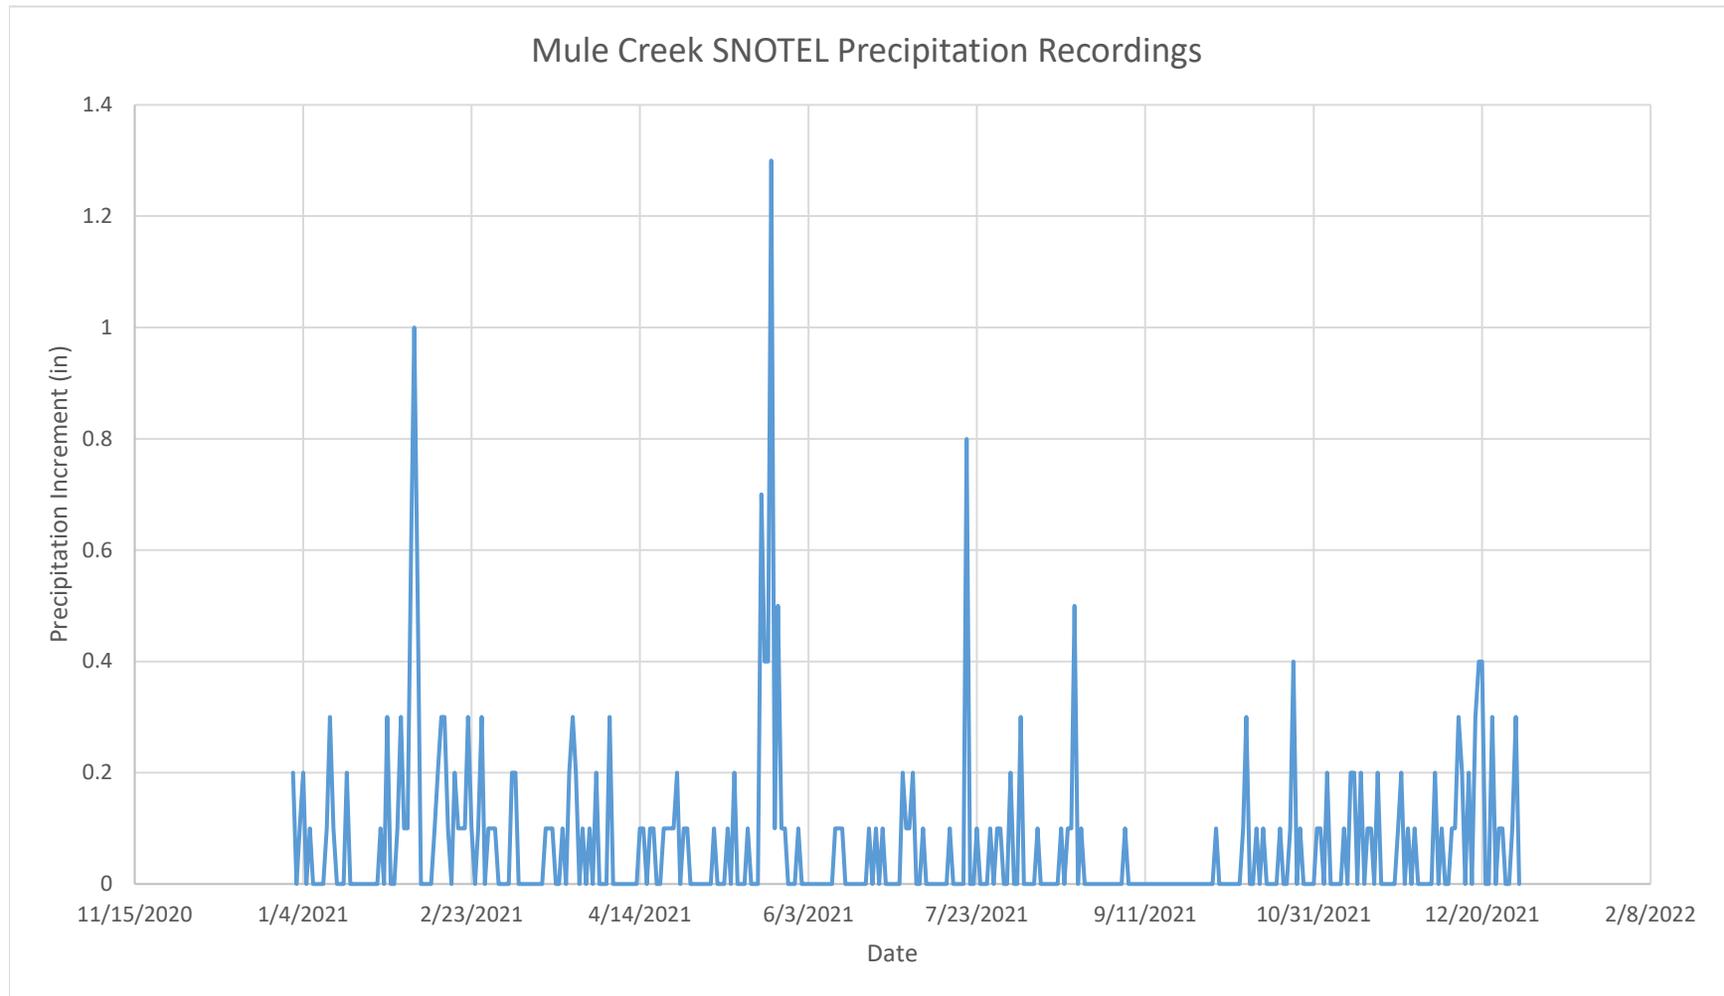
Figure 34: Daily precipitation increments for the study year

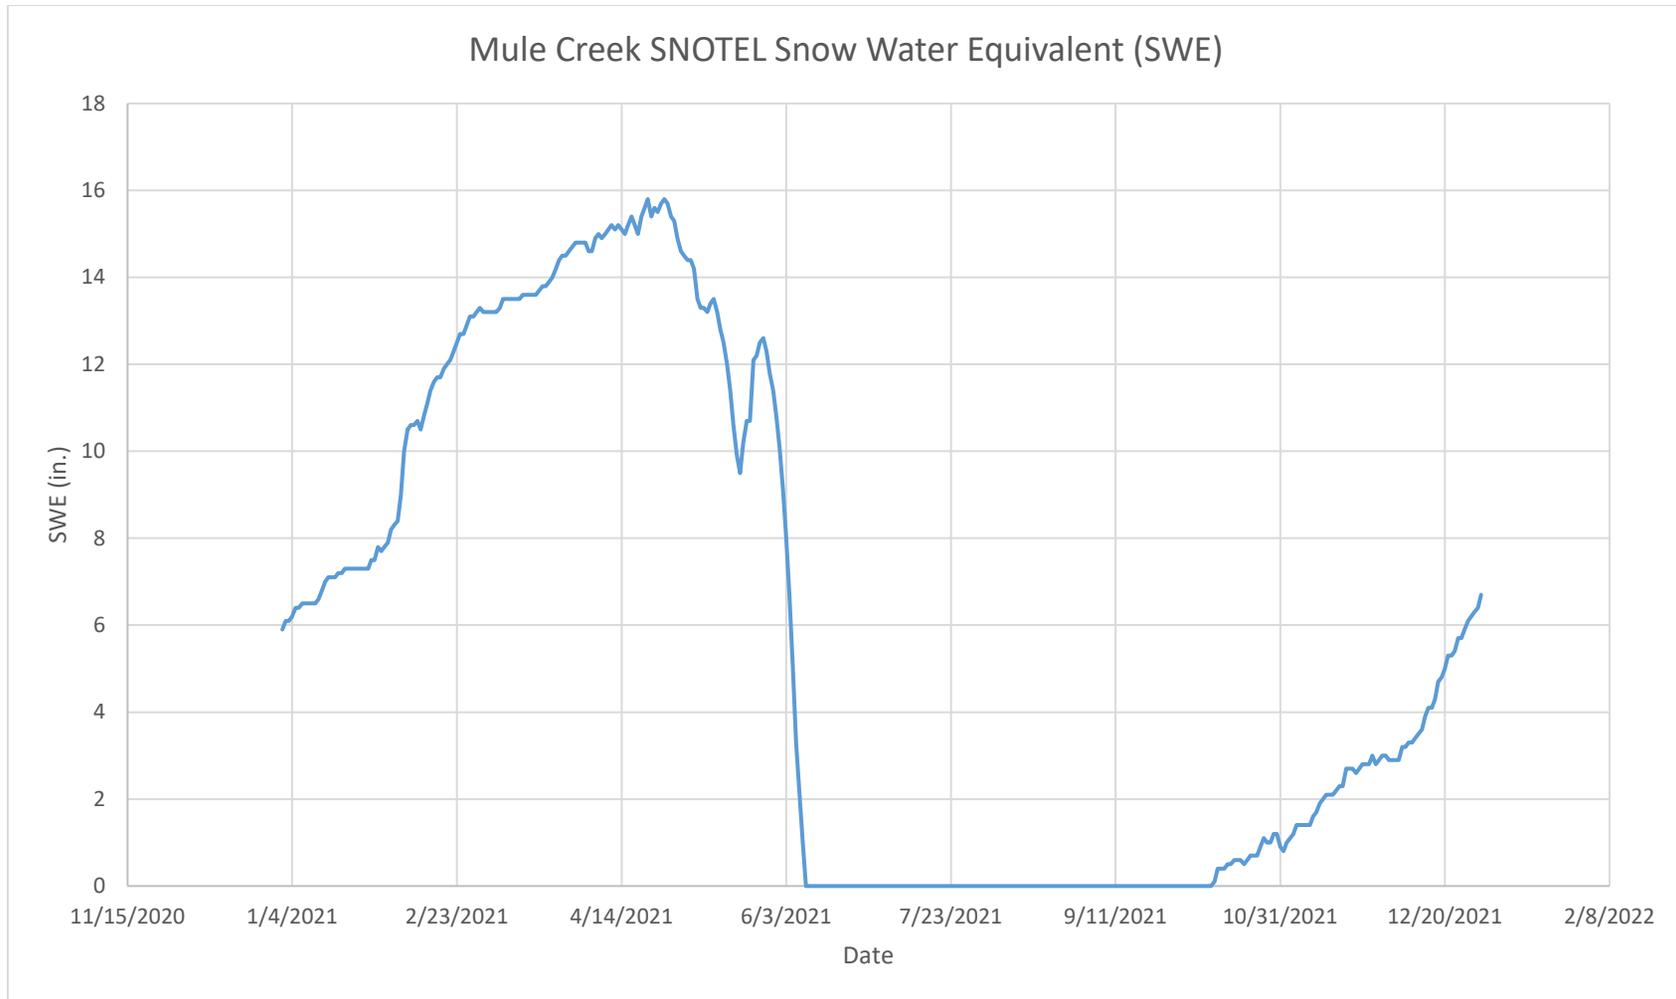
Figure 35: Snow water equivalent (snow pack) for the study year

The beginning of field data (end of June) caught the very end of the snowmelt runoff, as seen in Figure 19 and supported by Figure 35. Snowmelt had the greatest effect at EC1, where higher flows and greater fluctuations were evident (Figure 19). On July 6th, 2021, for example, flow was at 390 L/s and 12 hours later at 250L/s, then after another 12 hours was at 315 L/s. EC2 and EC3 flows up to August should be higher, but flow is split between the diversion and the creek. In August, however, EC3 is observed to have higher flows than the other sites. This can be interpreted as either continued groundwater inputs or groundwater being released from storage in the meadow.
