## **Residential Metals Abatement Program – Interior School Soil - Remedial Action Work Plan – Butte High School**

### **RE: Residential Metals Abatement Program – Interior School Soil - Remedial Action Work Plan – Butte High School**

# Remedial Action Work Plan

Butte High School

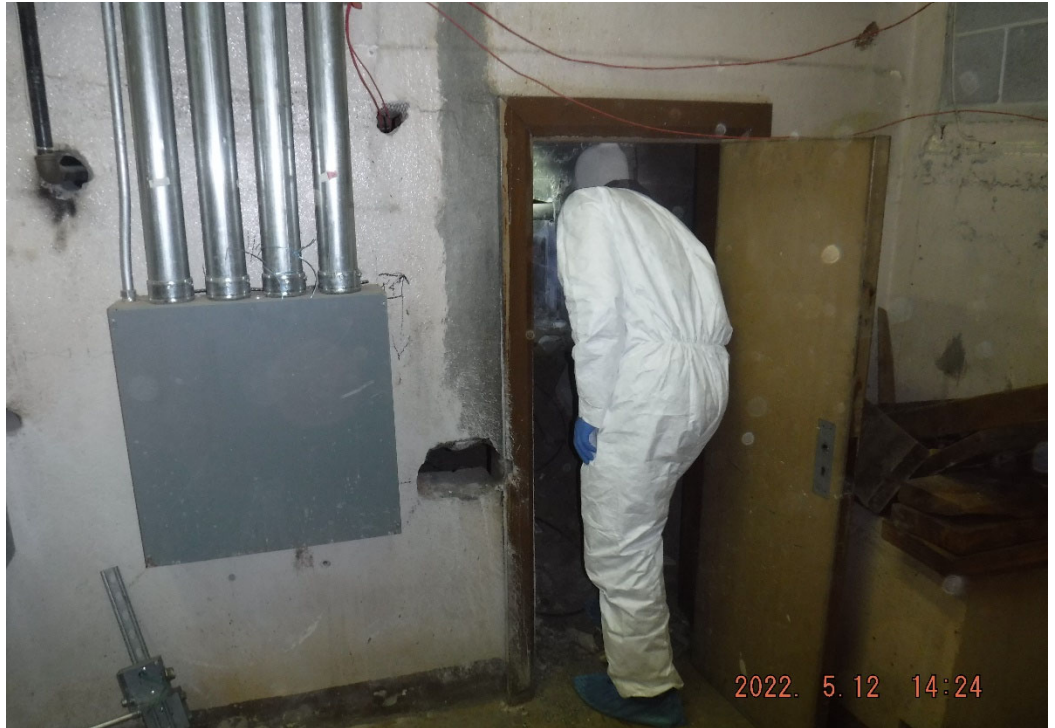
**Photo No.**  
**1**

**Description:**  
North entrance to Area 1 crawlspace.

The Area 1 crawlspace consists of an approximately 3,200 square-foot rectangular area roughly 320 feet in length and 10 feet in width. This crawlspace has one walk-in door at the north end and two 3-foot by 3-foot crawlspace openings at the south end. The crawlspace contains dirt, dust, and debris (i.e., old school crafting supplies, general refuse) on the ground surface. Steel and cast-iron conduits run through the full extent of Area 1. See Appendix A for photographs of the Area 1 crawlspace.

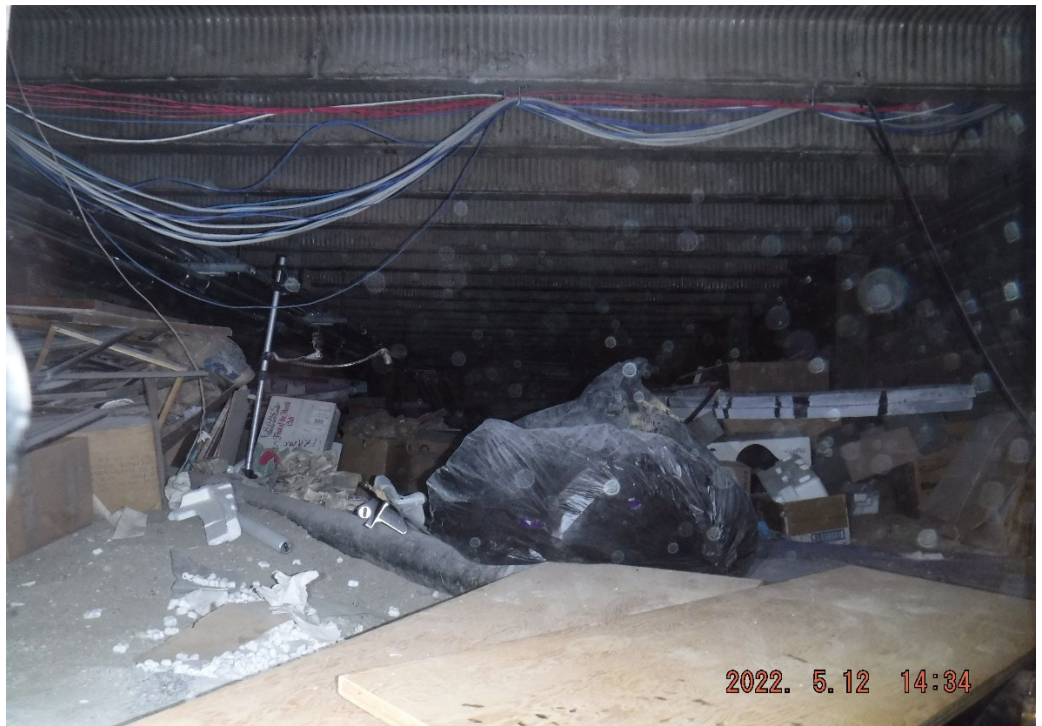
**Photo No.**  
**2**

**Description:**  
Trash in Area 1 crawlspace near entrance under room C-127.

Refuse and debris in the Area 1 crawlspace will be collected, and accumulated dust will be wiped from horizontal surfaces and pipe chases. Refuse, debris, soil, and wipes from this remedial action work will be placed in sealed waste bags before being transported out of Area 1 for proper disposal.

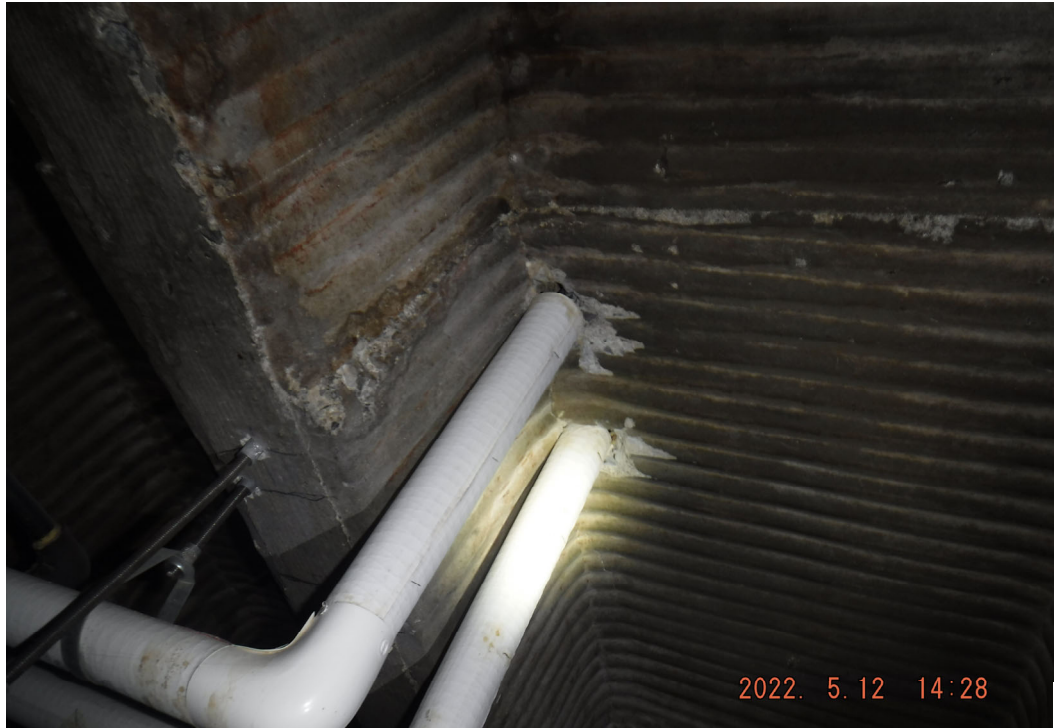
**Photo No.**  
3

**Description:**  
Pipes under room C-118 /  
restroom

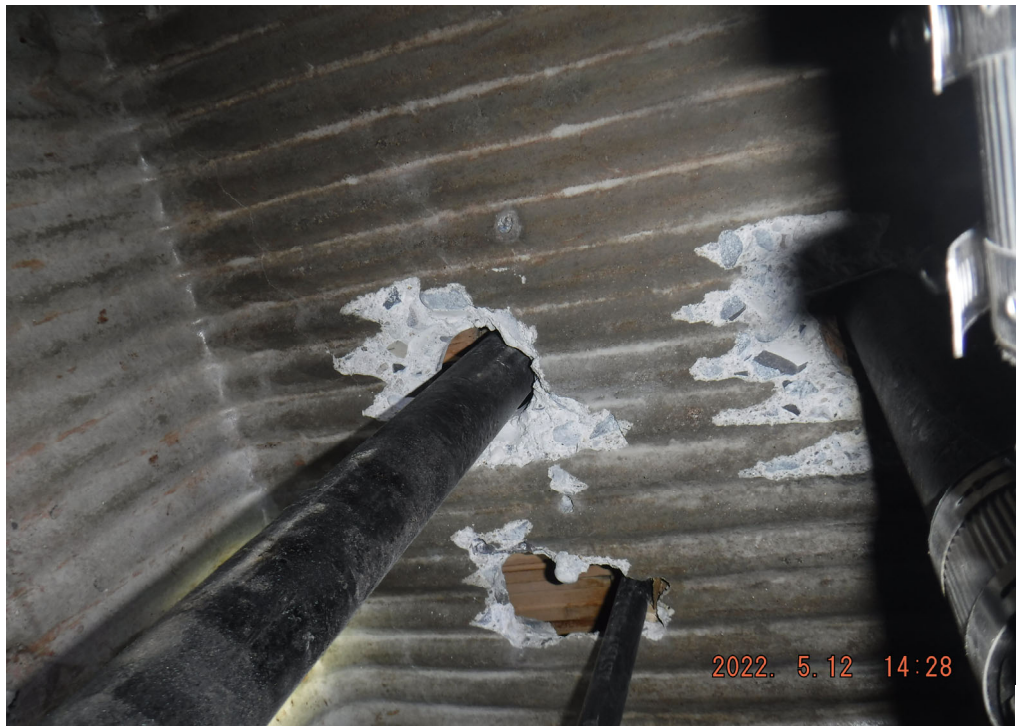
**Photo No.**  
4

**Description:**  
Pipes under room C-118 /  
restroom.

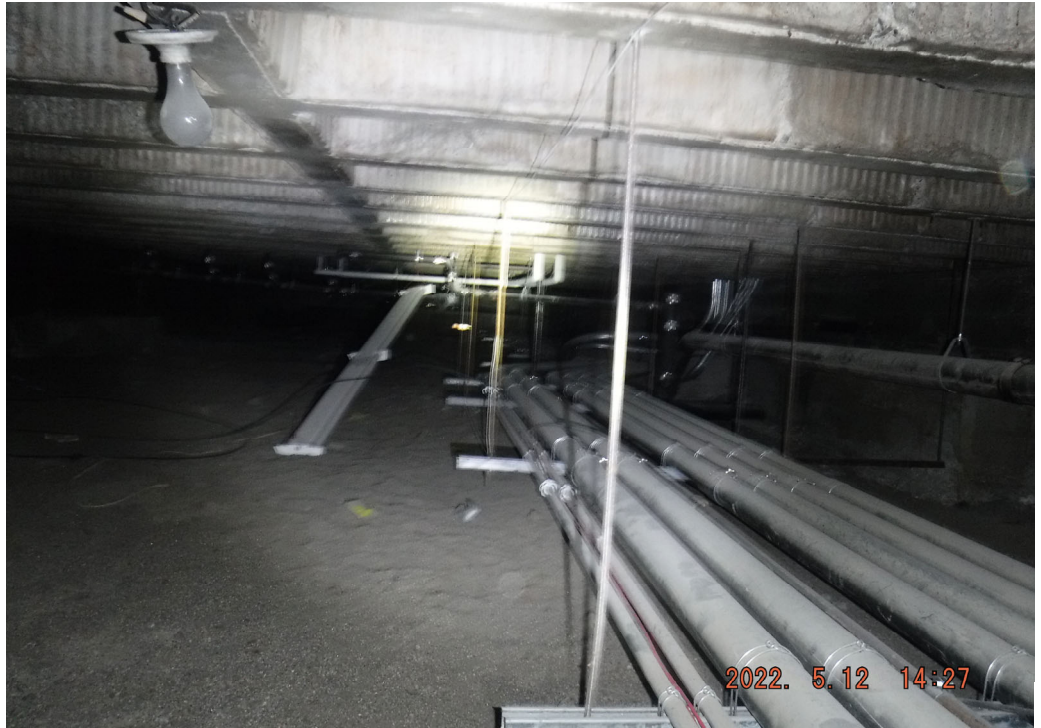
**Photo No.**  
**5**

**Description:**  
Utility pipe runs in Area 1.

Gaps between utility conduits and surrounding concrete foundations will be sealed to address the potential preferential pathways for soil particulate migration from the crawlspace to the occupied area of the school in Area 1. Sealing methods may include the use of spray foam insulation, rubber seals adhered in place, and/or grout placement to fill in large gaps.

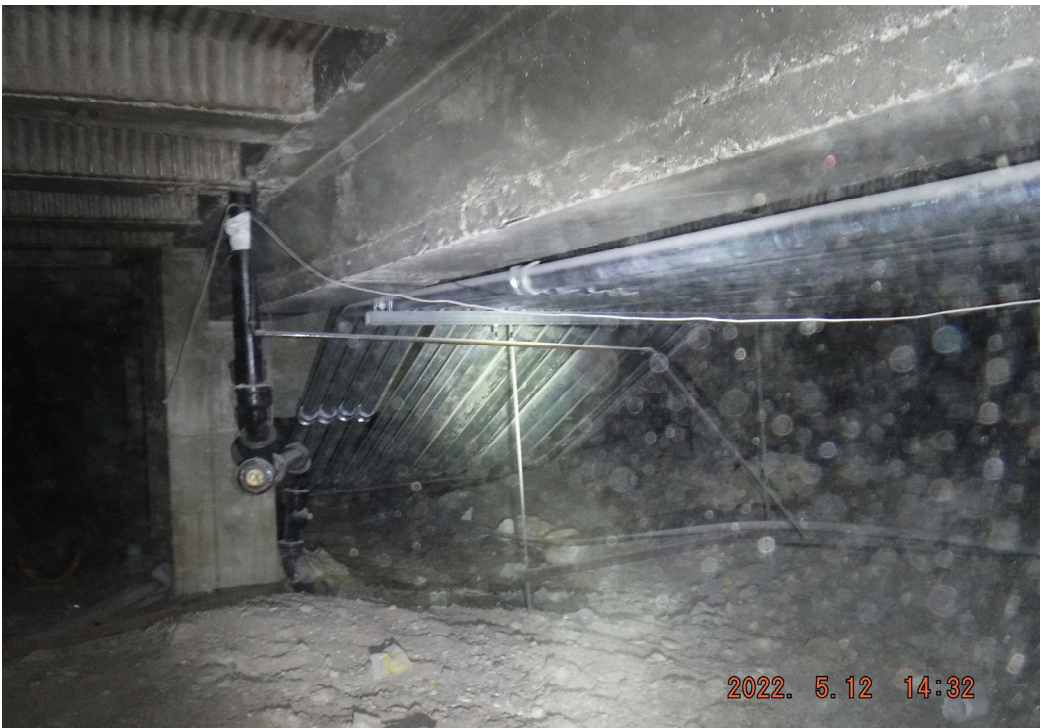
**Photo No.**  
**6**

**Description:**  
Utility pipe runs in Area 1.

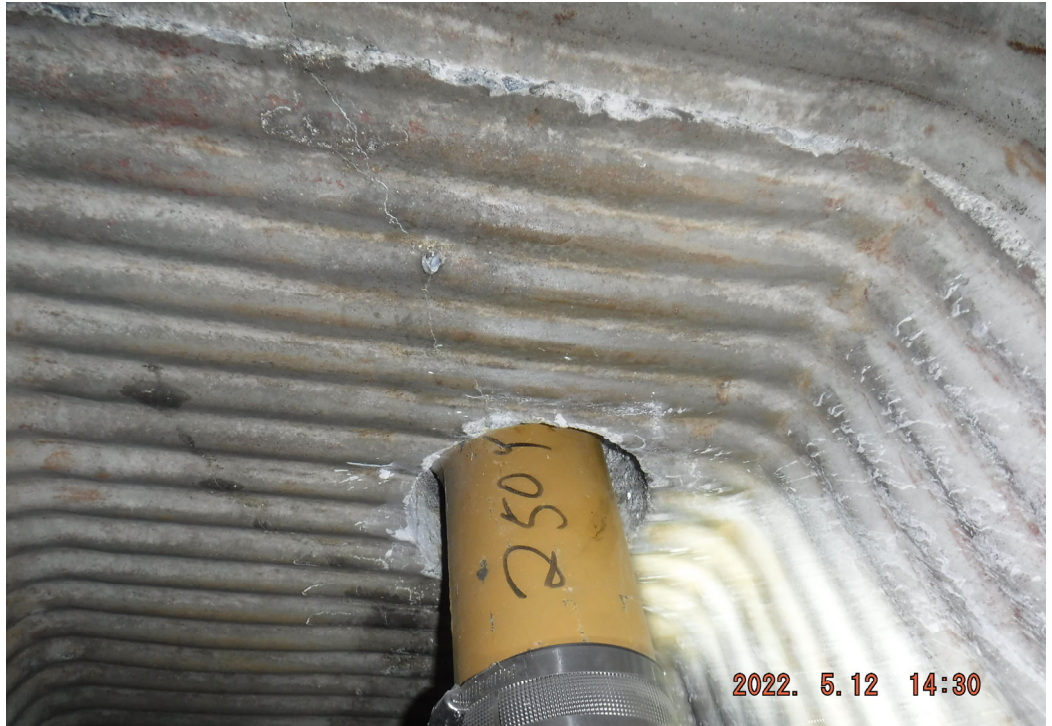
**Photo No.**  
7

**Description:**  
Pipes under room M-106.

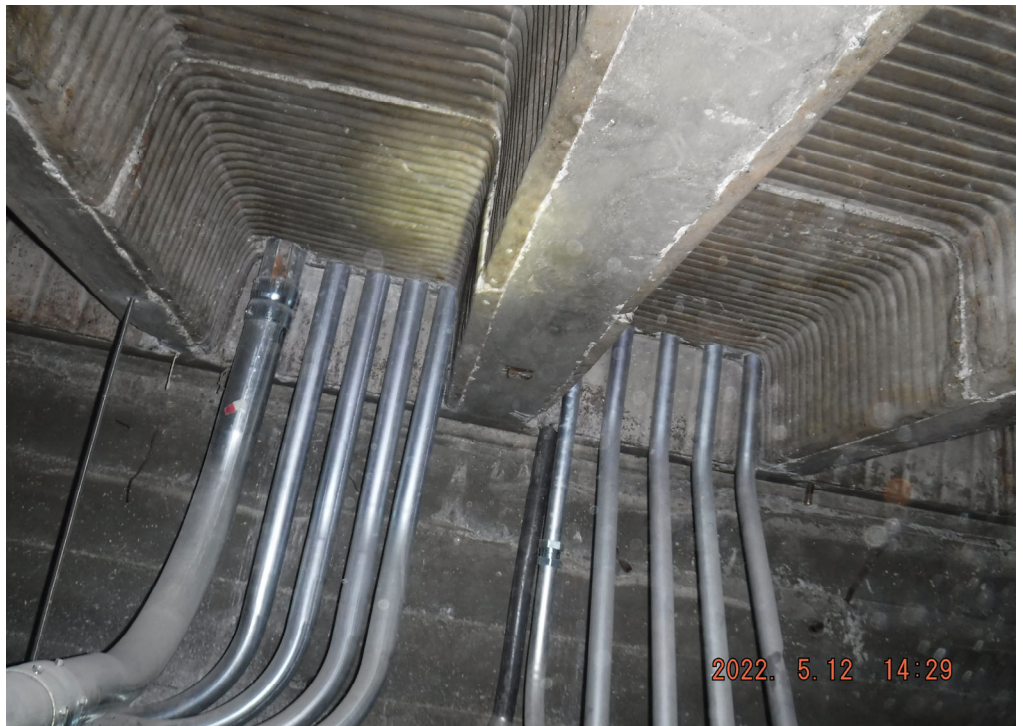
**Photo No.**  
8

**Description:**  
Pipes heading west towards cafeteria.
