Silver Bow Creek/Butte Area Superfund Site

### **Butte Priority Soils Operable Unit (BPSOU) Draft Final Insufficiently Reclaimed Sites – Field Sampling Plan (FSP) BRES No. 31 – Waste Dump #5**

**Re: Butte Priority Soils Operable Unit (BPSOU) Draft Final Insufficiently Reclaimed Sites – Field Sampling Plan (FSP) BRES No. 31 – Waste Dump #5.**

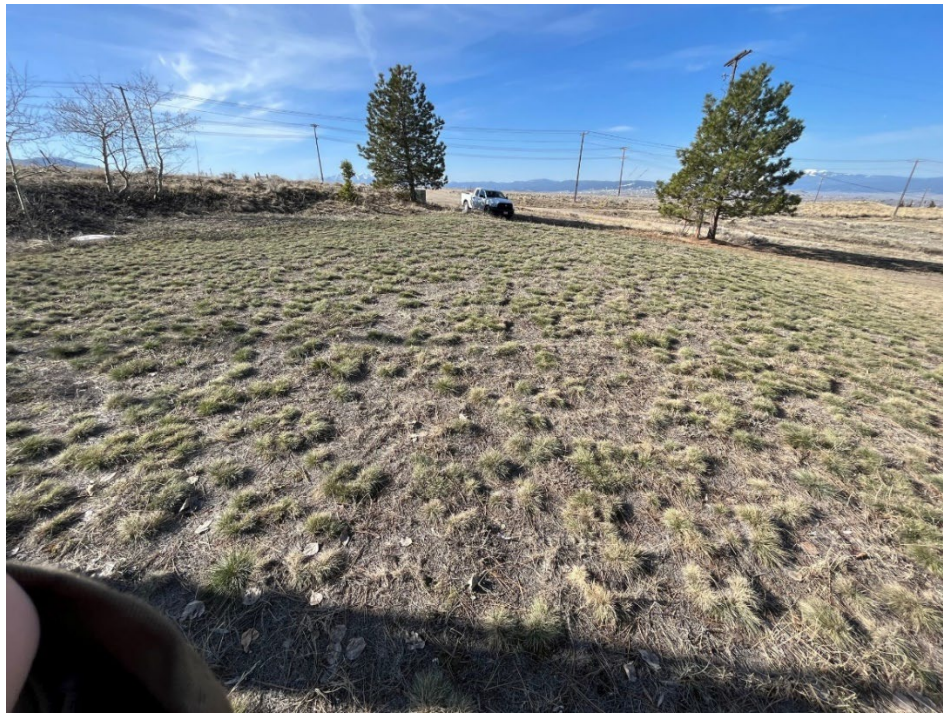
Photograph 1: Site overview looking south.

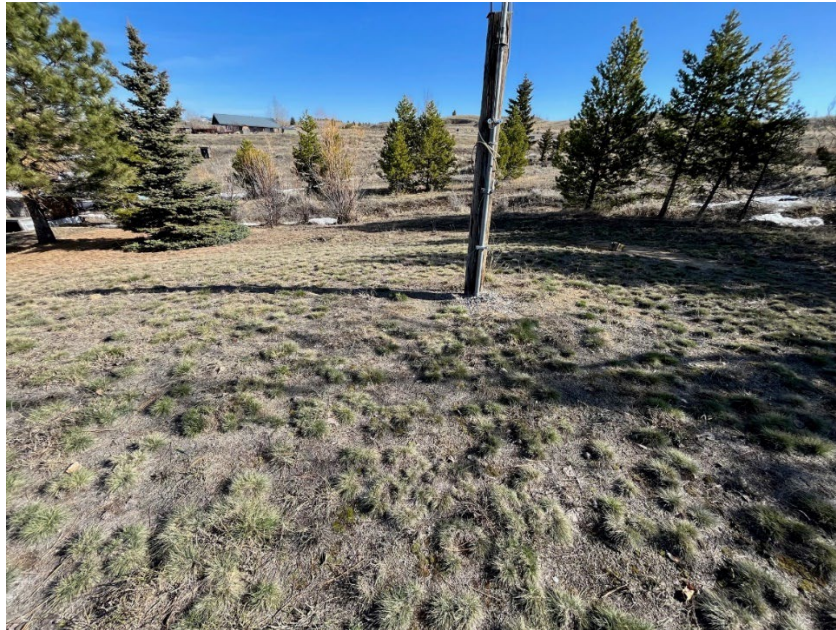
Photograph 2: Site overview looking north.

Overall, the site is in good condition. No erosion or weeds are present on site; however, vegetation is low, and sediment and litter are gathering in between clusters of vegetation. It appears the neighbor is maintaining the site as it is mowed, and a plant cage is around a planted tree. The site is protected from storm water and erosion on the north side from the berm along Cora Terrace Street to the north. A manhole is located on the southeast section of the site near the soil berm.

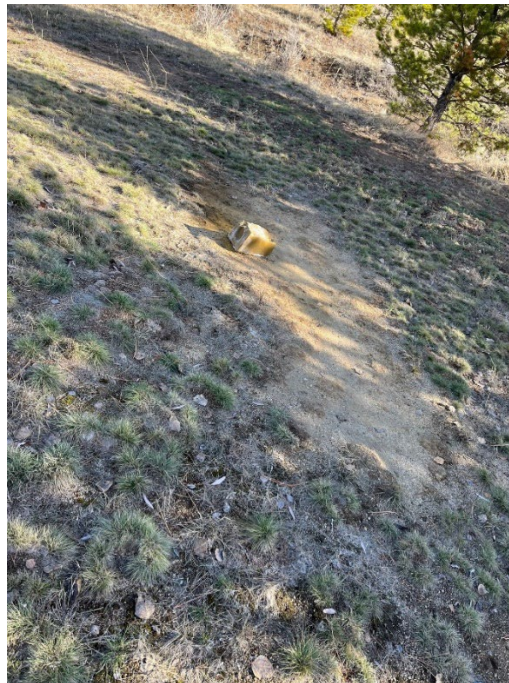
Photograph 3: Barren area with possible staining.

A barren area was found on the northeast portion of site. A salt lick was present in this barren area along with deer tracks in the soil. Orange to yellow staining is present in this area.

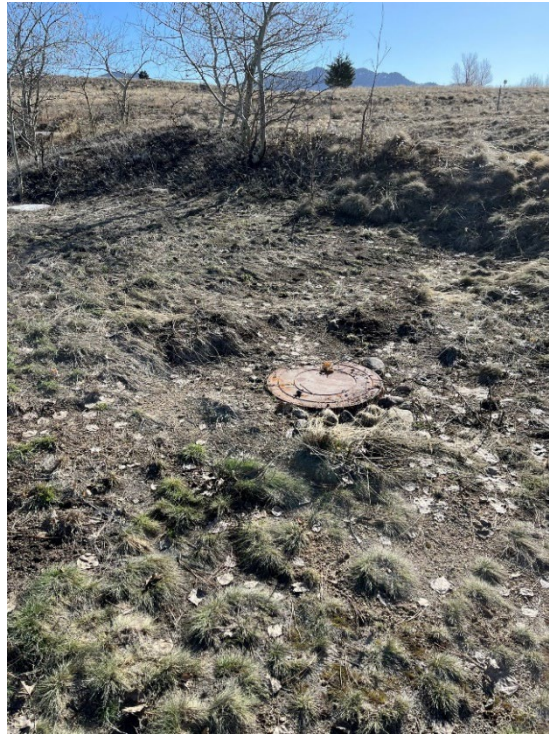
Photograph 4: Manhole located on site.

A manhole is located on the southeast portion of site near the soil berm. It appears the soil around the metal manhole is sloughed or shoveled to match the elevation of the manhole.

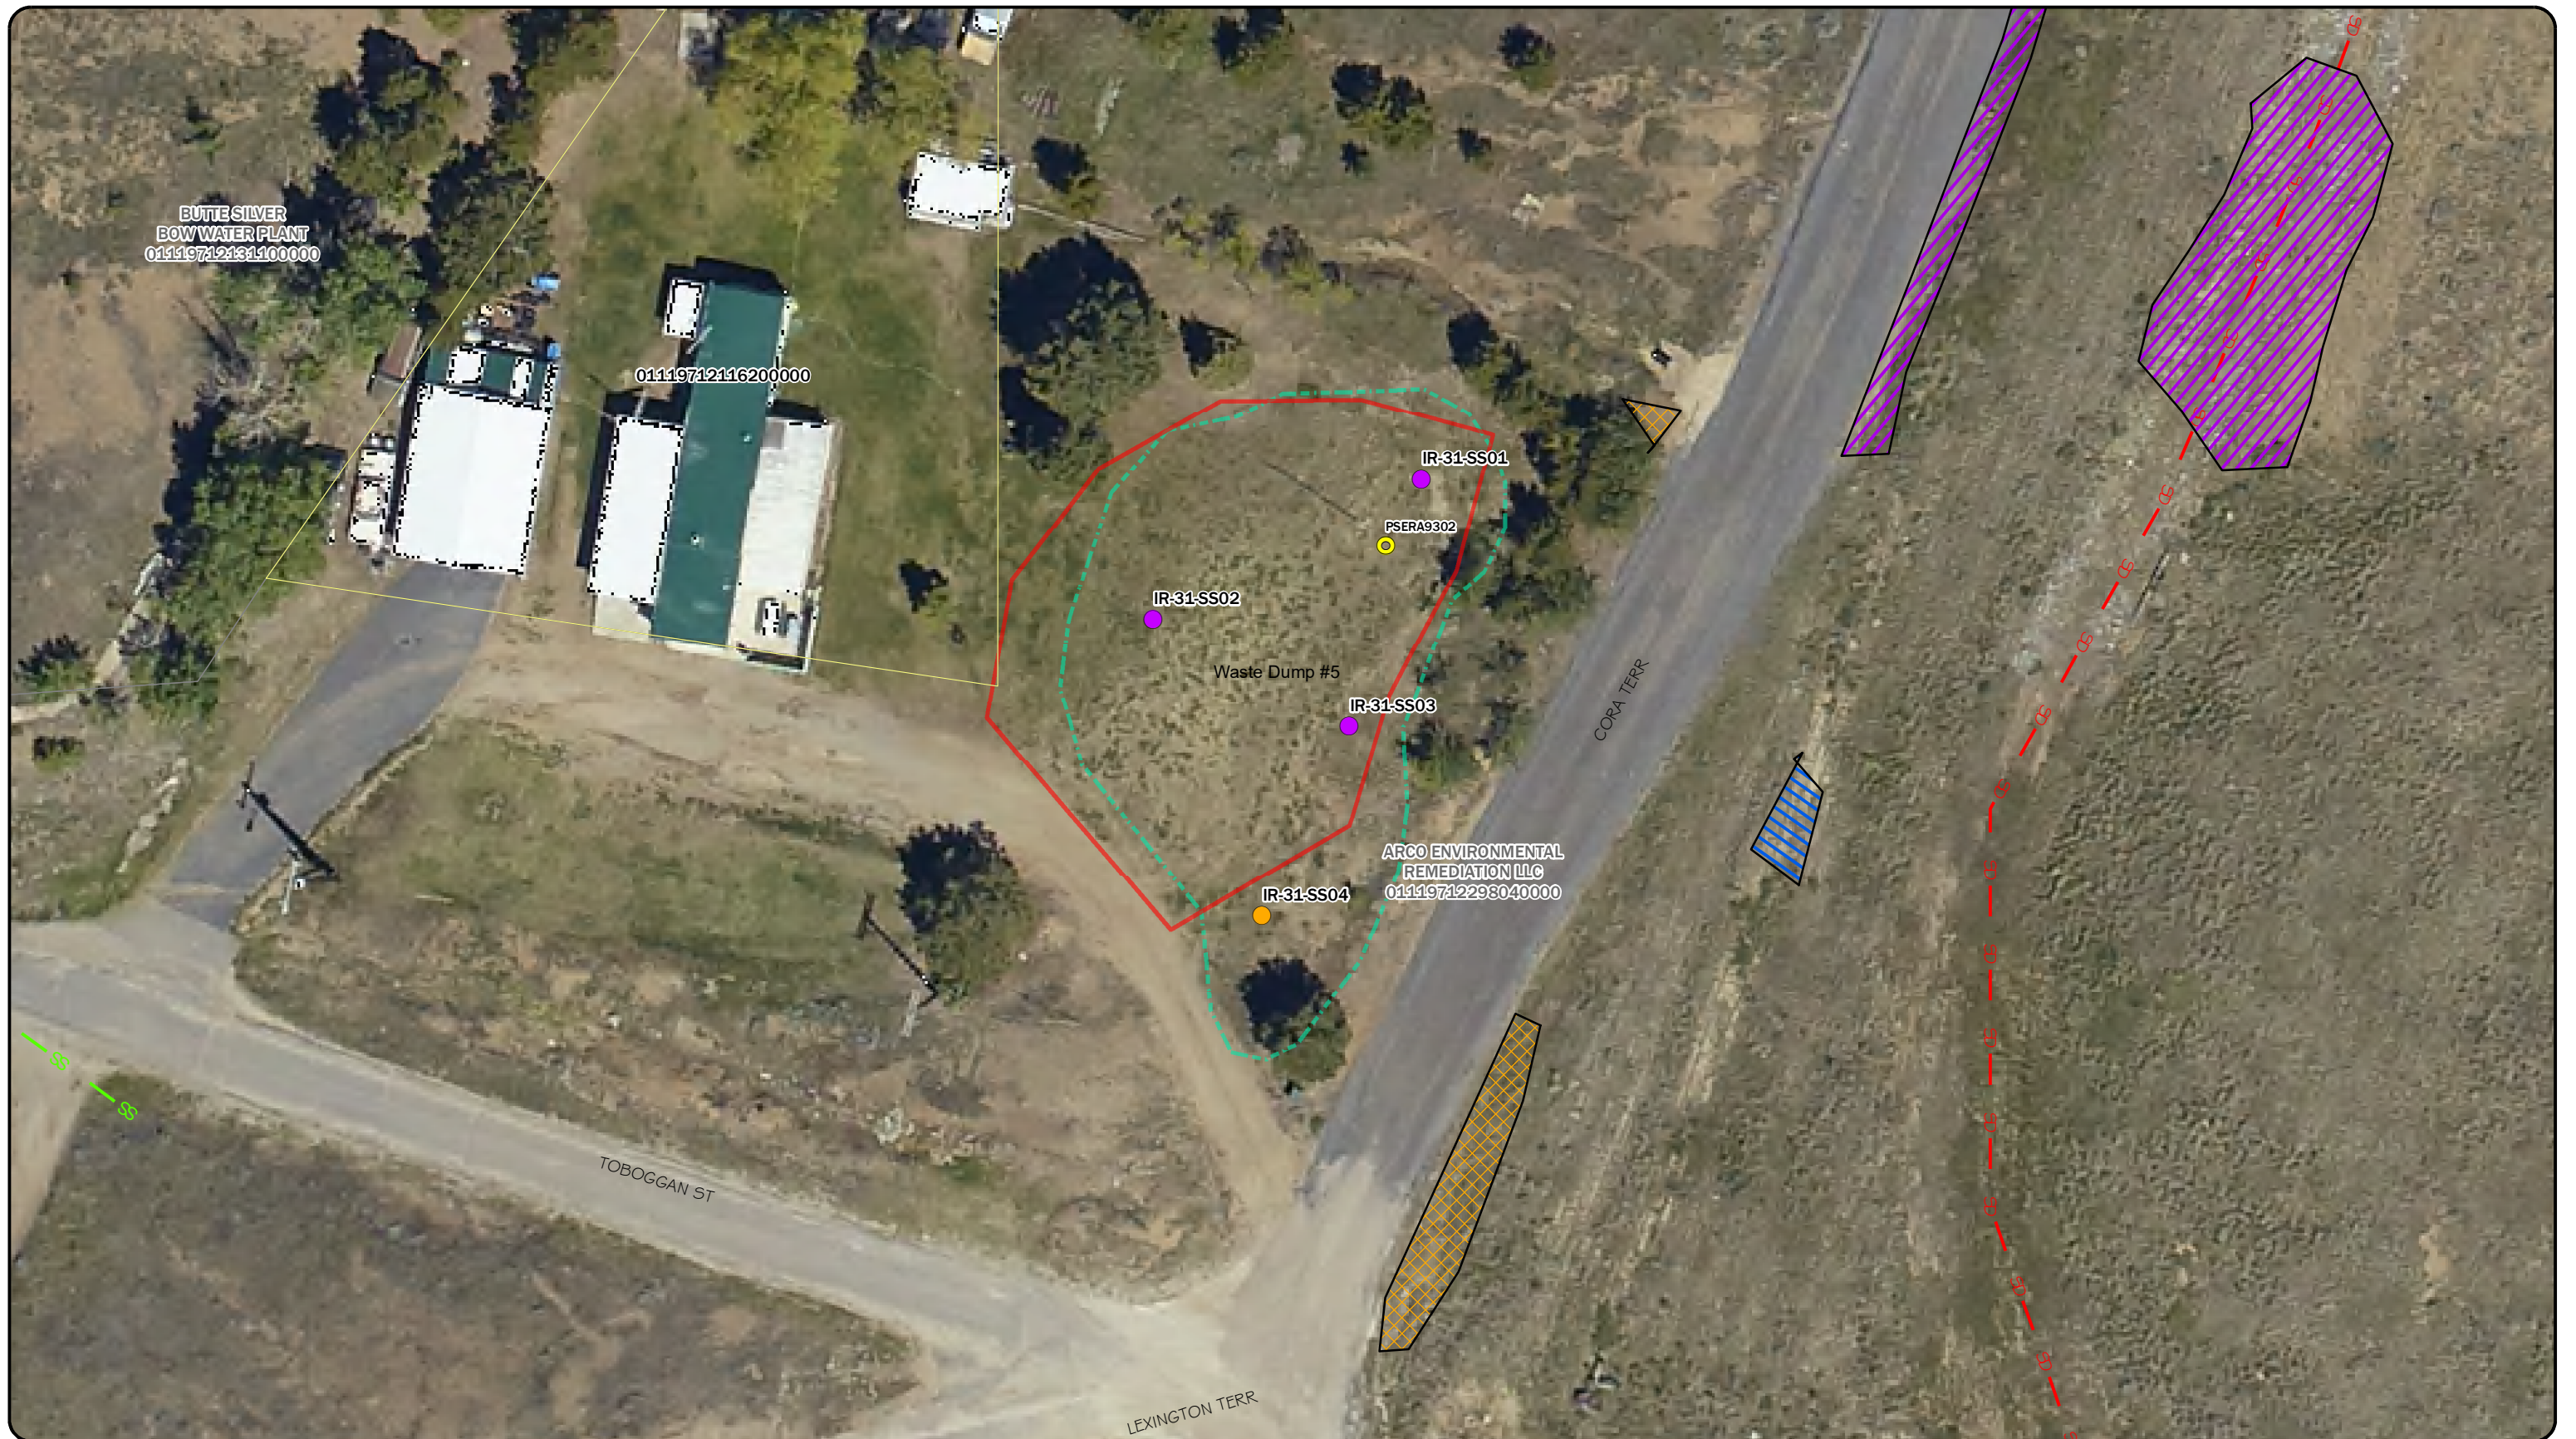
Figure 1 – Insufficiently Reclaimed Sites BRES No. 31 - Waste Dump #5 Proposed Sample Stations

This FSP describes field evaluation of the IR Site BRES No. 31 – Waste Dump #5. The sampling boundary and proposed soil sampling stations and deficiencies identified during previous BRES evaluations are shown on Figure 1.

Figure 1 illustrates the proposed sample stations as sited during the preliminary site evaluation. Adjusted boundary lines, previous sample locations, and other previous findings are included on Figure 1.

The Geocortex web-based database at <https://eis2.woodardcurran.com/Html5Viewer/index.html?viewer=BPButte.BPSOU> contains the records for previous soil samples within the BPSOU. The approximate sample stations located on BRES No. 31 – Waste Dump #5 are included on Figure 1 with results provided in Table 1 below. Sample results highlighted below exceed CD Solid Media soil
