Silver Bow Creek/Butte Area Superfund Site

### **Butte Priority Soils Operable Unit (BPSOU) Draft Final Insufficiently Reclaimed Sites – Field Sampling Plan (FSP) BRES No. 66 – West Ruby Dump**

**Re: Butte Priority Soils Operable Unit (BPSOU) Draft Final Insufficiently Reclaimed Sites – Field Sampling Plan (FSP) BRES No. 66 – West Ruby Dump.**

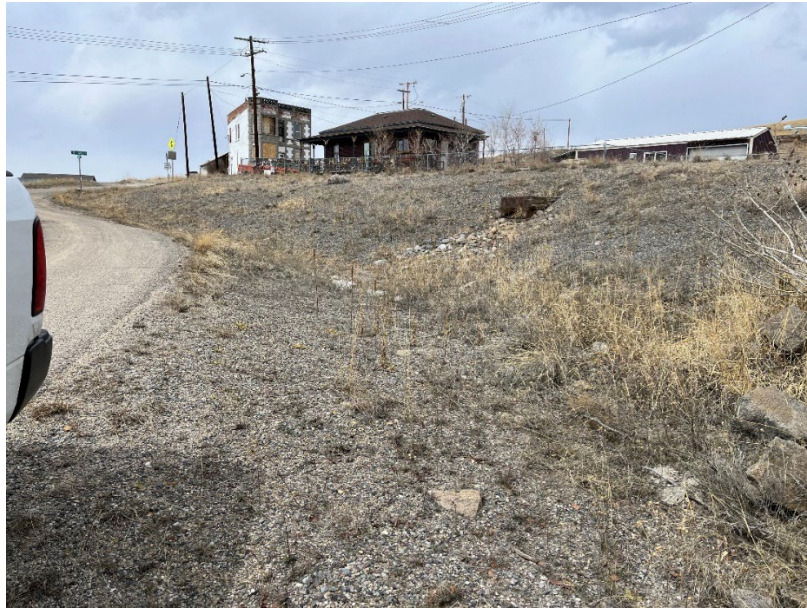
Photograph 1: West Ruby Dump site overview looking from the northwest.

A preliminary site evaluation was conducted during development of this sampling plan to inspect current site conditions and identify focus areas for further investigation. Photograph 1 through Photograph 8 show current site conditions. The investigation found the site to have a good, engineered cover taken over by weeds, low vegetation establishment near the walking trail, a barren area with surface staining and erosion, and sediment collection along site edges. The two southern areas were not evaluated due to the adjusted boundary area.

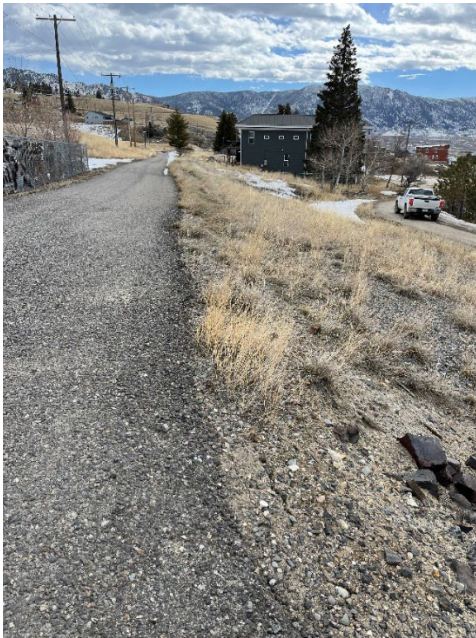
Photograph 2: West Ruby Dump site overview looking east.

Snow was still present on the site during the original site visit in the spring of 2023. Road sand is accumulating on the north edge along the walking trail and on the south edge along Ruby Street as seen on Photograph 2 and Photograph 3 above. Stormwater runoff and sediment migrates from the north to the southeast of the site.

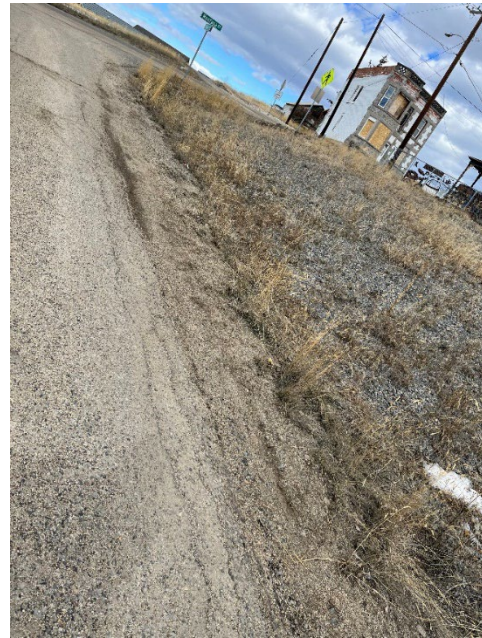
Photograph 3: Road sand accumulating south of site.

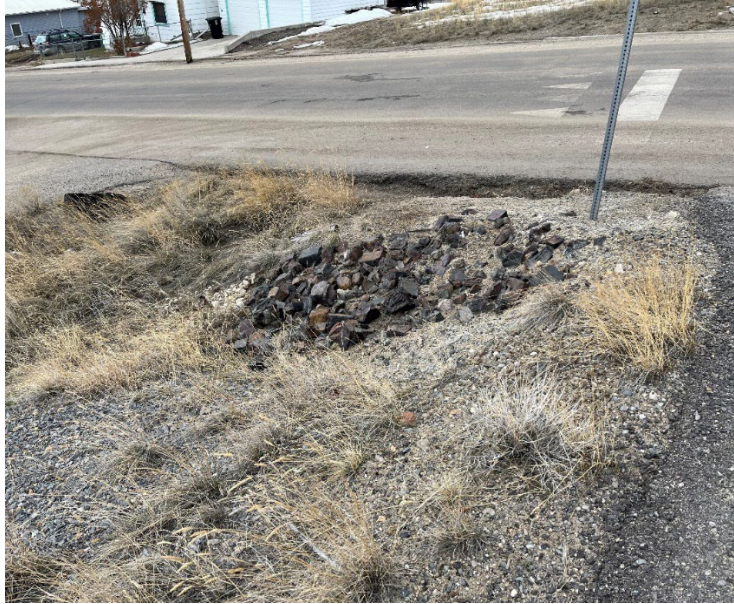
Photograph 4: Erosion and staining on the west side of site next to Montana Street looking west.

The west side of the site, adjoining the east side of Montana Street, shows a significant amount of erosion, gullies, sediment migration, manganese staining, and a barren area. Photograph 4 through Photograph 6 highlight these issues.

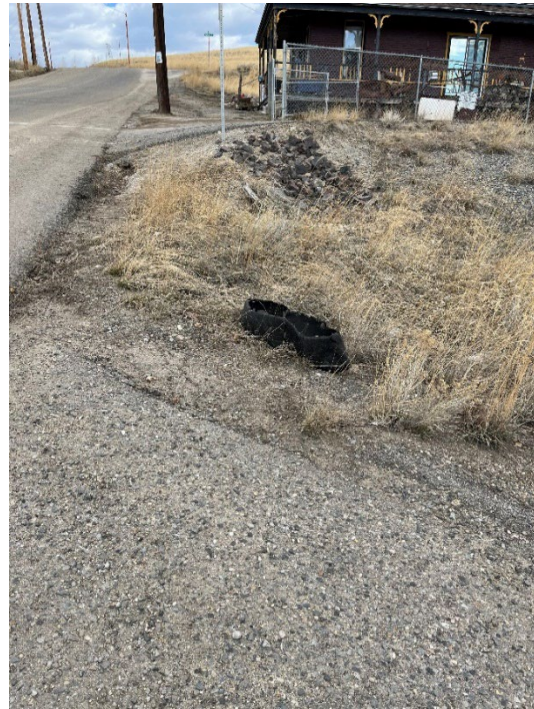
Photograph 6: Erosion next to Montana Street looking north.

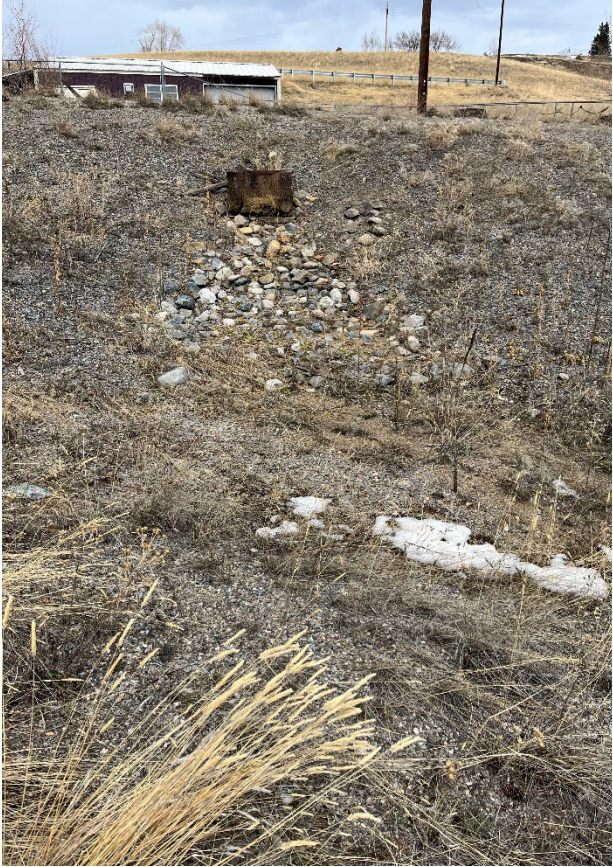
Photograph 7: Storm water outlet looking north.

The condition of the storm water outlet on site is deteriorating. Weeds are growing inside the structure, and the metal cage is deformed and detached from the wooden structure. The base of the outlet structure facilitates site water and sediment ponding, as shown on Photograph 7.

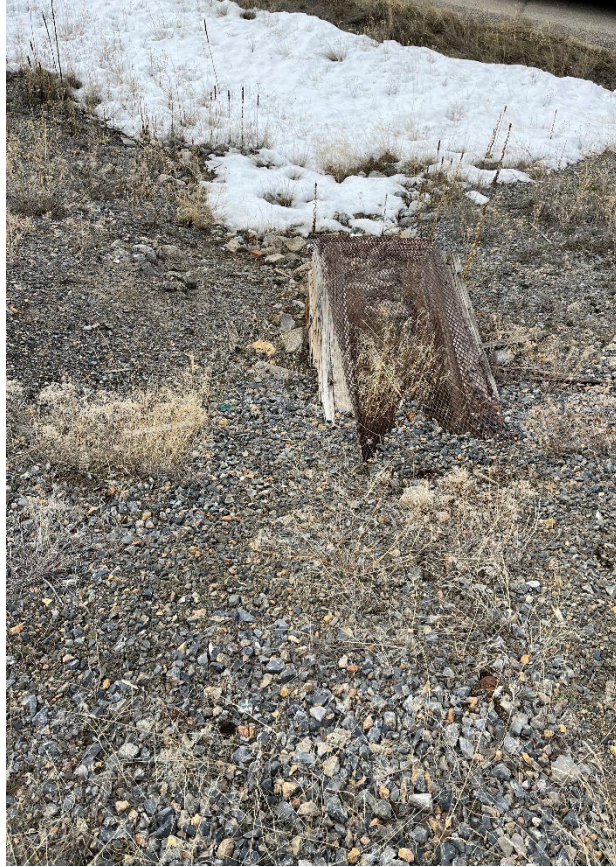
Photograph 8: Top of storm water outlet.

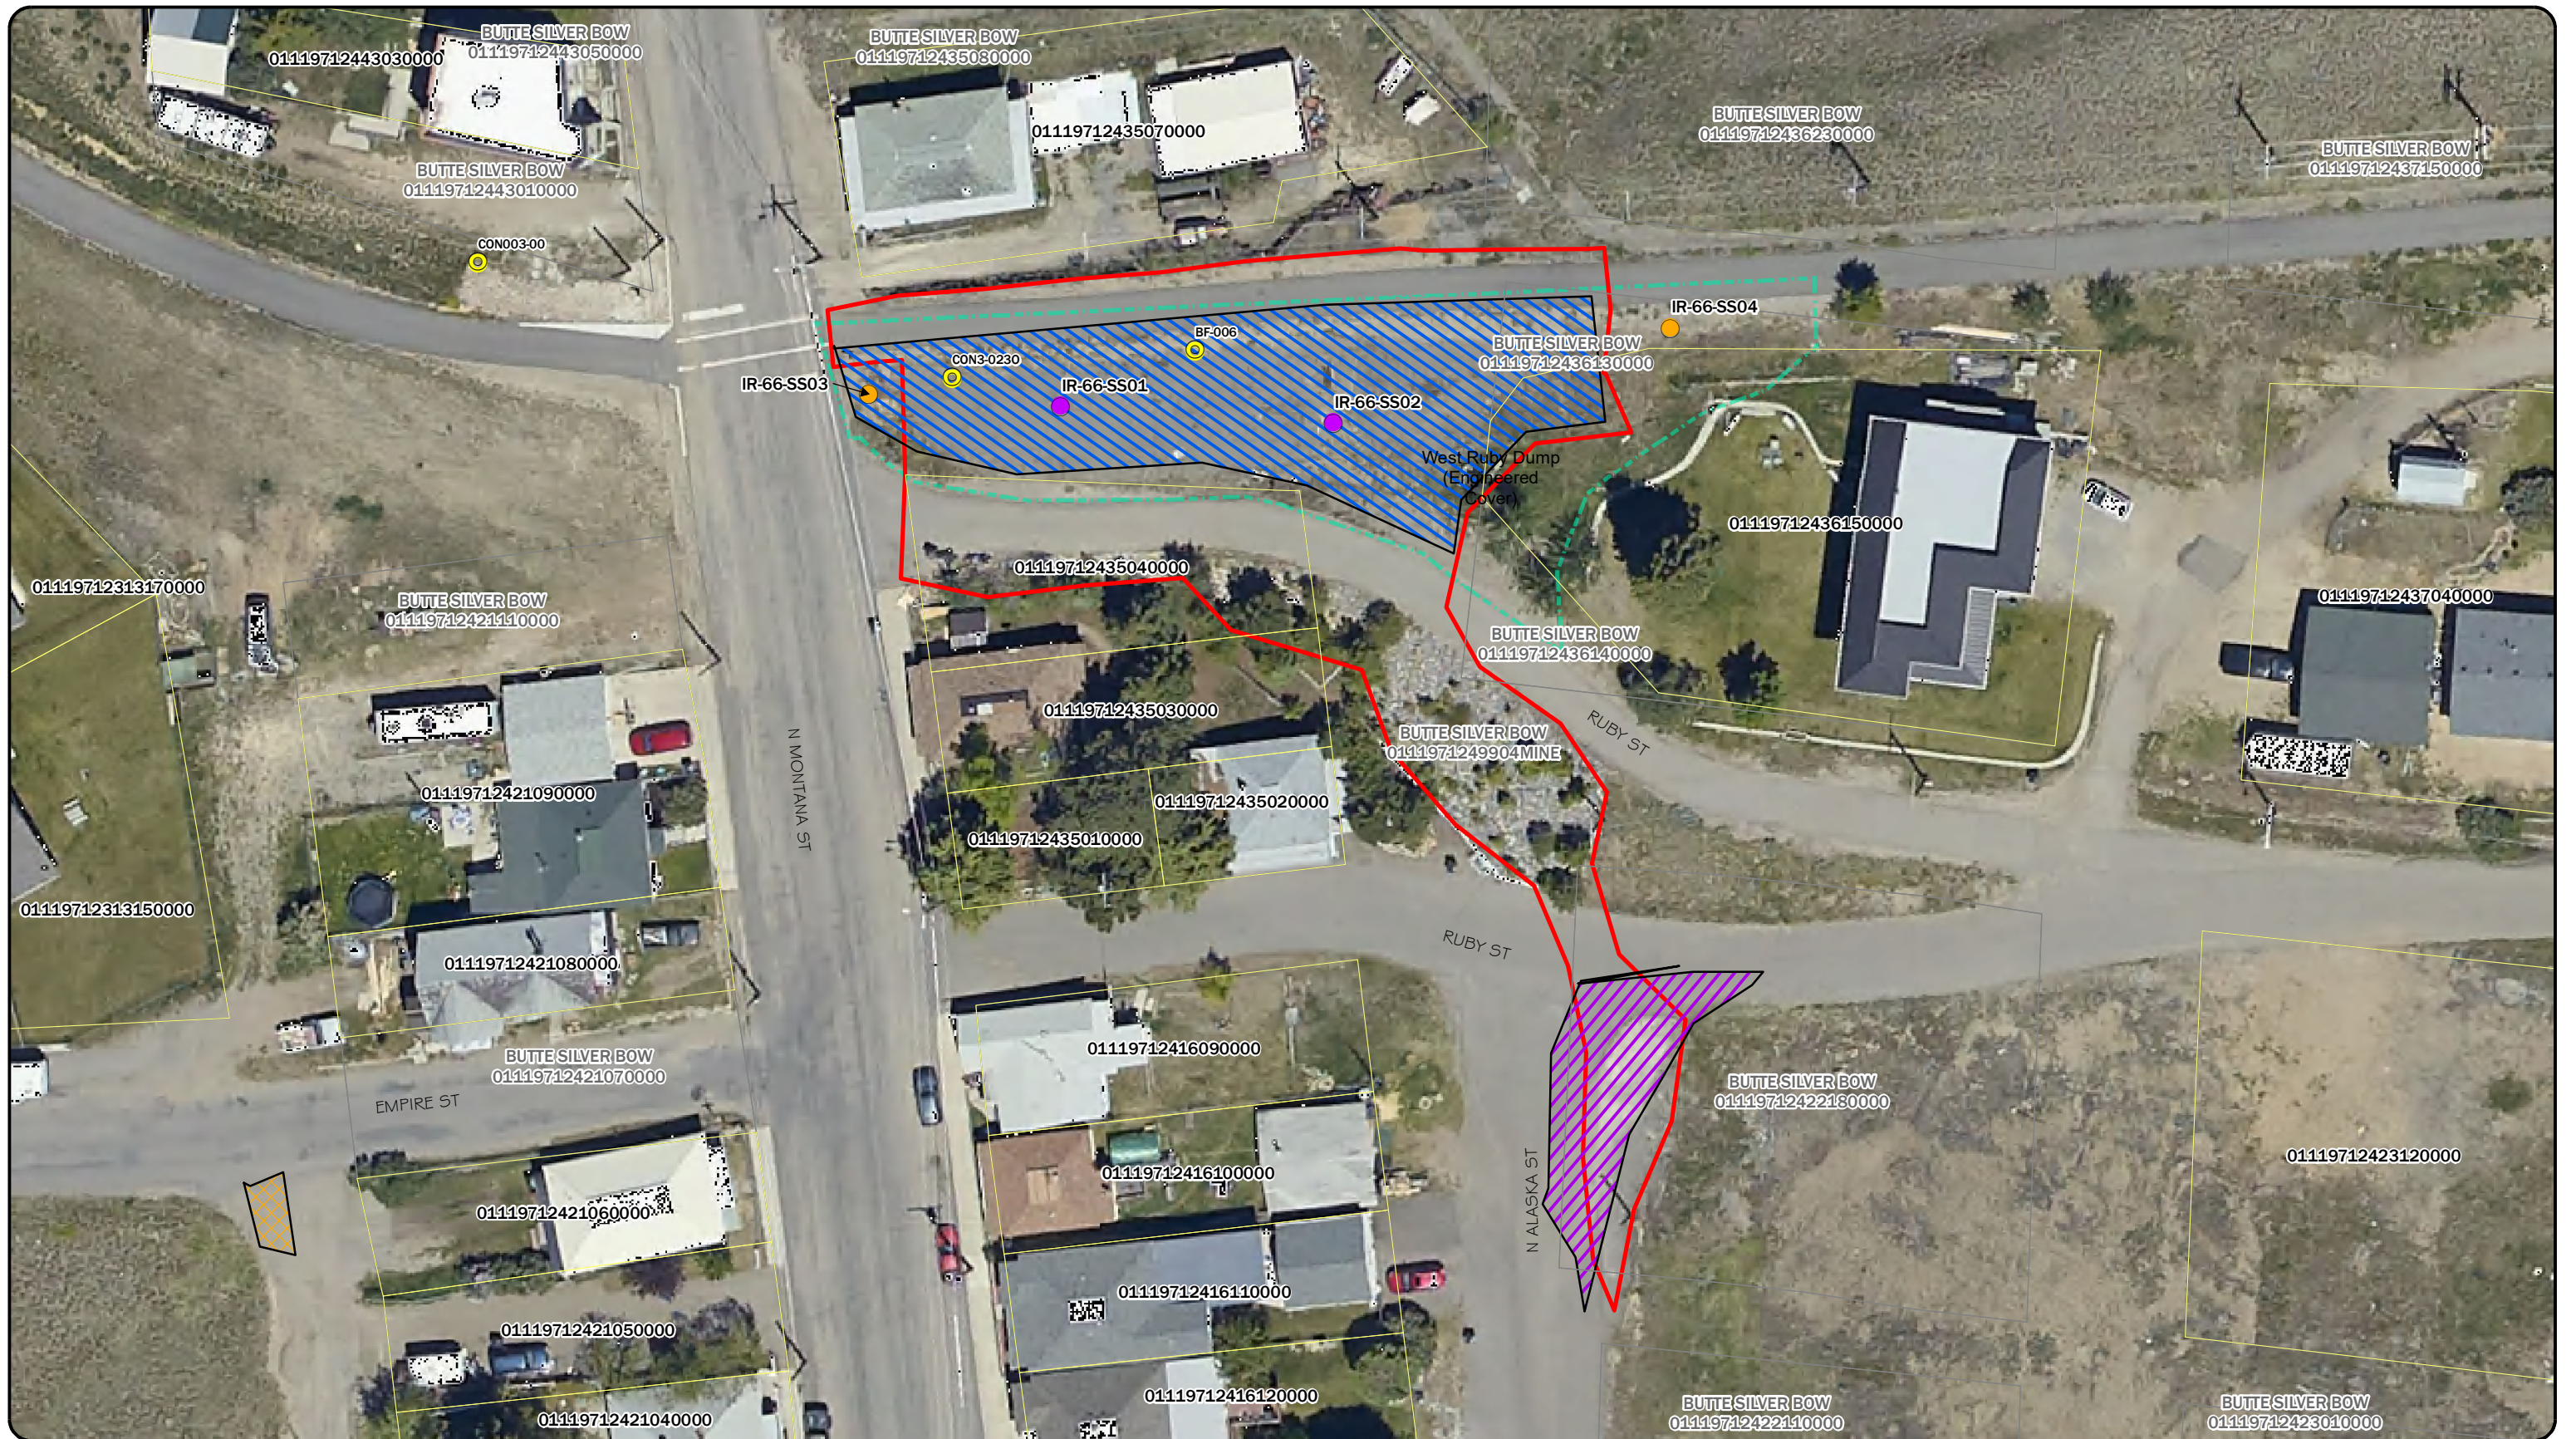
**FIGURE 1**  
 INSUFFICIENTLY RECLAIMED  
 SITE BRES No.66 WEST RUBY DUMP

This FSP describes field evaluation of the IR Site BRES No. 66 – West Ruby Dump, focusing on the engineered cover of the reclaimed area. The sampling boundary and proposed soil sampling stations and deficiencies identified during previous BRES evaluations are shown on Figure 1.

Figure 1 illustrates the proposed sample stations as sited during the preliminary site evaluation. Adjusted boundary lines, previous sample locations, and other previous findings are included on Figure 1.

An adjusted boundary was proposed for BRES No. 66 –West Ruby Dump to accurately represent the reclaimed area and align site boundaries with completed site remediation efforts. As described in the BPSOU *Source Areas and Reclaimed Boundary Adjustments*<sup>1</sup>, this was completed by using a high-resolution aerial image and visual comparisons to identify the areas of apparent remediation. Note that Agencies have not yet approved the proposed adjusted boundary. To verify the proposed boundary adjustment, samples will be collected in areas that are included in the proposed boundary area, but just outside of the original boundary area. The two portions of the original boundary south of Ruby Street were excluded in the proposed boundary update and can be seen on Figure 1.
