Butte Priority Soils Operable Unit (BPSOU) Draft Final Insufficiently Reclaimed Sites – Field Sampling Plan (FSP) BRES No. 134 – Star West Dump

July 25, 2023

I am writing to you on behalf of Atlantic Richfield Company (Atlantic Richfield) to submit the Butte Priority Soils Operable Unit (BPSOU) Draft Final Insufficiently Reclaimed (IR) Sites – Field Sampling and Investigation Plan (FSP) Butte Remediation Evaluation System (BRES) No. 134 – Star West Dump.

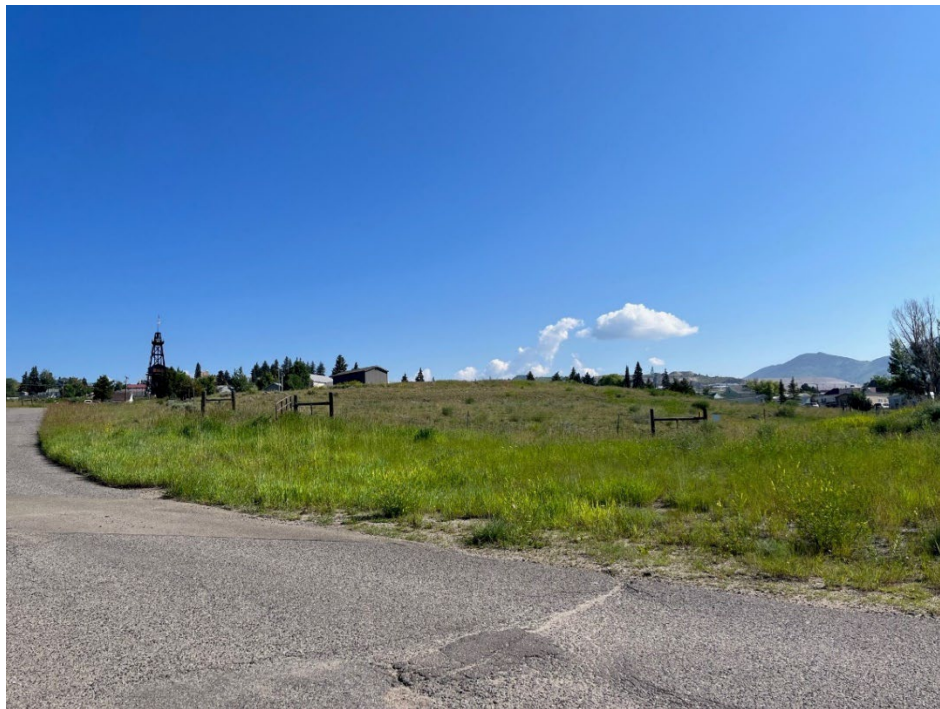
Photograph 1: Overview of site looking north.

Overall, the site is in good condition. Site edges are presenting with rills and sedimentation deposition onto Bryant Street. The site contains a good vegetation cover, with a few barren areas

located throughout the site. The dirt parking lot is contributing to sediment collection on the edges from a possible area where snow is plowed in the winter months.

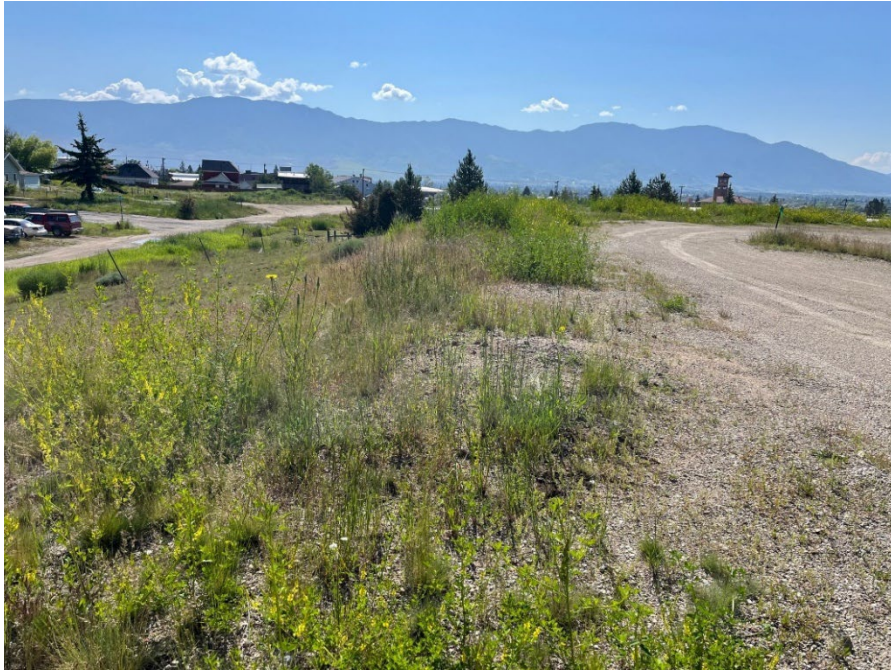
Photograph 2: Barren area located near the west side of the dirt parking area.

The dirt parking lot is contributing to sediment collection on the edges where snow is plowed in the winter months. A barren area and slight rilling on the north slope are developing.

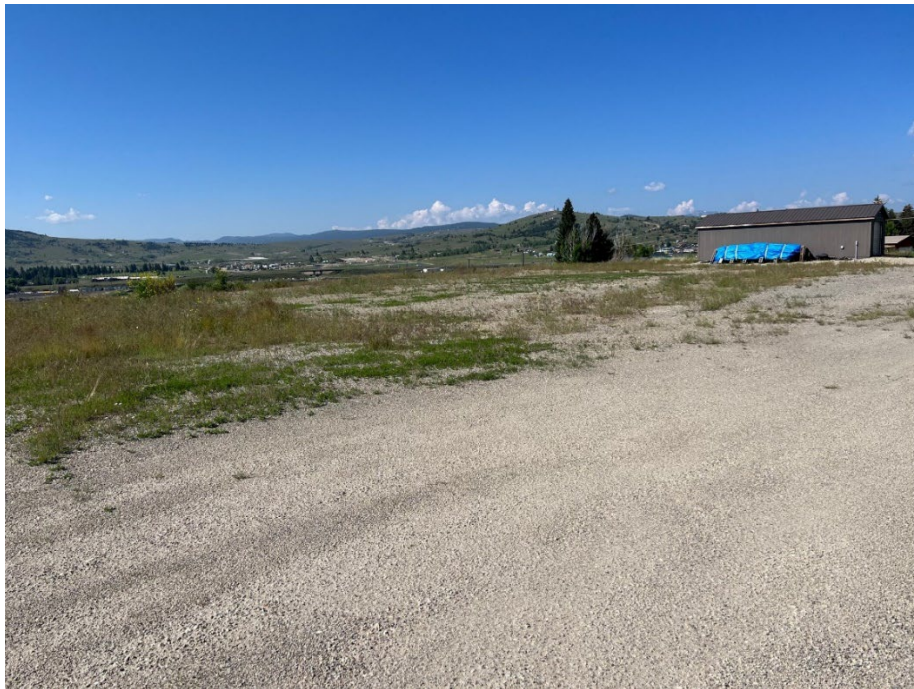
Photograph 3: Barren area.

A barren area was observed to the south of the dirt parking lot where a garage was recently constructed and fill material may have been imported for the construction of this building.
