Remedial Action Work Plan East Middle School

RE: Residential Metals Abatement Program – Interior School Dust - Remedial Action Work Plan – East Middle School

Remedial Action Work Plan

East Middle School

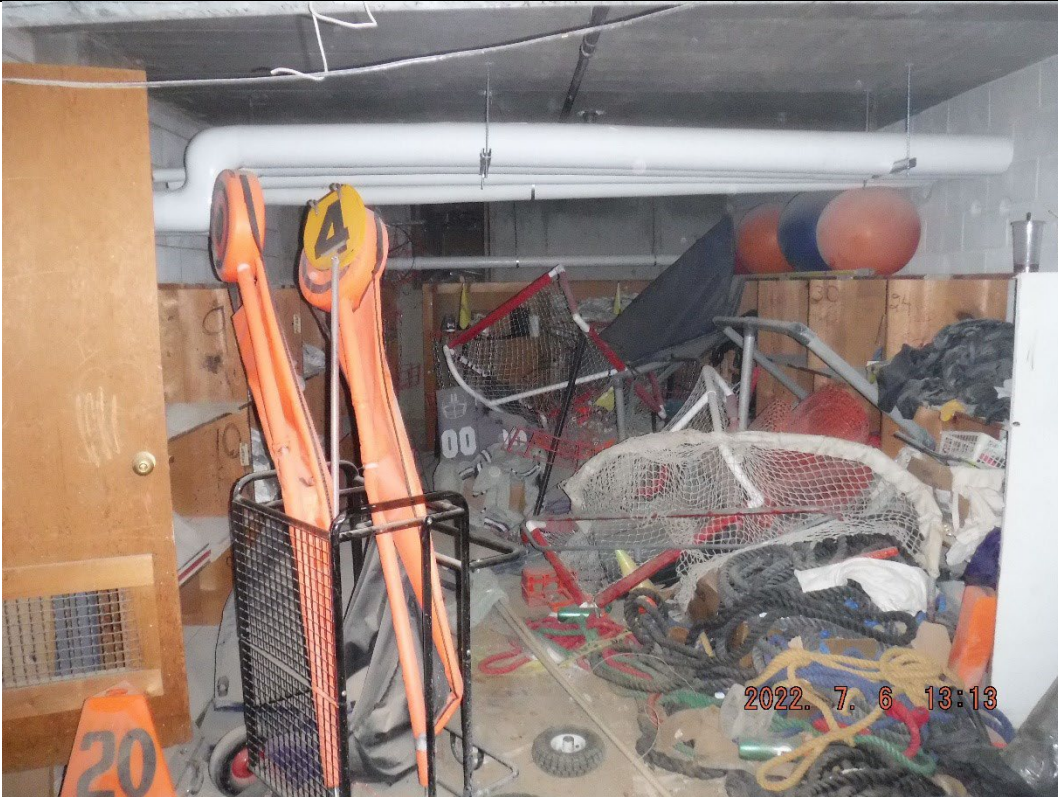
Photograph: 1 View of basement storage area, from bottom of stairwell, facing south.

Access to the basement storage area is adjacent to the south gym on the first floor. Access is currently restricted to engineering and janitorial staff. The basement storage room consists of an approximately 1,400 square foot rectangular area. The room contains equipment for the upstairs gym, including nets, balls, cones, and other recreational equipment. Steel utility conduits run throughout the basement storage area. There is a crawl space area with exposed soil to the west (no door), and a hallway crawl space with exposed soil through a doorway on the east side. In November 2022, soil from both crawl spaces were sampled, and no constituents were detected above the Butte Priority Soils Site-Specific Residential Action Levels. See Appendix A for photographs of the basement storage area.

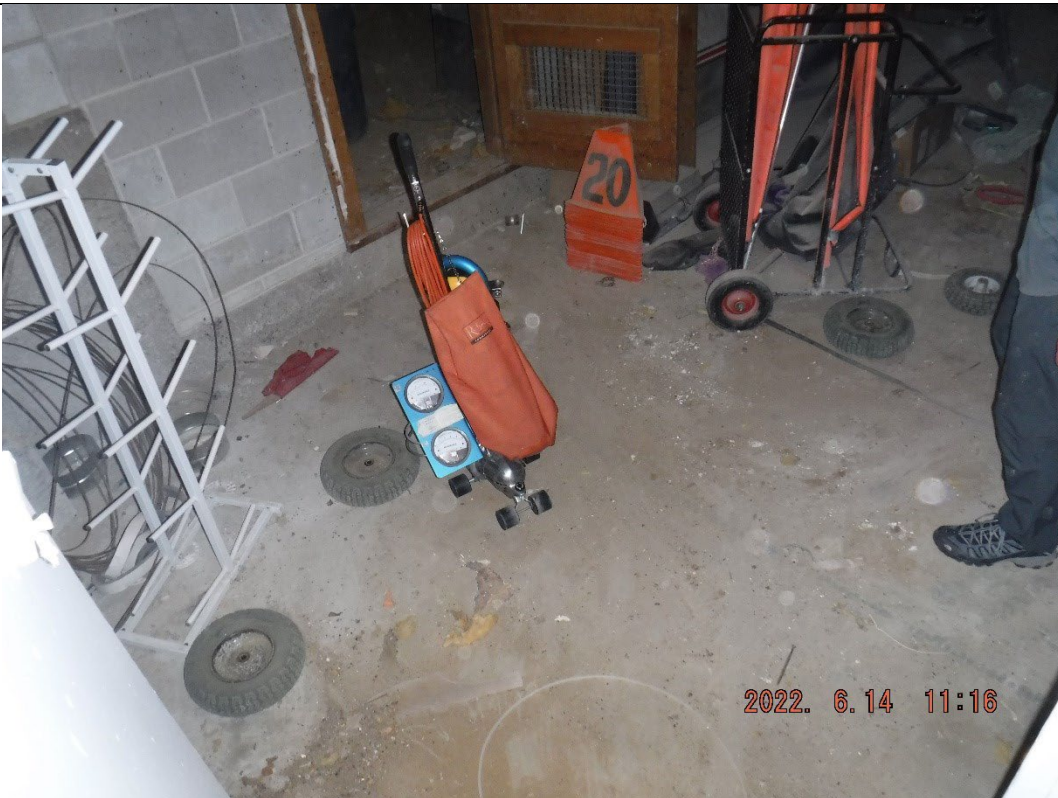
Photograph: 2 View of basement storage area floor, facing towards doorway that leads to eastern crawl space, facing southeast.
