Butte Priority Soils Operable Unit (BPSOU) Final Insufficiently Reclaimed (IR) Sites Field Sampling and Investigation Plan (FSP) Butte Remediation Evaluation System (BRES) No.174 – Buffalo Ditch

Re: Butte Priority Soils Operable Unit (BPSOU) Final Insufficiently Reclaimed Sites – Field Sampling Plan (FSP) BRES No. 174 – Buffalo South and BRES No 174 – Buffalo Ditch.

This FSP describes field evaluation of the IR Site BRES No. 174 – Buffalo South and BRES No. 174 – Buffalo Ditch. The sampling boundary and proposed soil sampling stations and deficiencies identified during previous BRES evaluations are shown on Figure 1 and Figure 2.

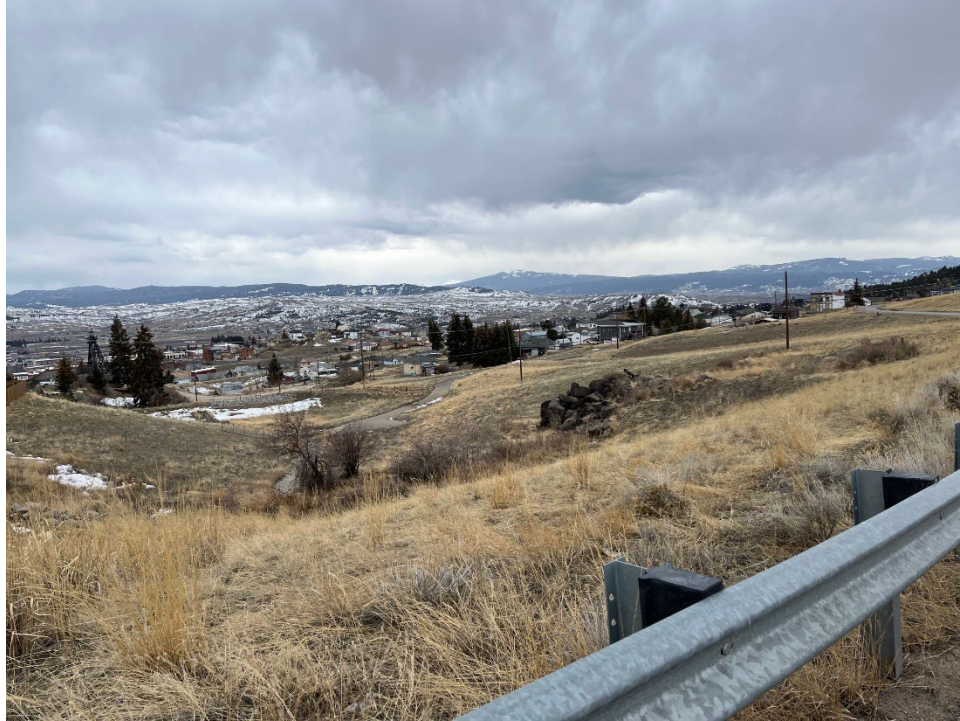
Photograph 1: Site overview facing southwest.

A preliminary site evaluation was conducted during development of this sampling plan to inspect current site conditions and identify focus areas for further investigation which included site photographs. Photograph 1 through Photograph 6 show current site conditions. The investigation found the site to have moderate vegetation establishment with a large area of low vegetation and barren areas. Undesirable vegetation and weeds are present throughout the whole site.

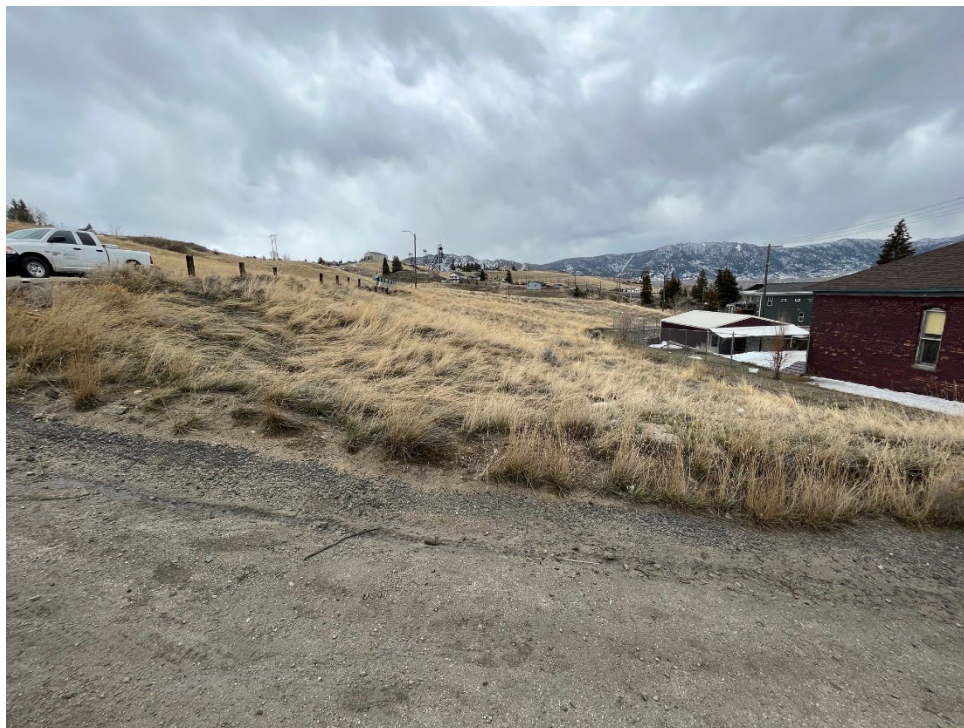
Photograph 2: Site overview facing east.

Sediment from Buffalo Street is migrating onto the site and is causing rills to form along the site edges. A few barren areas were also discovered. A culvert is located on the northeast portion of the

site. This culvert diverts water from BRES No. 53 and 54, north of BRES No. 174, under Buffalo Street and onto BRES No. 174 Buffalo South site.

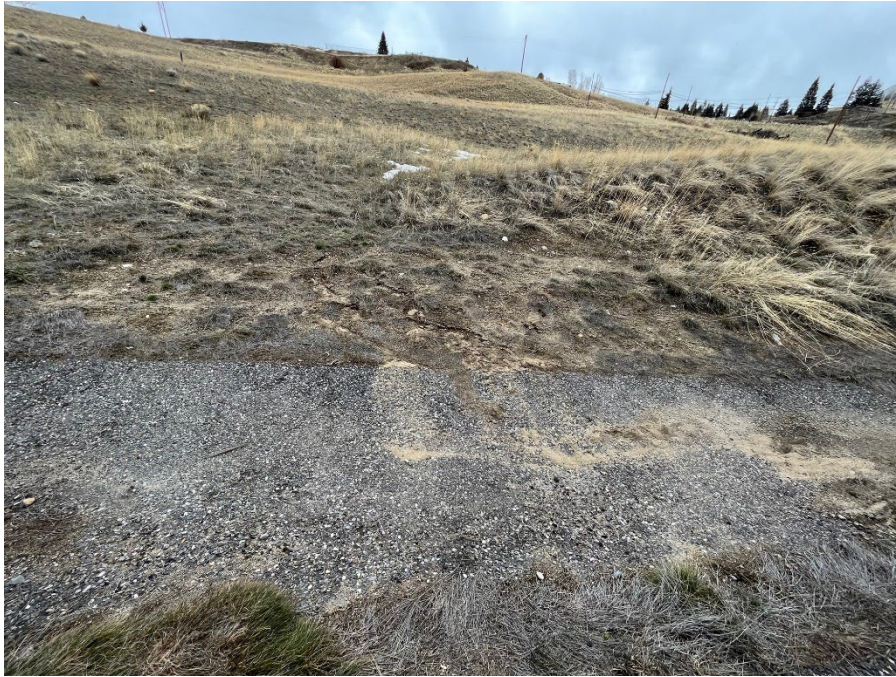
Photograph 3: Barren area on the south side of site.

Sediment from a barren area on the south portion of the site is depositing into the paved channel that runs along the south border of the site.

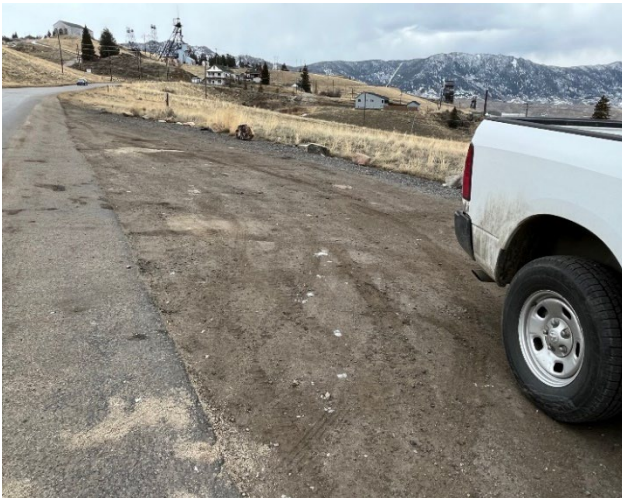
Photograph 4: East vehicle pullout area on Buffalo Street.

Two areas along Buffalo Street are used as vehicle pull outs. These two locations are not barren areas, but rather, an engineered cap with asphalt millings and appear to be in good condition. No samples will be collected here since it is capped and not included in the boundary.

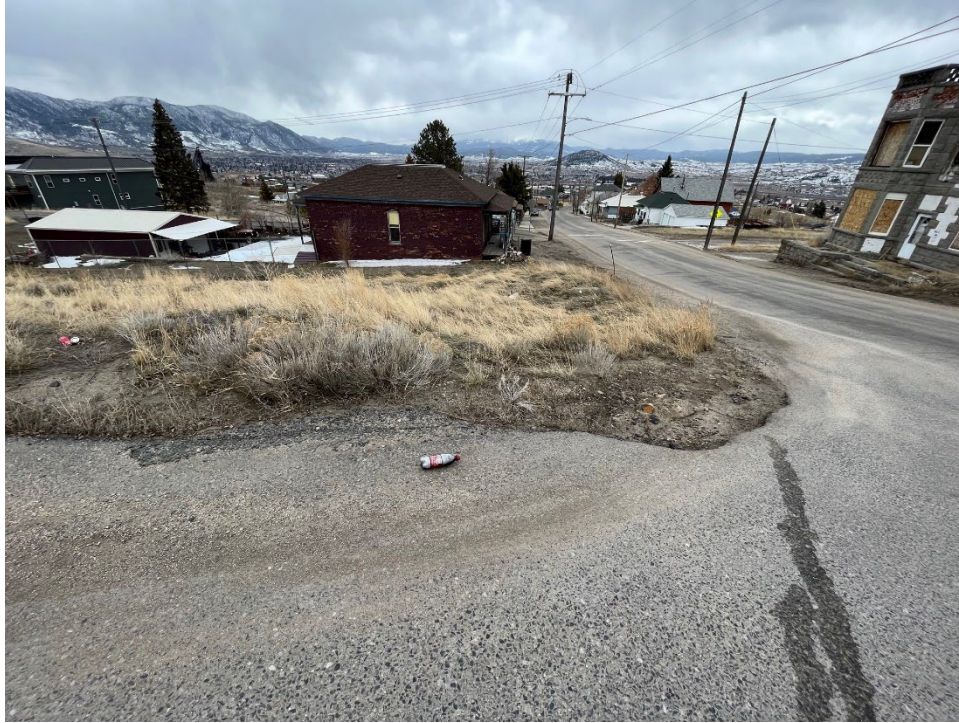
Photograph 6: East side of site along North Montana Street

The corner of Buffalo Street and North Montana Street shows heavy storm water and sediment collection and migration. Undercutting of this intersection was observed. Sediment and storm water run along the site, down North Montana Street, and into a storm water inlet north of the private property shown on Photograph 6.

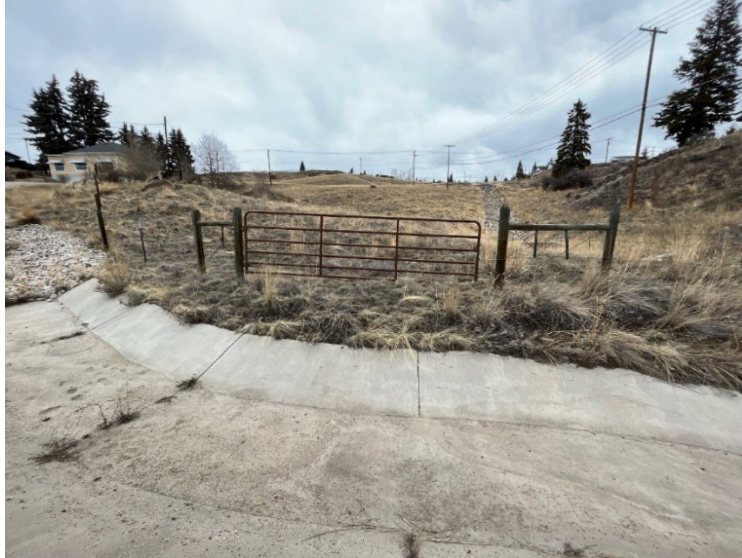
Photograph 7: Overview of Buffalo Ditch looking north.

A preliminary site evaluation was conducted during development of this sampling plan to inspect current site conditions and identify focus areas for further investigation. Photograph 7 through Photograph 9 show current site conditions. The investigation found the site to have good vegetation establishment with undesirable vegetation and weeds throughout the whole site. Buffalo Gulch channel is located on the east side of the site. No samples will be collected from the channel.

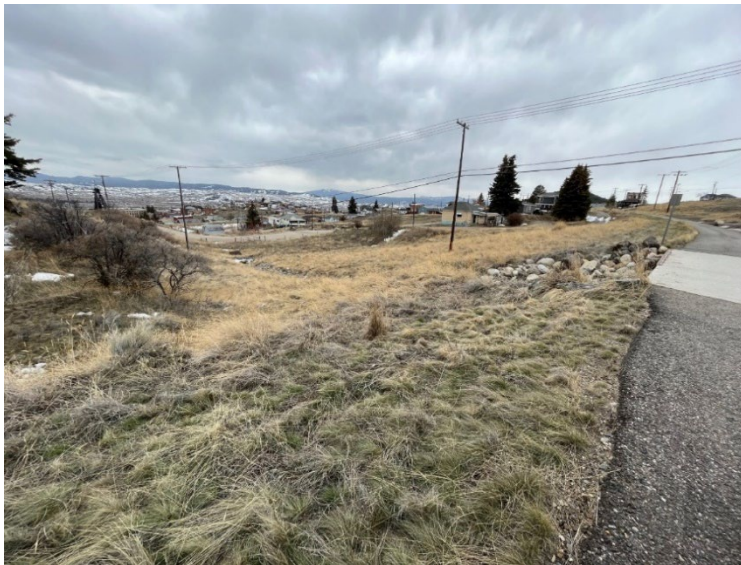
Photograph 8: Overview of Buffalo Ditch looking southwest.

A gravel and cement-lined channel (Buffalo Gulch channel) runs along the southwest and south borders of the site. A storm water inlet is located in the cemented line portion of the channel. BSB maintenance crews completed seeding along the north portion of the site, and vegetation is well established.

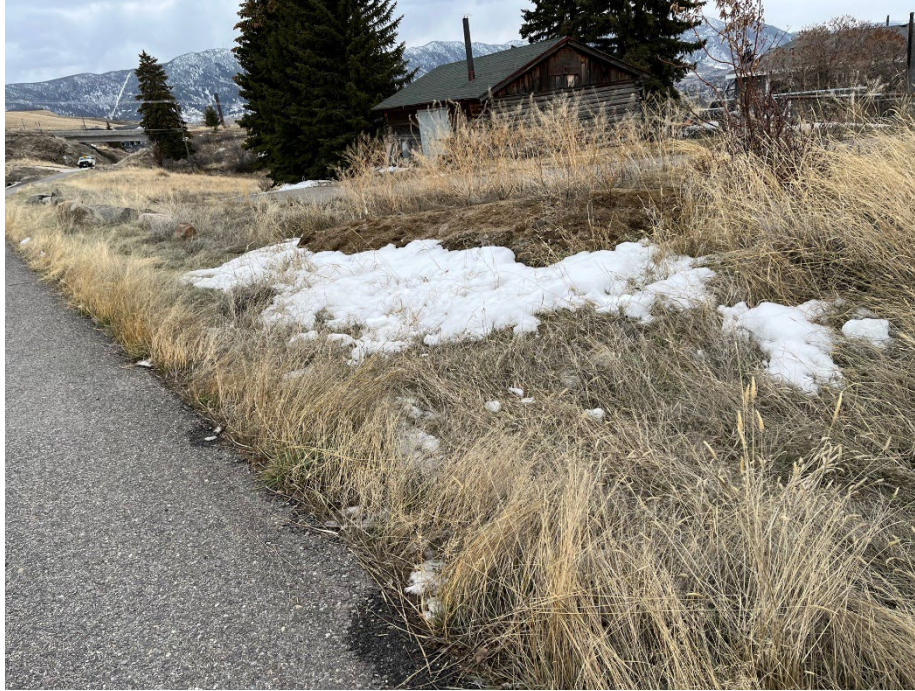
Photograph 9. Dirt pile on the northwest of site.

An unknown barren dirt pile was observed during the evaluation. A sample location has been proposed for this area.

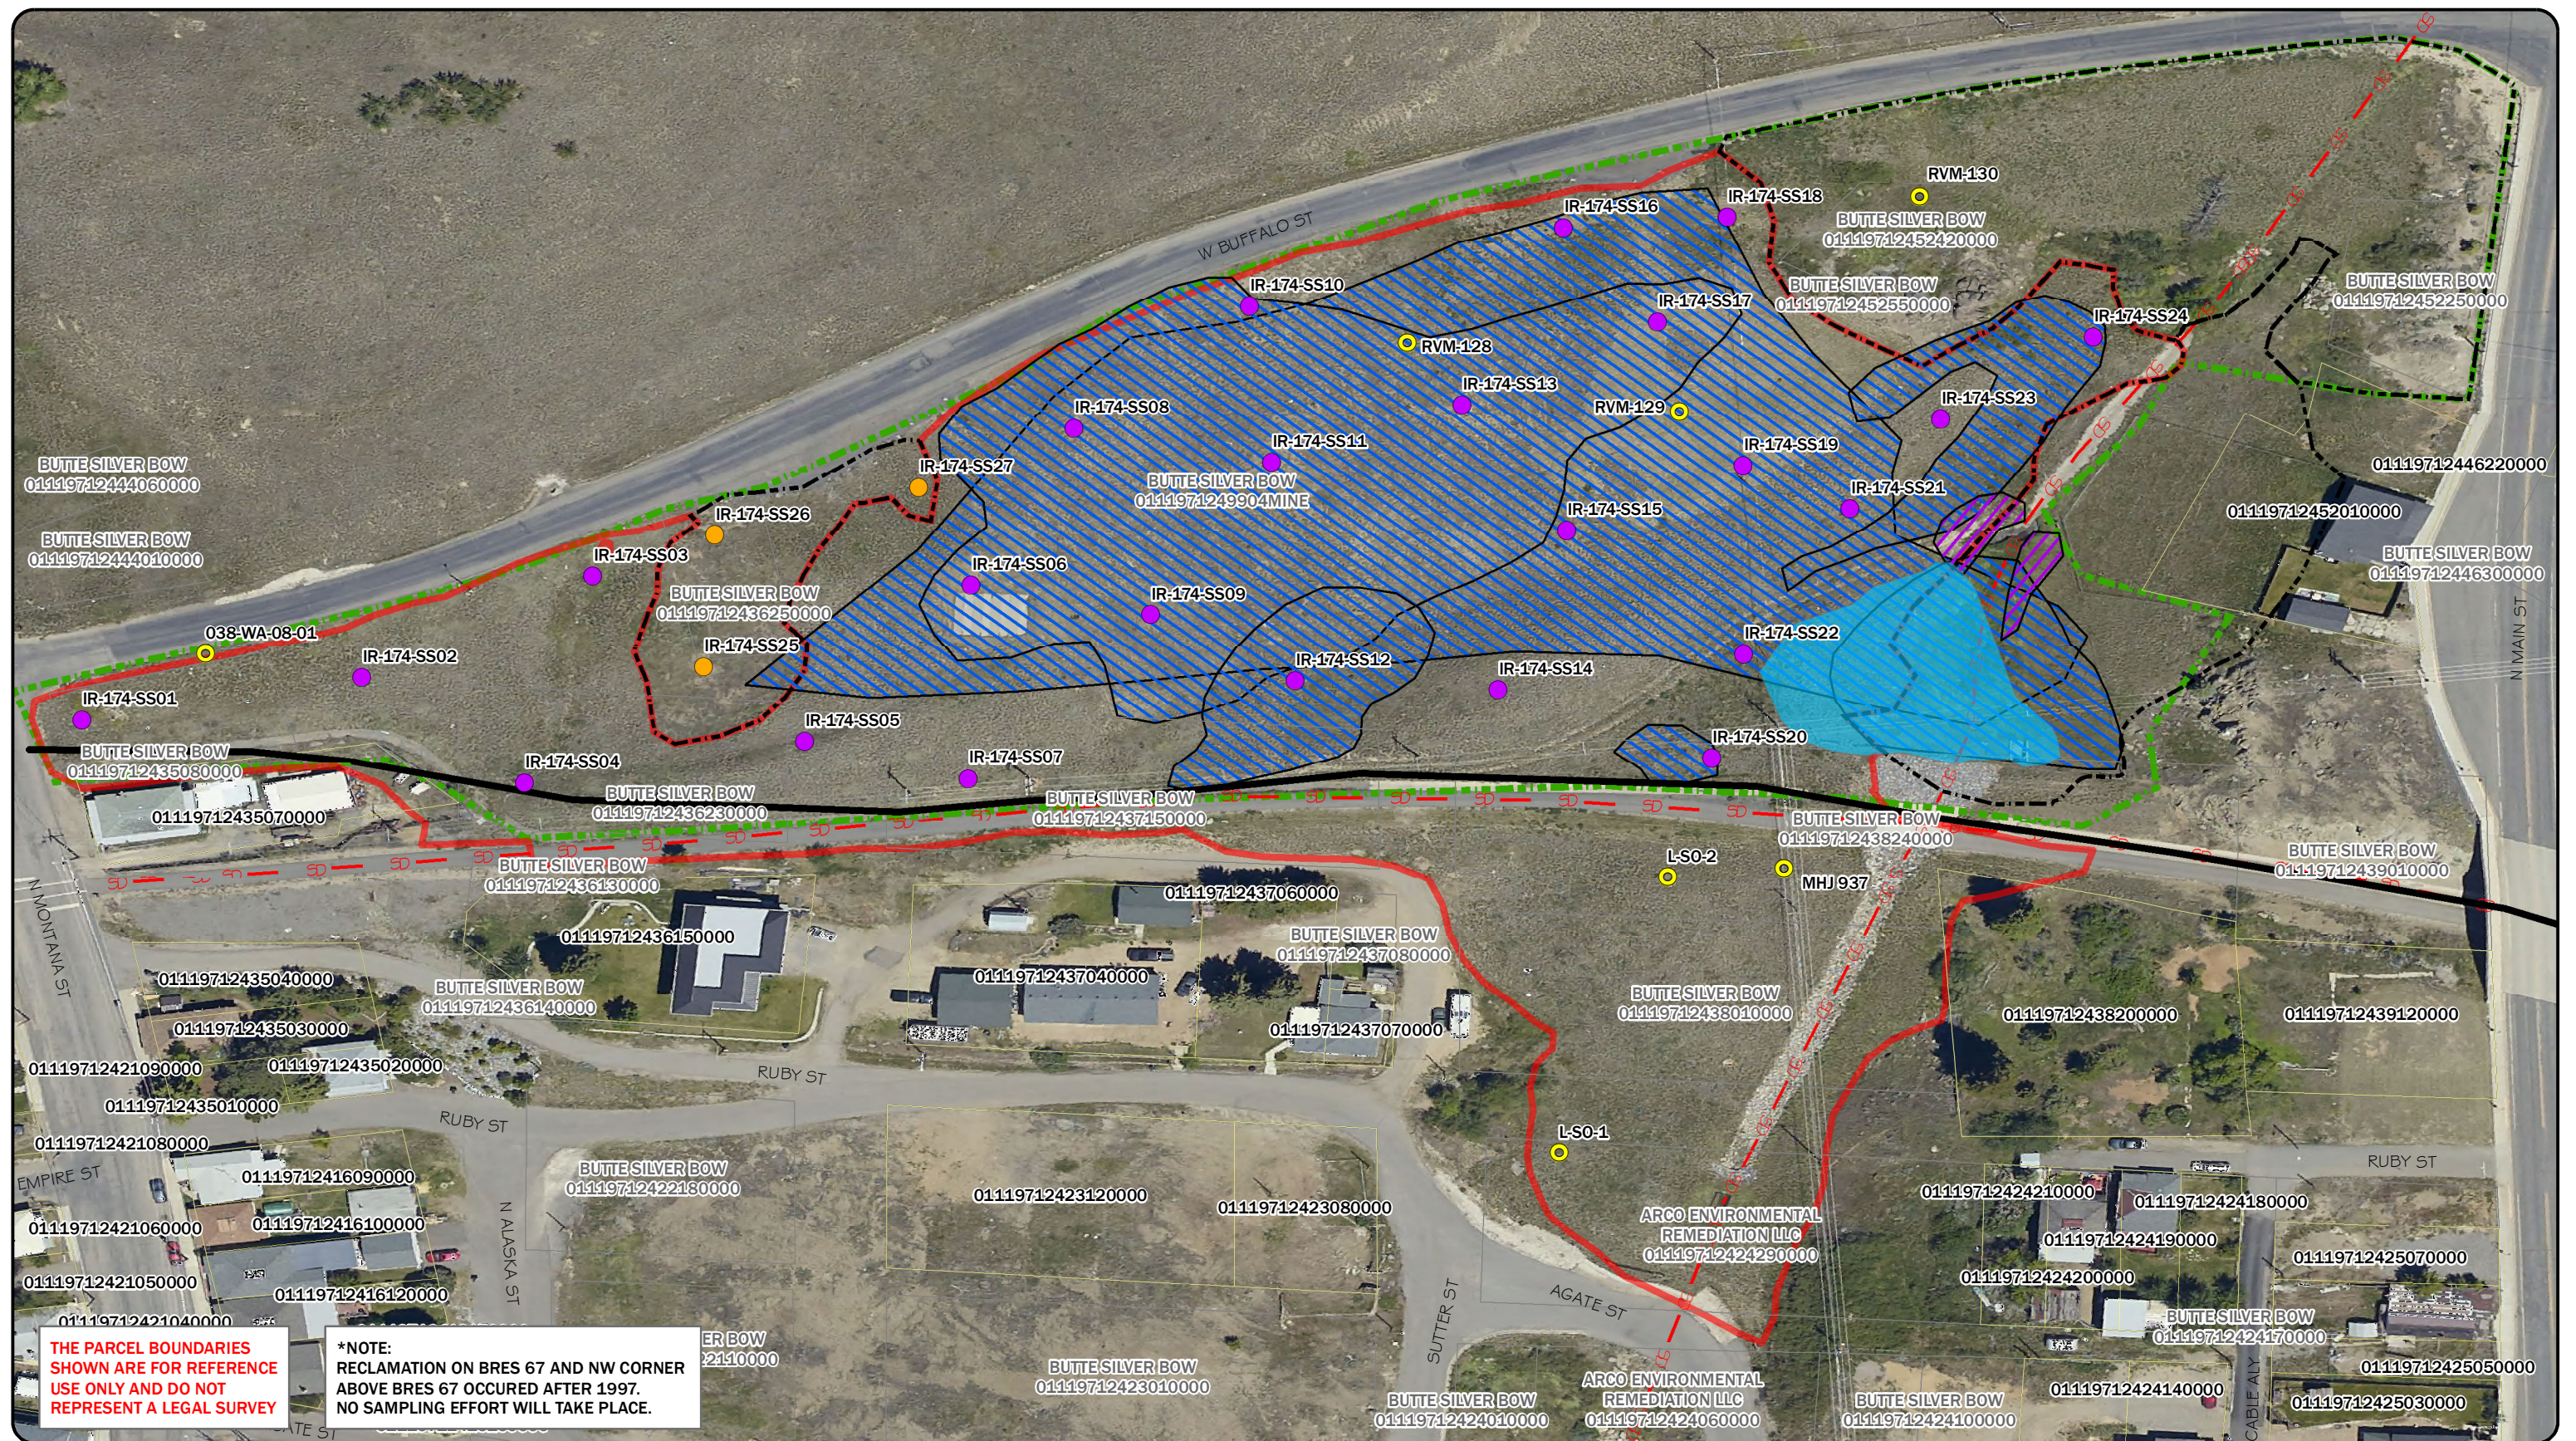
**INSUFFICIENTLY RECLAIMED
 SITE BRES No.174 BUFFALO SOUTH**

An adjusted boundary is proposed for BRES No. 174 – Buffalo South, as shown on Figure 1 and Figure 2, to accurately represent the reclaimed area and align site boundaries with completed site remediation efforts. Note that the proposed adjusted boundary has not been approved by the Agencies. As described in the BPSOU *Source Areas and Reclaimed Boundary Adjustments*¹, this was completed by using a high-resolution aerial image and visual comparisons to identify the areas of apparent remediation. To verify the proposed adjusted boundary, samples will be collected in areas that are included in the proposed boundary area, but just outside of the original boundary. The proposed site boundary for this area consolidates Buffalo South and Silver Hill Dump and was verified to include the previously reclaimed portion in the northeast corner of the site, just southwest of the intersection of Buffalo Street and North Main Street. The proposed boundary excludes a residential property from BRES No. 67 Silver Hill Dump. As shown on Figure 1 and Figure 2, the proposed boundary separates the portion south of the walking trail into a new BRES site, Buffalo Ditch; however, both sites were labeled as BRES No. 174. To eliminate confusion during the evaluation of the sites, Buffalo Ditch will be identified as BRES No. 174D. BRES No. 174, Buffalo South, will remain the same. This modification is proposed for sampling purposes only and will not change the identification of the site. No samples will be collected on BRES No. 67 Silver Hill Dump and the corner of Main Street and Buffalo Street sites during this evaluation since this area was reclaimed after 1997.

Figure 1 and Figure 2 illustrate the proposed sample stations as sited during the preliminary site evaluation. Adjusted boundary lines, previous sample locations, and other previous findings are included on Figure 1 and Figure 2.

Figure 1 – Insufficiently Reclaimed Sites BRES No. 174 – Buffalo South Proposed Sample Stations

All soil sampling and characterization activities and procedures within the existing site boundary will follow the IR Sites QAPP. Samples will be obtained from the sample stations listed below. The IR Sites QAPP describes the quality assurance/quality control policies and procedures that will be used during sample collection and analyses.
