## **Residential Metals Abatement Program Construction Completion Report (Non-Residential Parcels – Indoor Soil) - Butte High School**

# **Residential Metals Abatement Program Construction Completion Report (Non-Residential Parcels – Indoor Soil)**

Butte High School

12 February 2024

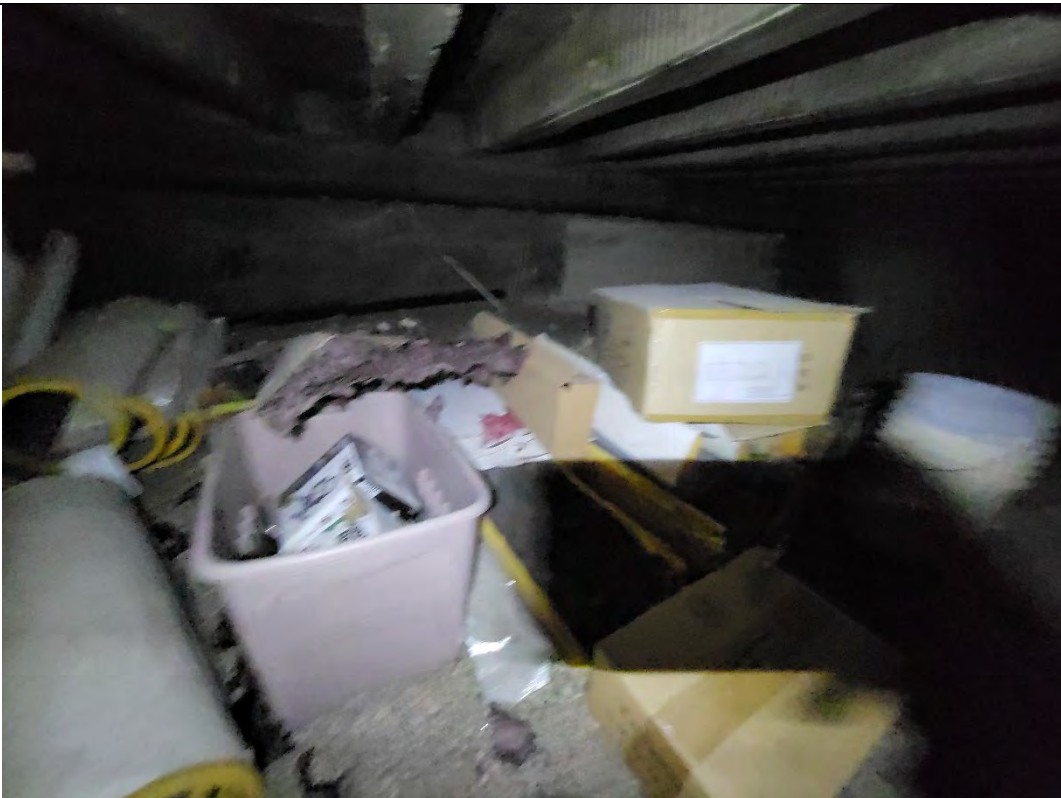
**Photograph: 2** More refuse located deeper at north entrance of crawl space.

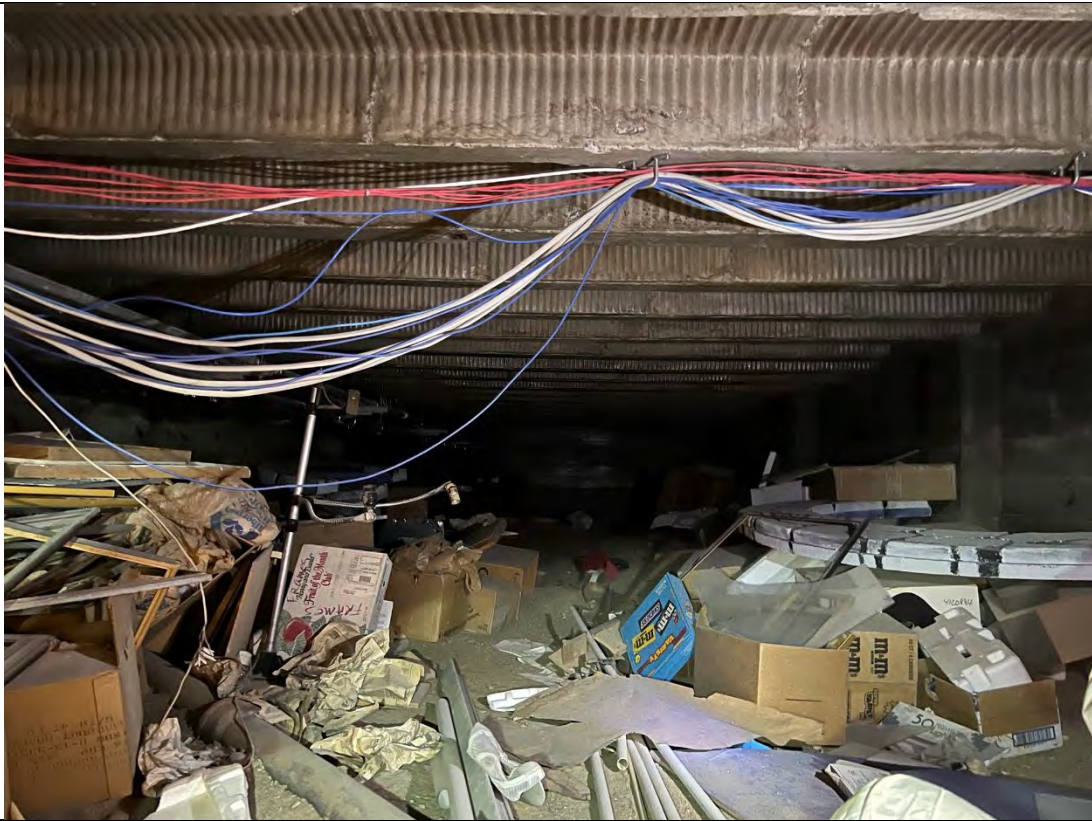
**Photograph: 3** Refuse in southwest crawl space area. The southwest crawl space was completely full of refuse and it took the field team all day Tuesday and Wednesday morning to remove all materials. Approximately 40 cubic yards (filled 4 10 yard dumpsters) of material was removed from this area.

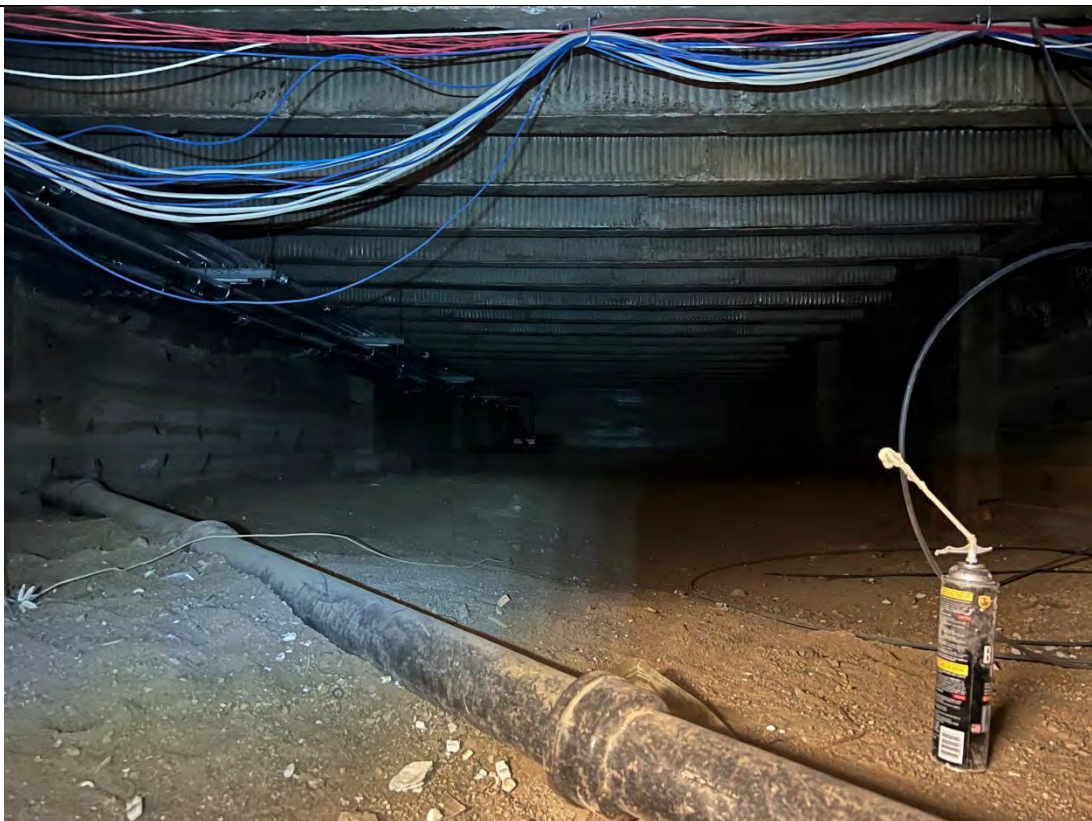
**Photograph: 4** After all refuse was removed from southwestern crawl space corner.

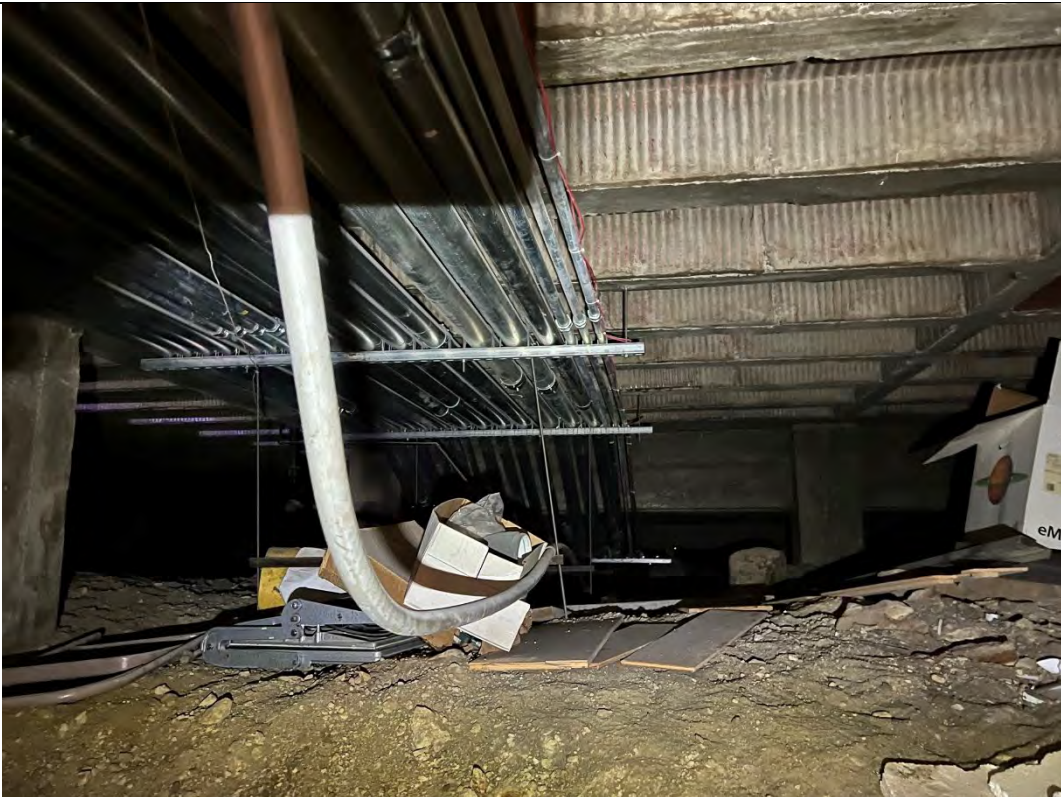
**Photograph: 5** Refuse in south east crawl space entrance. Approximately 2-3 cubic yards of material was removed.

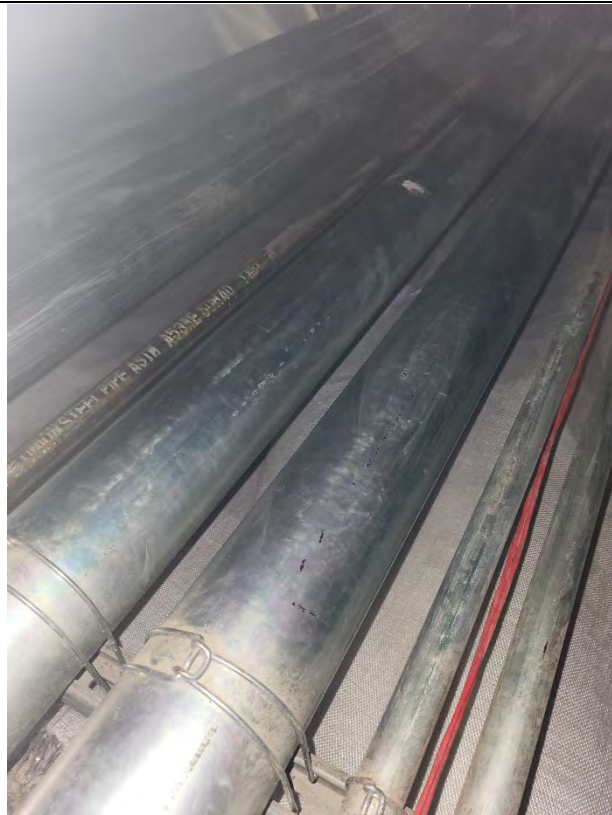
**Photograph: 6** Pipes after they were wiped down, near the northern boiler room entrance. All horizontal surfaces in crawl space were wiped down with tri-phosphate wipes.

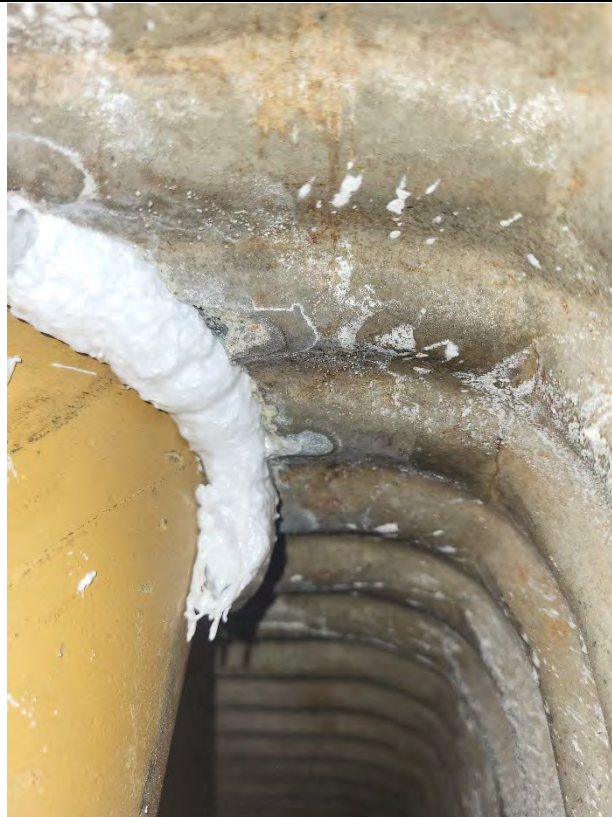
**Photograph: 7** Openings around pipes in crawl space were sealed with insulation foam.

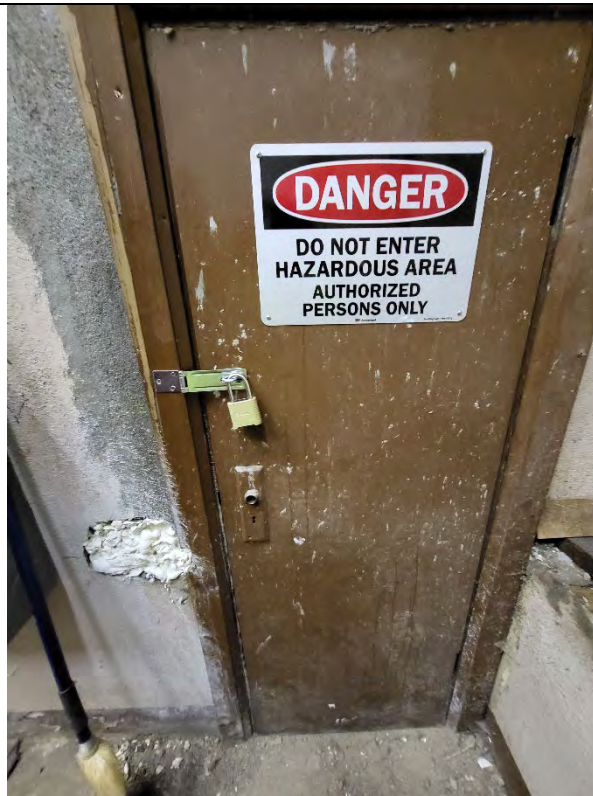
**Photograph: 8** Door in boiler room with aluminum sign stating: "Danger: Do Not Enter Hazardous Area Authorized Personnel Only". Door would not close, so door hinges were removed to allow for door to be closed properly. A double hinge hasp was installed, and combination lock was used to lock the door. The combination was given to administrative staff.

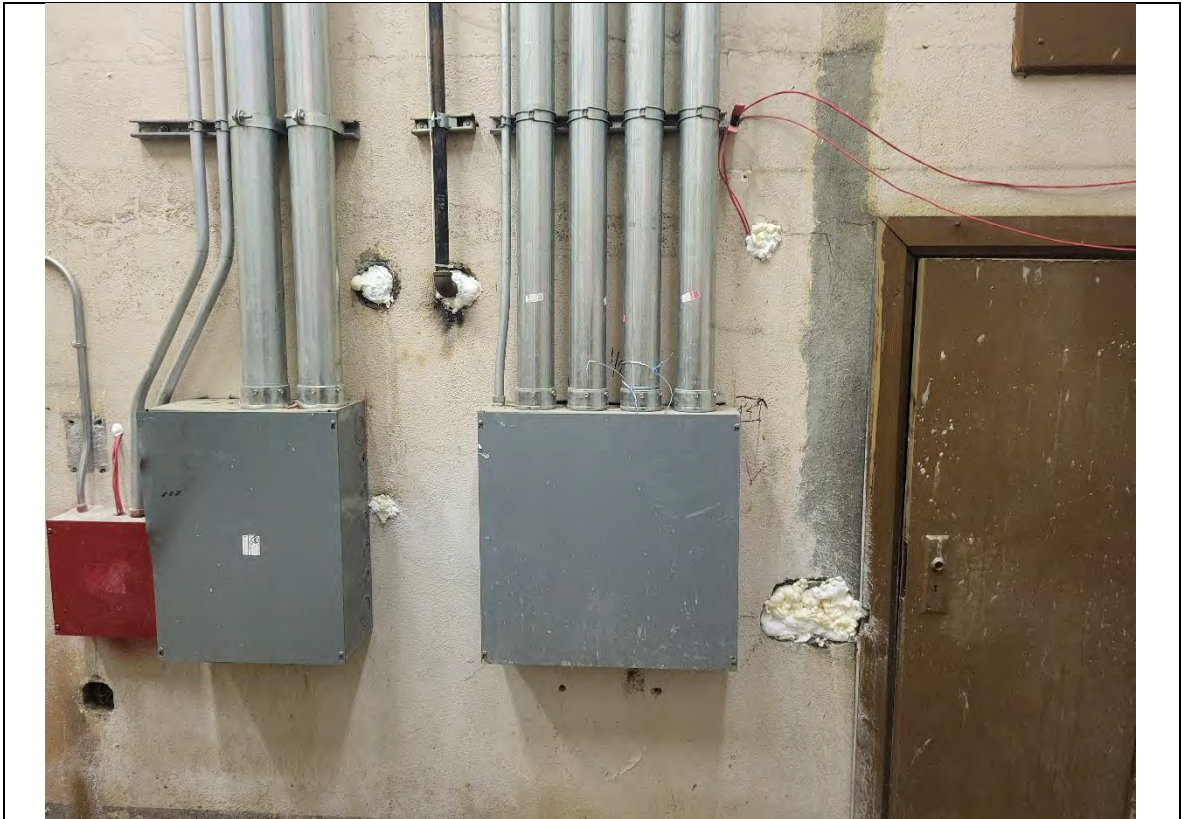
**Photograph: 9** Smaller holes were filled with combination of insulation foam and DAP concrete patch.

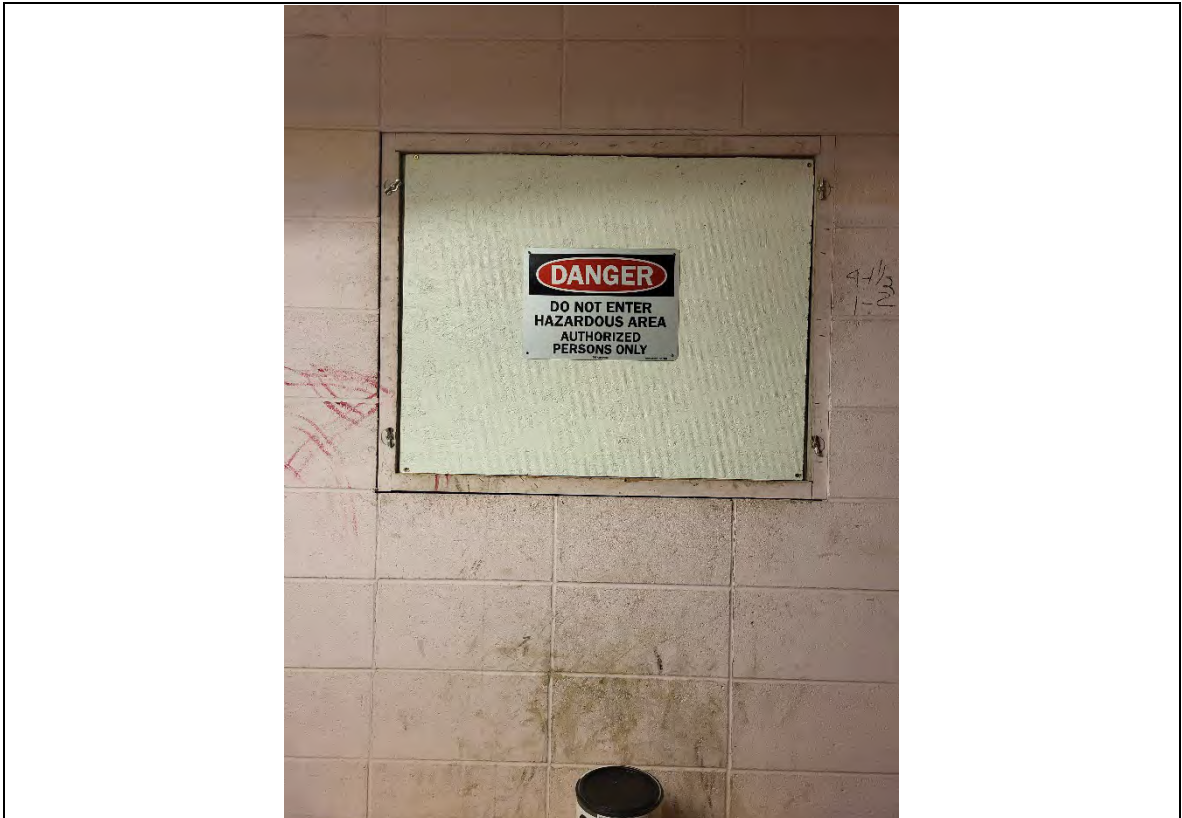
**Photograph: 10** Southwest crawl space entrance, sealed with screws and attached aluminum sign stating "Danger: Do Not Enter Hazardous Area Authorized Personnel Only".

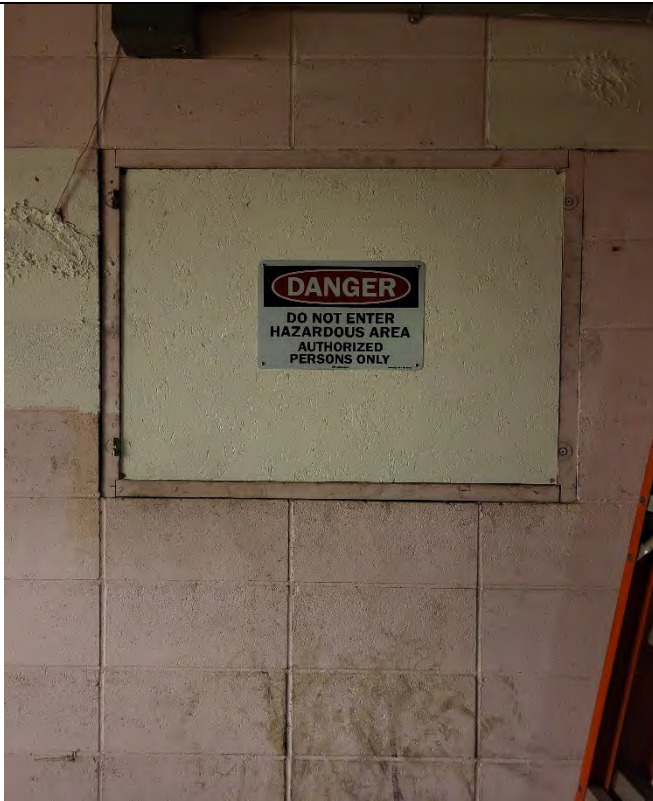
**Photograph: 11** South crawl space entrance, sealed with screws and attached aluminum sign stating "Danger: Do Not Enter Hazardous Area Authorized Personnel Only".

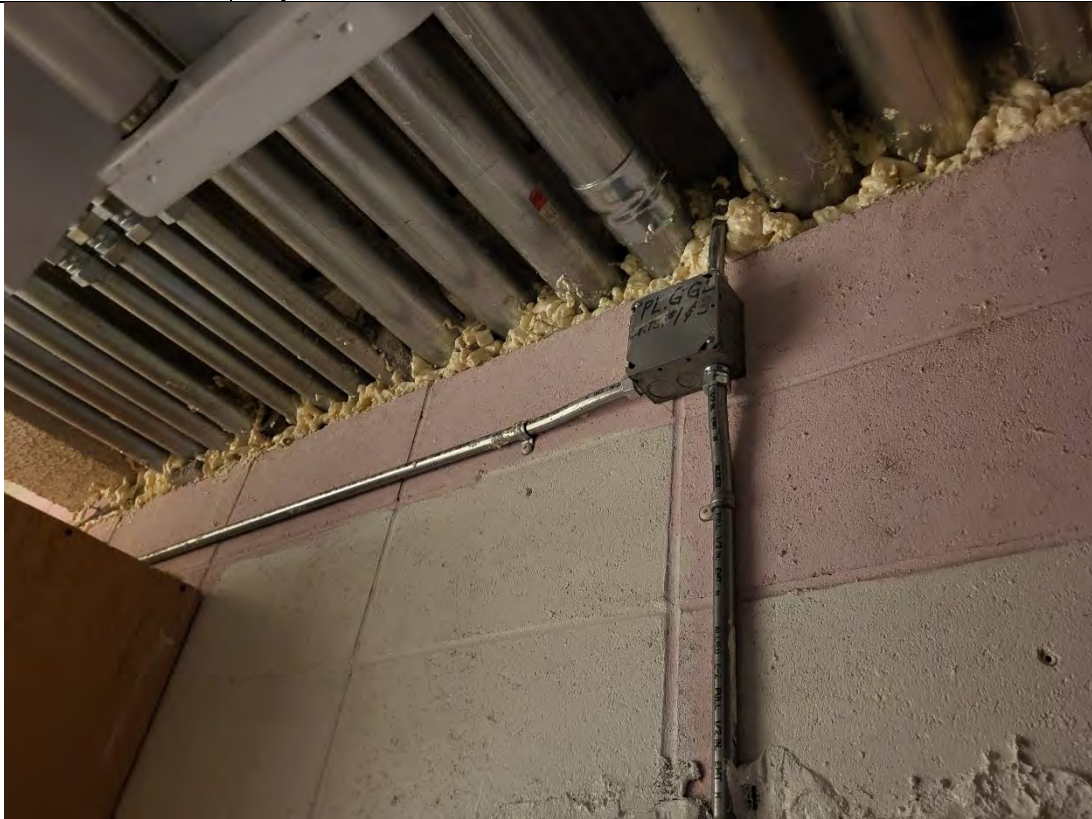
**Photograph: 12** Large gap above southern crawl space entrance, sealed with DAP and insulation foam.

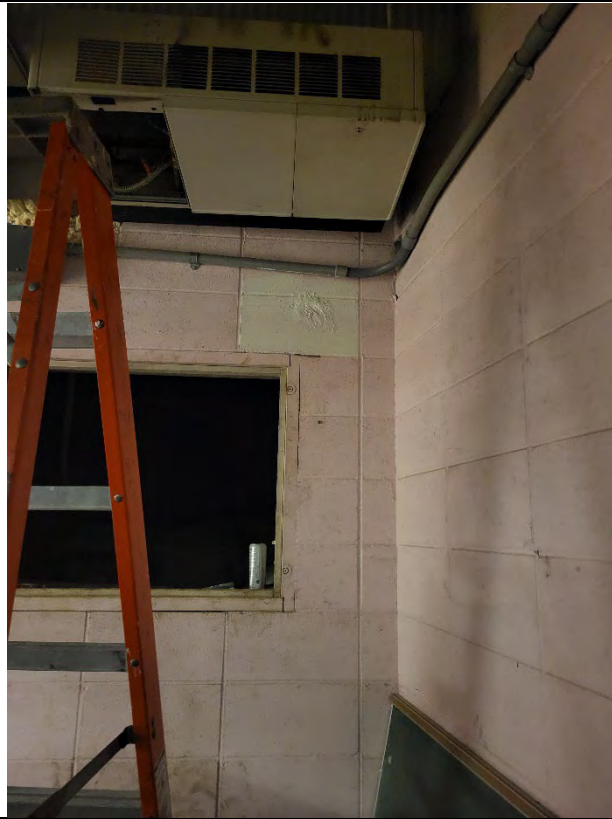
**Photograph: 13** Hole above southern crawl space entrance, sealed with DAP and painted.

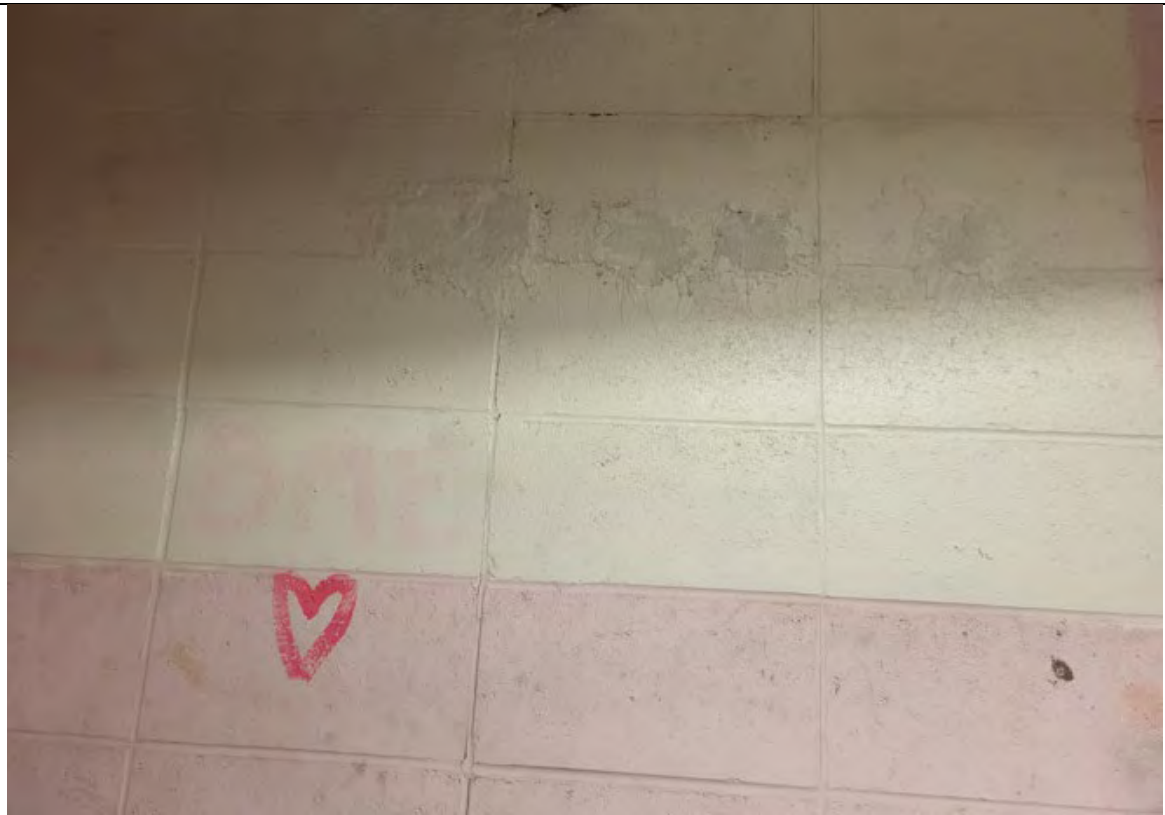
**Photograph: 14** Four holes next to southwest crawl space entrance, sealed with DAP and painted.

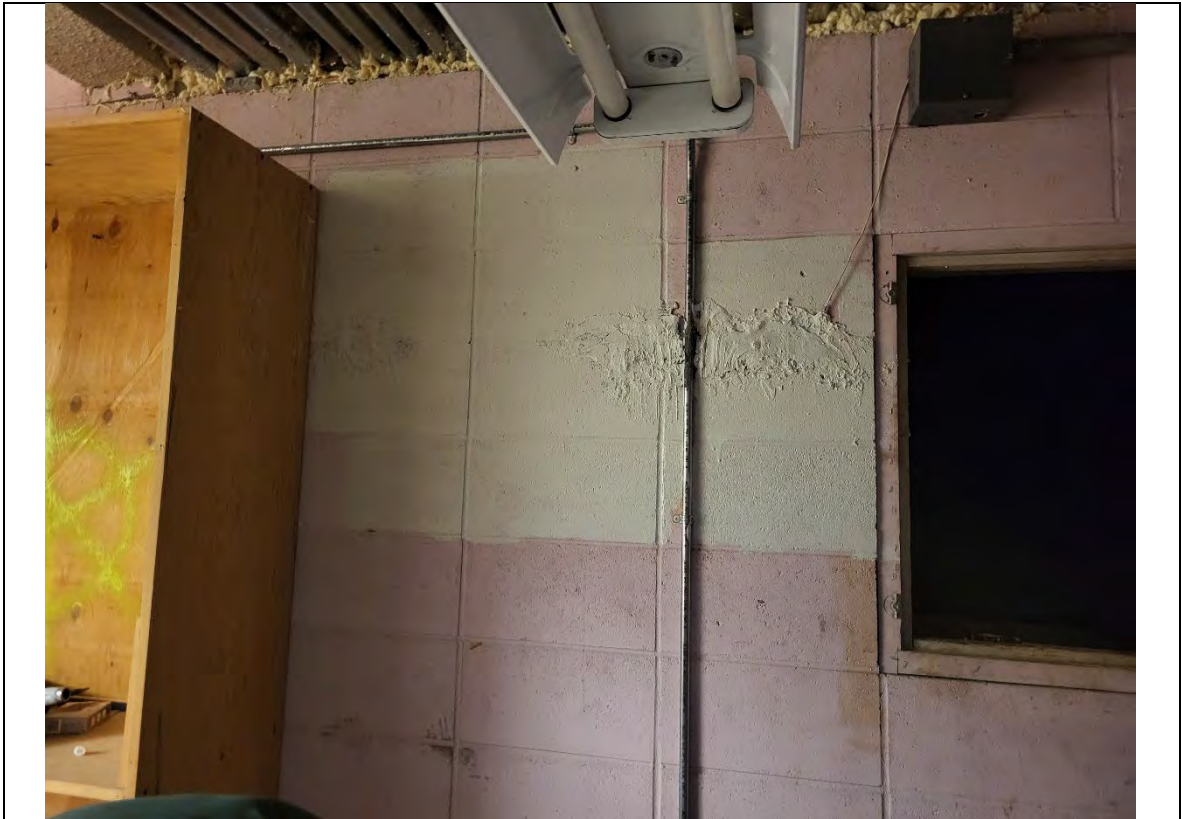
**Photograph: 15** Two large holes, next to southern crawl space entrance, sealed with DAP.

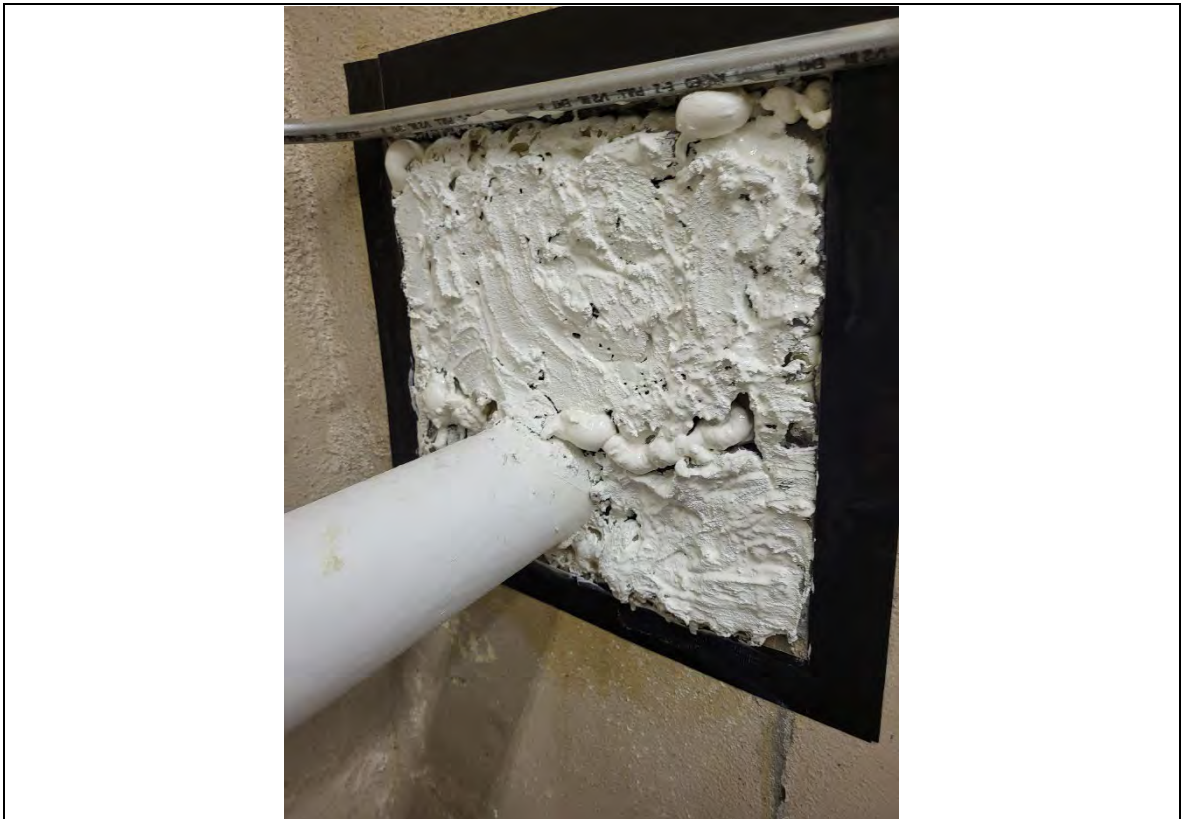
**Photograph: 16** Large hole in boiler room, sealed with combination of wood, DAP, and insulation foam.

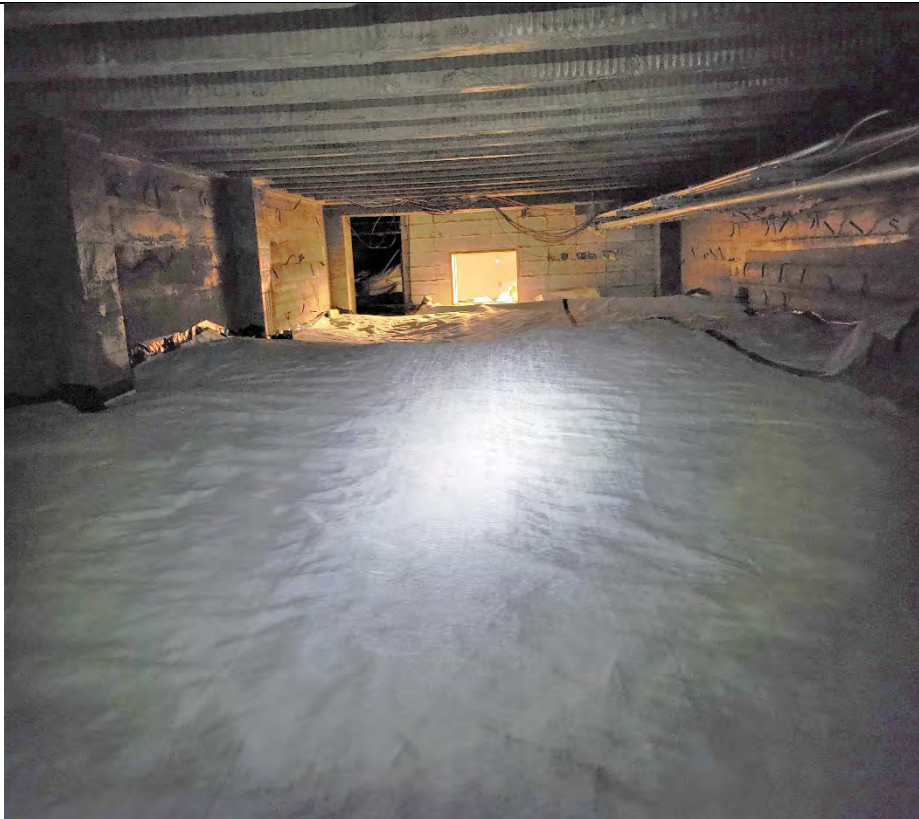
**Photograph: 17** | Geo-textile fabric, fixed to southwest crawl space entrance, facing east.

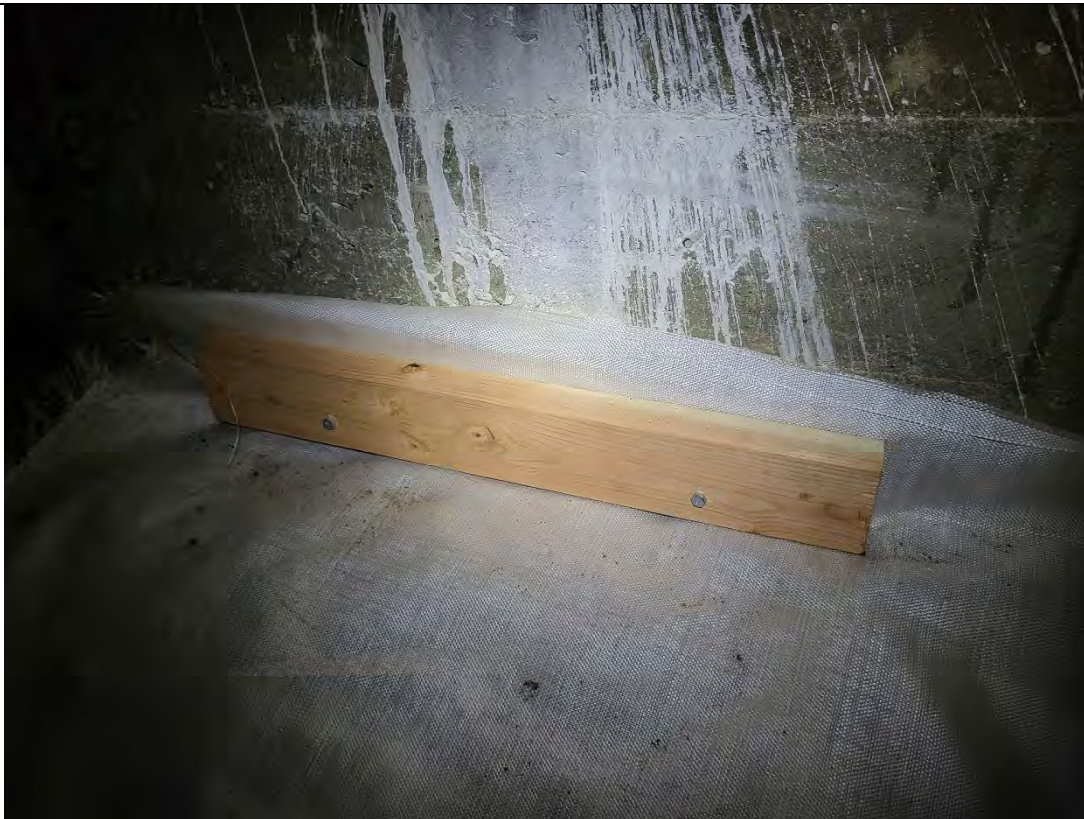
**Photograph: 18** | The fabric could not be secured to the earthen crawl space with stakes or adhesive (soil material was too fine for stakes, adhesive would not stick to tarp material), so 2x4s were adhered to each corner of concrete walls, and additional 2x4s were drilled to the tarp and to the 2x4s adhered to the wall.

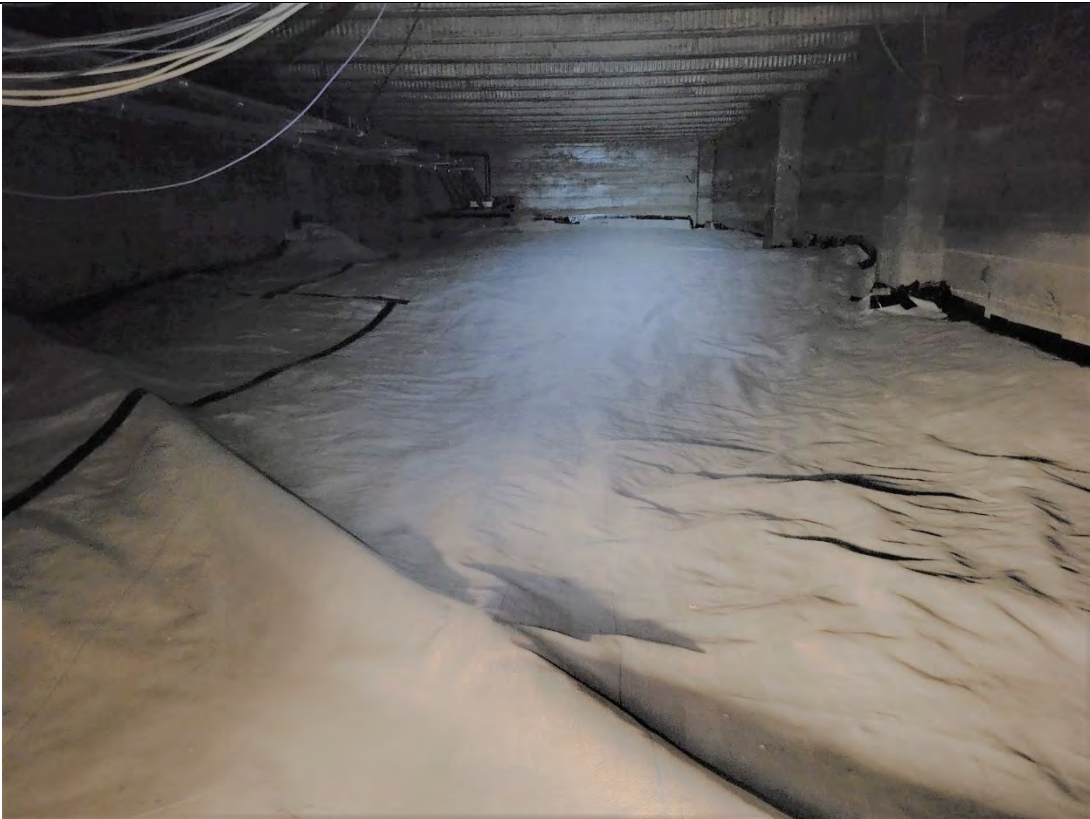
**Photograph: 19** View from southwest crawl space entrance, with geo-textile fabric fixed to ground, facing west. Existing pipes created "bumps" on fabric surface.

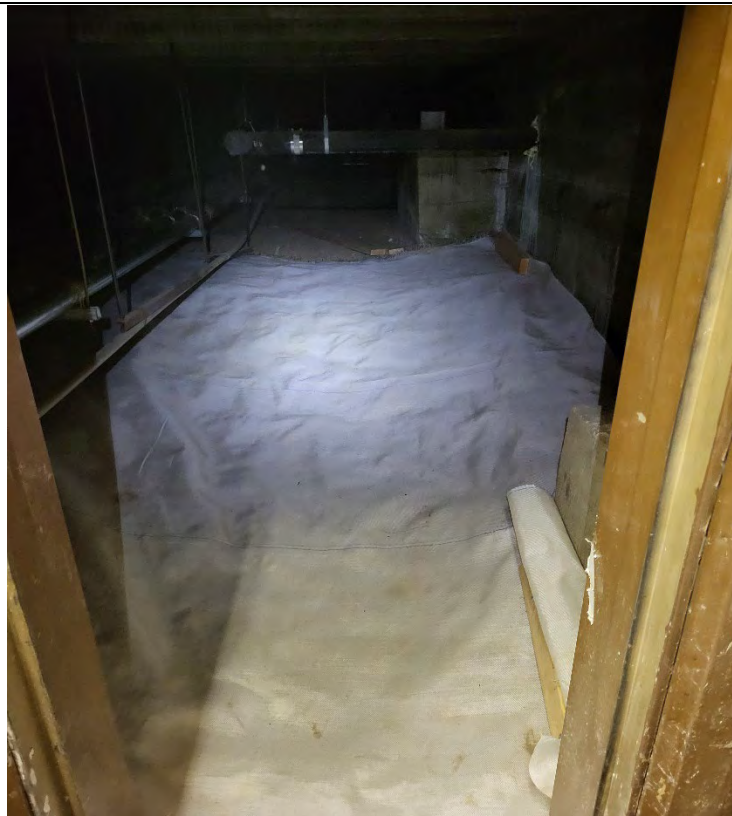
**Photograph: 20** Main entrance of crawl space from boiler room doorway, with geo-textile fabric, facing south.

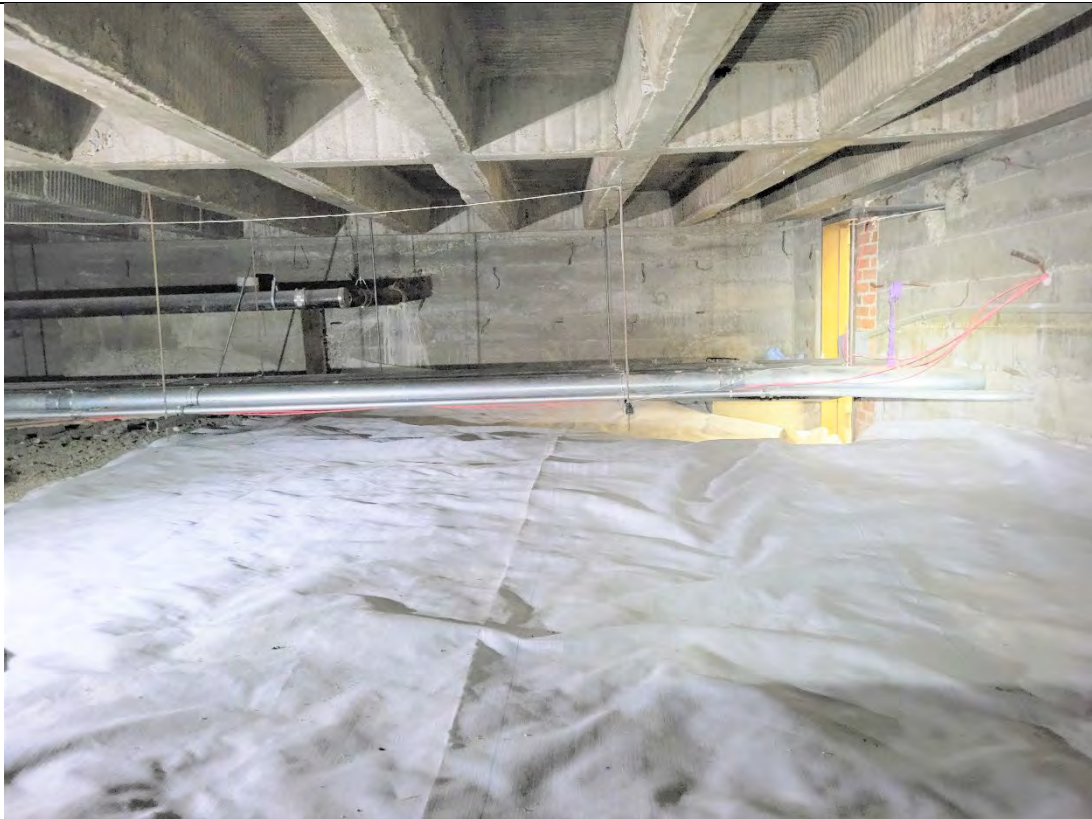
**Photograph: 21** View from east corner of crawl space entrance by boiler room, with geotextile fabric, facing west. Door entrance is on the right in the photograph.

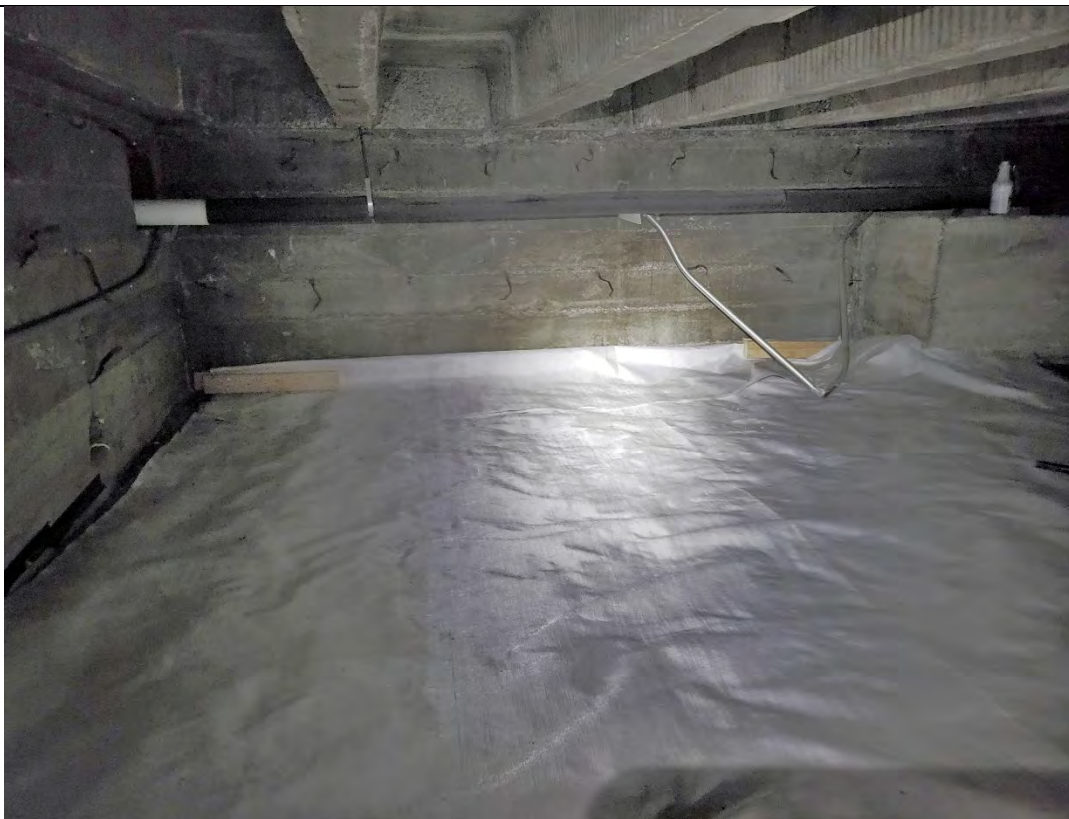
**Photograph: 22** View of east side of crawl space entrance by boiler room, with geotextile fabric, facing east.

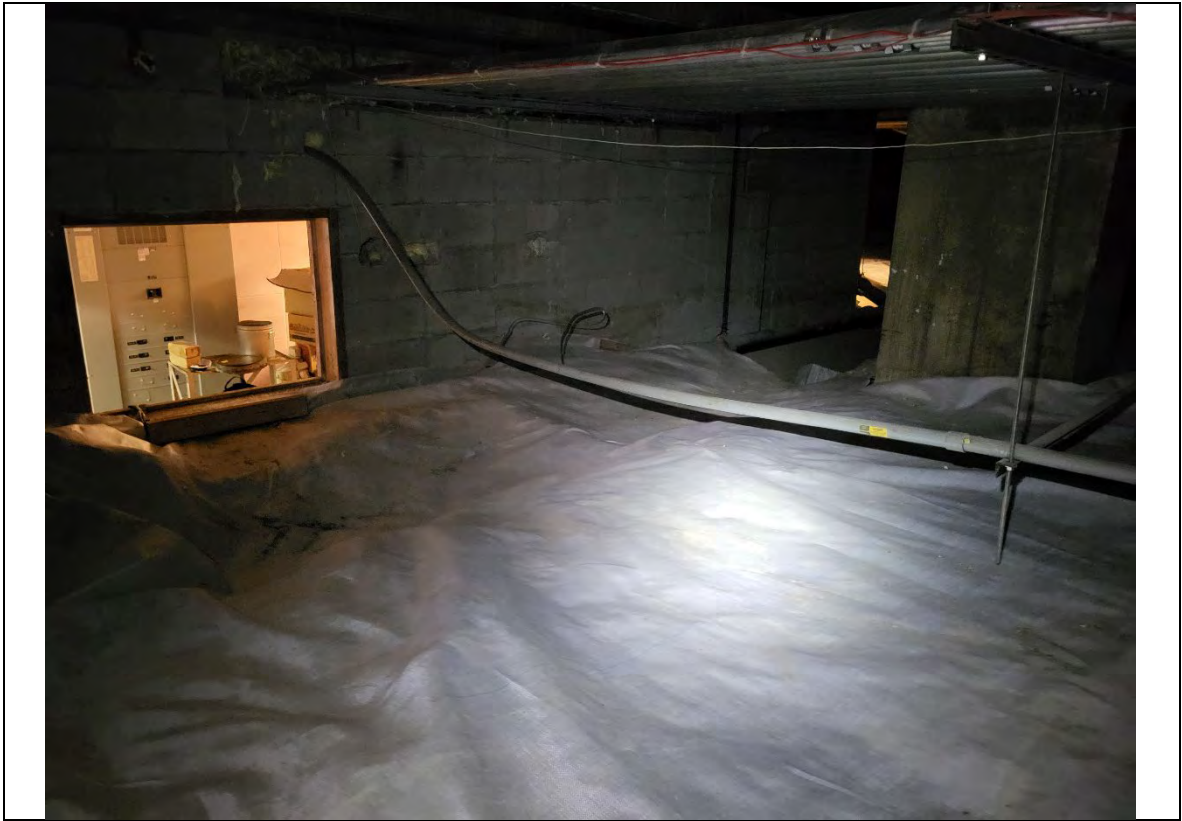
**Photograph: 23** | South entrance of crawl space, with geo-textile fabric, facing southwest.

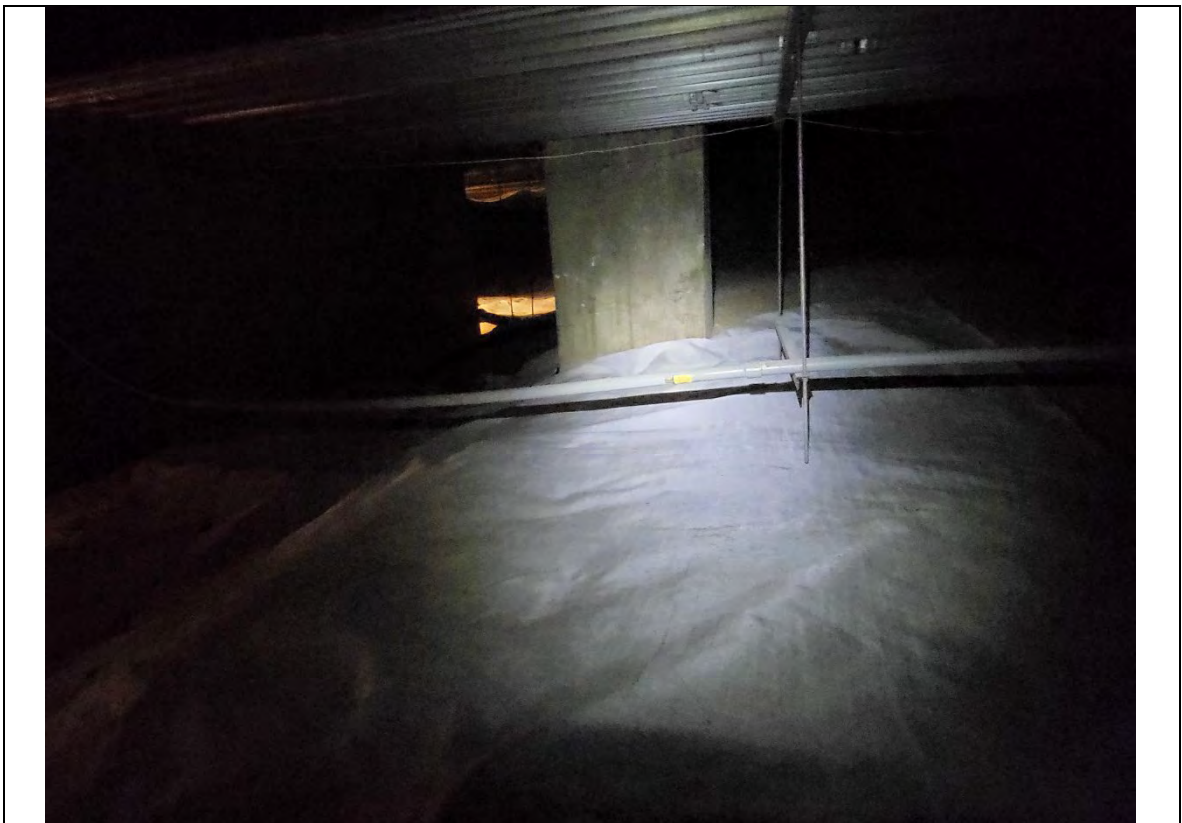
**Photograph: 24** | South entrance of crawl space, with geo-textile fabric, facing west.

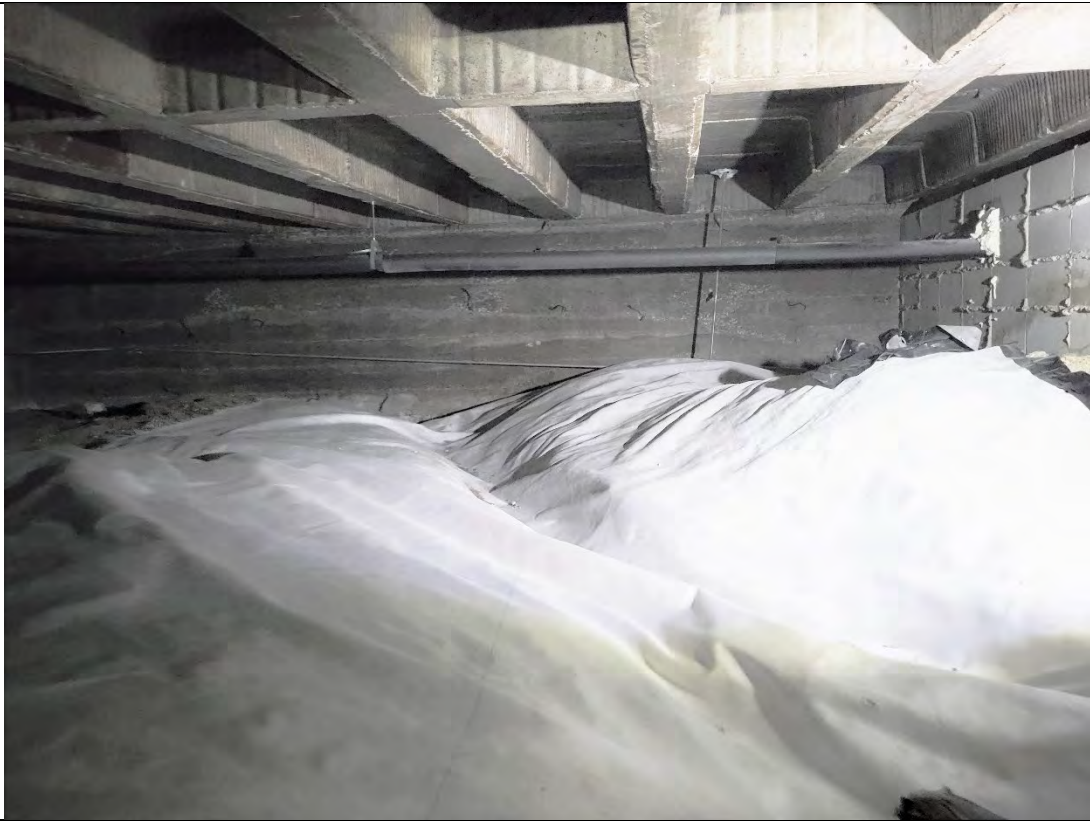
**Photograph: 25**

South entrance of crawl space, with geo-textile fabric facing east. A large trench (center of photo) made establishing geo-textile fabric flush to ground difficult. This area is still relatively uneven, and personnel inspecting the south crawl space entrance should use caution.
