**Residential Metals Abatement Program Construction Completion  
Report (Non- Residential Parcels – Indoor Dust) Silver Bow  
Montessori**

# Residential Metals Abatement Program Construction Completion Report Silver Bow Montessori

# Residential Metals Abatement Program Construction Completion Report (Non- Residential Parcels – Indoor Dust)

Silver Bow Montessori  
0722184

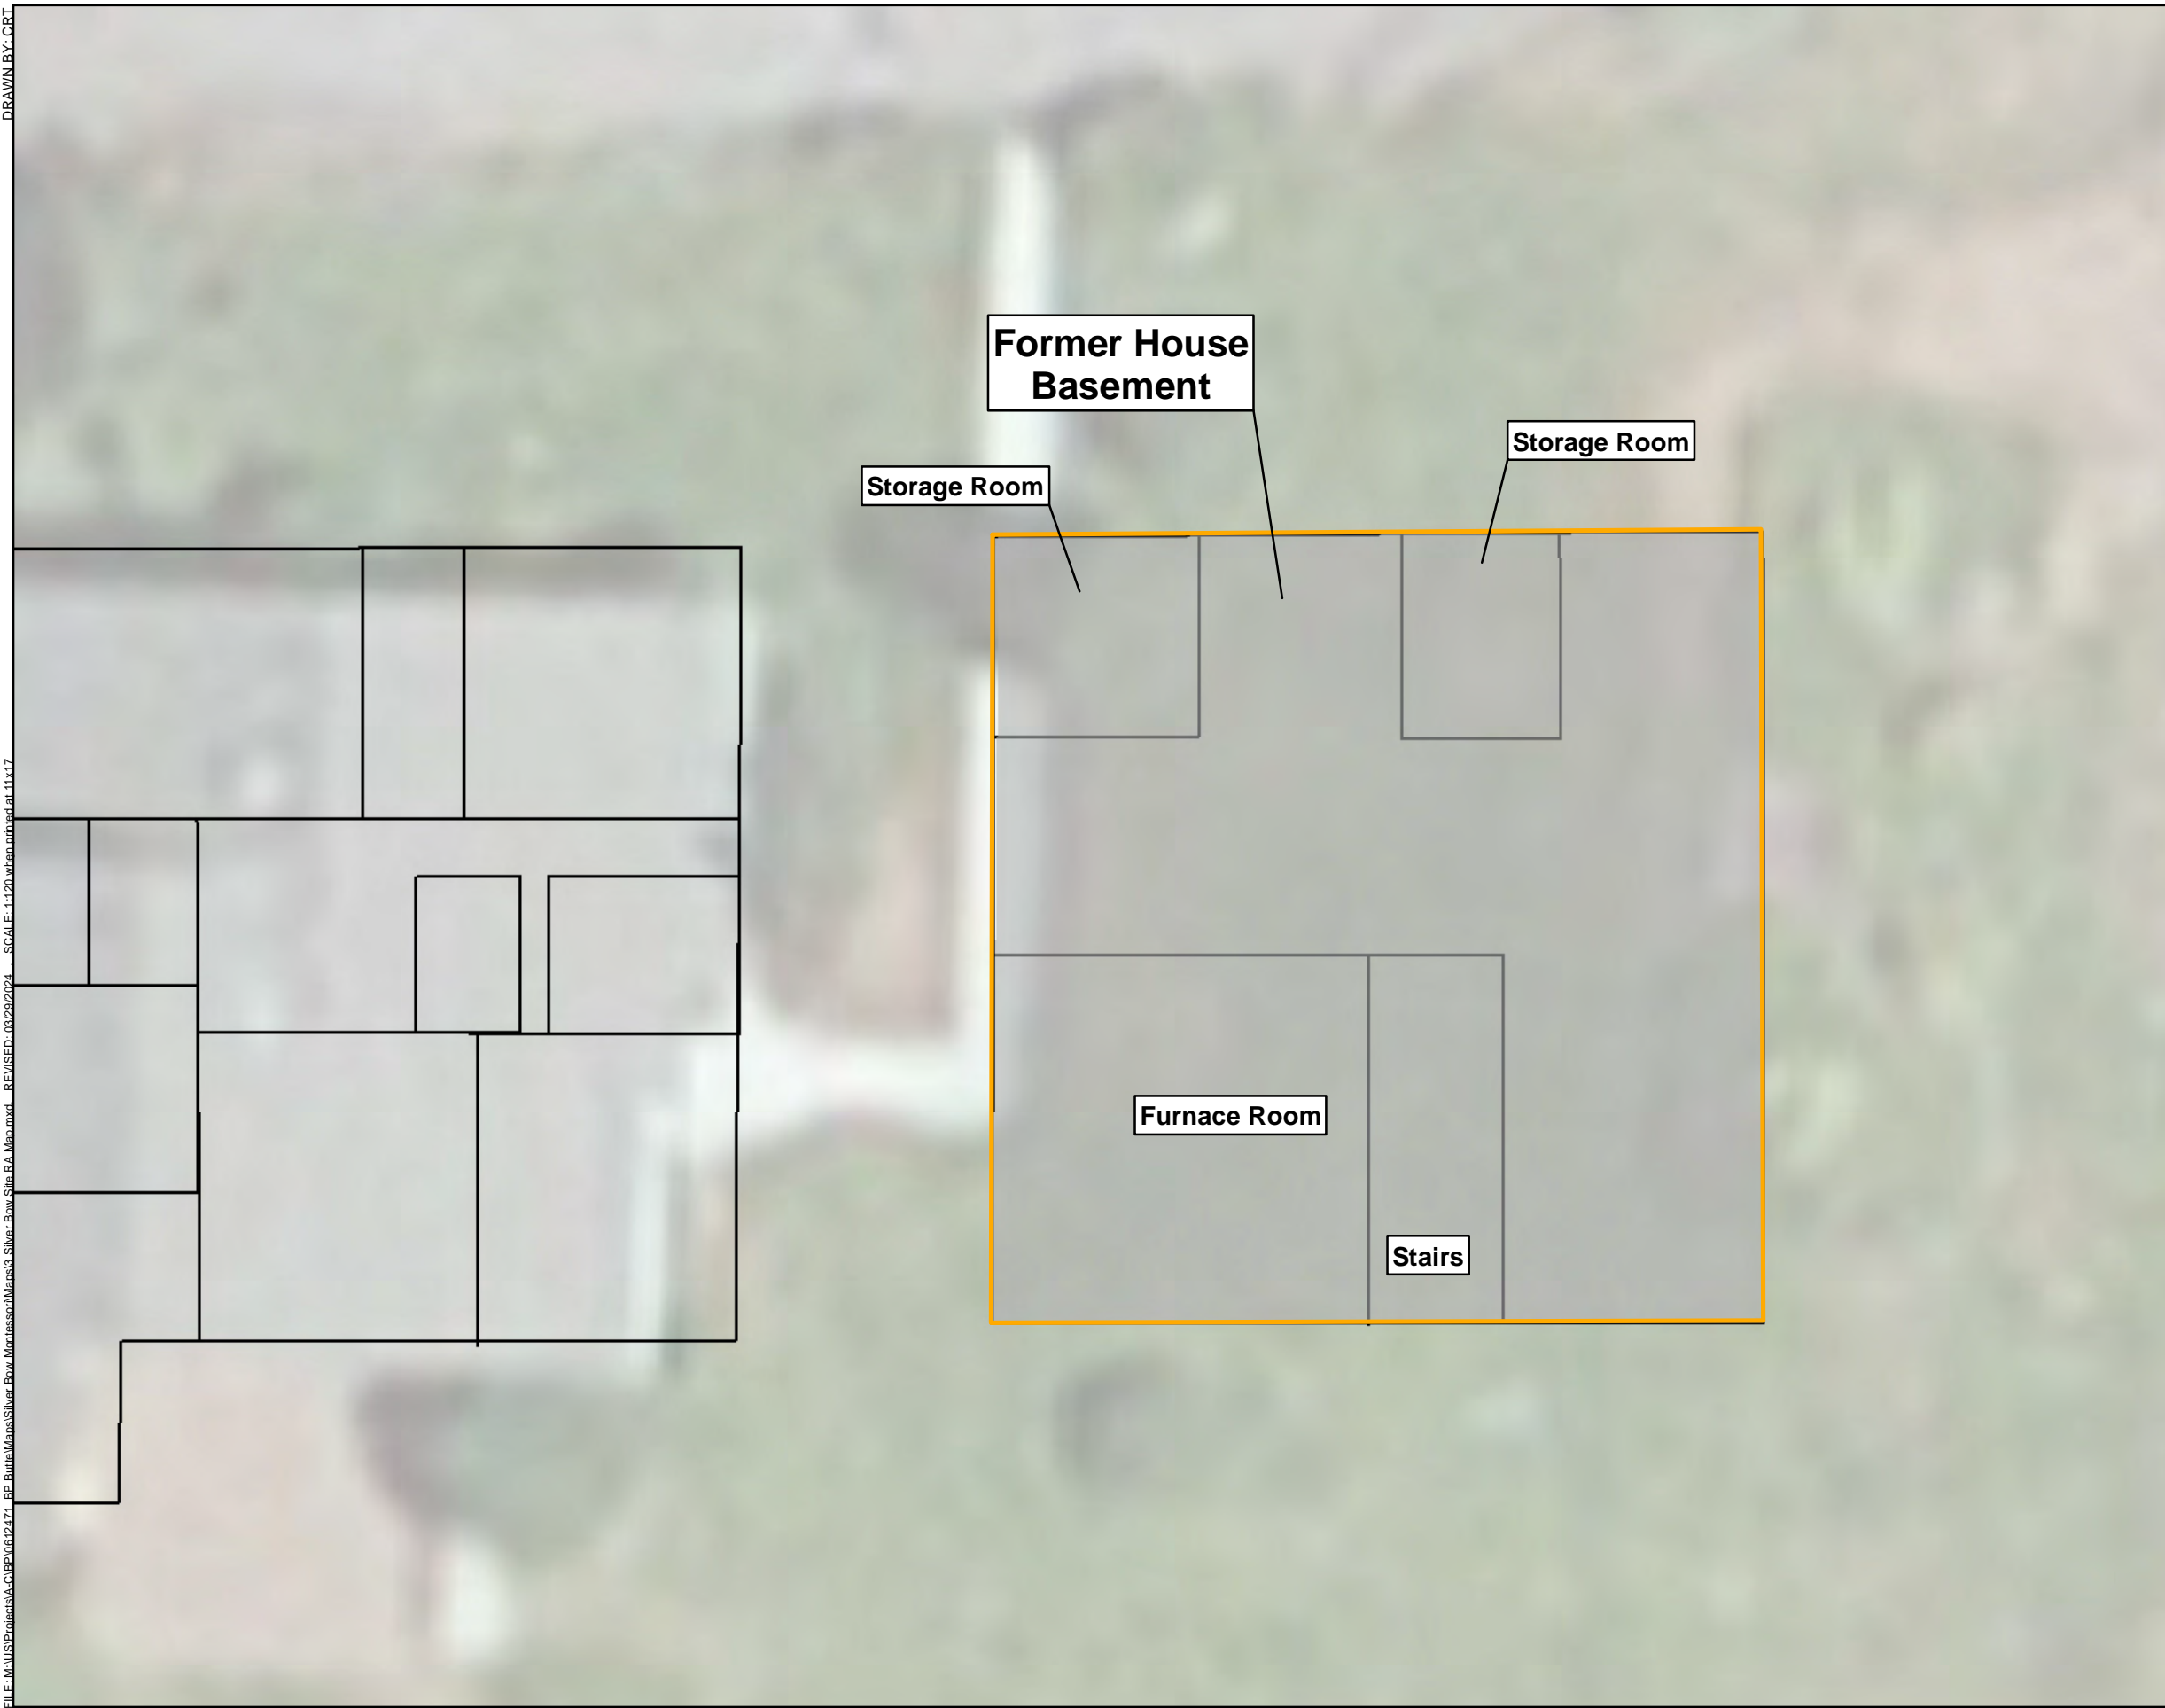
**Figure 3**  
**Silver Bow Montessori**  
**Basement Remedial Action Work Area**  
 1800 Sunset Rd  
 Butte, MT 59701

The Silver Bow Montessori basement remediation area is shown in Figure 3. Access to the basement is through the main east building, down a stairwell adjacent to the southeast classroom. Access is currently restricted to Silver Bow Montessori staff. The basement is approximately 1,100 square feet, has two storage closets and a furnace/boiler room. Apart from the furnace/boiler room, the basement is primarily used for storage. Materials in the basement include books, shelves, toys, furniture, and plastic storage containers. See Appendix A for photographs of the basement. Containment of dust is necessary due to the lead concentrations detected in exceedance of the Butte Priority Soils Site-Specific Residential Action Levels for indoor dust in the floor surface sample and field duplicate location in the basement storage area. This containment is

to prevent the migration of particulates and dust from the basement storage area to the occupied areas of the school.

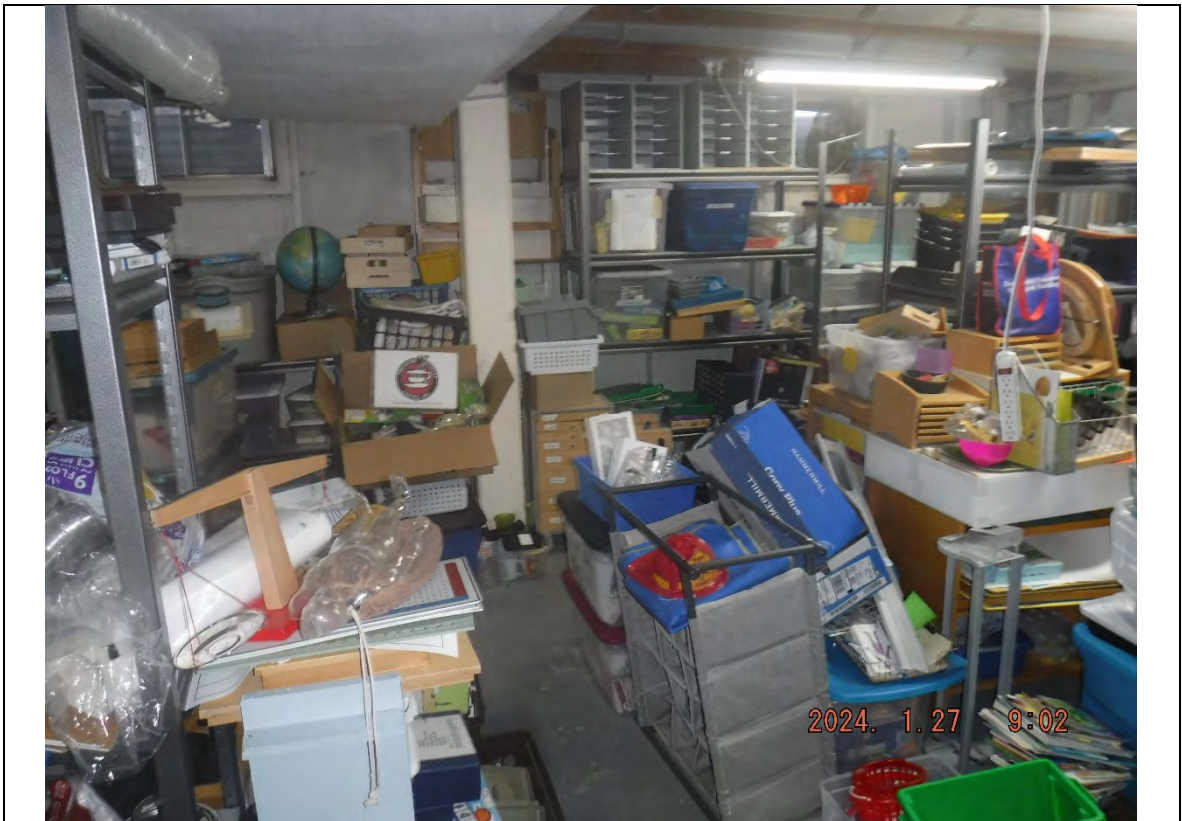
**Photograph:** 2220 Center of basement, prior to cleaning, facing east.

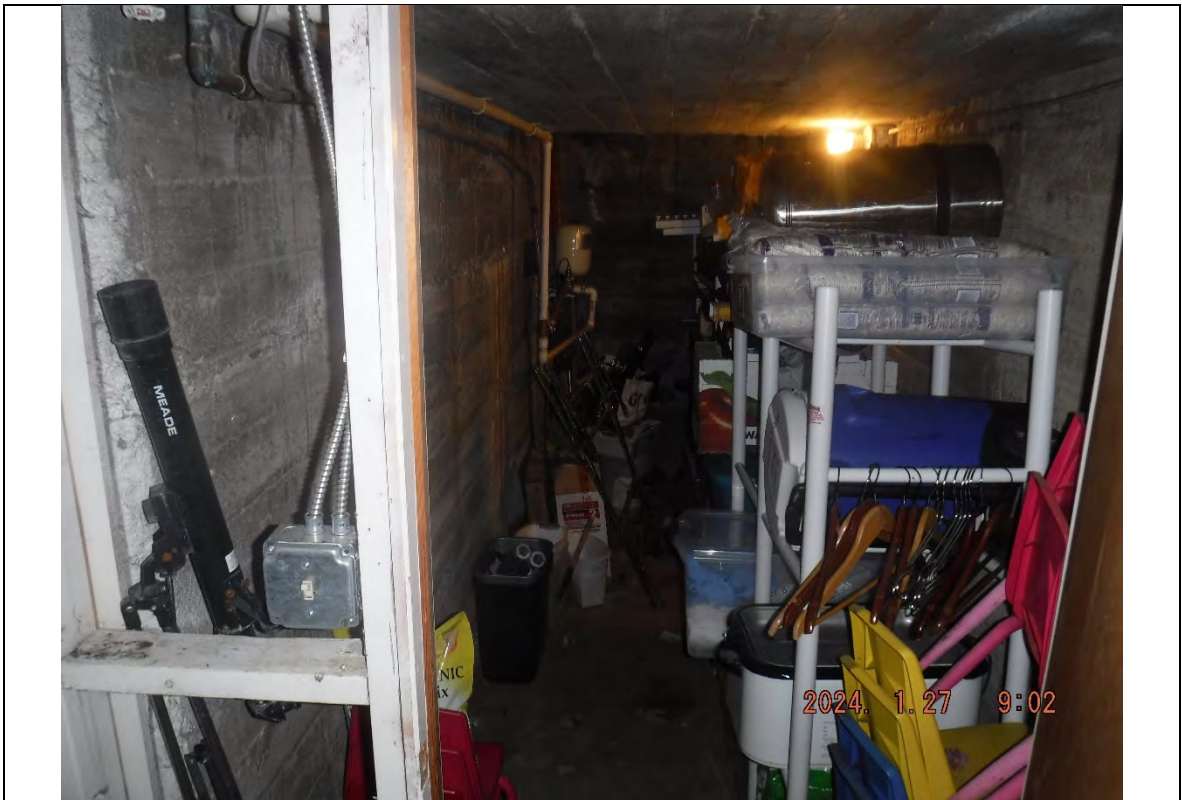
**Photograph:** 2221 North storage closet, prior to cleaning, facing north.

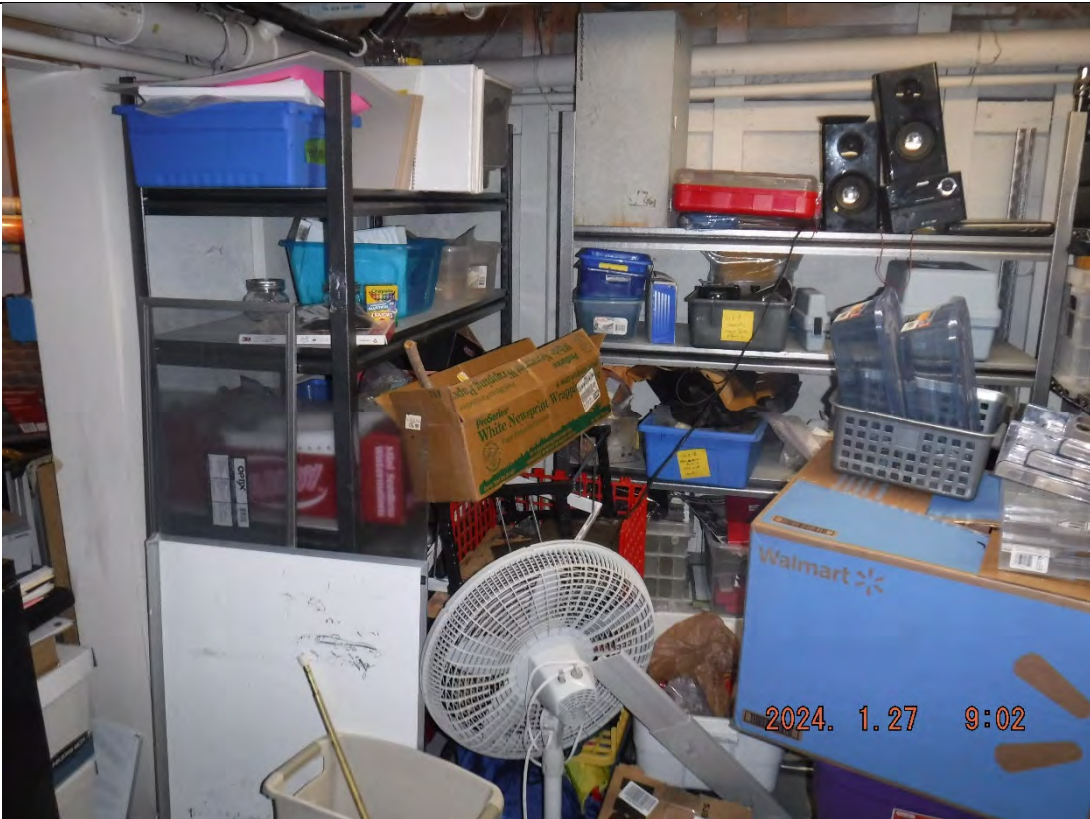
**Photograph:**  
2222

West side of basement, prior to cleaning, facing north.

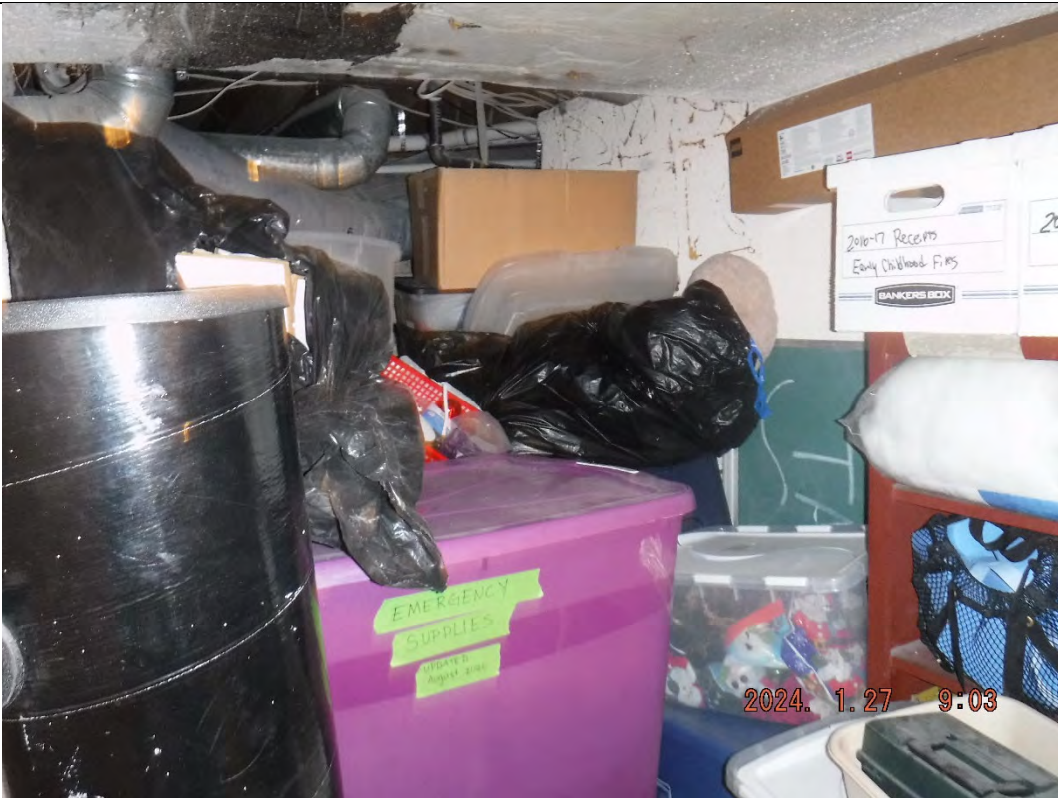
**Photograph:**  
2223

West storage closet, prior to cleaning, facing south.

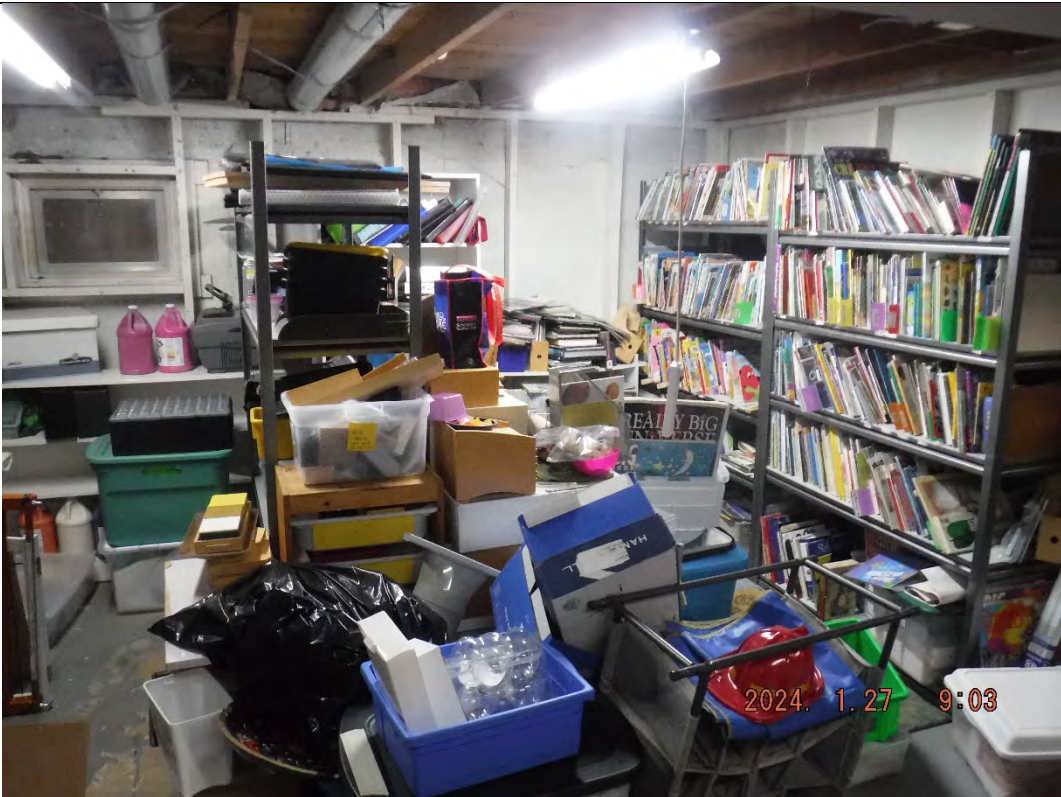
**Photograph:** 2224 East side of basement, prior to cleaning, facing south.

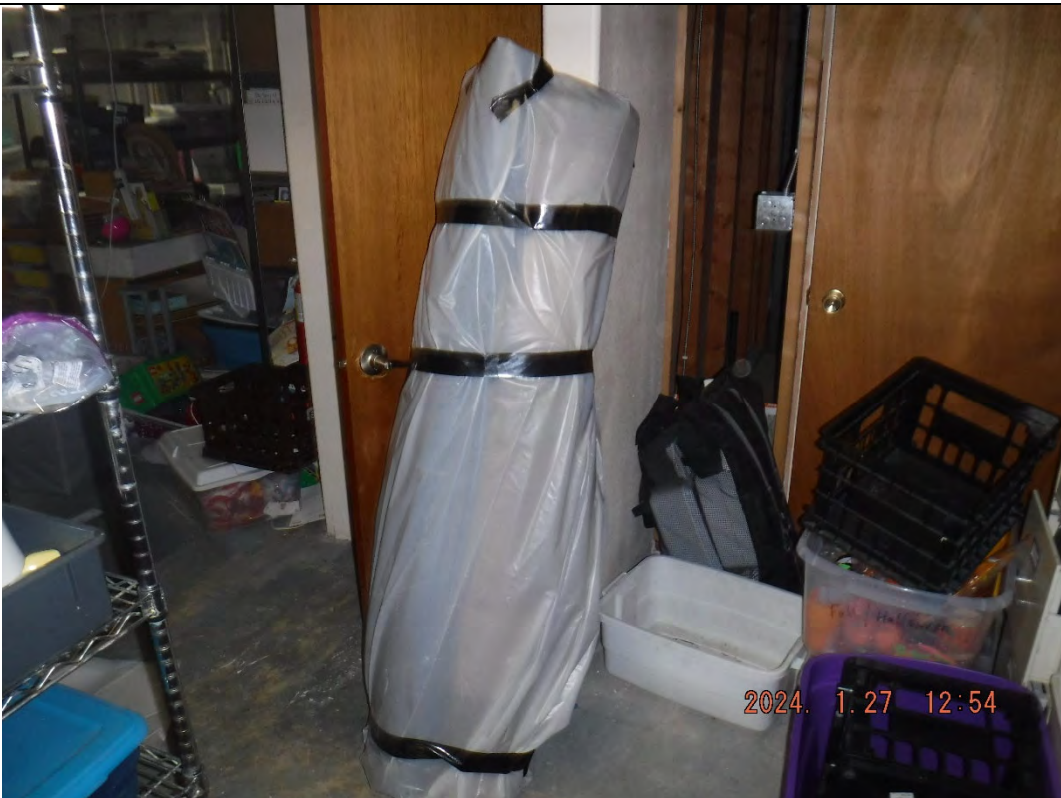
**Photograph:** 2225 Larger refuse wrapped in 6-milimeter wrap and wiped down with cleaning solution.

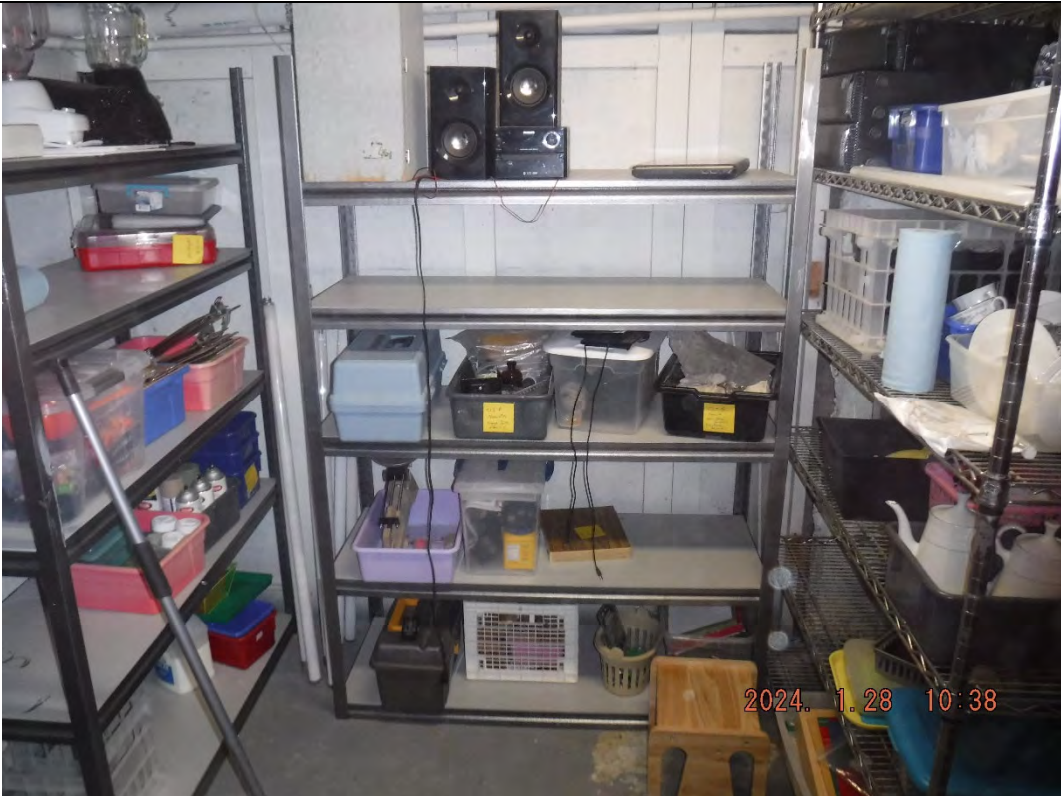
**Photograph:**  
2249

Northwest corner of basement, following removal of materials and initial cleaning, facing north.

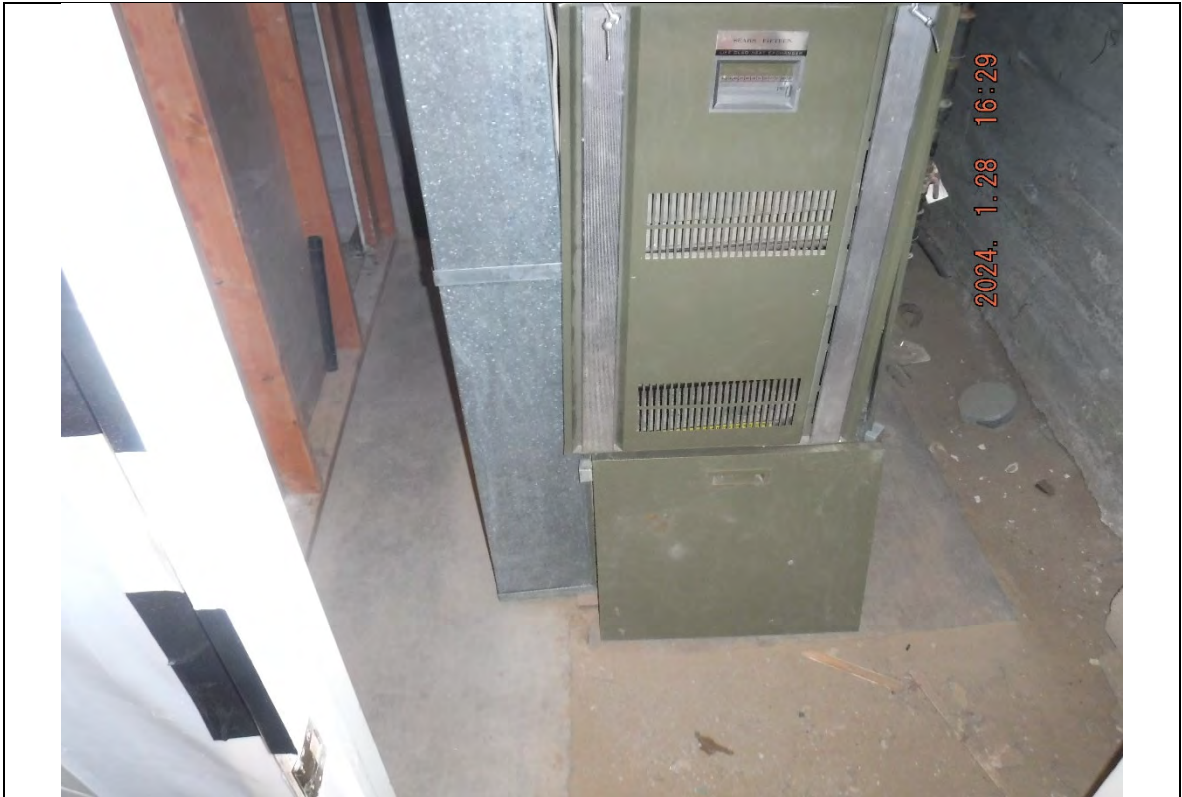
**Photograph:** 2270 Furnace room, following final cleaning, facing south (exposed earthen areas shown at bottom right).

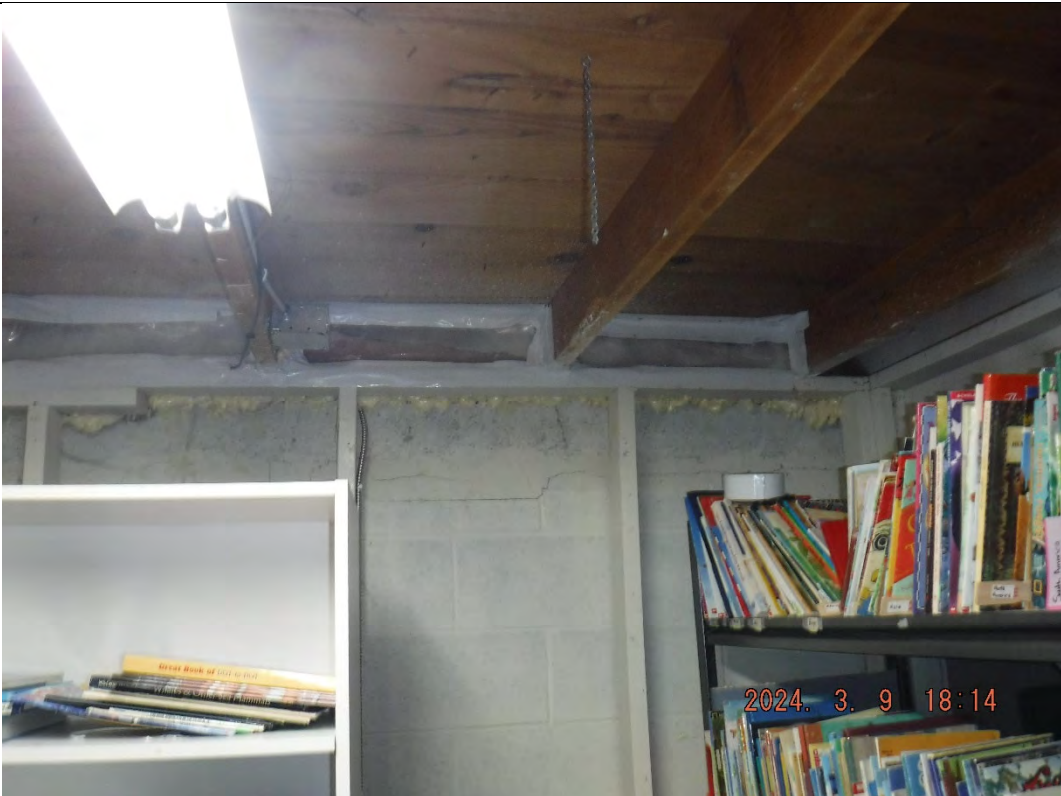
**Photograph:**  
2437

Sealed insulation, south side of basement, facing south. Insulation foam was applied to the gap between the concrete and wood frame.

All porous materials were placed in industrial garbage bags. The bags were wiped down with an all-purpose detergent solution and placed in dumpsters outside of the school. Larger materials were wrapped in 6-millimeter plastic wrap, secured with tape, wiped down, and placed in dumpsters. All materials placed in the dumpsters were ultimately disposed of at the Butte Landfill. Following the removal of impacted refuse, a high-efficiency particulate vacuum (HEPA) was used to clean all surfaces including ceilings, shelves, doors, and floors, working from higher to lower surfaces. Once vacuuming was complete, all surfaces were wiped down with disposable towels and all-purpose detergent. Cleaning was suspended for an hour to allow for the surfaces to dry and any suspended dust to settle. After an hour, all surfaces were cleaned again with the HEPA vacuum. Following the cleaning procedures, the basement area was visually inspected to ensure that all visible dust and debris were removed. During refuse removal exposed insulation was identified by the field team. The insulation was covered with 6-millimeter plastic wrap, which was secured in place with industrial-strength duct tape. The corners of the 6-millimeter plastic wrap were stapled in place with 3/8-inch staples, and an additional layer of tape was applied. Smaller pathways were sealed using insulation spray foam.

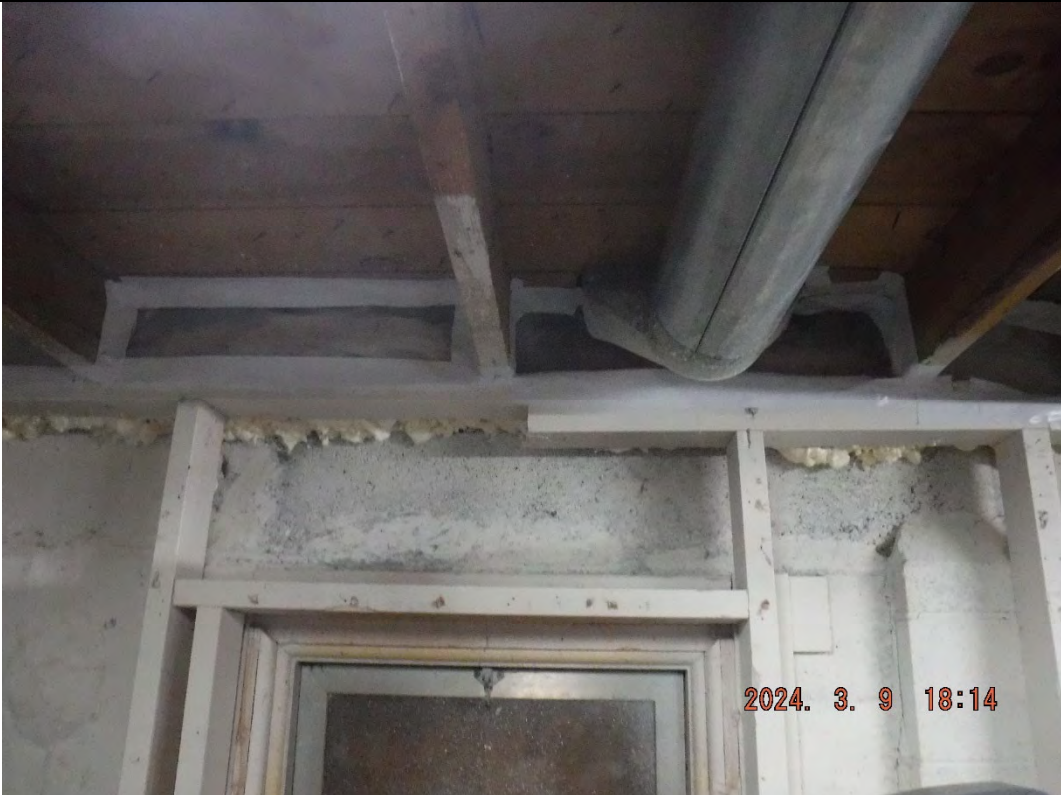
**Photograph:**  
2438

Sealed insulation, south side of basement, facing south. Insulation foam was applied to the gap between the concrete and wood frame.

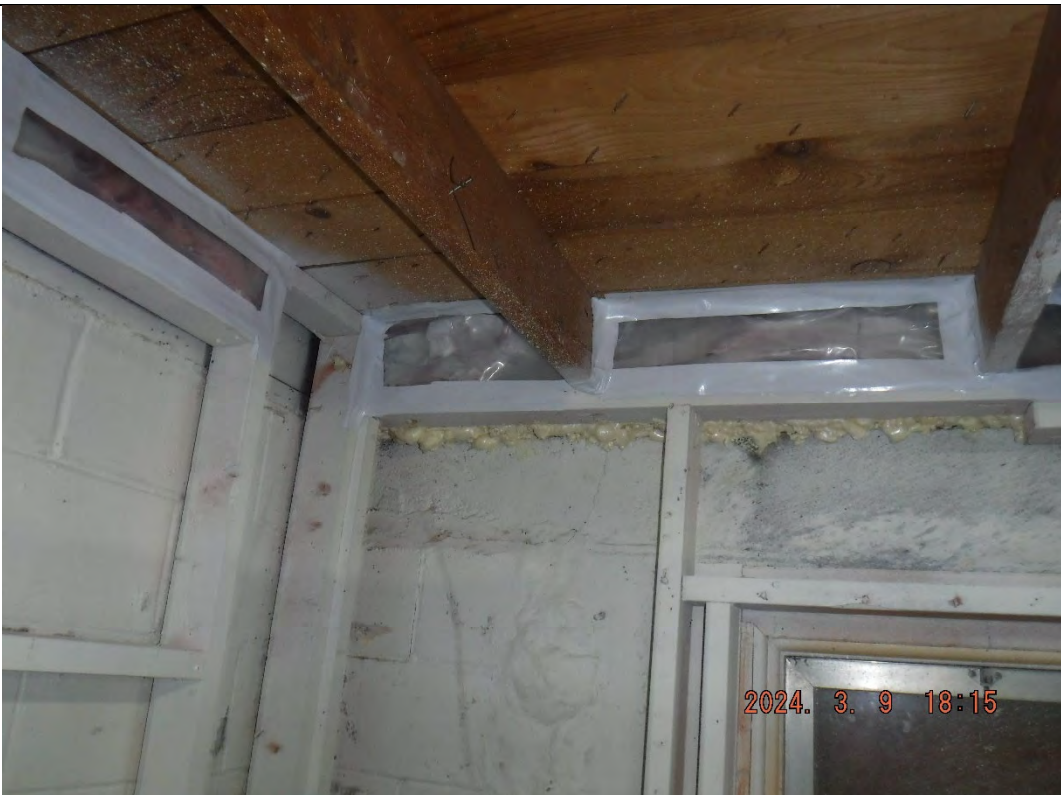
**Photograph:**  
2439

Sealed insulation, south side of basement, facing southeast. Insulation foam was applied to the gap between the concrete and wood frame.

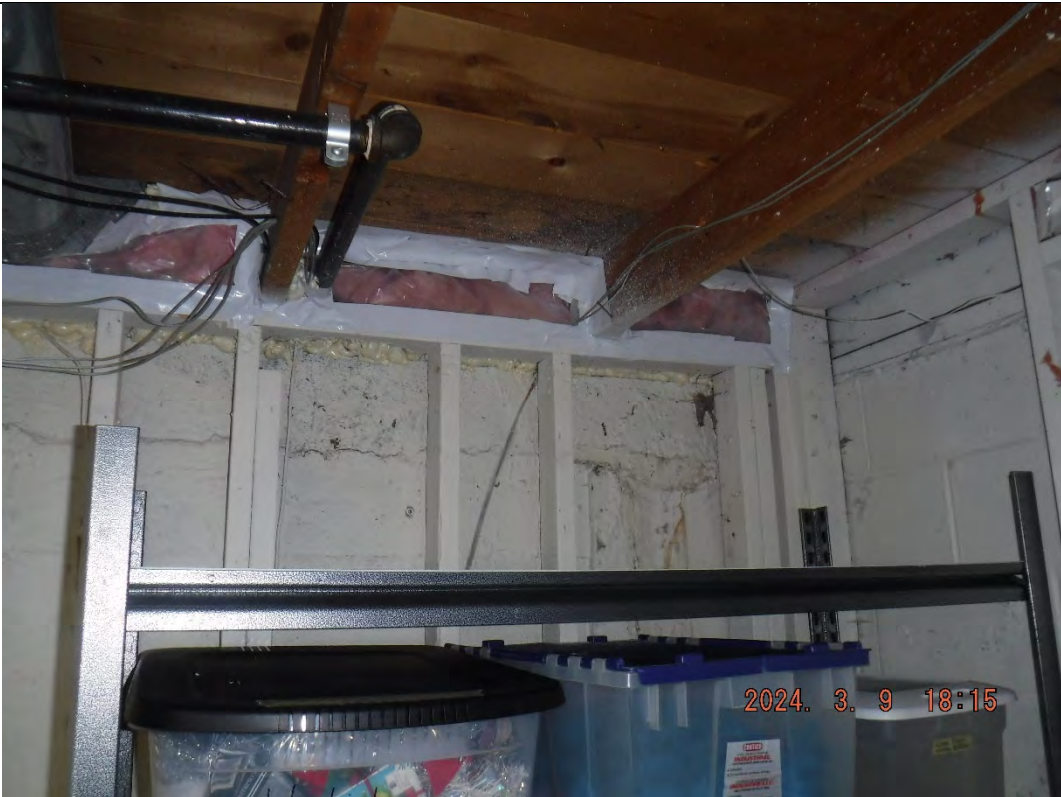
**Photograph:**  
2440

Sealed insulation, north side of basement, facing northeast. Insulation foam was applied to the gap between the concrete and wood frame.

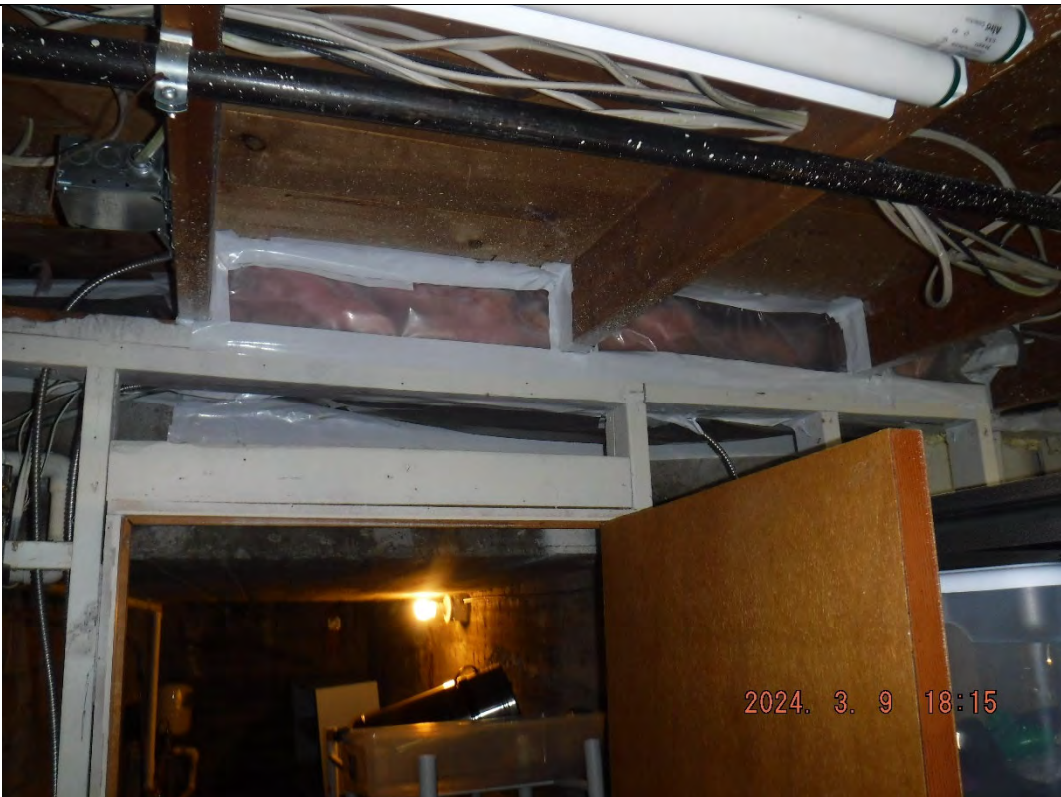
**Photograph:**  
2441

Sealed insulation, north side of basement, facing north.

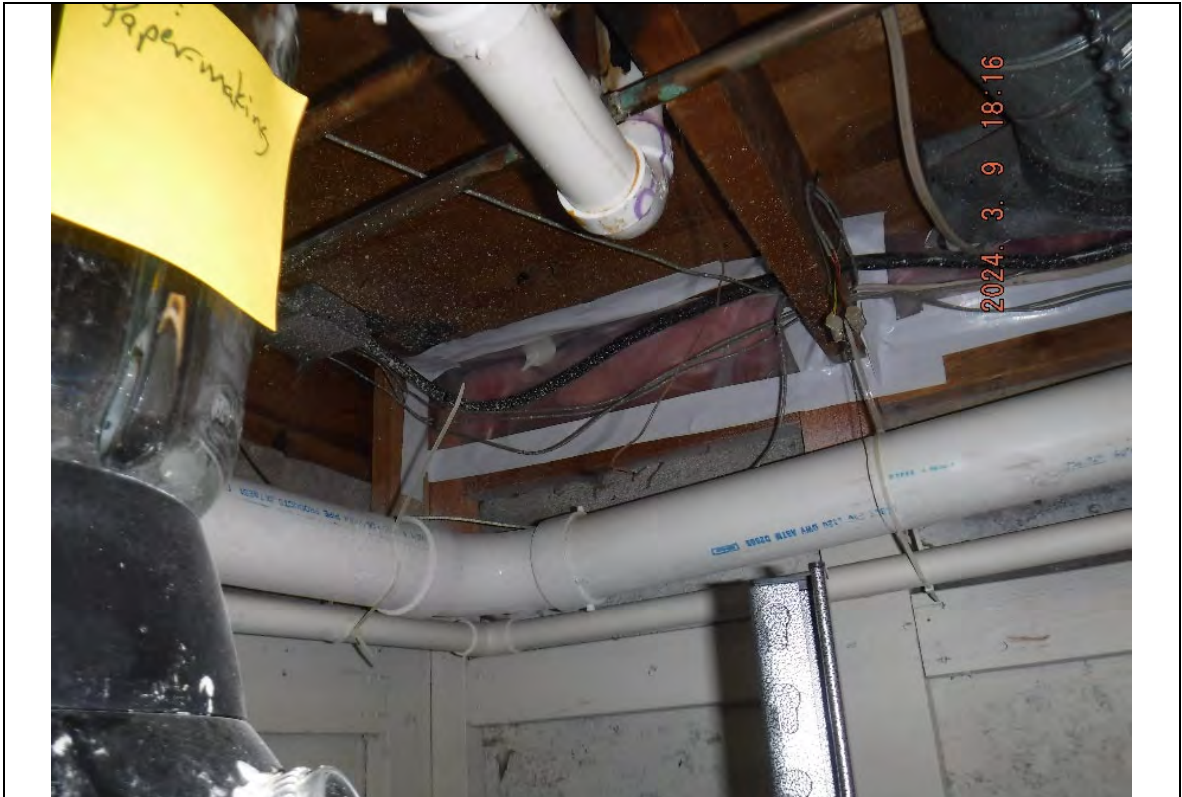
<b>Photograph:</b> 2444	Sealed insulation, northwest side of basement, facing northwest.
----------------------------	--

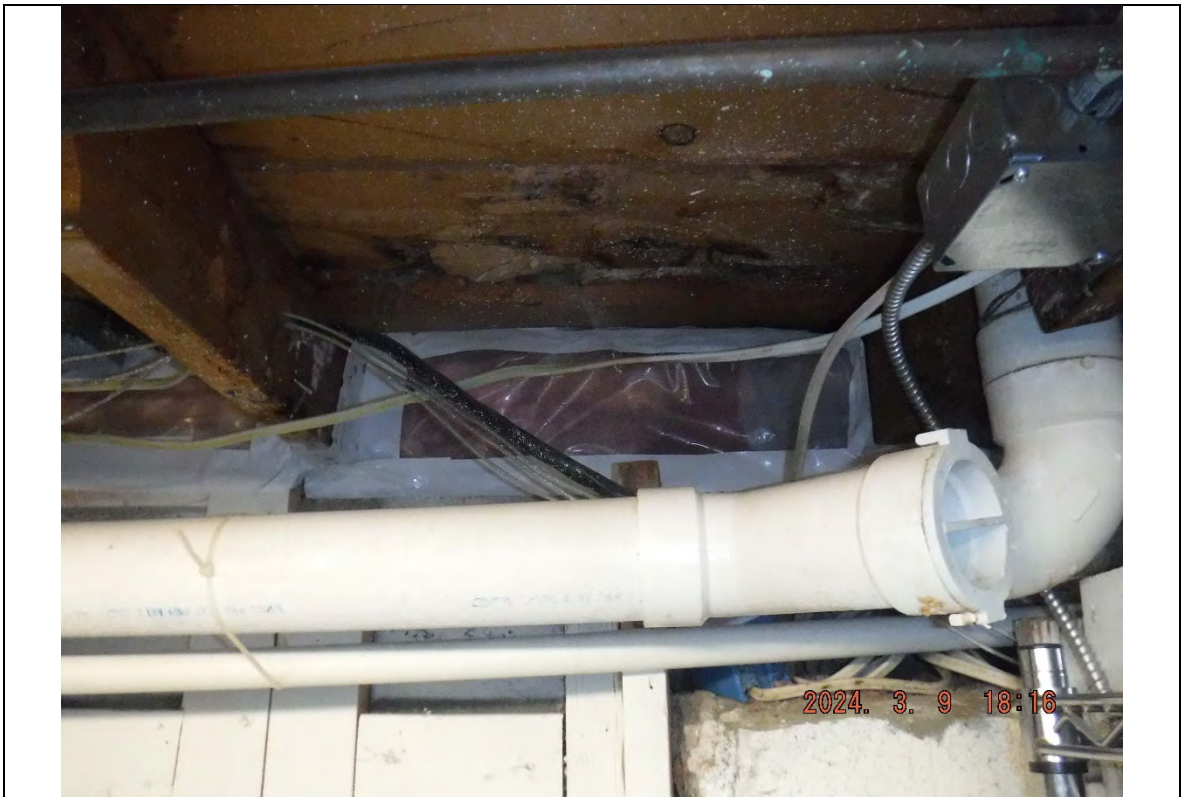
<b>Photograph:</b> 2445	Sealed insulation, north side of basement, facing north.
----------------------------	--

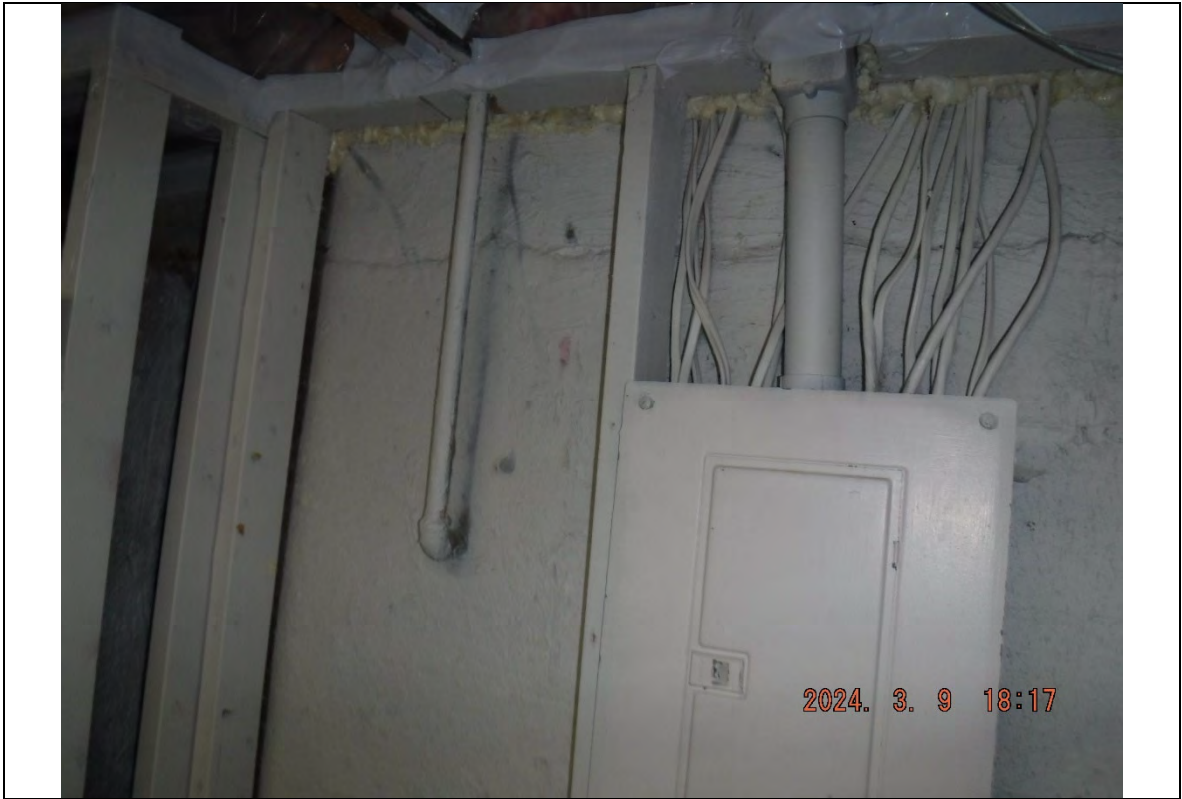
**Photograph:** 2446 Smaller pathways were sealed with insulation foam, north side of basement, facing north.

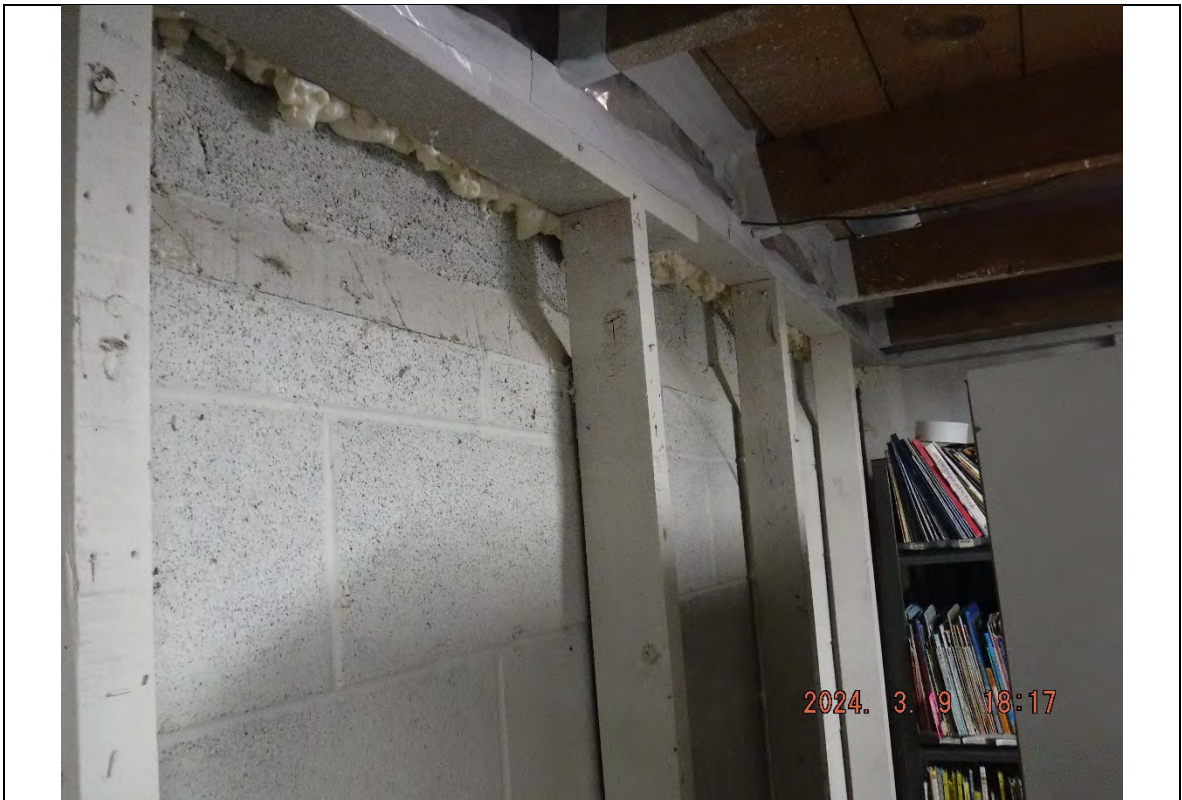
**Photograph:** 2248 Insulation foam, south side of basement, facing west.
