# Butte Priority Soils Operable Unit (BPSOU) Final Insufficiently Reclaimed Sites - Field Sampling Plan (FSP) BRES No. 93 – Soudan Dump

**August 17, 2022**

**Re: Butte Priority Soils Operable Unit (BPSOU) Final Insufficiently Reclaimed Sites - Field Sampling Plan (FSP) BRES No. 93 – Soudan Dump.**

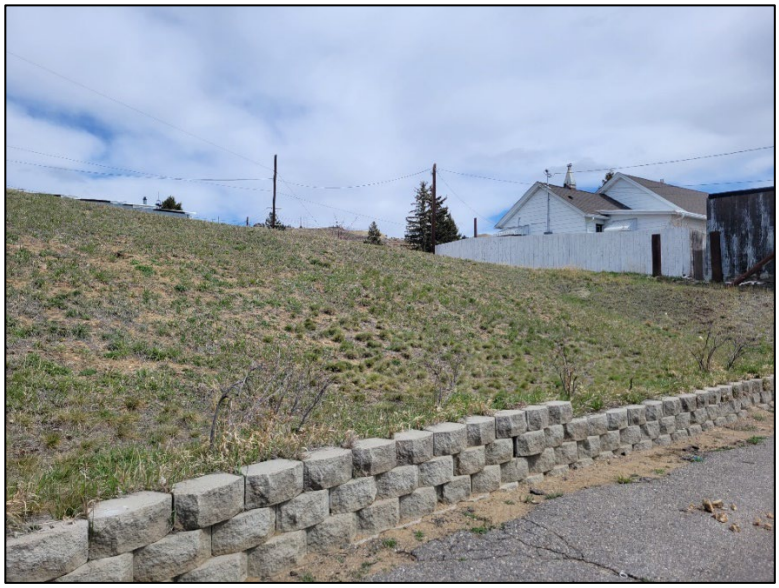
**Photograph 1: Good Grass Cover with Minimal Barren Areas.**

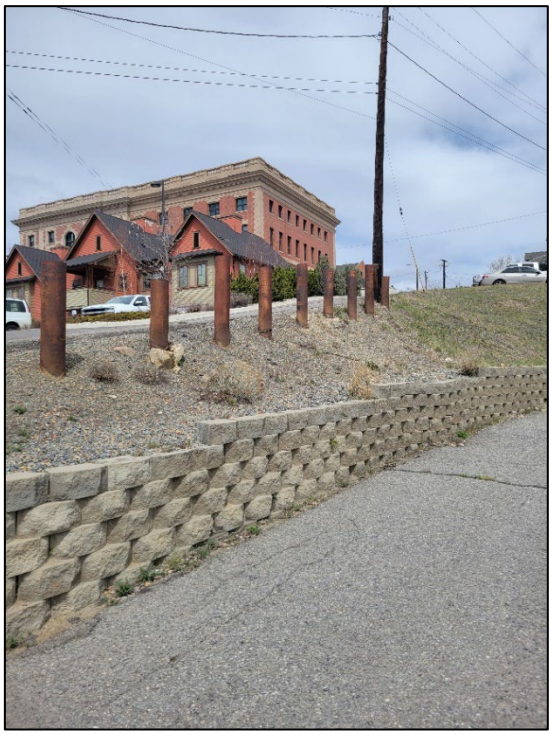
A preliminary site visit was conducted to better qualify existing site conditions and identify areas of focus for additional evaluation. Site photographs from the site investigation in the spring of 2022 are provided in this section for reference. The west boundary of the site contains gravel and undesirable plant species. The site has well-established grass along the south facing slope and contains barren areas near the residential house along the east steel casings. There is light colored and stained material present, seen on Photograph 4, along the east boundary where historical sample 038WA12-0 was collected. Butte-Silver Bow made a note that the structures are remnants of a collapsed steam line.

**Photograph 2: Butte-Silver Bow Noted a Collapsed Steam Line.**

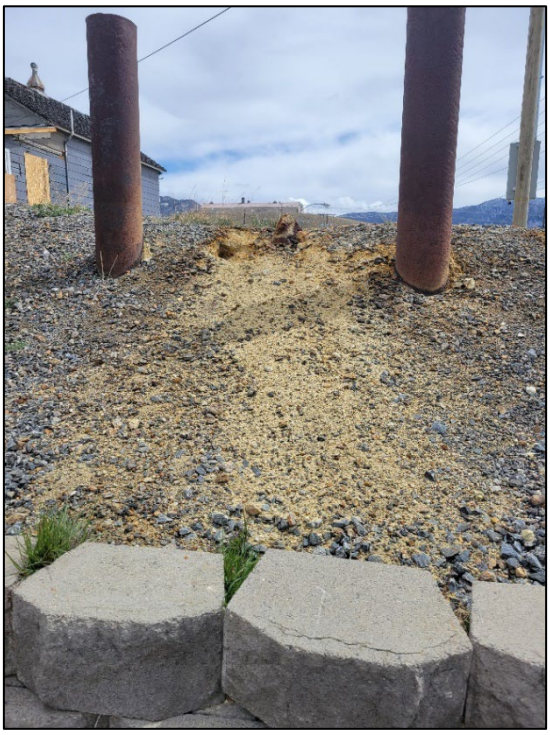
**Photograph 3: Light Colored Material Along East Boundary.**

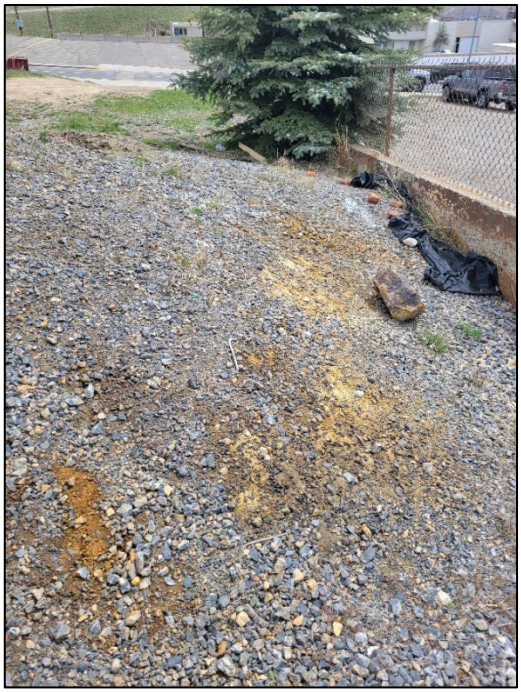
**Photograph 4: Possible Waste Pile in Southeast Corner of the Site.**

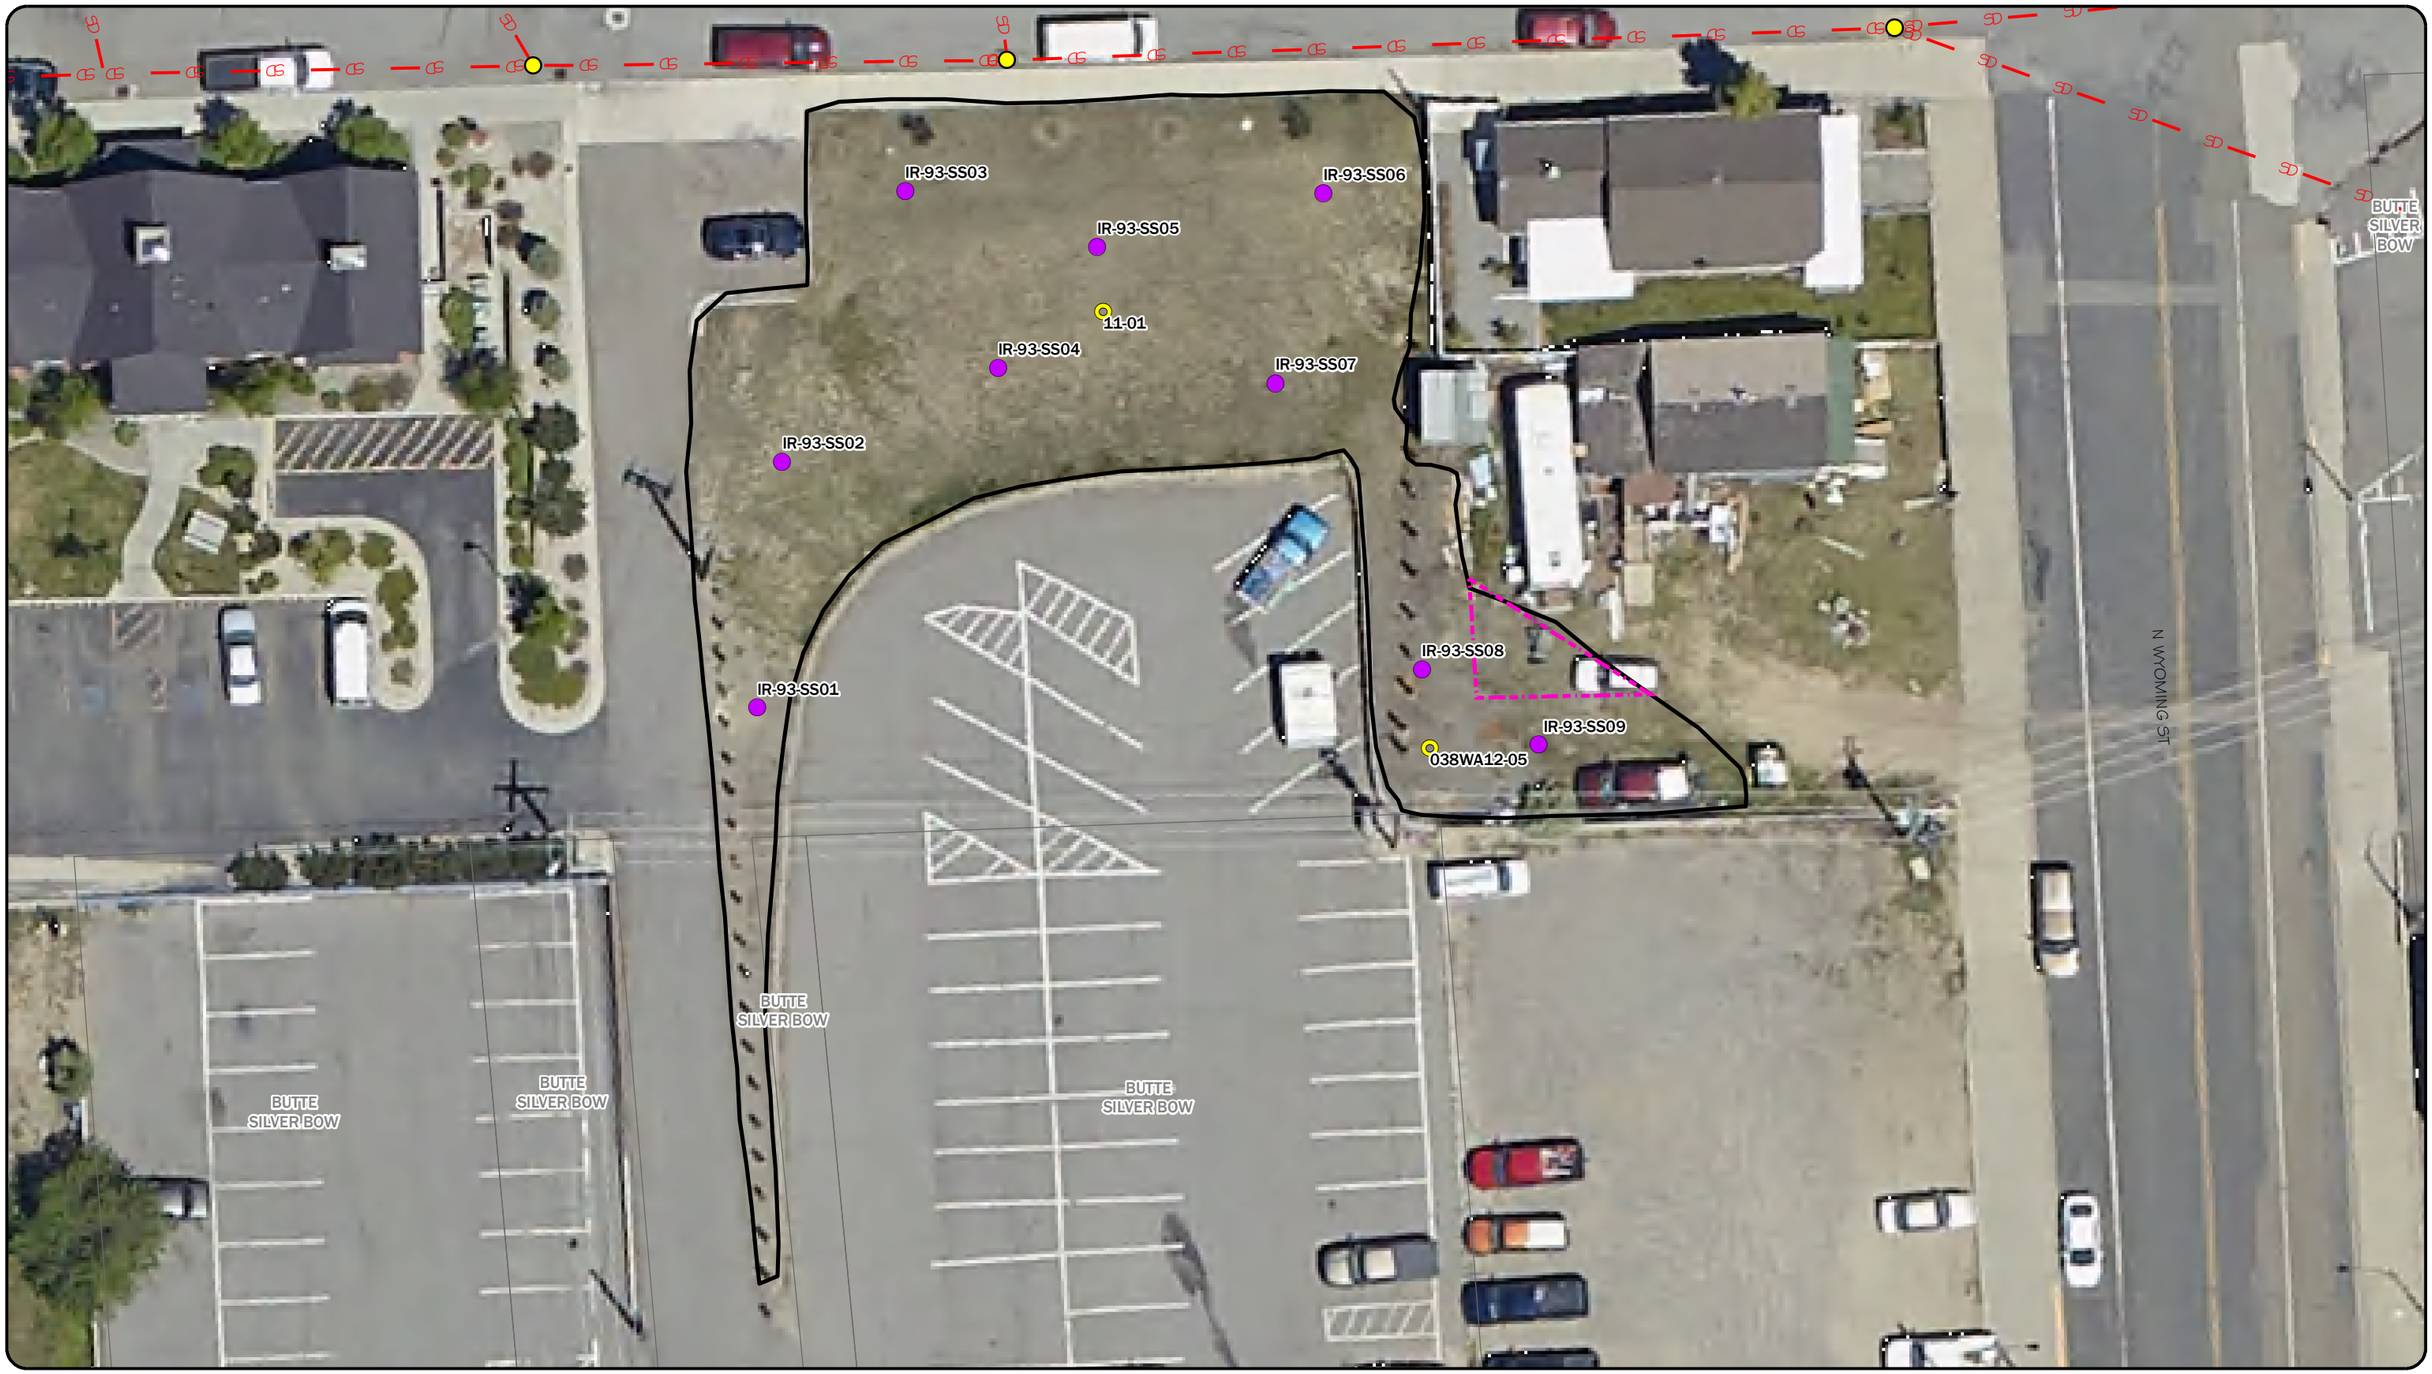
FIGURE 1

Field sampling within the proposed adjusted boundary shown on Figure 1 will be performed to determine whether contaminants are present, whether growth media is adequate, and whether there are previously unidentified sources contributing to site deficiencies.

This FSP provides details related to the field evaluation of the IR Site BRES No. 93 Soudan Dump. The site will be evaluated following the Commercial Land Use Waste Identification and Action Level Criteria provided in the IR QAPP. Proposed soil sampling stations and areas of known deficiencies are shown on Figure 1. The site evaluation is anticipated to be completed in 2022.

INSUFFICIENTLY RECLAIMED SITES BRES No. 93 SOUDAN DUMP PROPOSED SAMPLE STATIONS
