Silver Bow Creek/Butte Area Superfund Site

**2022 Stormwater BMPs Repair, Inspection Report, and
Maintenance Work Plan BNSF Railway Company and Union
Pacific Railroad Company Butte Priority Soils Operable Unit KJ
2299019.00**

16 February 2023

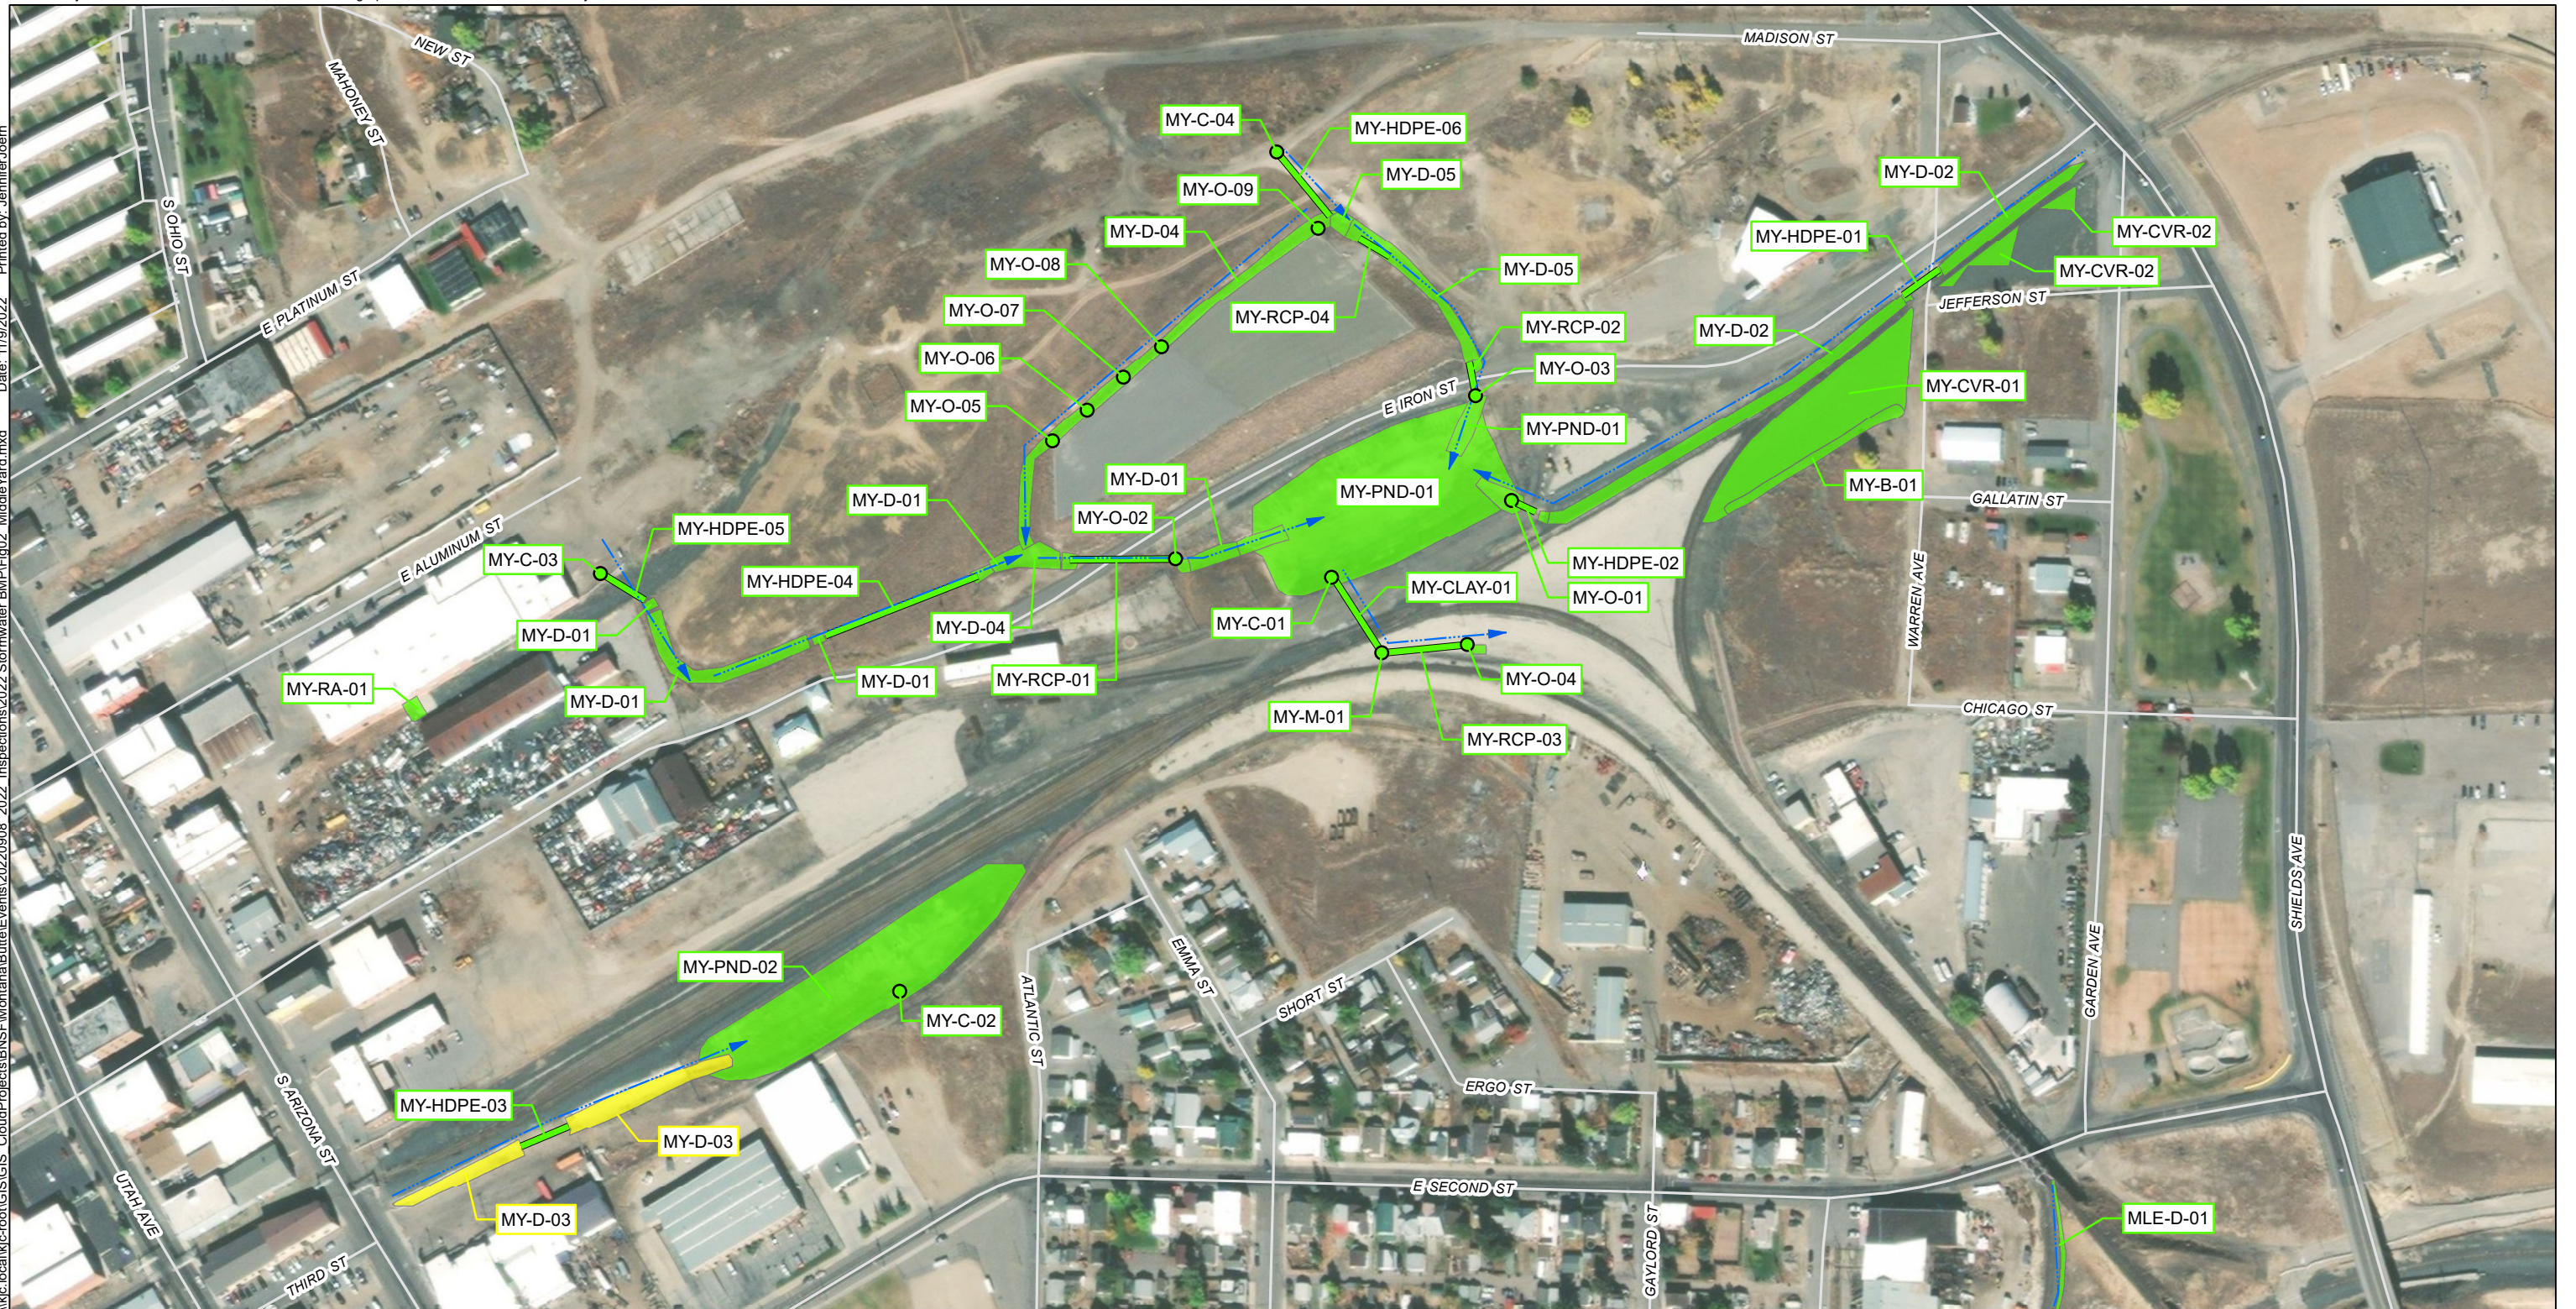
1. BMP = Best Management Practices
2. Inspections performed 27-28 September 2022.
3. All features shown are stormwater BMPs, BRES sites are not shown.

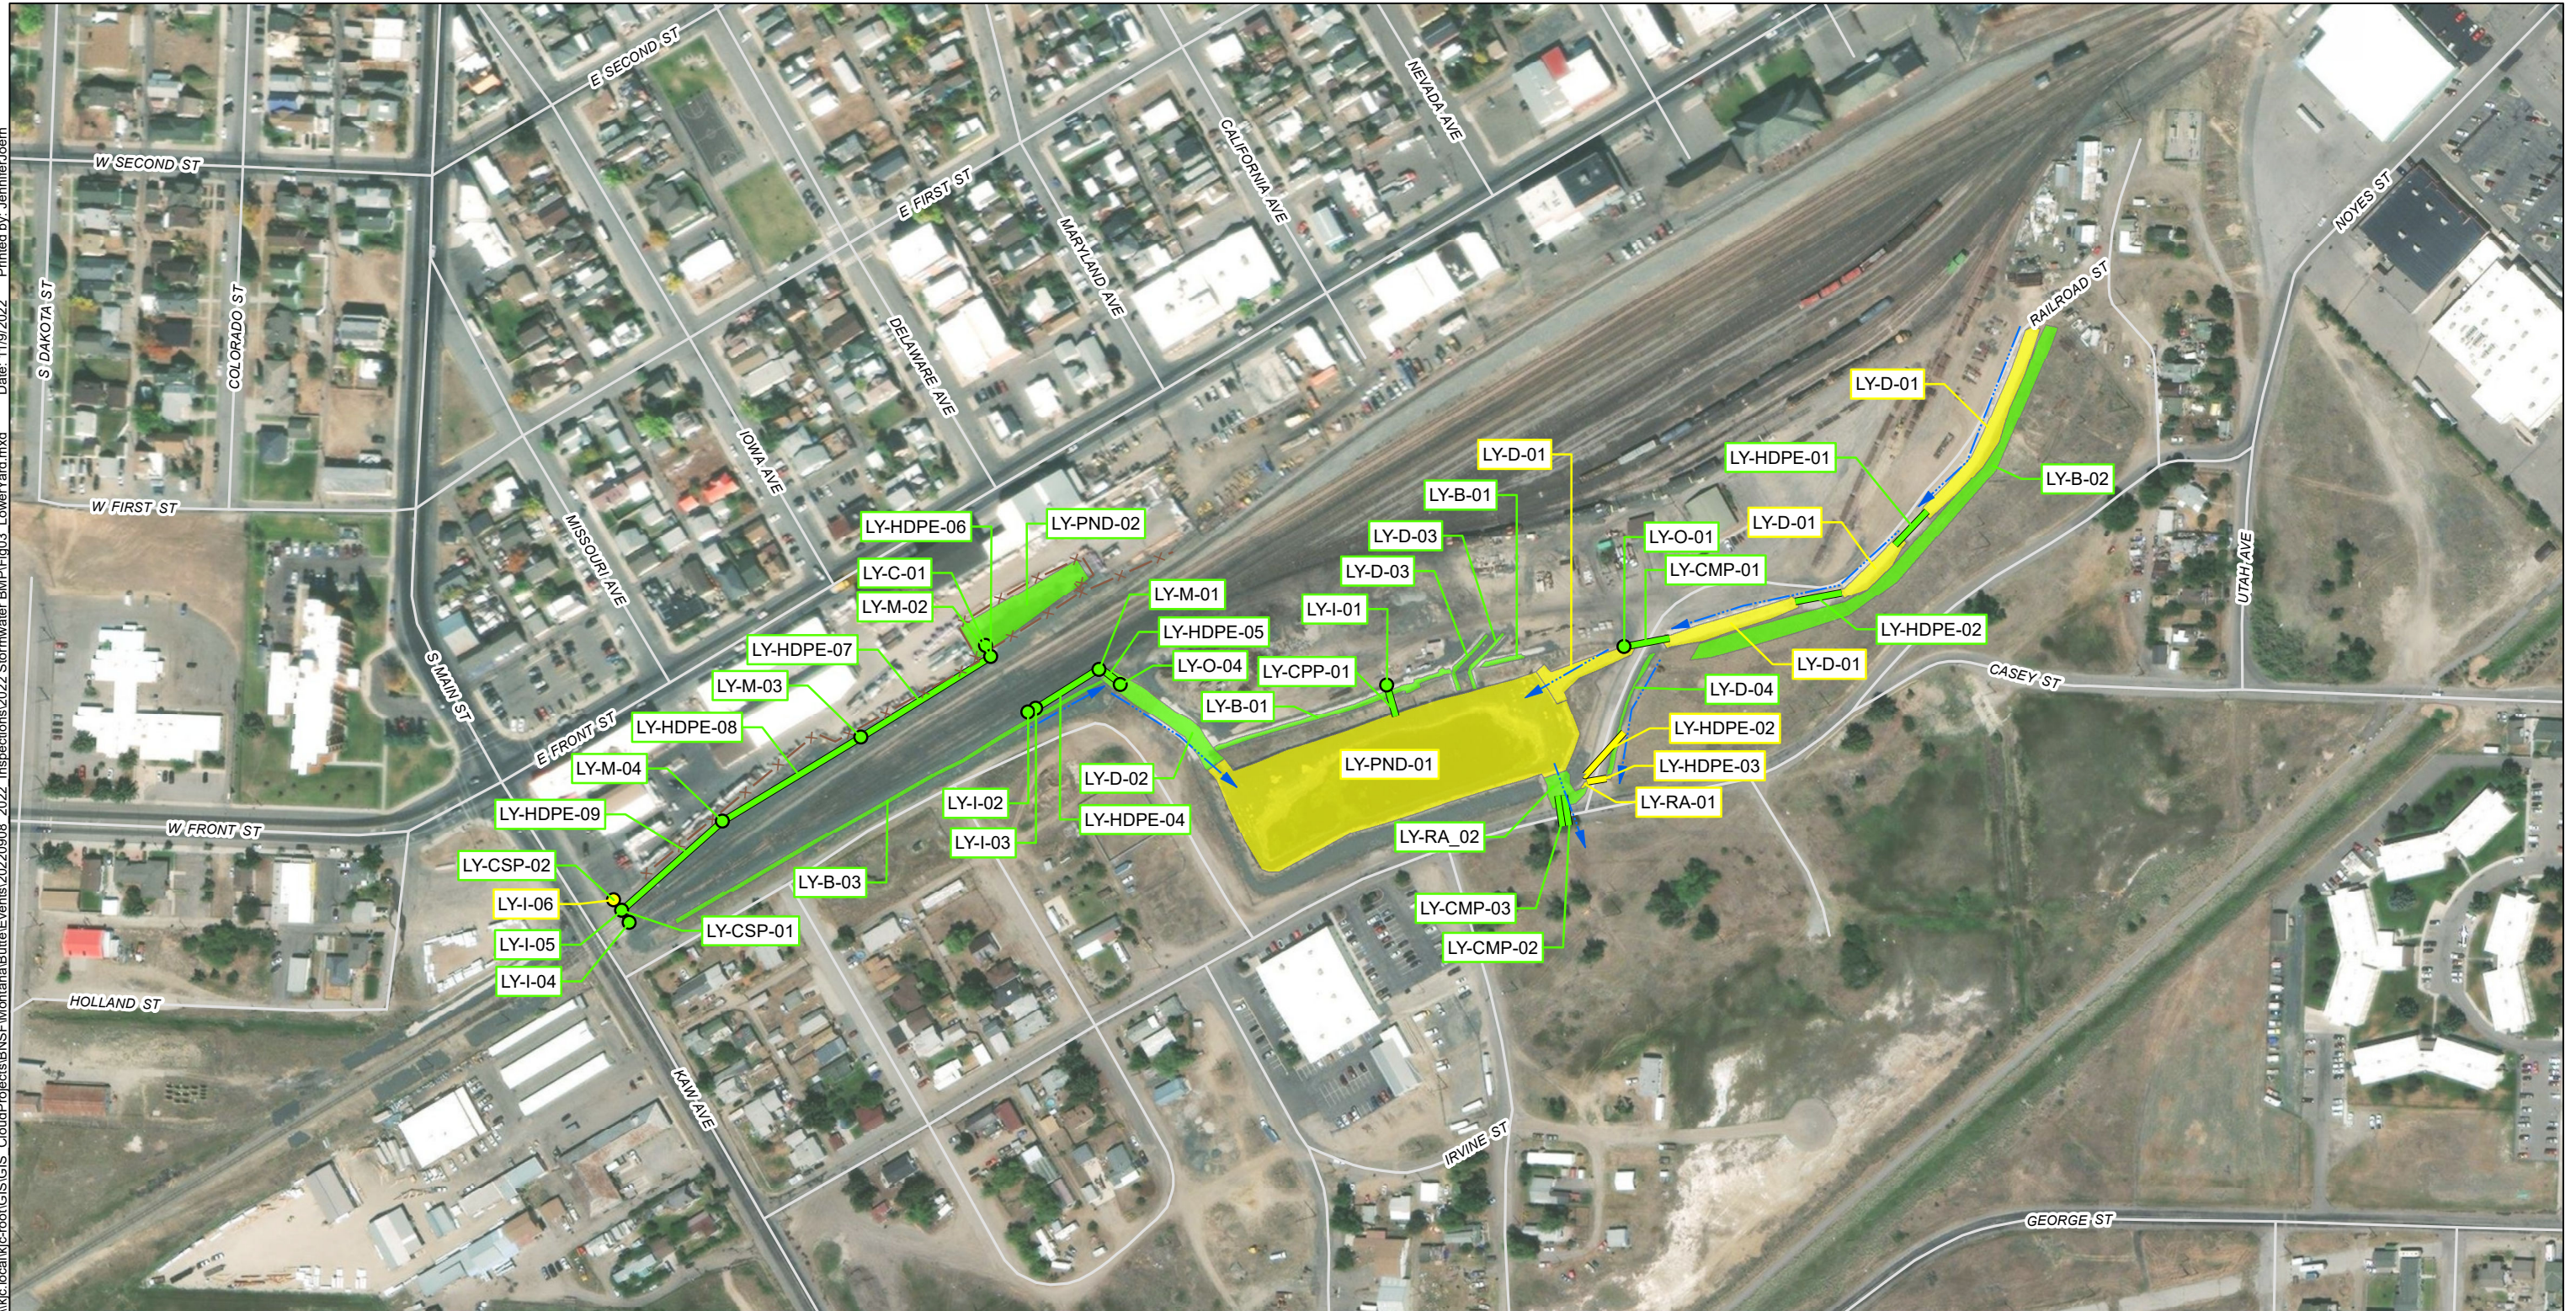
1. BMP = Best Management Practices
- BRES = Butte Reclamation Evaluation System
2. Inspections performed 27-28 September 2022.
3. All features shown are stormwater BMPs, BRES sites are not shown.
