Butte Priority Soils Operable Unit (BPSOU) Final Insufficiently Reclaimed Sites - Field Sampling Plan (FSP) BRES No. 16 - Curry.

Atlantic Richfield Company

August 19, 2022

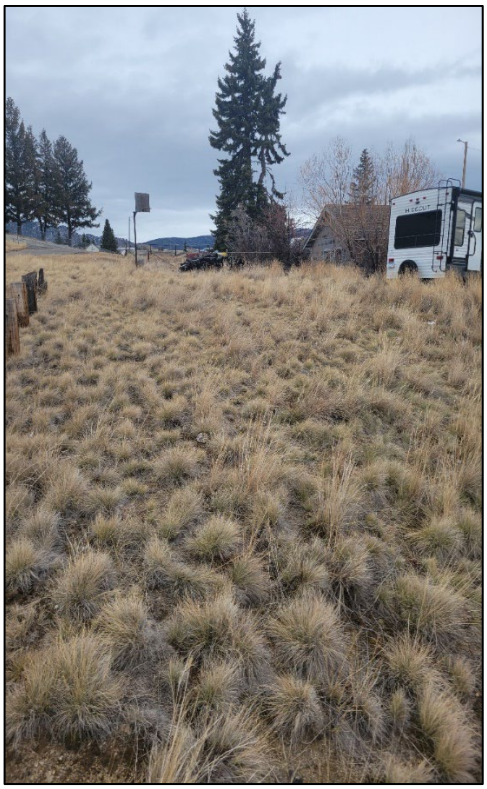
Photograph 1: North Portion of Site is Well Vegetated

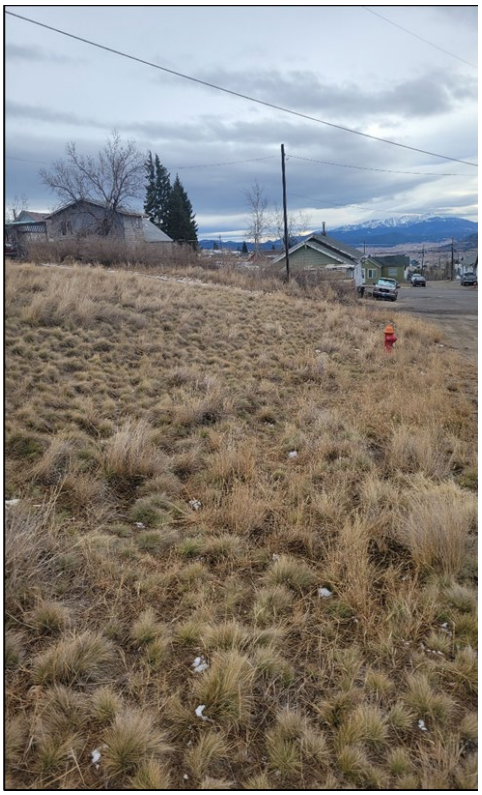
Photograph 2: Southwest Portion of Site is Well Vegetated

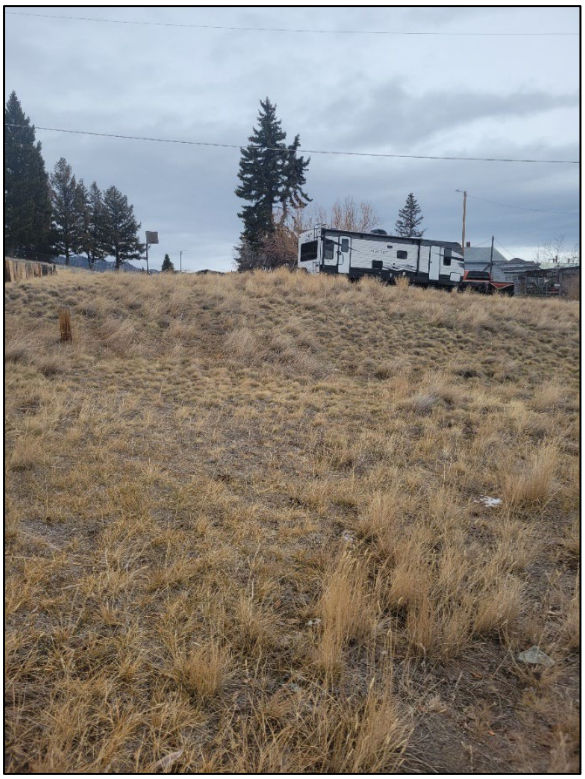
Photograph 3: East Portion of Site Contains Minor Barren Areas

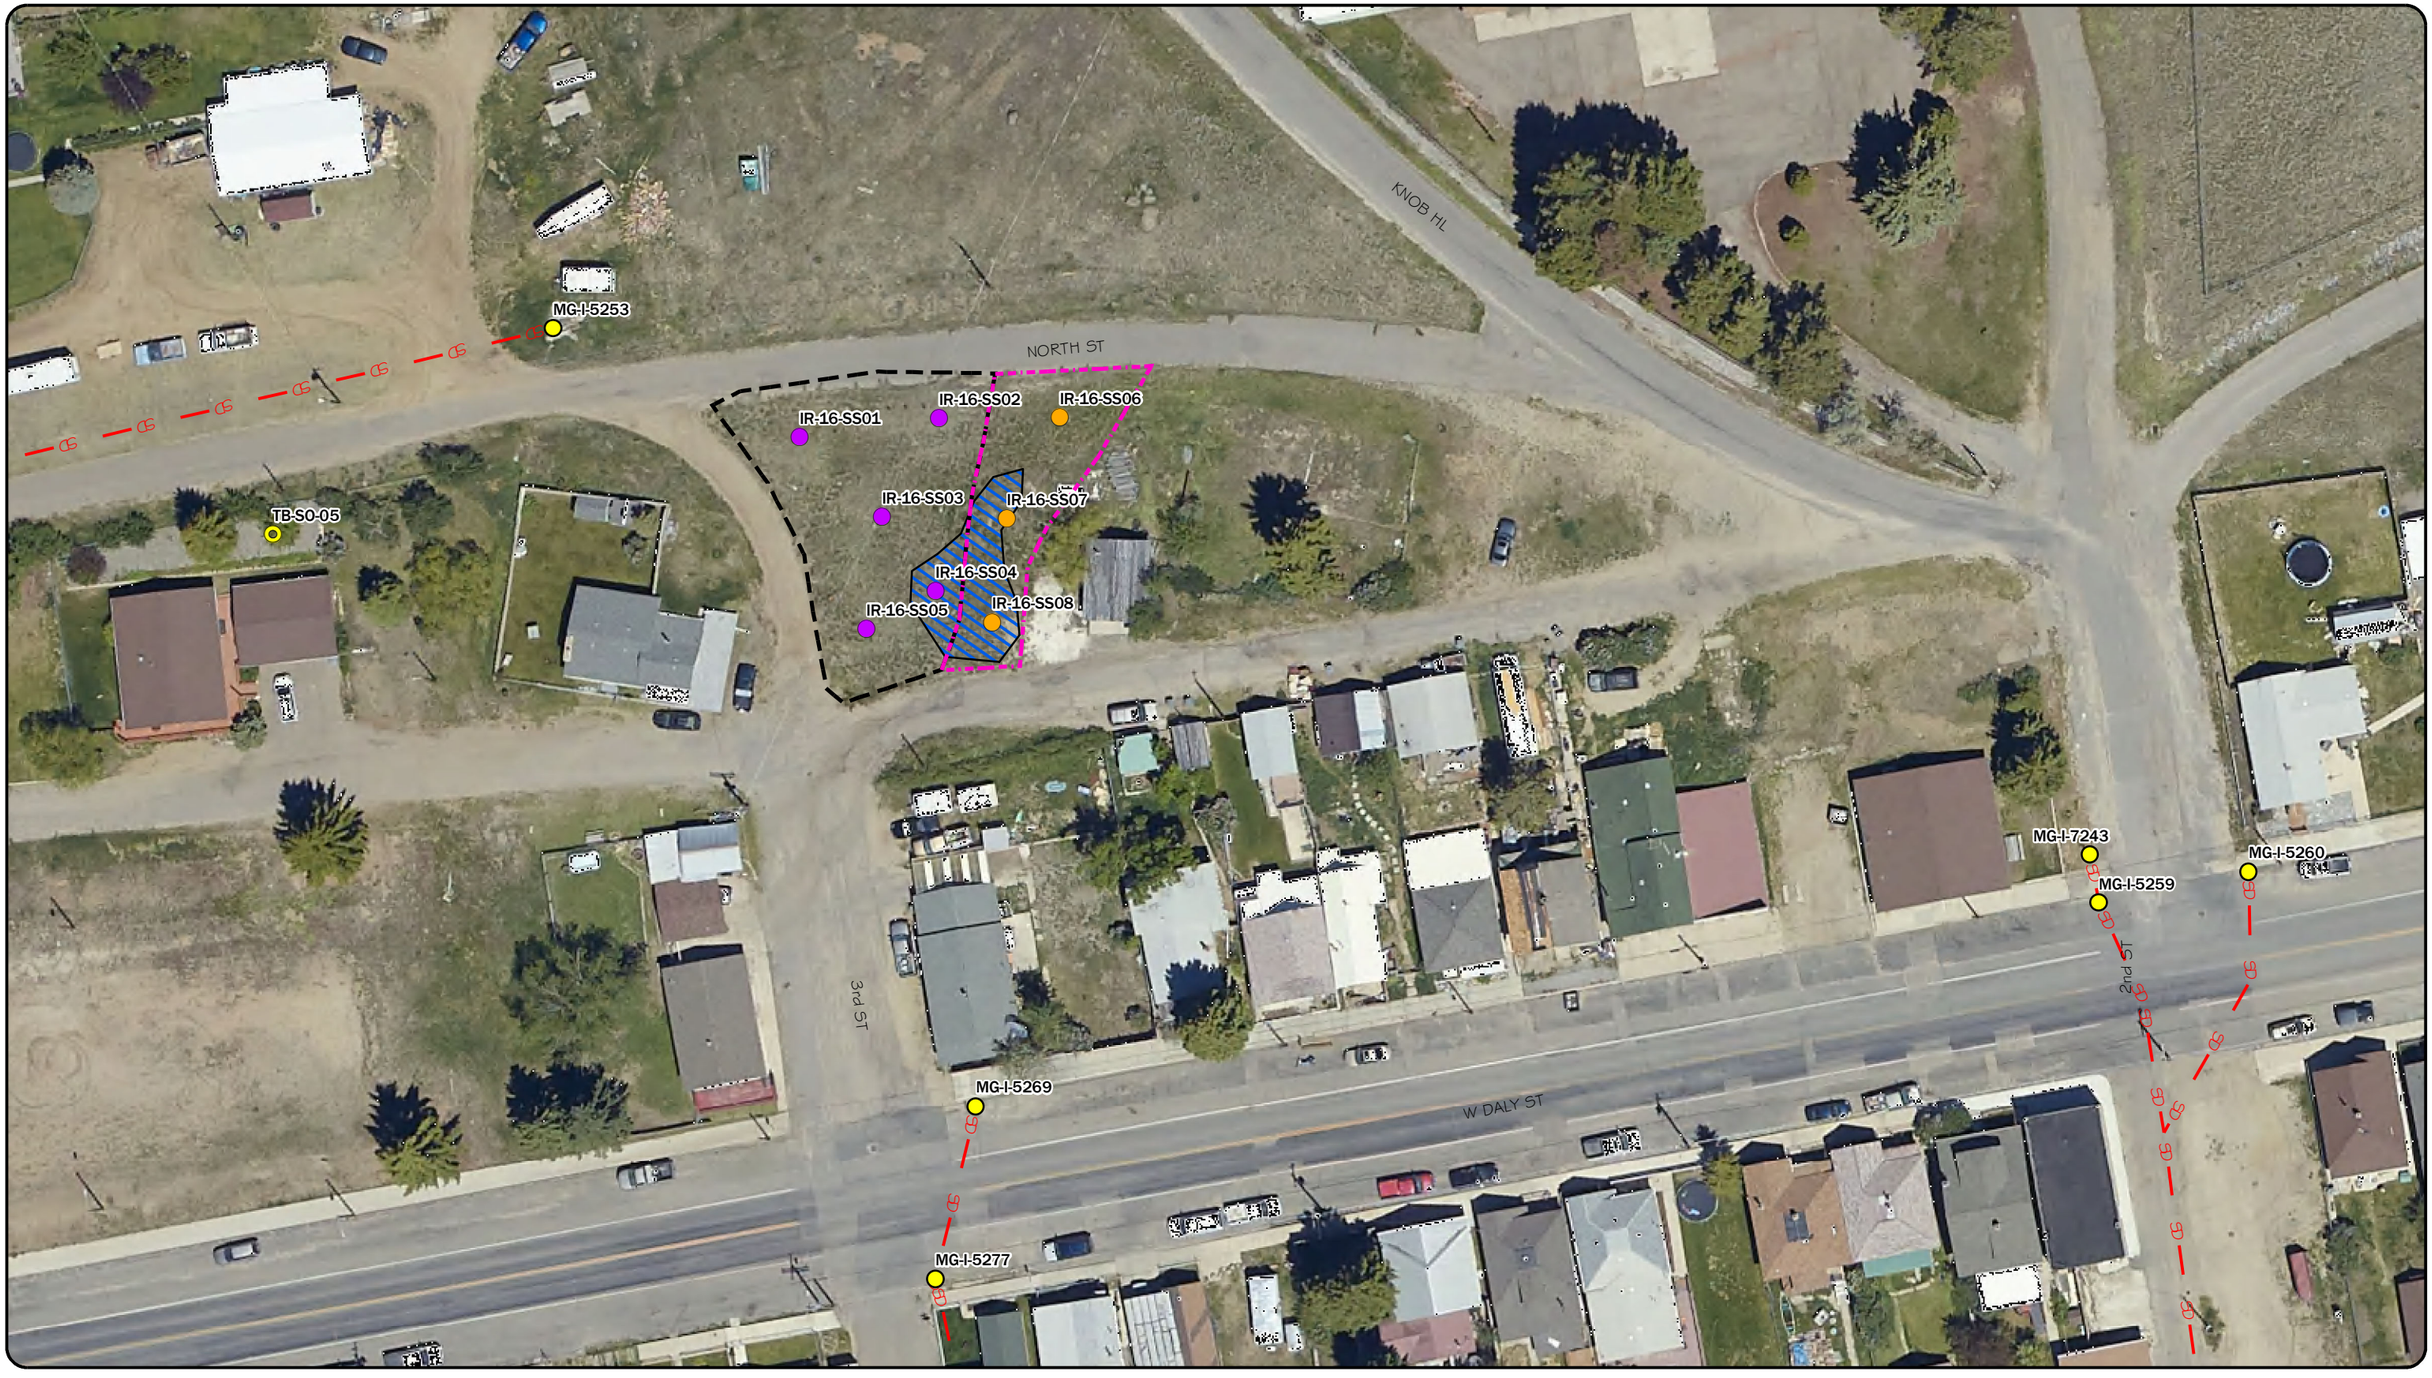
FIGURE 1

This FSP provides details related to the field evaluation of the Insufficiently Reclaimed Site BRES No. 16 – Curry. Proposed soil sampling locations and areas of known deficiencies are shown on Figure 1.

Data obtained from the Geocortex web-based database at https://eis2.woodardcurran.com/Html5Viewer/index.html?viewer=BPButte.BPSOU contain the records for previous soil samples collected near BRES 16 Curry. The approximate sample locations are included on Figure 1 with results provided in Table 1 below. Sample results do not exceed ROD Solid Media soil screening criteria. The BPSOU action levels are listed in Table 1 and Table 2 of the IR Sites QAPP, Section 2.4.
