Silver Bow Creek/Butte Area Superfund Site

Draft Final Annual Operations and Maintenance (O&M) Report, Butte Treatment Lagoon (BTL) System – 2021

RE: Butte Priority Soils Operable Unit (BPSOU) Draft Final Annual Operations and Maintenance (O&M) Report Butte Treatment Lagoon System – 2021

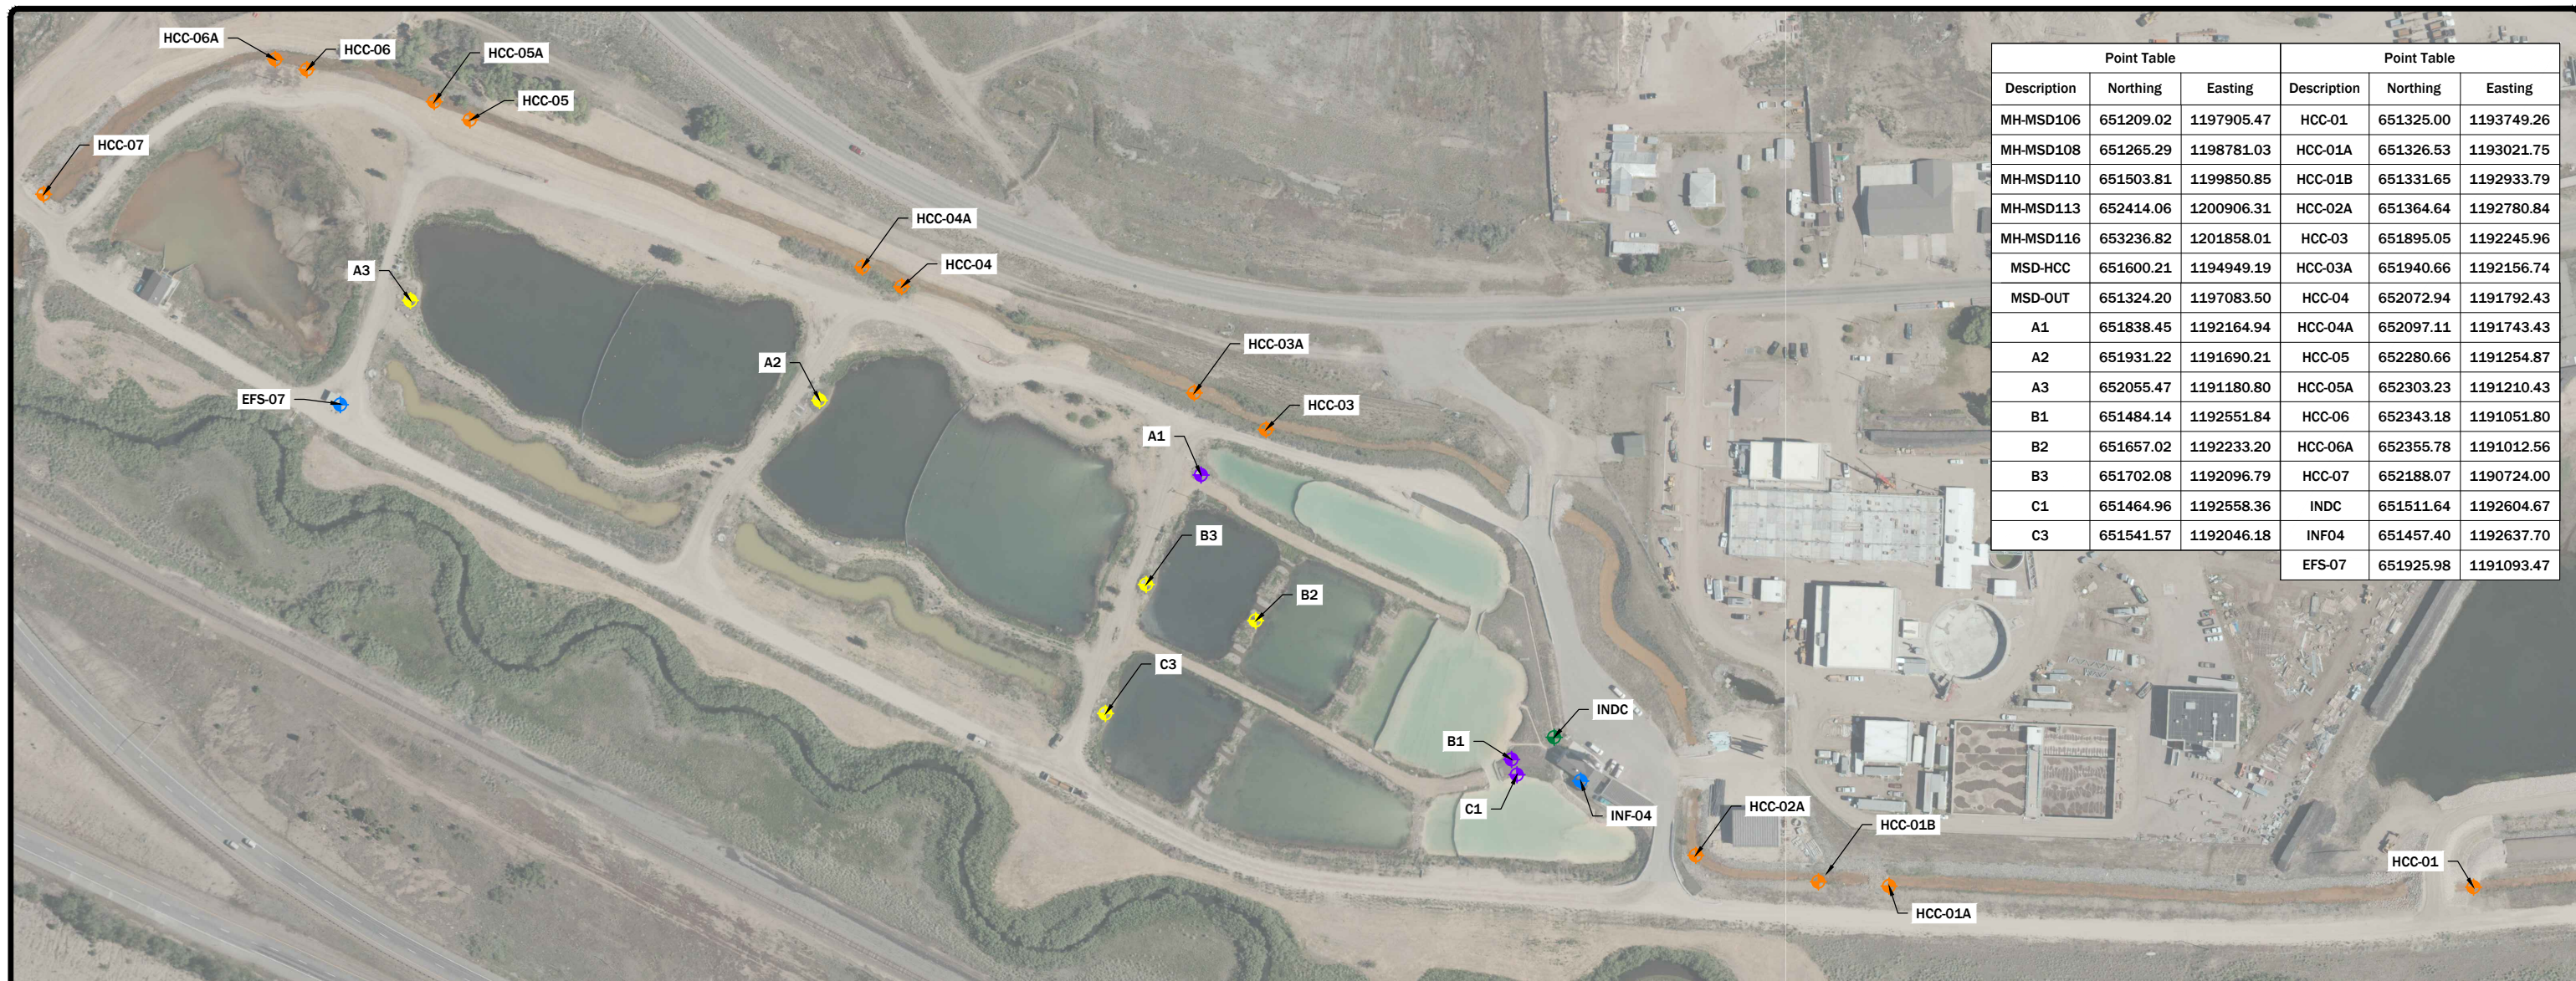
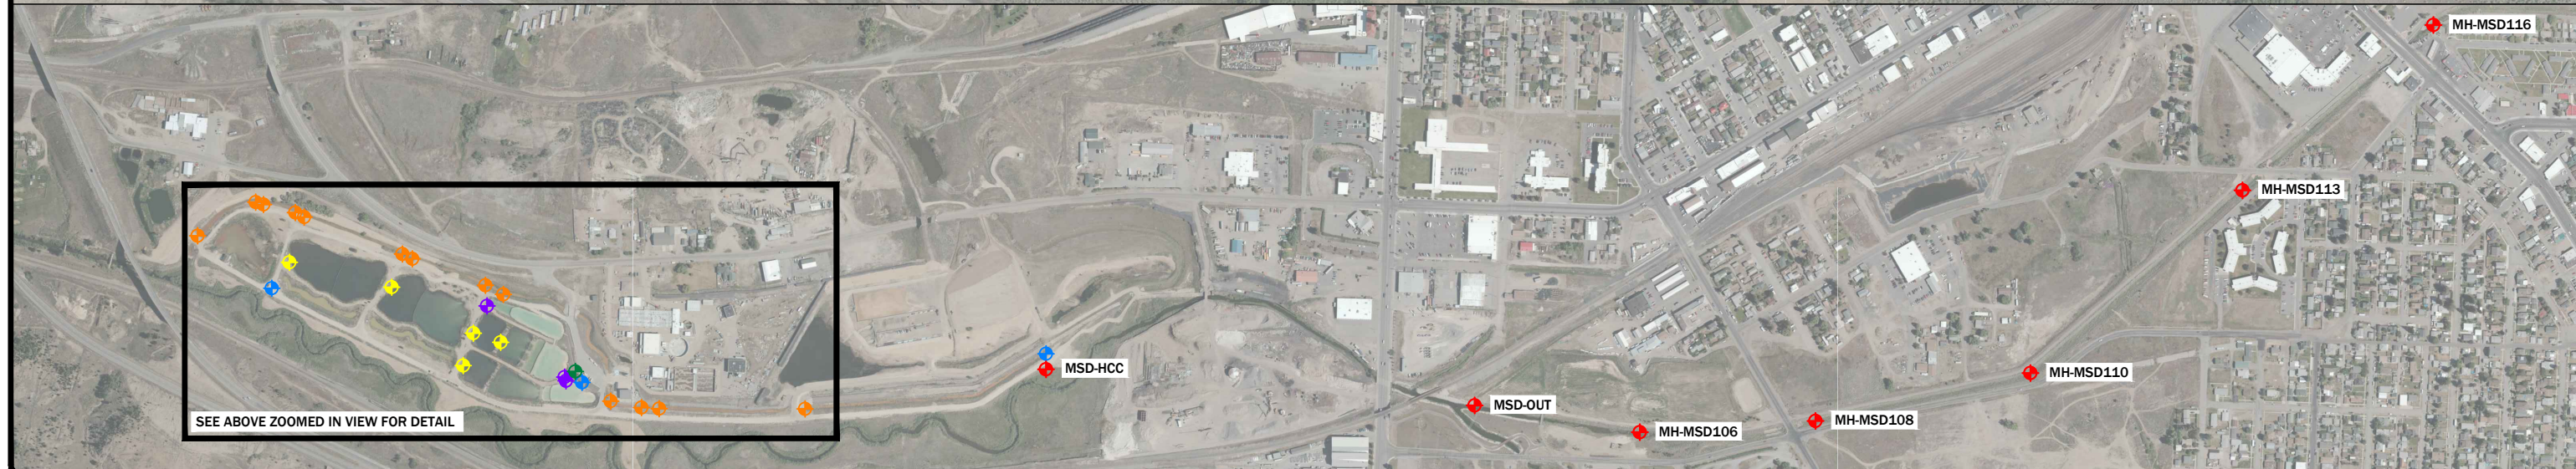
Figure 1. BTL and BPSOU Subdrain Routine Sample and Monitoring Locations

- LEGEND:**
- BTL ANALYTICAL SAMPLE COLLECTION
 - SUBDRAIN LOADING - FLOW WATER LEVEL, FIELD PARAMETERS. ANALYTICAL SAMPLES
 - BTL FIELD DATA - LEVEL
 - HCC STAFF GAUGE LOCATIONS
 - BTL FIELD DATA- pH, TEMP, CONDUCTIVITY
 - INDC

Additional details related to sampling and monitoring tasks are provided in the Routine OM&M Plan. All required samples were collected at the sample station locations shown on Figure 1 and sent to Pace Analytical Laboratory, LLC (Pace) in Minneapolis, Minnesota, for analyses. The laboratory completed data verification and provided Level 4 validation packages according to the laboratory quality assurance procedures for all data.

Influent and effluent water quality samples are typically collected using automated Teledyne ISCO samplers programmed to collect composite samples over a 24-hour period. Sample station locations referenced in this section are shown on Figure 1. Effluent water samples are collected twice weekly at the BTL effluent sampling station EFS-07 (SS-1). Influent waters are sampled weekly at the Influent Pump Station (IPS) INF-04 (SS-2). Field grab samples are collected monthly at station MSD-HCC (SS-3), where the collected subdrain flow discharges to the upper HCC. Samples are analyzed for total recoverable metals (aluminum, arsenic, cadmium, calcium, copper, iron, lead, magnesium, mercury, silver, uranium, zinc) and hardness. Also, alkalinity, total dissolved solids, total suspended solids, and nitrates/nitrites are measured monthly at the influent station INF-04 (SS-2), effluent station EFS-07 (SS-1), and MSD-HCC station (SS-3). One field blank sample (SS-4), one rinsate blank sample (SS-10), and one field duplicate sample (T) are collected monthly for quality control as described in the sampling and monitoring QAPP for the BTL Groundwater Treatment System (Atlantic Richfield Company, 2018)¹.

Following the procedures outlined in BTL-SOP-20, jetting of the subdrain was completed using the new Warthog jet nozzle on two specific occasions. The first event, performed on June 15 and 16, 2021, consisted of jetting the subdrain from MSD-MH116 to MSD-MH106. The second event, performed on October 12 and 13, 2021, consisted of jetting the subdrain from manhole MH-MSD-116 to MH-MSD106 (manhole locations are shown on Figure 1).

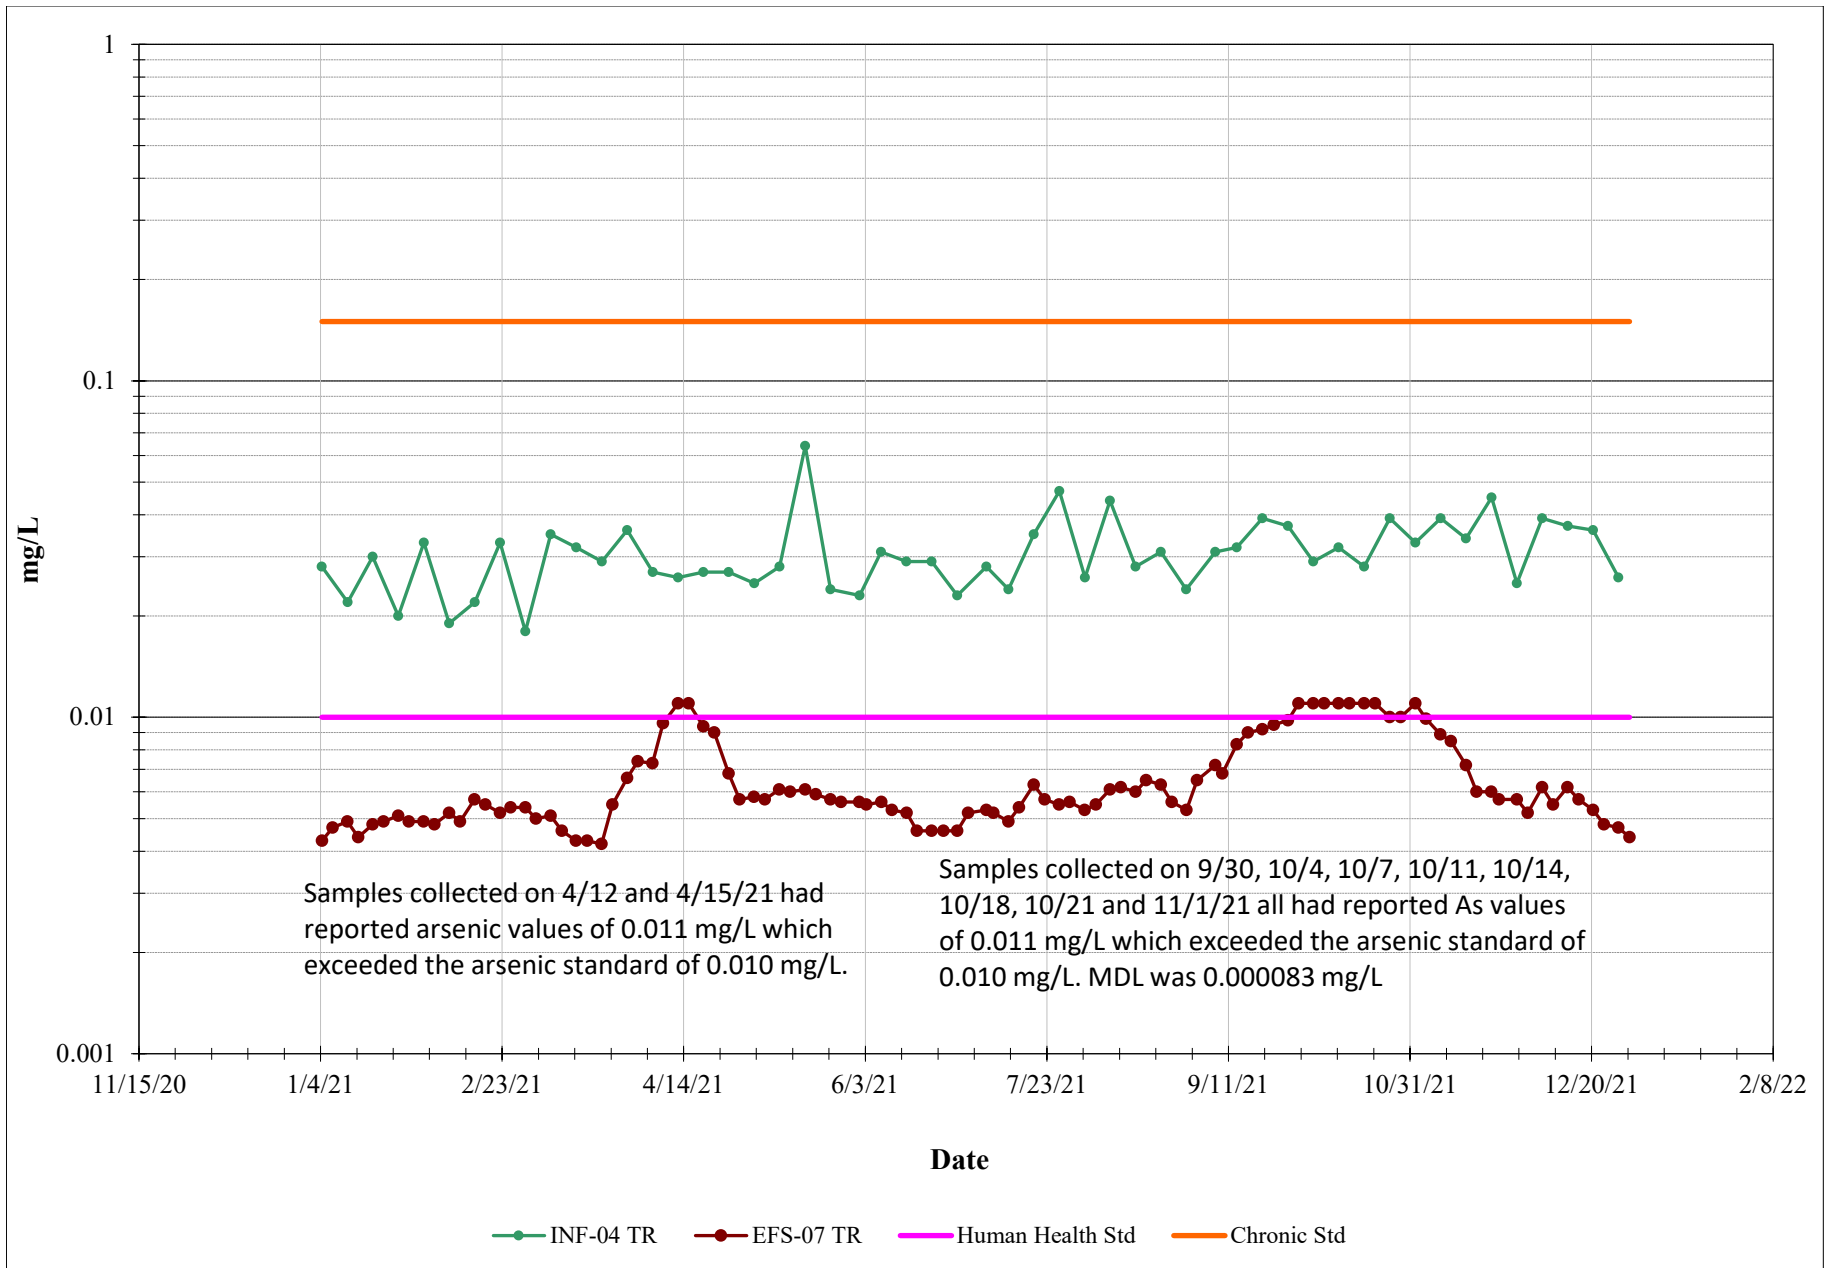
Butte Treatment Lagoon System Arsenic Concentration- Final

Arsenic maximum standard is DEQ-7 Human Health standard.

- The operations team reviewed the available operating data for the periods that the recent reported arsenic values were above standard (Table 8-1) (spring and fall of 2021), including the spring/fall dredging events. The 2022 spring dredging activities will also be pushed back to the first or second week in May if lagoon conditions/capacity will allow. This is intended to determine if dredging activities contributed to the elevated arsenic levels at EFS-07.

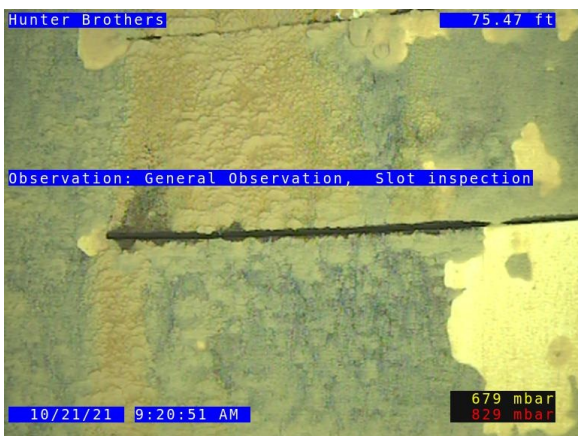
File name: **MH-MSD106 to MH-MSD108_0002.jpeg**
 Inspection date and time: **21/10/2021 08:54**
 Position: **75.46 ft**
 Code: **MGO**
General Observation, Slot inspection

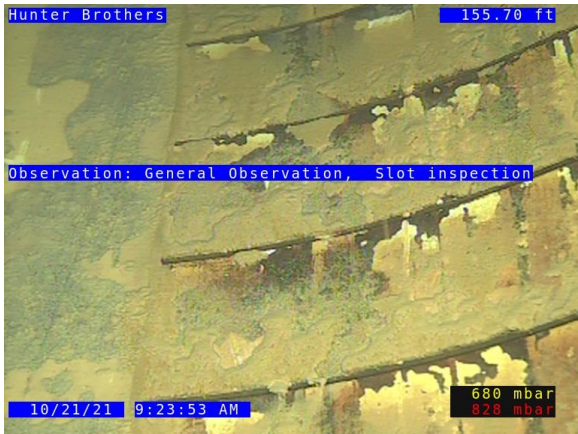
File name: **MH-MSD106 to MH-MSD108_0003.jpeg**
 Inspection date and time: **21/10/2021 08:54**
 Position: **155.69 ft**
 Code: **MGO**
General Observation, Slot inspection

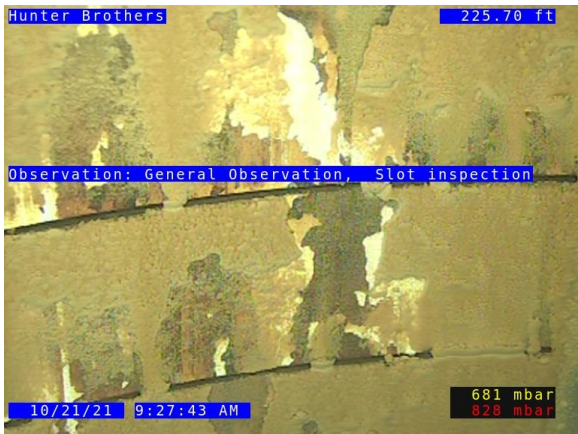
File name: **MH-MSD106 to MH-MSD108_0004.jpeg**
 Inspection date and time: **21/10/2021 08:54**
 Position: **225.70 ft**
 Code: **MGO**
General Observation, Slot inspection

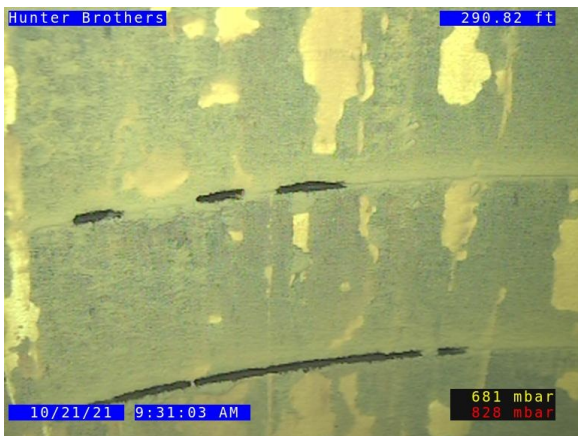
File name: **MH-MSD106 to MH-MSD108_0005.jpeg**
 Inspection date and time: **21/10/2021 08:54**
 Position: **290.82 ft**
 Code: **MGO**
General Observation, Slot inspection

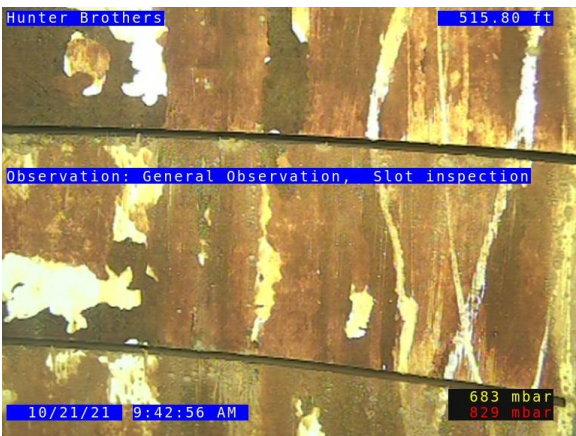
File name: **MH-MSD106 to MH-MSD108_0008.jpeg**
 Inspection date and time: **21/10/2021 08:54**
 Position: **515.79 ft**
 Code: **MGO**
General Observation, Slot inspection

recommended in the 2018 report (Atlantic Richfield Company, 2018). This would ensure multiple passes along identified problem areas above MH-MSD108 from 480 feet to 580 feet and from approximately 470 feet above MH-MSD110. The jetting SOP has been updated to include that additional hose will be added during the jetting process to ensure adequate overlap during jetting between manholes with distances greater than 1,000 feet between them.

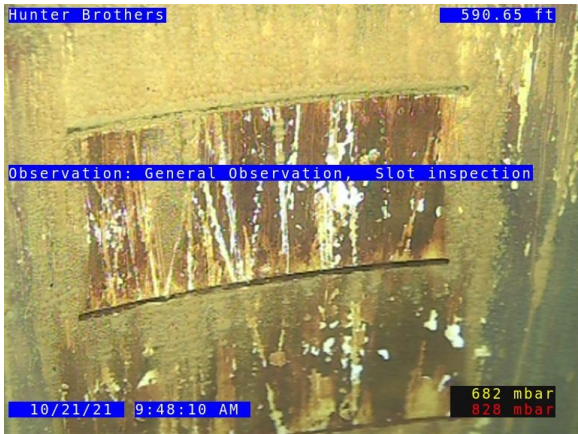
File name: **MH-MSD106 to MH-MSD108_0009.jpeg**
 Inspection date and time: **21/10/2021 08:54**
 Position: **590.64 ft**
 Code: **MGO**
General Observation, Slot inspection

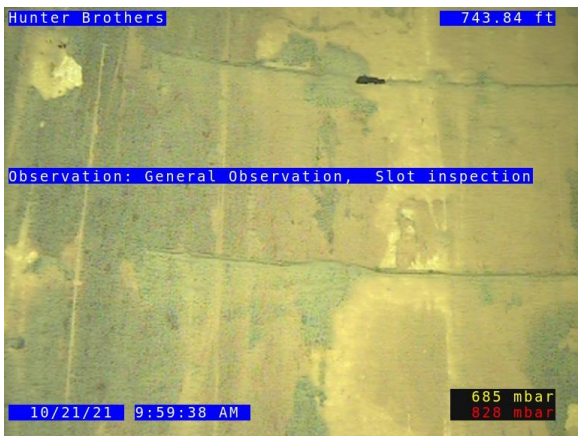
File name: **MH-MSD106 to MH-MSD108_0011.jpeg**
 Inspection date and time: **21/10/2021 08:54**
 Position: **743.83 ft**
 Code: **MGO**
General Observation, Slot inspection

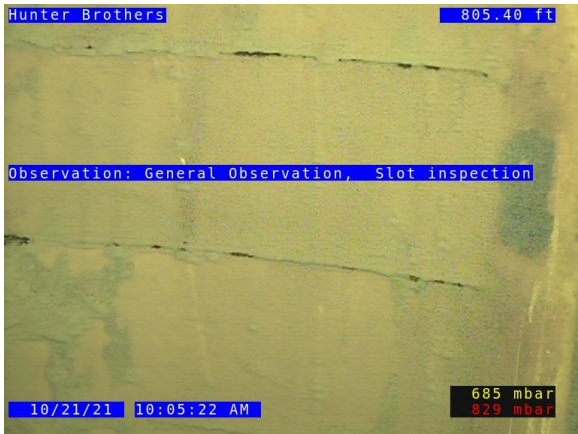
File name: **MH-MSD106 to MH-MSD108_0012.jpeg**
 Inspection date and time: **21/10/2021 08:54**
 Position: **805.39 ft**
 Code: **MGO**
General Observation, Slot inspection

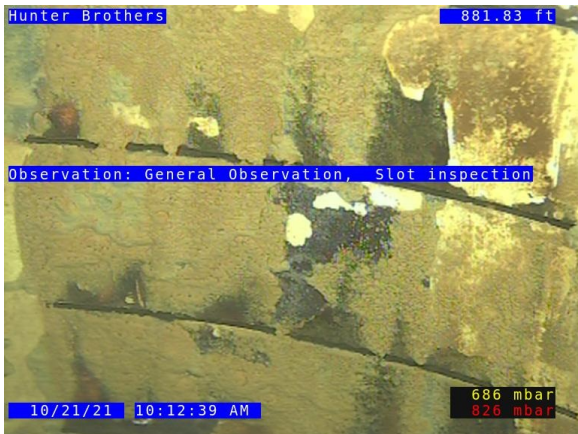
File name: **MH-MSD106 to MH-MSD108_0013.jpeg**
 Inspection date and time: **21/10/2021 08:54**
 Position: **881.82 ft**
 Code: **MGO**
General Observation, Slot inspection

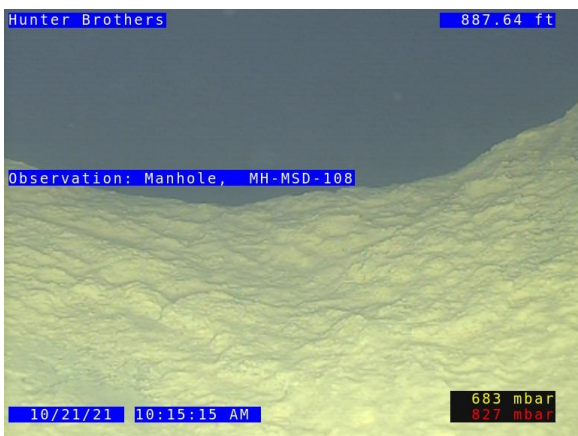
File name: **MH-MSD106 to MH-MSD108_0014.jpeg**
 Inspection date and time: **21/10/2021 08:54**
 Position: **887.63 ft**
 Code: **AMH**
Manhole, MH-MSD-108

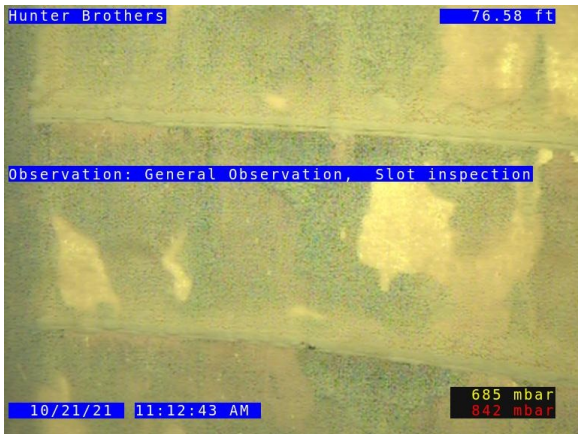
File name: **MH-MSD108 to MH-MSD110_0001.jpeg**
 Inspection date and time: **21/10/2021 11:02**
 Position: **76.58 ft**
 Code: **MGO**
General Observation, Slot inspection

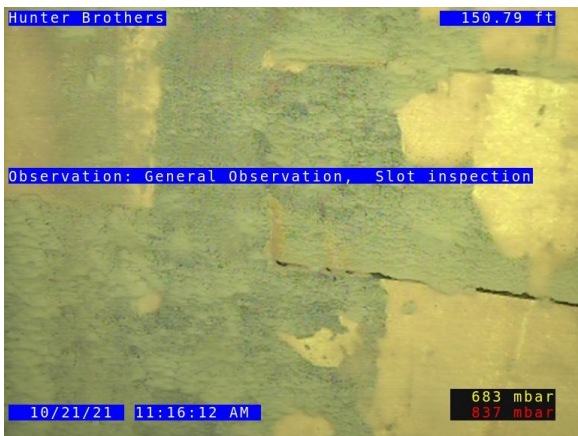
File name: **MH-MSD108 to MH-MSD110_0002.jpeg**
 Inspection date and time: **21/10/2021 11:02**
 Position: **150.79 ft**
 Code: **MGO**
General Observation, Slot inspection

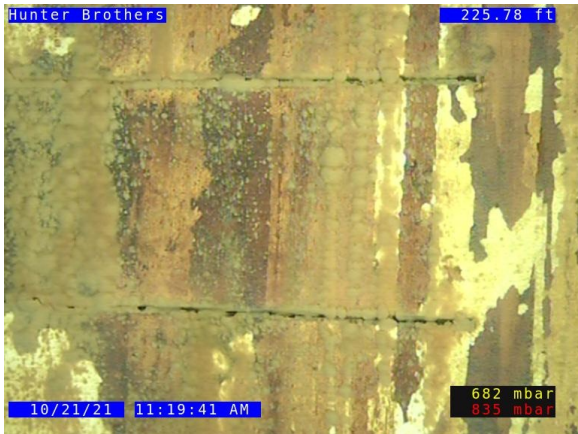
File name: **MH-MSD108 to MH-MSD110_0003.jpeg**
 Inspection date and time: **21/10/2021 11:02**
 Position: **225.77 ft**
 Code: **MGO**
General Observation, Slot inspection

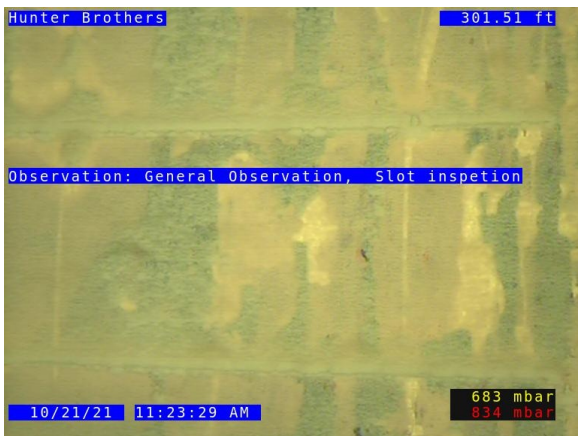
File name: **MH-MSD108 to MH-MSD110_0004.jpeg**
 Inspection date and time: **21/10/2021 11:02**
 Position: **301.50 ft**
 Code: **MGO**
General Observation, Slot inspection

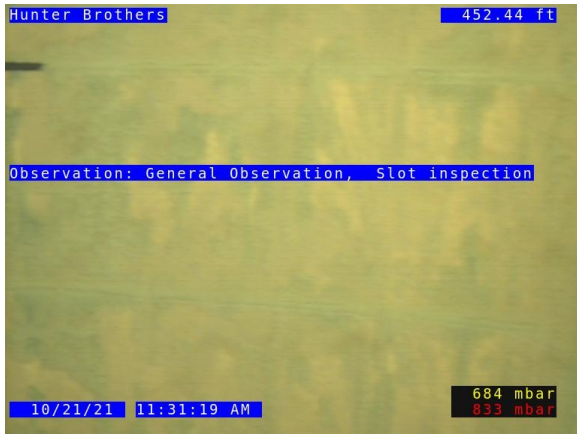
File name: **MH-MSD108 to MH-MSD110_0006.jpeg**
 Inspection date and time: **21/10/2021 11:02**
 Position: **452.43 ft**
 Code: **MGO**
General Observation, Slot inspection

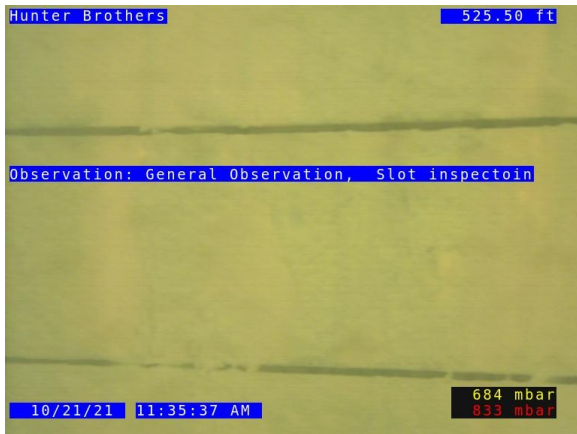
File name: **MH-MSD108 to MH-MSD110_0007.jpeg**
 Inspection date and time: **21/10/2021 11:02**
 Position: **525.49 ft**
 Code: **MGO**
General Observation, Slot inspectoin

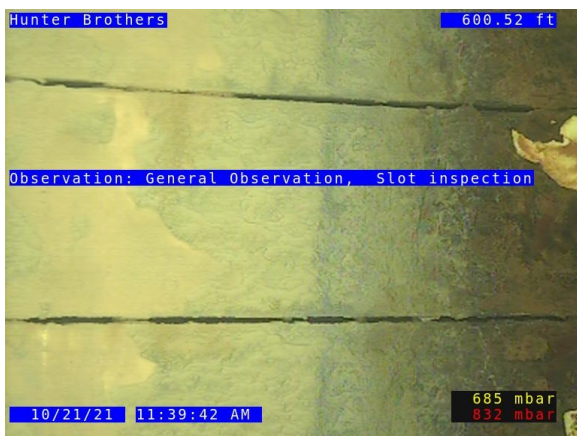
File name: **MH-MSD108 to MH-MSD110_0008.jpeg**
 Inspection date and time: **21/10/2021 11:02**
 Position: **600.52 ft**
 Code: **MGO**
General Observation, Slot inspection

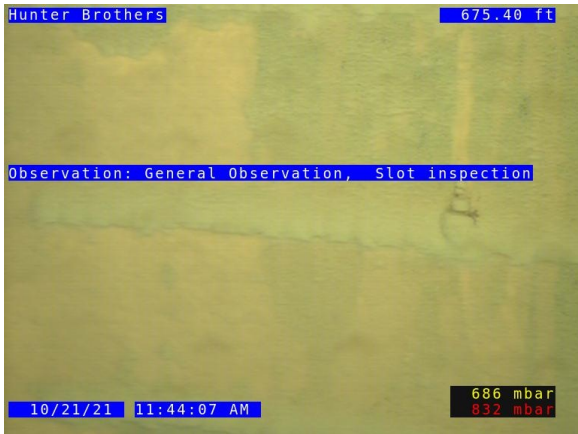
File name: **MH-MSD108 to MH-MSD110_0009.jpeg**
 Inspection date and time: **21/10/2021 11:02**
 Position: **675.40 ft**
 Code: **MGO**
General Observation, Slot inspection

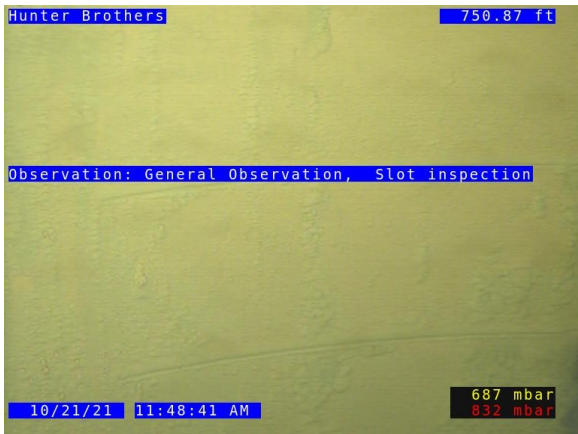
File name: **MH-MSD108 to MH-MSD110_0010.jpeg**
 Inspection date and time: **21/10/2021 11:02**
 Position: **750.86 ft**
 Code: **MGO**
General Observation, Slot inspection

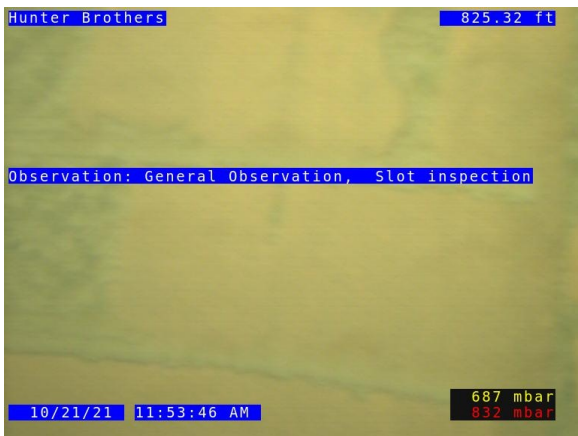
File name: **MH-MSD108 to MH-MSD110_0011.jpeg**
 Inspection date and time: **21/10/2021 11:02**
 Position: **825.31 ft**
 Code: **MGO**
General Observation, Slot inspection

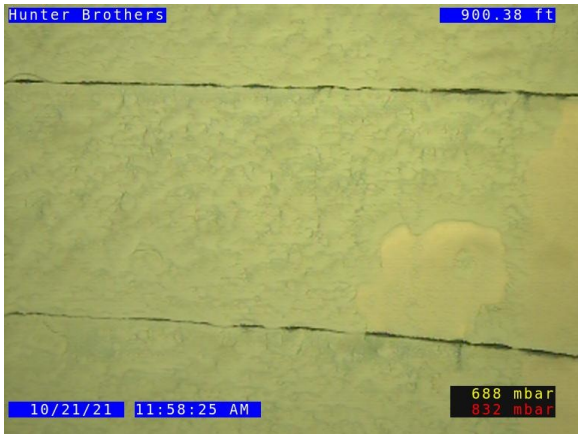
File name: **MH-MSD108 to MH-MSD110_0012.jpeg**
 Inspection date and time: **21/10/2021 11:02**
 Position: **900.36 ft**
 Code: **MGO**
General Observation, Slot inspection

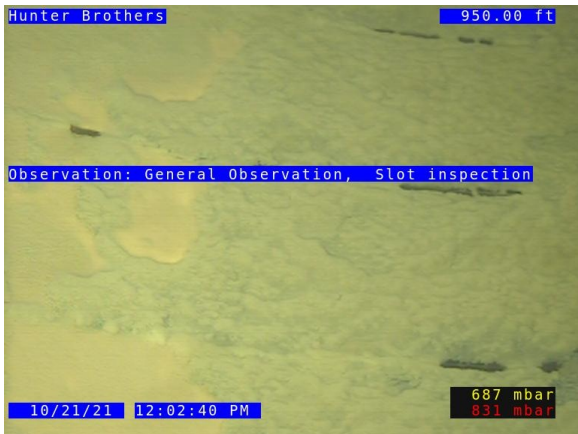
File name: **MH-MSD108 to MH-MSD110_0013.jpeg**
 Inspection date and time: **21/10/2021 11:02**
 Position: **949.99 ft**
 Code: **MGO**
General Observation, Slot inspection

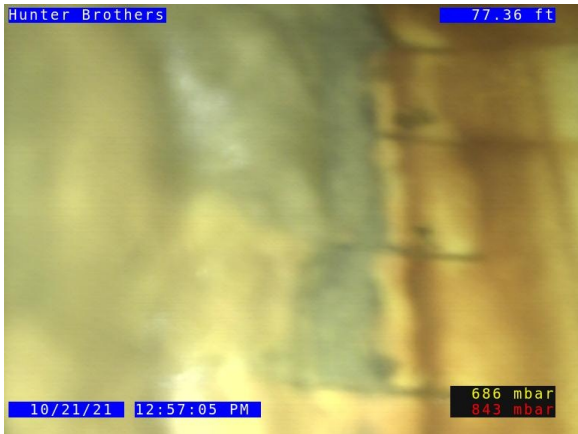
File name: **MH-MSD110 to MH-MSD108_0001.jpeg**
 Inspection date and time: **21/10/2021 12:44**
 Position: **77.36 ft**
 Code: **MGO**
General Observation, Slot inspection

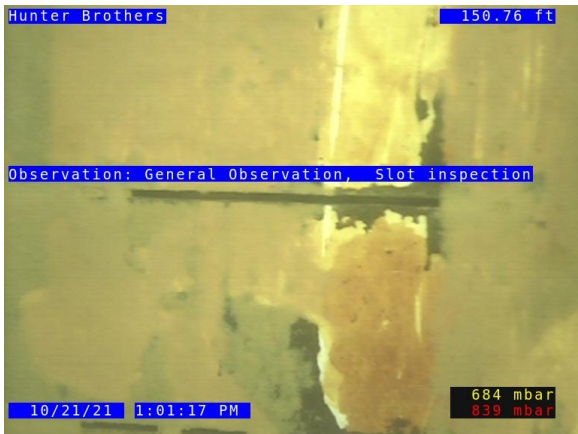
File name: **MH-MSD110 to MH-MSD108_0002.jpeg**
 Inspection date and time: **21/10/2021 12:44**
 Position: **150.76 ft**
 Code: **MGO**
General Observation, Slot inspection

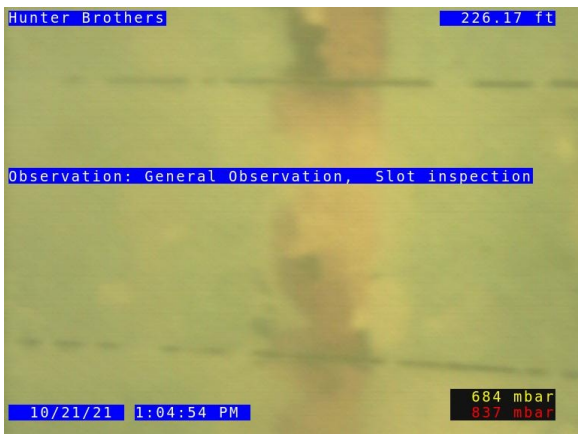
File name: **MH-MSD110 to MH-MSD108_0003.jpeg**
 Inspection date and time: **21/10/2021 12:44**
 Position: **226.16 ft**
 Code: **MGO**
General Observation, Slot inspection

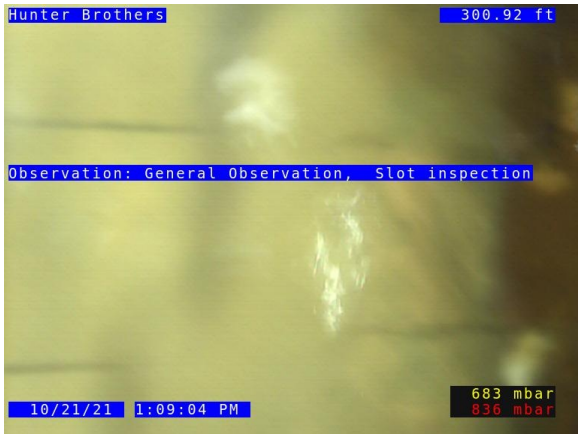
File name: **MH-MSD110 to MH-MSD108_0004.jpeg**
 Inspection date and time: **21/10/2021 12:44**
 Position: **300.91 ft**
 Code: **MGO**
General Observation, Slot inspection

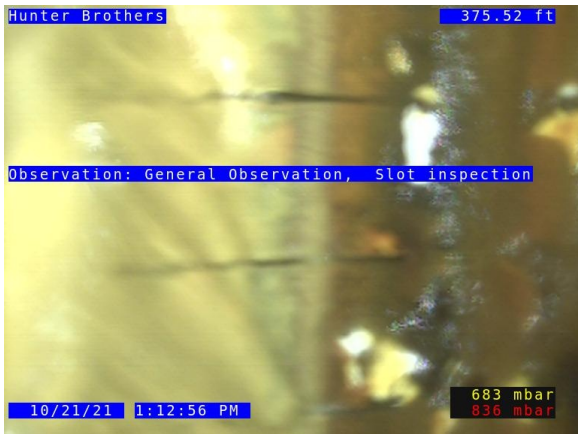
File name: **MH-MSD110 to MH-MSD108_0005.jpeg**
 Inspection date and time: **21/10/2021 12:44**
 Position: **375.51 ft**
 Code: **MGO**
General Observation, Slot inspection

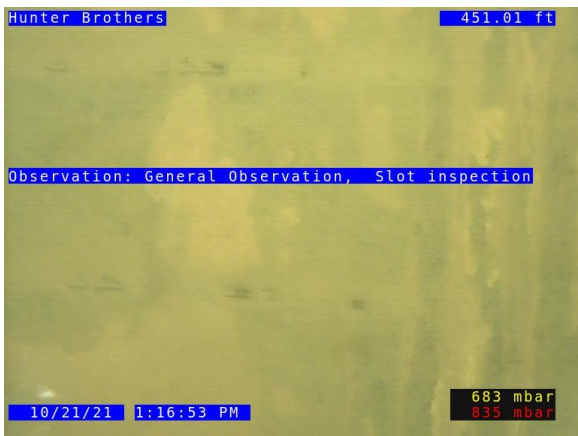
File name: **MH-MSD110 to MH-MSD108_0006.jpeg**
 Inspection date and time: **21/10/2021 12:44**
 Position: **451.00 ft**
 Code: **MGO**
General Observation, Slot inspection

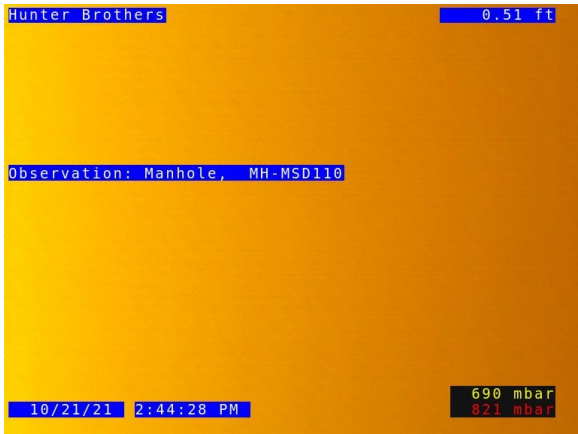
File name: **MH-MSD110 to MH-MSD113_0016.jpeg**
 Inspection date and time: **21/10/2021 13:32**
 Position: **0.51 ft**
 Code: **AMH**
Manhole, MH-MSD110

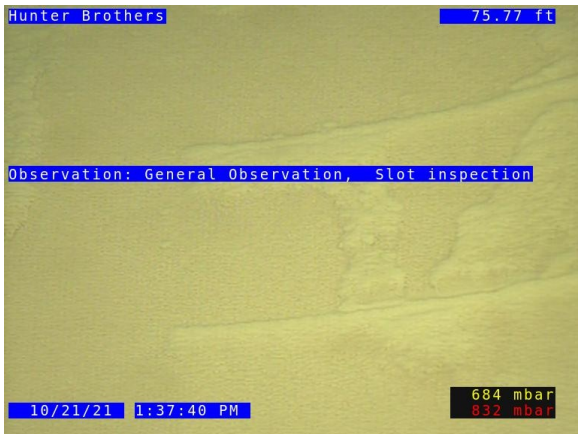
File name: **MH-MSD110 to MH-MSD113_0001.jpeg**
 Inspection date and time: **21/10/2021 13:32**
 Position: **75.77 ft**
 Code: **MGO**
General Observation, Slot inspection

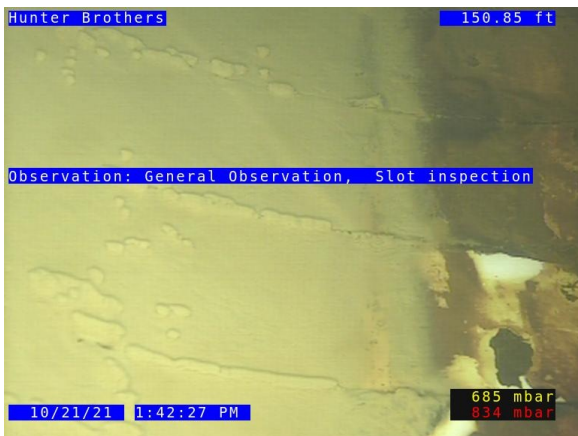
File name: **MH-MSD110 to MH-MSD113_0002.jpeg**
 Inspection date and time: **21/10/2021 13:32**
 Position: **150.85 ft**
 Code: **MGO**
General Observation, Slot inspection

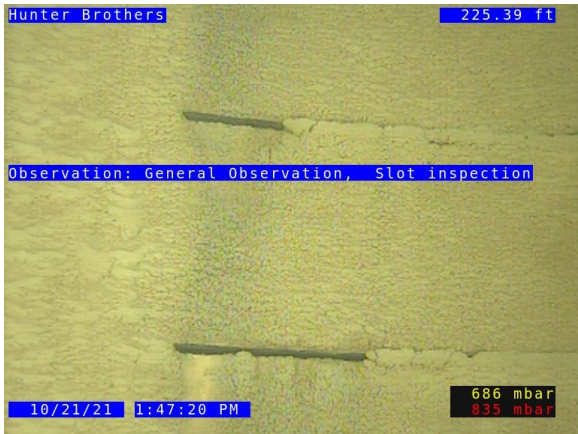
File name: **MH-MSD110 to MH-MSD113_0003.jpeg**
 Inspection date and time: **21/10/2021 13:32**
 Position: **225.39 ft**
 Code: **MGO**
General Observation, Slot inspection

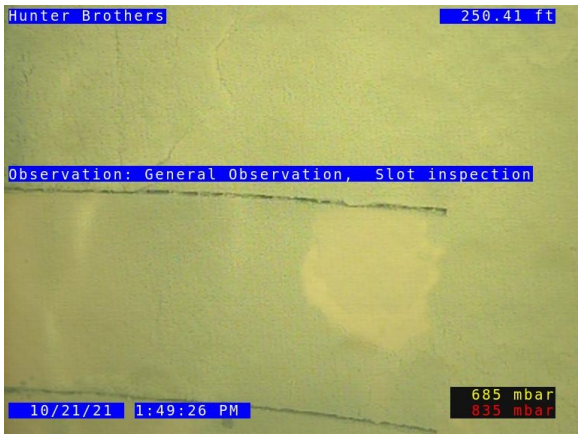
File name: **MH-MSD110 to MH-MSD113_0004.jpeg**
 Inspection date and time: **21/10/2021 13:32**
 Position: **250.41 ft**
 Code: **MGO**
General Observation, Slot inspection

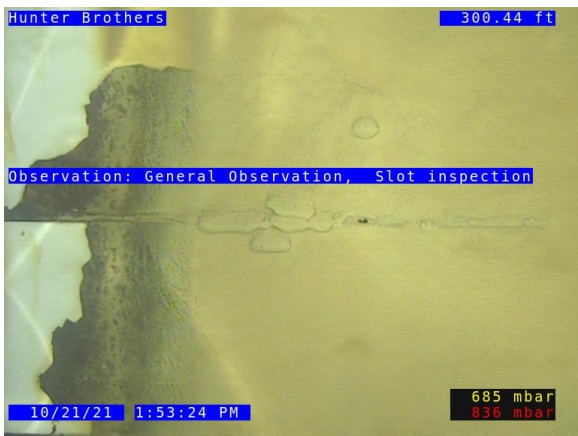
File name: **MH-MSD110 to MH-MSD113_0005.jpeg**
 Inspection date and time: **21/10/2021 13:32**
 Position: **300.44 ft**
 Code: **MGO**
General Observation, Slot inspection

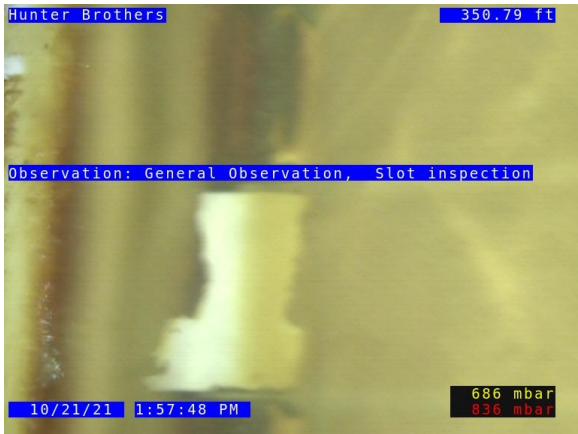
File name: **MH-MSD110 to MH-MSD113_0006.jpeg**
 Inspection date and time: **21/10/2021 13:32**
 Position: **350.79 ft**
 Code: **MGO**
General Observation, Slot inspection

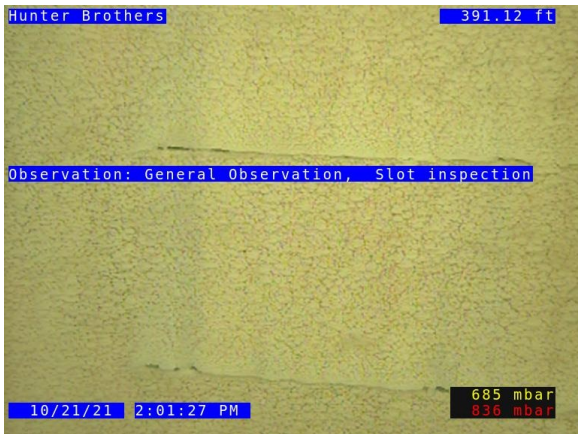
File name: **MH-MSD110 to MH-MSD113_0007.jpeg**
 Inspection date and time: **21/10/2021 13:32**
 Position: **391.11 ft**
 Code: **MGO**
General Observation, Slot inspection

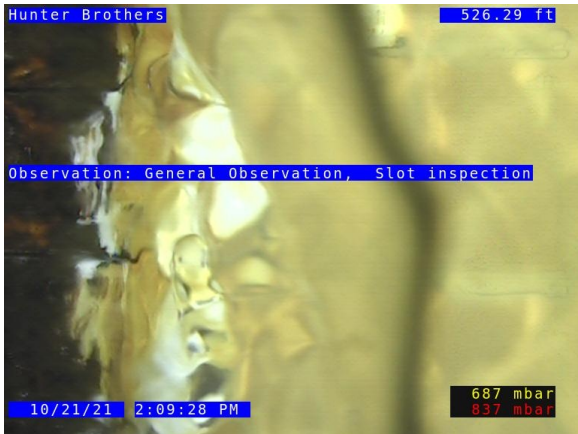
File name: **MH-MSD110 to MH-MSD113_0009.jpeg**
 Inspection date and time: **21/10/2021 13:32**
 Position: **526.28 ft**
 Code: **MGO**
General Observation, Slot inspection

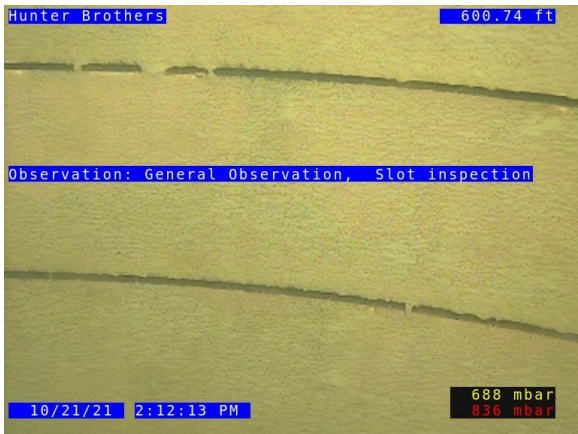
File name: **MH-MSD110 to MH-MSD113_0010.jpeg**
 Inspection date and time: **21/10/2021 13:32**
 Position: **600.73 ft**
 Code: **MGO**
General Observation, Slot inspection

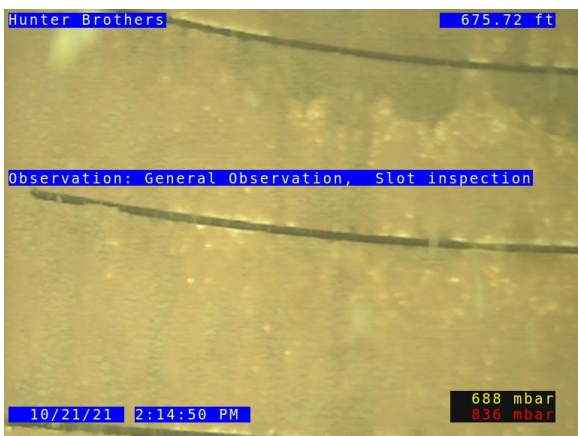
File name: **MH-MSD110 to MH-MSD113_0011.jpeg**
 Inspection date and time: **21/10/2021 13:32**
 Position: **675.71 ft**
 Code: **MGO**
General Observation, Slot inspection

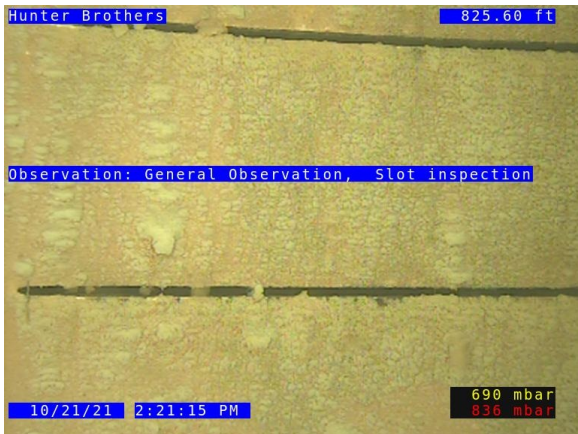
File name: **MH-MSD110 to MH-MSD113_0013.jpeg**
 Inspection date and time: **21/10/2021 13:32**
 Position: **825.59 ft**
 Code: **MGO**
General Observation, Slot inspection

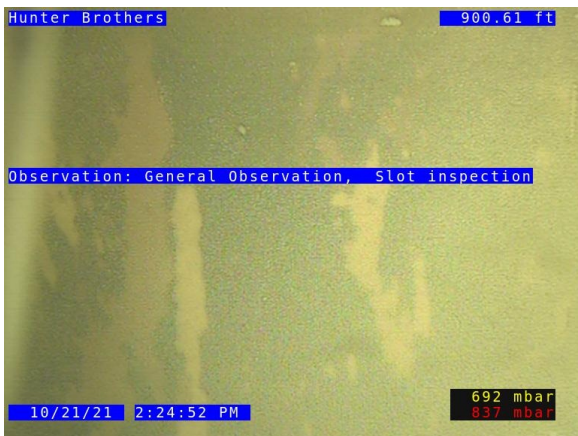
File name: **MH-MSD110 to MH-MSD113_0014.jpeg**
 Inspection date and time: **21/10/2021 13:32**
 Position: **900.60 ft**
 Code: **MGO**
General Observation, Slot inspection

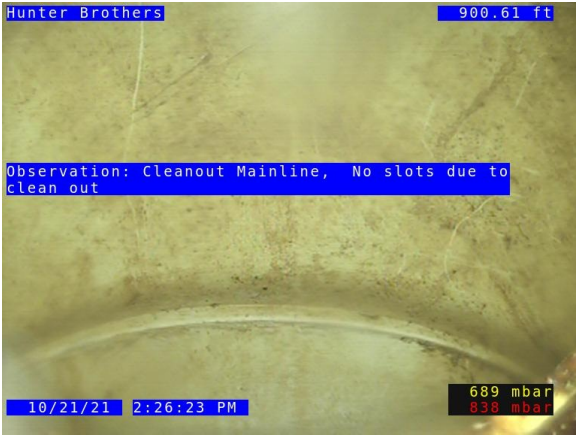
File name: **MH-MSD110 to MH-MSD113_0015.jpeg**
 Inspection date and time: **21/10/2021 13:32**
 Position: **900.60 ft**
 Code: **ACOM**
Cleanout Mainline, No slots due to clean out

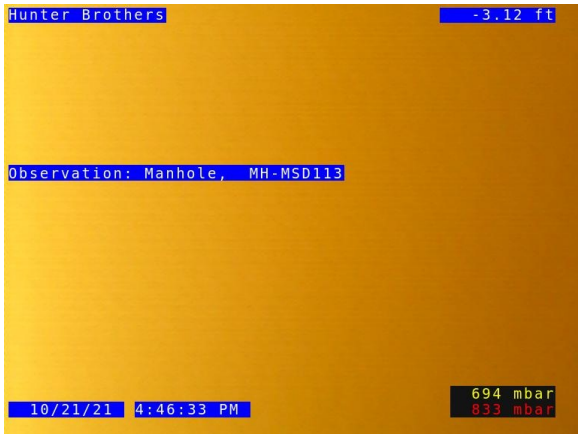
File name: **MH-MSD113 to MH-MSD116_0013.jpeg**
 Inspection date and time: **21/10/2021 15:44**
 Position: **-3.12 ft**
 Code: **AMH**
Manhole, MH-MSD113

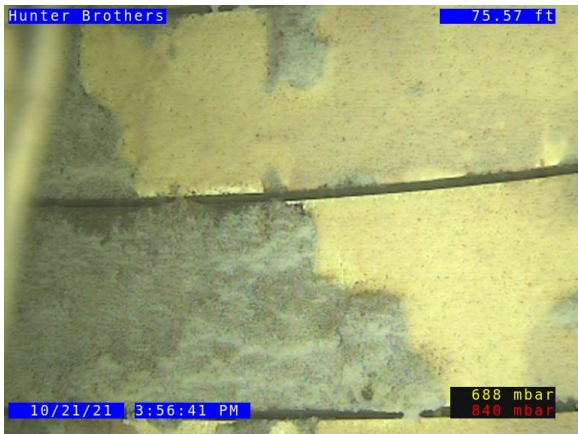
File name: **MH-MSD113 to MH-MSD116_0001.jpeg**
 Inspection date and time: **21/10/2021 15:44**
 Position: **75.57 ft**
 Code: **MGO**
General Observation, Slot inspection

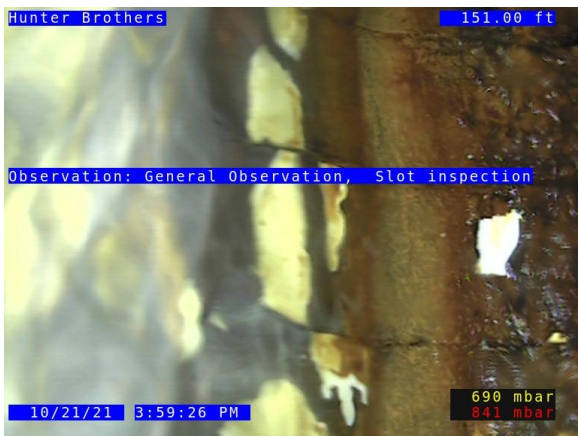
File name: **MH-MSD113 to MH-MSD116_0002.jpeg**
 Inspection date and time: **21/10/2021 15:44**
 Position: **151.00 ft**
 Code: **MGO**
General Observation, Slot inspection

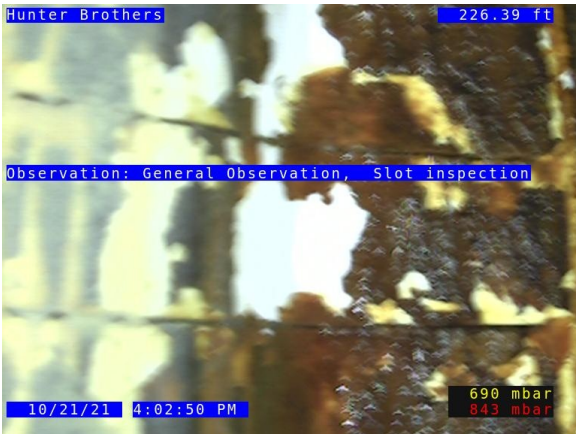
File name: **MH-MSD113 to MH-MSD116_0003.jpeg**
 Inspection date and time: **21/10/2021 15:44**
 Position: **226.39 ft**
 Code: **MGO**
General Observation, Slot inspection

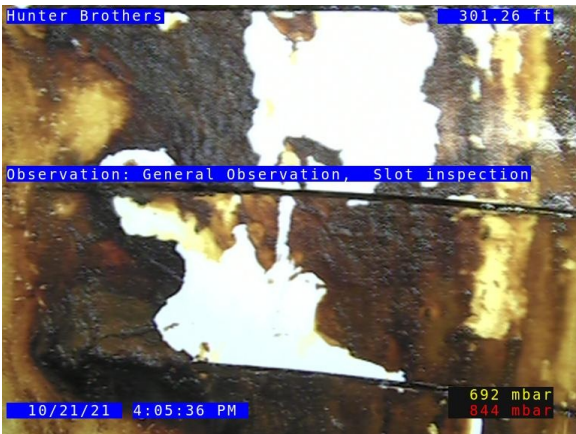
File name: **MH-MSD113 to MH-MSD116_0004.jpeg**
 Inspection date and time: **21/10/2021 15:44**
 Position: **301.26 ft**
 Code: **MGO**
General Observation, Slot inspection

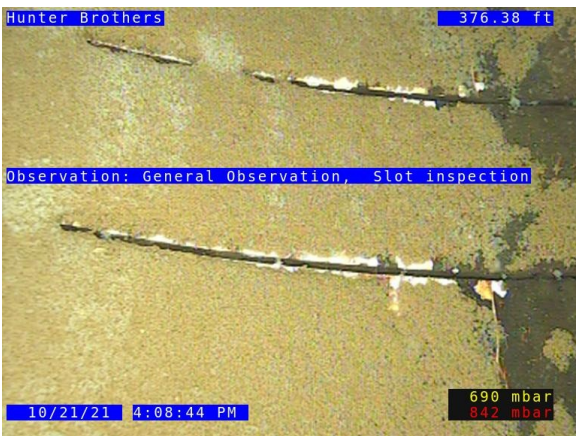
File name: **MH-MSD113 to MH-MSD116_0005.jpeg**
 Inspection date and time: **21/10/2021 15:44**
 Position: **376.38 ft**
 Code: **MGO**
General Observation, Slot inspection

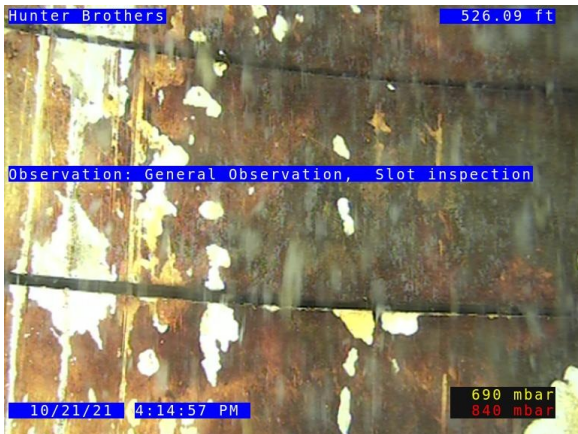
File name: **MH-MSD113 to MH-MSD116_0007.jpeg**
 Inspection date and time: **21/10/2021 15:44**
 Position: **526.08 ft**
 Code: **MGO**
General Observation, Slot inspection

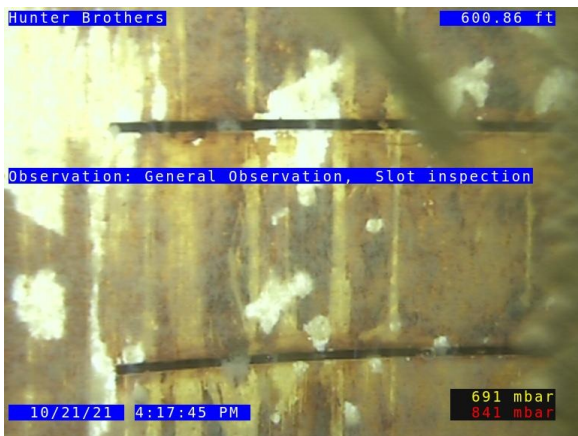
File name: **MH-MSD113 to MH-MSD116_0008.jpeg**
 Inspection date and time: **21/10/2021 15:44**
 Position: **600.85 ft**
 Code: **MGO**
General Observation, Slot inspection

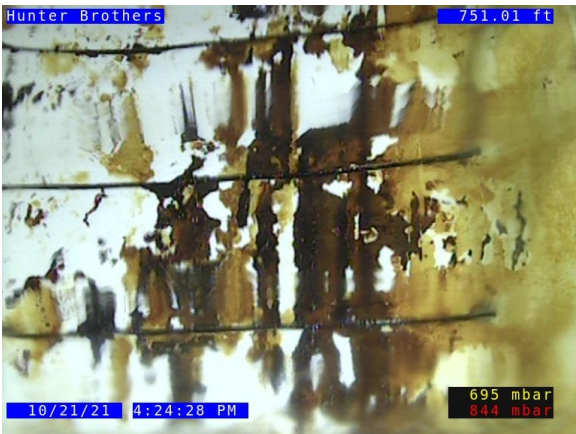
File name: **MH-MSD113 to MH-MSD116_0010.jpeg**
 Inspection date and time: **21/10/2021 15:44**
 Position: **751.00 ft**
 Code: **MGO**
General Observation, Slot inspection

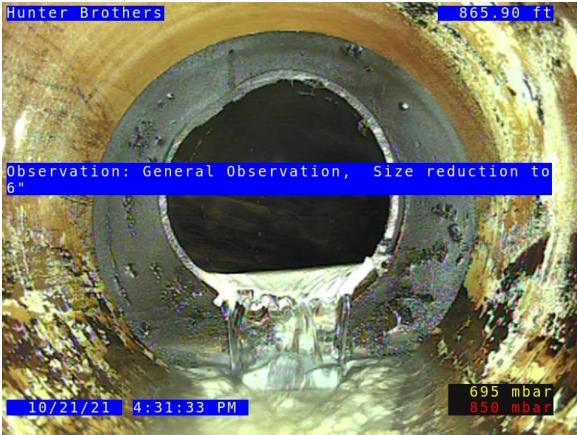
File name: **MH-MSD113 to MH-MSD116_0012.jpeg**
 Inspection date and time: **21/10/2021 15:44**
 Position: **865.89 ft**
 Code: **MGO**
General Observation, Size reduction to 6"

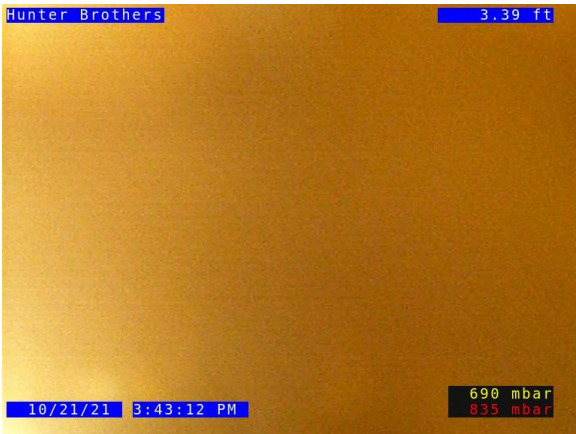
File name: **MH-MSD113 to MH-MSD110_0009.jpeg**
 Inspection date and time: **21/10/2021 15:06**
 Position: **3.39 ft**
 Code: **MGO**
General Observation, MH-MSD113
