Silver Bow Creek/Butte Area Superfund Site

Draft Final Annual Operations and Maintenance (O&M) Report, Butte Treatment Lagoon (BTL) System – 2021

RE: Butte Priority Soils Operable Unit (BPSOU) Draft Final Annual Operations and Maintenance (O&M) Report Butte Treatment Lagoon System – 2021

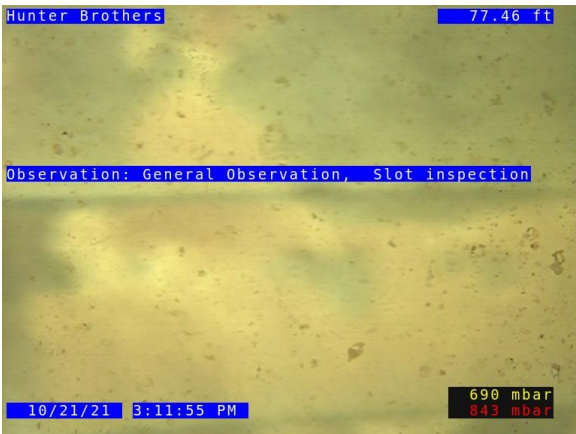
File name: **MH-MSD113 to MH-MSD110_0001.jpeg**
 Inspection date and time: **21/10/2021 15:06**
 Position: **77.46 ft**
 Code: **MGO**
General Observation, Slot inspection

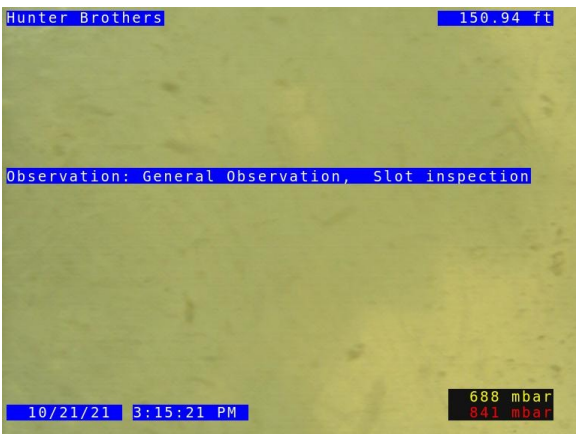
File name: **MH-MSD113 to MH-MSD110_0002.jpeg**
 Inspection date and time: **21/10/2021 15:06**
 Position: **150.93 ft**
 Code: **MGO**
General Observation, Slot inspection

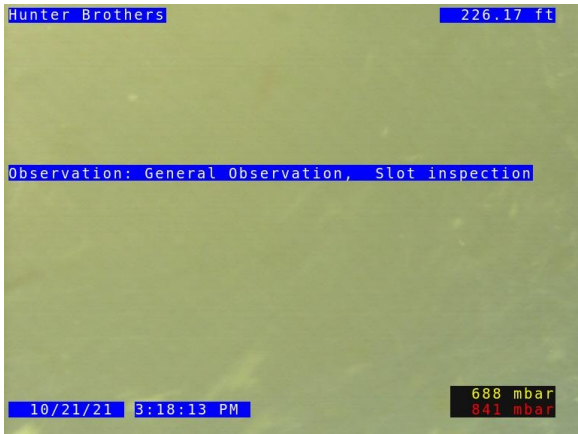
File name: **MH-MSD113 to MH-MSD110_0003.jpeg**
 Inspection date and time: **21/10/2021 15:06**
 Position: **226.17 ft**
 Code: **MGO**
General Observation, Slot inspection

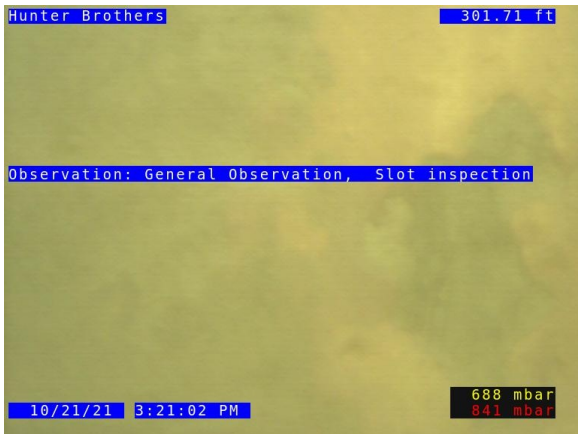
File name: **MH-MSD113 to MH-MSD110_0004.jpeg**
 Inspection date and time: **21/10/2021 15:06**
 Position: **301.71 ft**
 Code: **MGO**
General Observation, Slot inspection

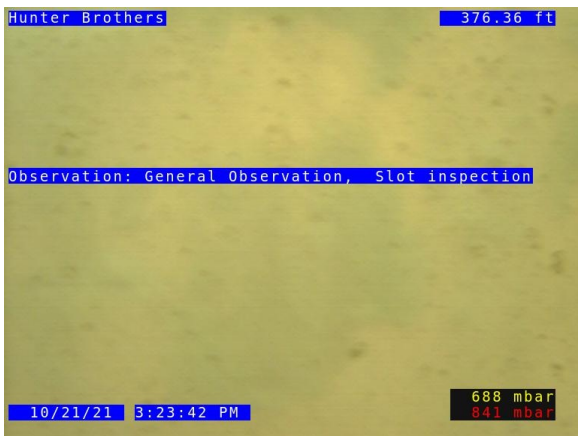
File name: **MH-MSD113 to MH-MSD110_0005.jpeg**
 Inspection date and time: **21/10/2021 15:06**
 Position: **376.35 ft**
 Code: **MGO**
General Observation, Slot inspection

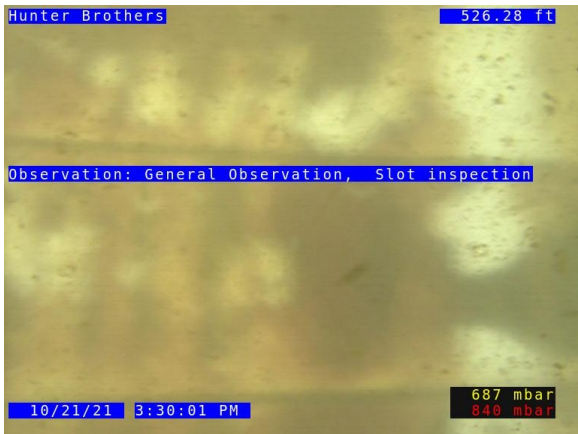
File name: **MH-MSD113 to MH-MSD110_0007.jpeg**
 Inspection date and time: **21/10/2021 15:06**
 Position: **526.27 ft**
 Code: **MGO**
General Observation, Slot inspection

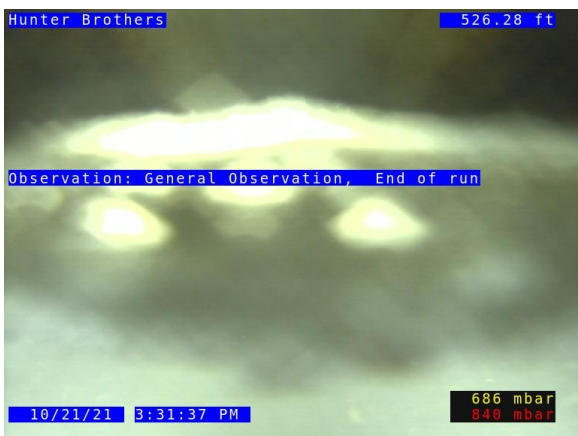
File name: **MH-MSD113 to MH-MSD110_0008.jpeg**
 Inspection date and time: **21/10/2021 15:06**
 Position: **526.27 ft**
 Code: **MGO**
General Observation, End of run

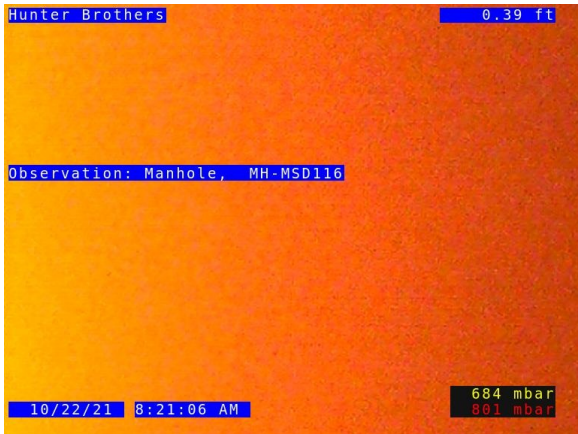
File name: **MH-MSD116 to East end_0006.jpeg**
 Inspection date and time: **22/10/2021 07:51**
 Position: **0.39 ft**
 Code: **AMH**
Manhole, MH-MSD116

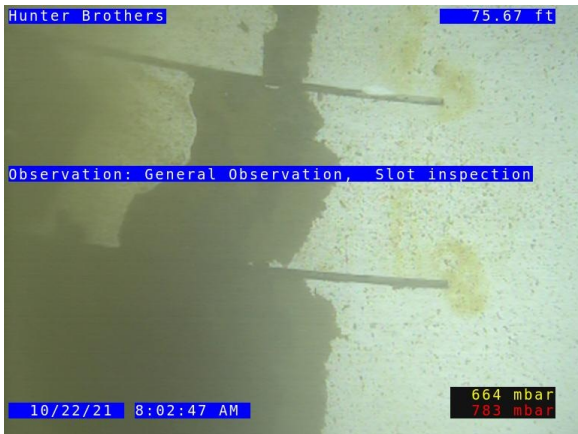
File name: **MH-MSD116 to East end_0001.jpeg**
 Inspection date and time: **22/10/2021 07:51**
 Position: **75.67 ft**
 Code: **MGO**
General Observation, Slot inspection

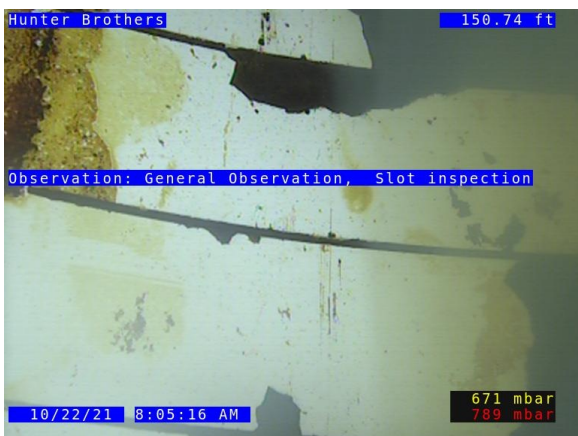
File name: **MH-MSD116 to East end_0002.jpeg**
 Inspection date and time: **22/10/2021 07:51**
 Position: **150.74 ft**
 Code: **MGO**
General Observation, Slot inspection

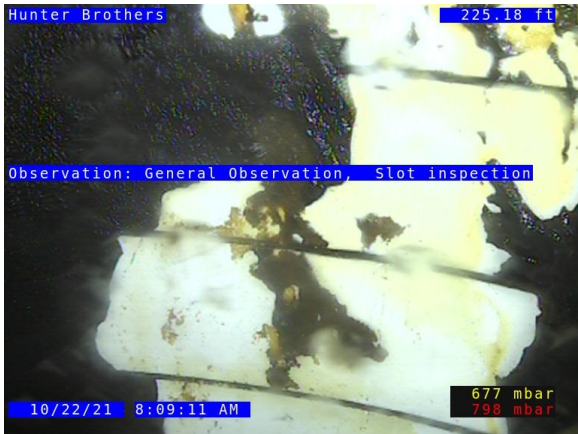
File name: **MH-MSD116 to East end_0003.jpeg**
 Inspection date and time: **22/10/2021 07:51**
 Position: **225.17 ft**
 Code: **MGO**
General Observation, Slot inspection

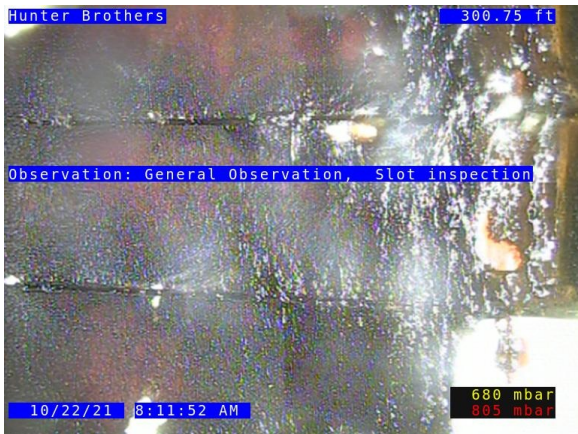
File name: **MH-MSD116 to East end_0004.jpeg**
 Inspection date and time: **22/10/2021 07:51**
 Position: **300.75 ft**
 Code: **MGO**
General Observation, Slot inspection

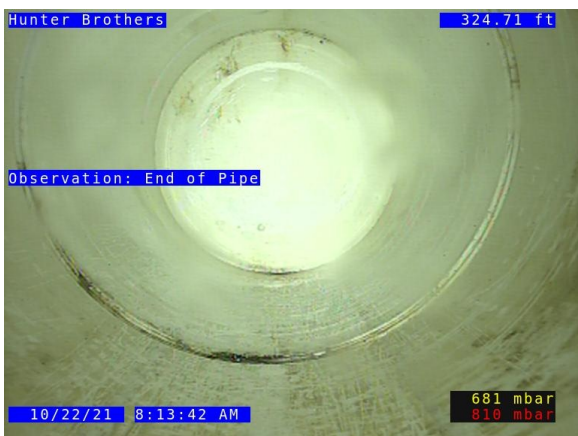
File name: **MH-MSD116 to East end_0005.jpeg**
 Inspection date and time: **22/10/2021 07:51**
 Position: **324.71 ft**
 Code: **AEP**
End of Pipe
