### Slip Resistance Evaluation of 10 Indoor Floor Surfaces

**How to cite this article:** Snow C, Hays C, Girard S, Birkenbuel L, Autenrieth D, Gilkey D. Slip Resistance Evaluation of 10 Indoor Floor Surfaces. *IgMin Res.* June 17, 2024; 2(6): 440-445. IgMin ID: igmin199; DOI: 10.61927/igmin199; Available at: [igmin.link/p199](https://igmin.link/p199)

# Slip Resistance Evaluation of 10 Indoor Floor Surfaces

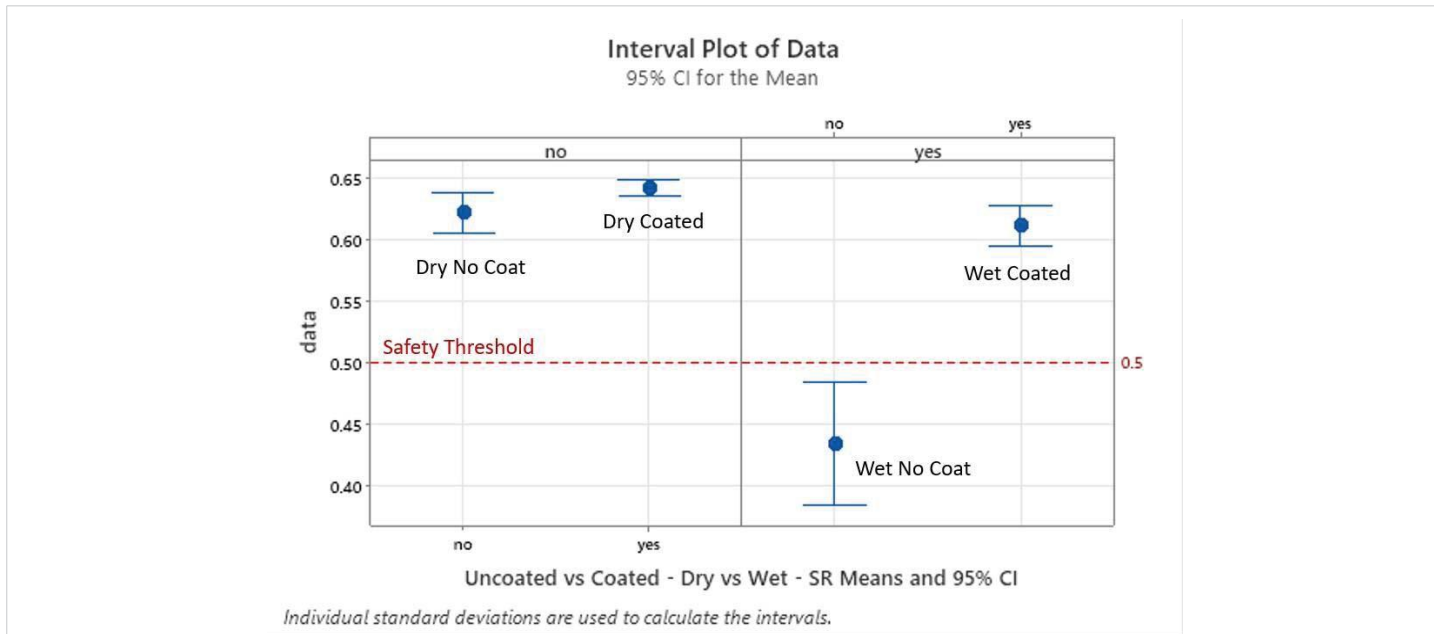
**Figure 1:** Interval Plot of Dry vs. Wet and Uncoated vs. Coated Mean SR w/95% CI. Significant Differences – *p* - values < 0.05 in Uncoated Dry vs. Wet.

Looking at the means seen on an interval plot, one can see the dry SR measurements were well above the 0.50 safety threshold for both coated and uncoated surfaces, Figure 1. Whereas, looking at the wet conditions the SR measurements of the uncoated tiles were below the recommended 0.50 SR level.

The data were skewed to the right. The GLM provided a best-fit model yielding normality plots, fitted values, residuals, and observation orders, see Figure 1. Data conform to a straight line on the residual normality plot. The versus fits plot identifies the random nature of the distribution of data points with a right skewness. The histogram of residuals shows a more normal distribution of data points. The versus order plots confirm the independence of data points, see Figure 1.

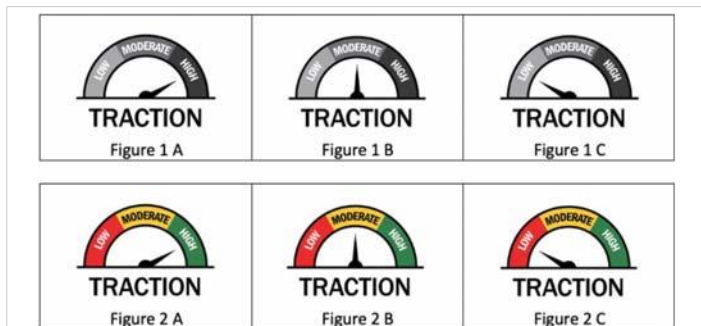
**Figure 2:** Proposed NFSI Labeling Exemplars.

or floor [3]. Falls are the third leading cause of unintentional fatality among the general population and #1 for those over 70 years of age [3]. Falls disproportionately adversely impact our seniors with 20% to 30% suffering moderate to severe injury due to fall events [3]. The overall lifetime risk for death due to a fall is 1 in 102. Assessing SR and informing users is a sound strategy to reduce slips and falls. The NFSI has provided some exemplar figures, see Figure 2, that represent low, moderate, and high traction [3].

The NFSI provided specific definitions for low, moderate, and high resistance (Table 2). The exemplars seen in Figure 2 were designed and developed to assist the residential and commercial consumer in selecting products not only for functional and aesthetic appeal but also for safety reasons. The exemplars were created to convey the meaningful slip resistance values listed in Table 2 [3]. The arrows pointing to the classifications of traction are consistent with prior NFSI standards adopted in 2015 for recommended slip resistance
