# WHOLE BODY VIBRATION EXPOSURE TO CRANE OPERATOR'S

Steve Campbell, CSP

A report submitted in partial fulfillment of the  
requirements for the  
Master of Science Degree in Industrial Hygiene

2015

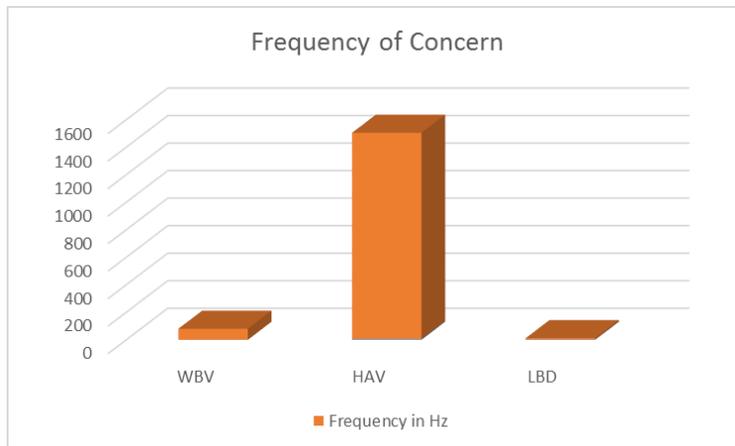
Chart 1: Frequency Ranges of Concern by Body Part

In this study we will look for vibration throughout the range of concern but we will give more relevance to ranges between the 2-10 Hz range. These ranges are illustrated in the chart following, Chart 1.

The frequency of concern for whole body vibration is 0.5 to 80 Hz (ANSI, 2002). Depending on the part of the body we are concerned with the range of frequency can be a subset of the overall range. As an example the range of frequency of concern for hand-arm vibration (HAV) is 5 to 1500 Hz (Paschold, 2011). The lower back appears to be most sensitive to the range of 2 – 10 Hz according to one study (Limerick, 2015).

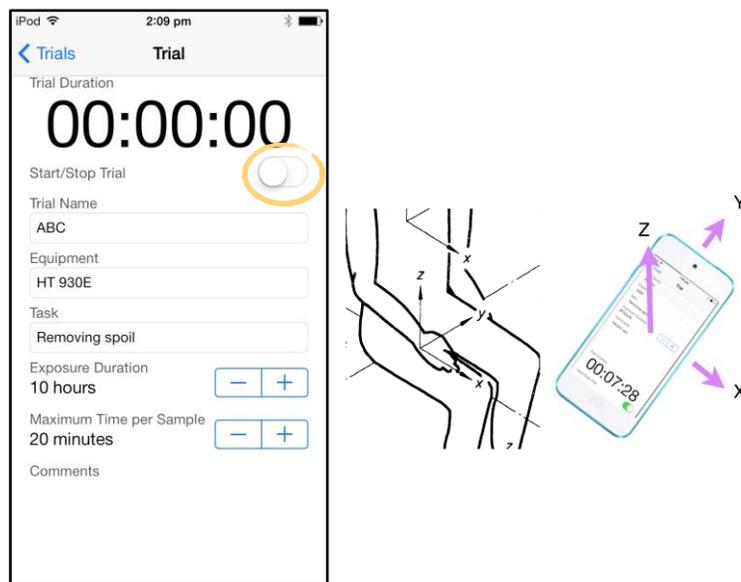
**Figure 1: x, y and z axis and proper alignment for testing**

floor tests were done at the base of the seats of the cranes. The I-phone was placed per figure 1, on the floor at the base of the center of the seat. Seat tests were conducted between the operator's legs while seated in the crane, in alignment with figure 1 alignment. The collection of data was primarily done with cranes working on a wind farm site over the course of a month. All of the cranes at the wind site were sitting on earthen crane pads. In most cases this consisted of blasted rock. The rough terrain hydraulic cranes were all supported by the outriggers in the fully extended position. The outriggers rested on outrigger pads on the ground. The two Linkbelt 418 and 518 cranes were tested at a bridge construction site. Both cranes were crawler type and sitting directly on wood mats set atop a temporary trestle.

Root mean squared (RMS) values for the x axis ranged from .01 to .13 on the floor for rough terrain cranes and .01 to .10 for lattice boom crawler style cranes. RMS values for the y axis ranged from .02 to .14 on the floor for rough terrain cranes and .01 to .10 for lattice boom crawler style cranes. Root mean squared (RMS) values for the z axis ranged from .05 m/s<sup>2</sup> to .16 m/s<sup>2</sup> on the floor for rough terrain cranes and .03 m/s<sup>2</sup> to .17m/s<sup>2</sup> for lattice boom crawler style cranes. None of these values exceed the Action Level of 0.5 m/s<sup>2</sup> let alone the Exposure Limit Value of 1.15 m/s<sup>2</sup> as set by the ISO2631.1 or AS2670.1. See Figure 1 below for reference to the axis of measurement.
