Silver Bow Creek/Butte Area Superfund Site

Butte Priority Soils Operable Unit (BPSOU) Unreclaimed Sites Draft Final Field Sampling Plan (FSP) Package #7: UR-01, UR-02, UR-03, UR-04, UR-15, and UR-17

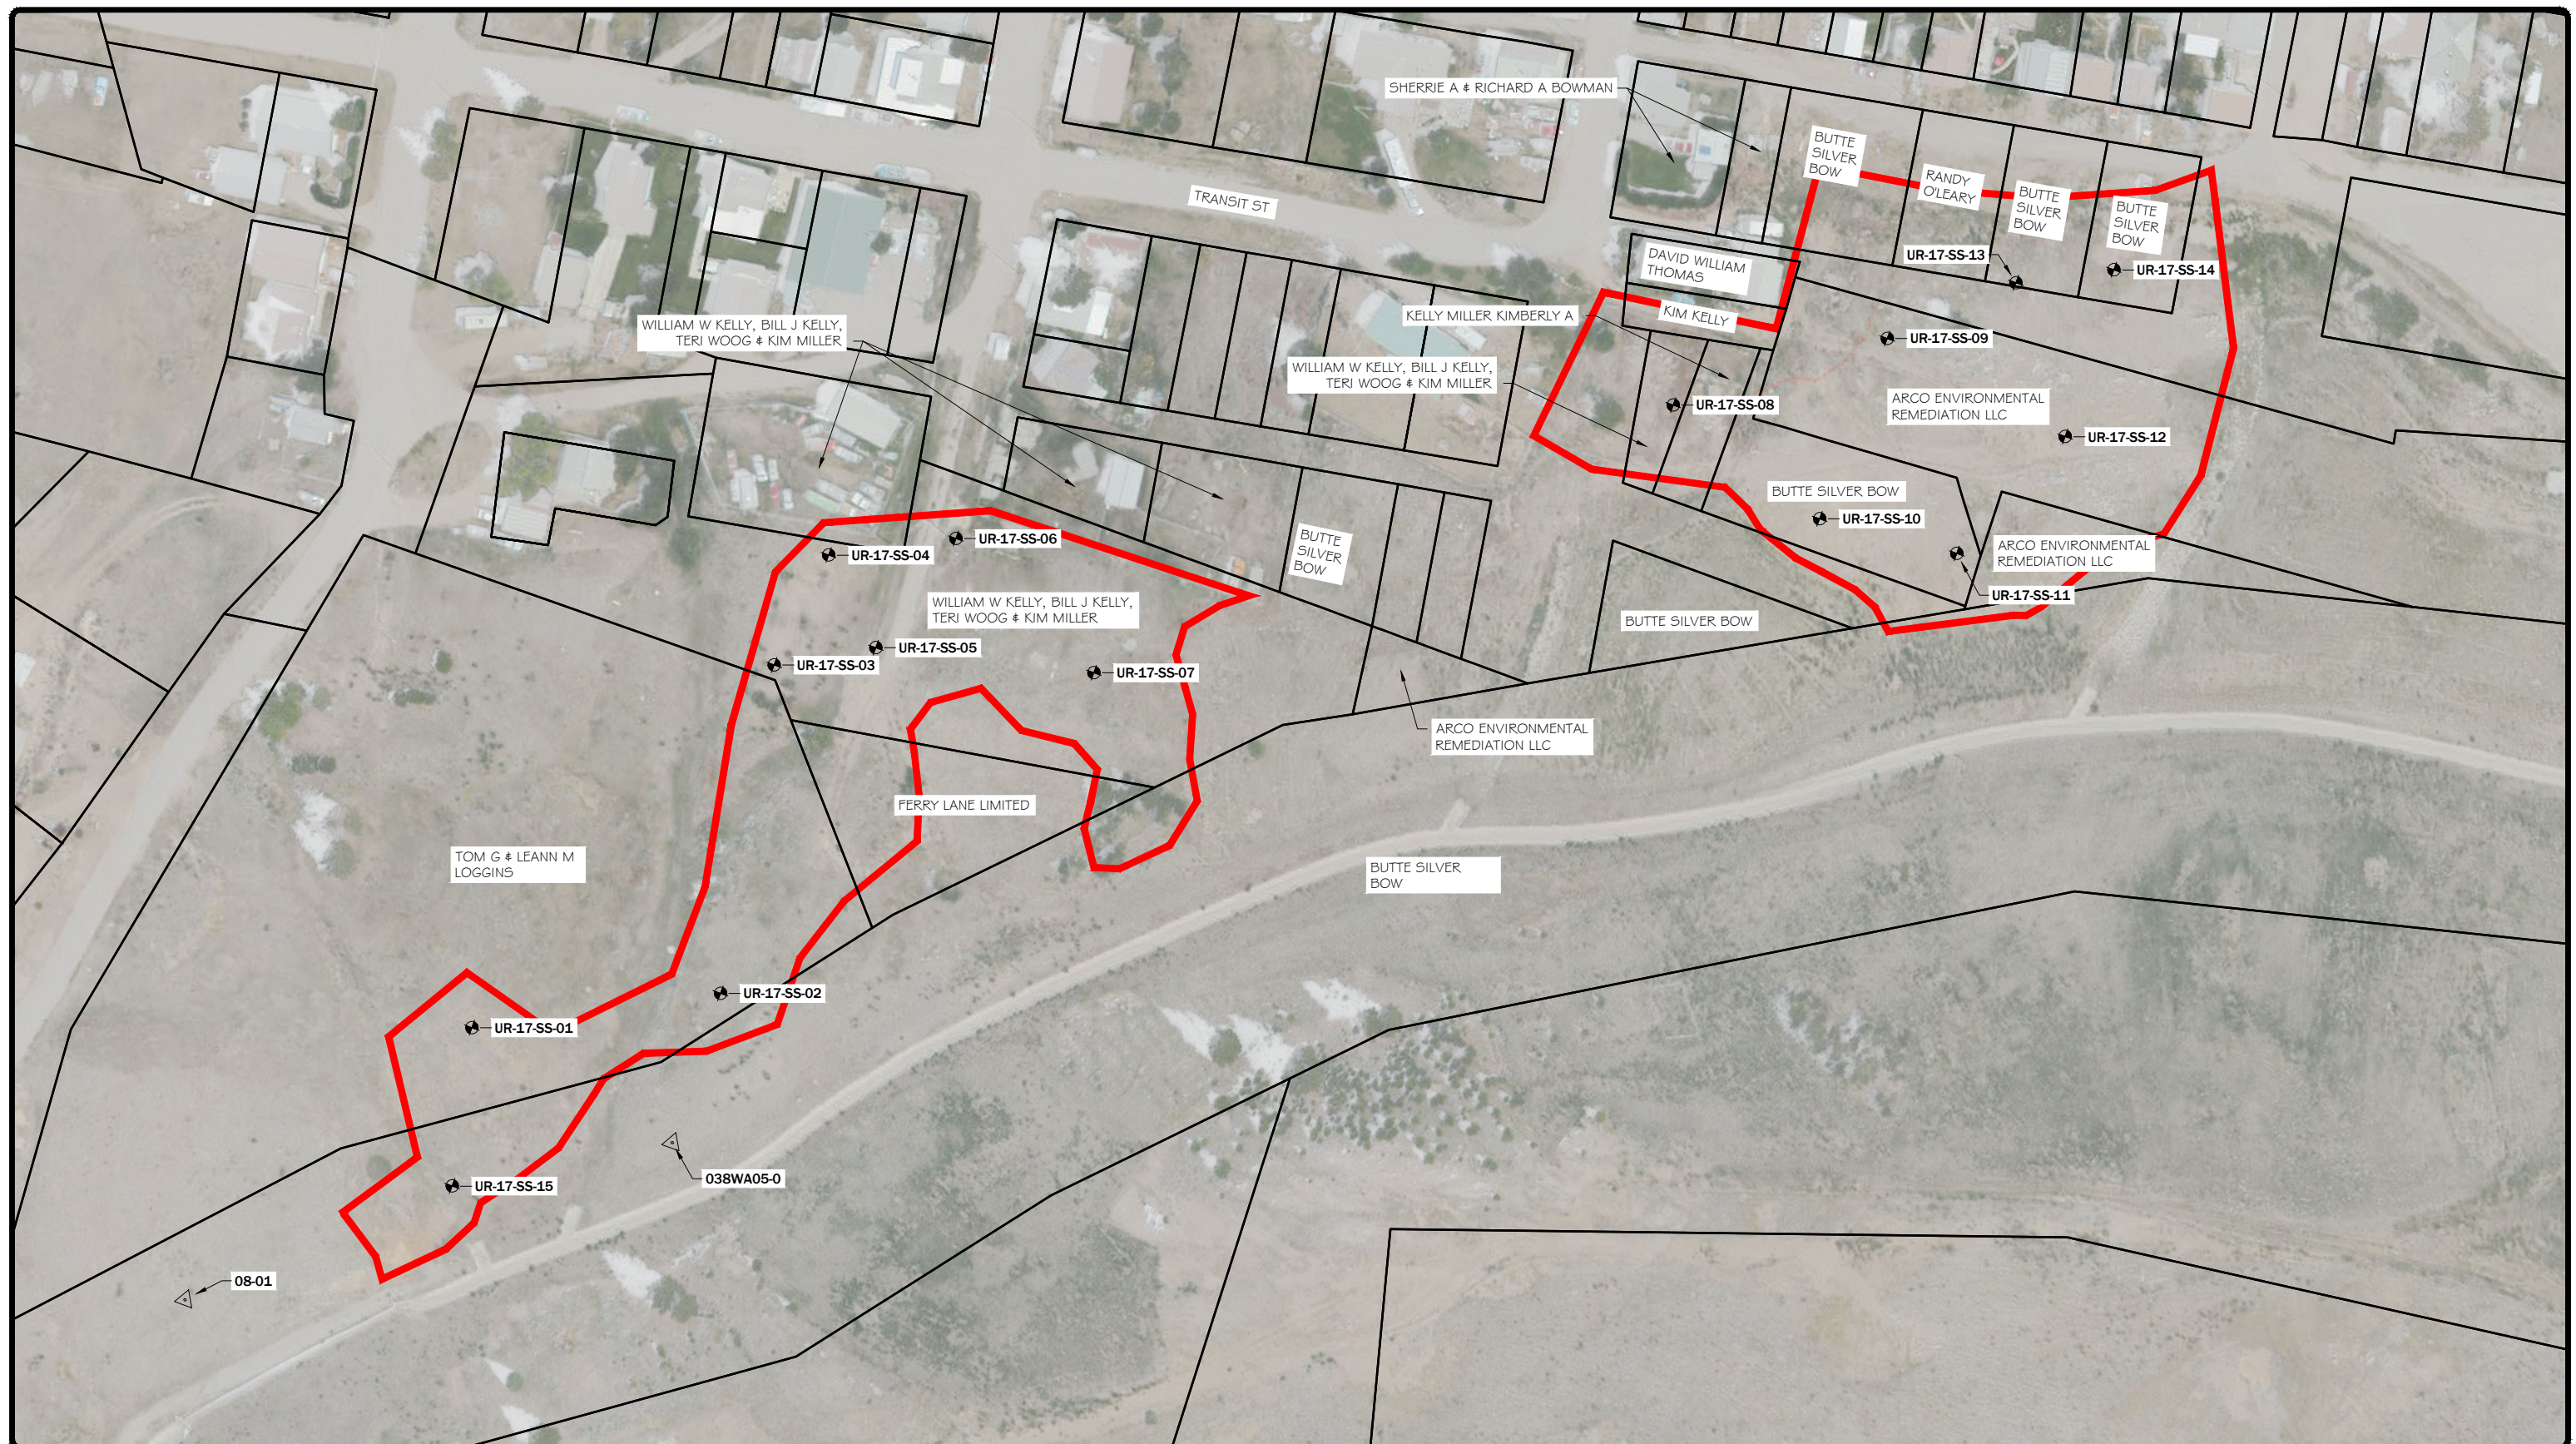
FIGURE 6 UNRECLAIMED SITE
 UR-17
 PROPOSED
 SAMPLE LOCATIONS

Site UR-17 is approximately 5.0 acres and is located in the upper reaches of the Missoula Gulch drainage on the south side of Walkerville (Figure 6) and consists of two non-contiguous UR areas to be evaluated. The site occupies a south-facing slope between a residential part of Walkerville and the bottom of Missoula Gulch. Ownership of Site UR-17 includes Atlantic Richfield Company, Butte-Silver Bow, Ferry Lane Limited, Randy and Greg O’Leary, Kimberly Kelly-Miller, William Kelly and associated parties, and Tom and Leann Loggins.

Data obtained from the Geocortex web-based database at <https://eis2.woodardcurran.com/Html5Viewer/index.html?viewer=BPButte.BPSOU> contain the records for previous soil samples within Site UR-17. The approximate sample locations are shown on Figure 6 with the results listed in Table 5 below. Some of the results listed show exceedances of the BPSOU action levels for lead and zinc (highlighted in yellow). The BPSOU action levels are listed in Tables 1 and 2 of the UR Sites QAPP.

Areas comprising Site UR-17 are vacant land near residential areas with relatively good vegetation throughout the southwest section. There is an access road from 4th Street that contains a small gully and apparent impacted soils. The northeast section of the site has large bare areas with high manganese and iron staining. There are cars on top of the steep slopes that appear to have oil leaks running down the slope. Scrap metal and glass are found through the section with variants of soil colors and erosion. Site UR-17 is in the Missoula Gulch drainage basin.
