Silver Bow Creek/Butte Area Superfund Site

Butte Priority Soils Operable Unit (BPSOU) Unreclaimed Sites Draft Final Field Sampling Plan (FSP) Package #7: UR-01, UR-02, UR-03, UR-04, UR-15, and UR-17

September 14, 2021

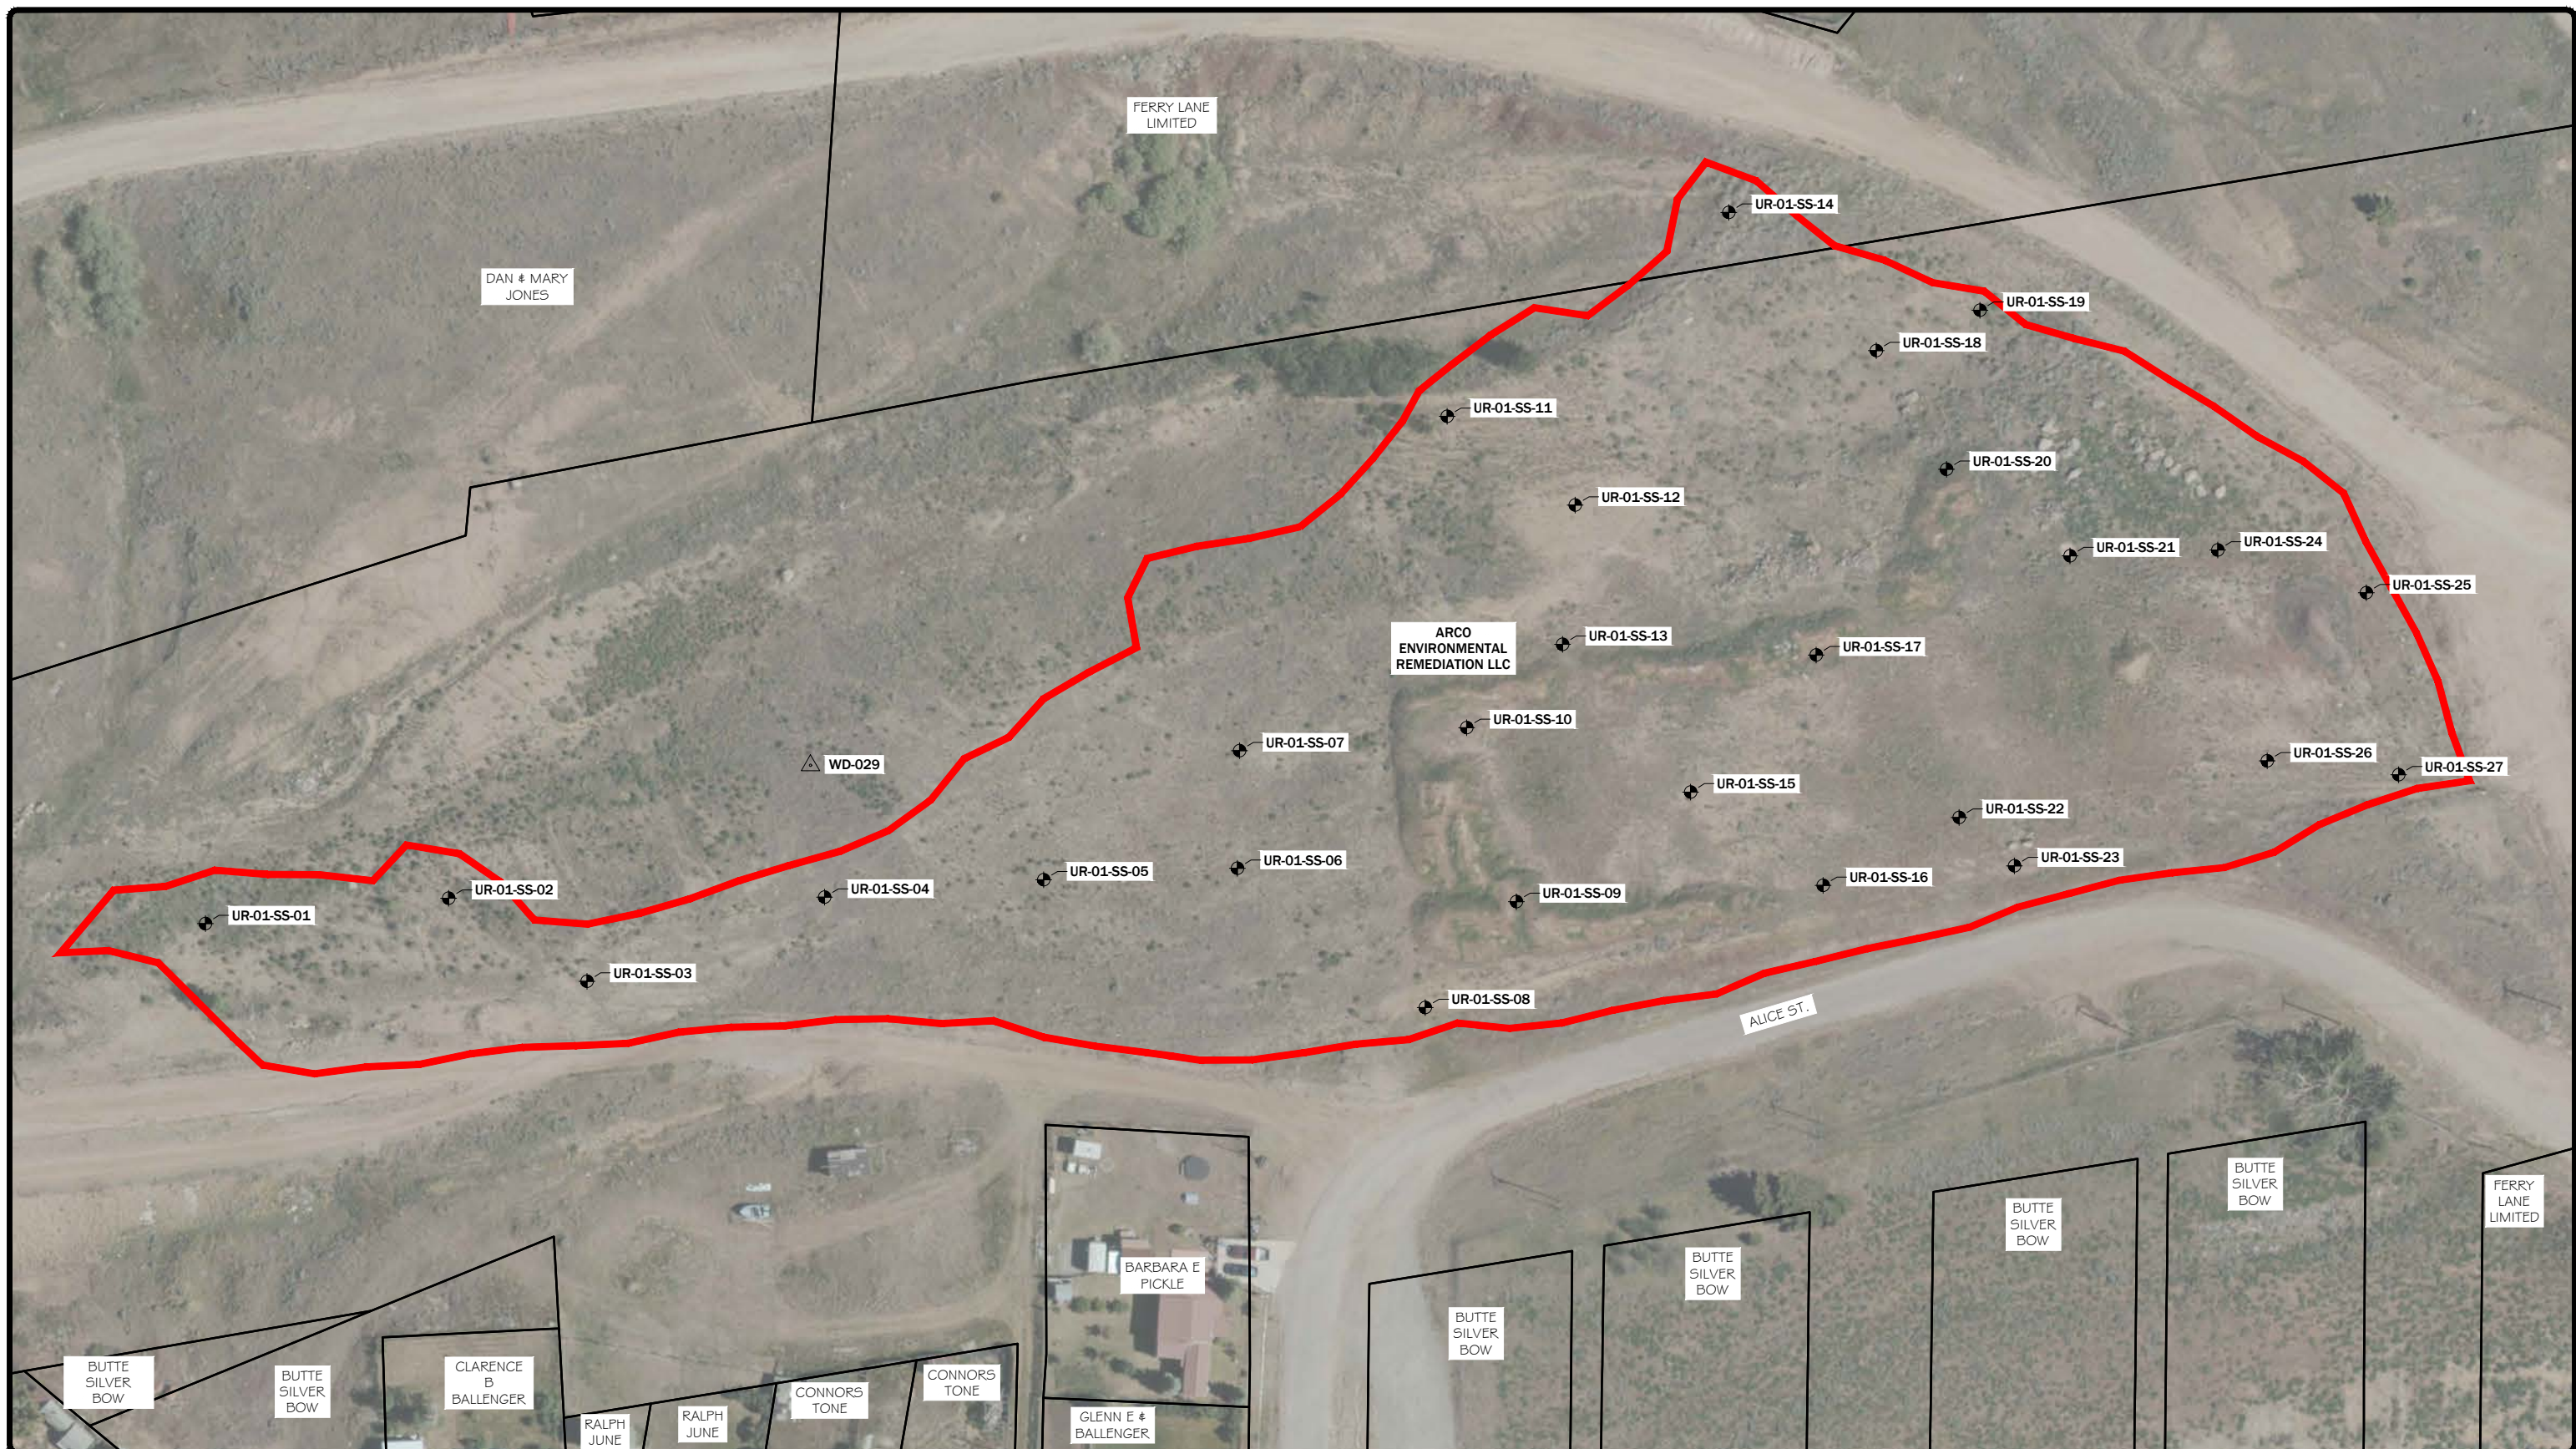
FIGURE 1 UNRECLAIMED SITE
 UR-01
 PROPOSED
 SAMPLE LOCATIONS

Site UR-01 is approximately 9.2 acres and is located north of Walkerville and just north of the Alice Pit. Site UR-01 is bounded on the south by North Alice Street and on the north by Ryan Road (Figure 1). Ownership of Site UR-01 includes Atlantic Richfield Company and Ferry Lane Limited.

Data obtained from the Geocortex web-based database at <https://eis2.woodardcurran.com/Html5Viewer/index.html?viewer=BPButte.BPSOU> contain the record for one previous soil sample near Site UR-01. The approximate sample location is shown on Figure 1 with the results provided in Table 1 below. None of the results listed exceed the BPSOU action levels. The BPSOU action levels are listed in Tables 1 and 2 of the UR Sites QAPP.

Site UR-01 is vacant land with well-established vegetation and several bare areas including windrows of dumped material. The dumped material is covered with established weeds and grasses. Erosion rill starting from the middle of the site running northwest into the drainage ditch appears to have iron staining and impacted soils. There are residences within 200 feet of UR-01 in several directions. Site UR-01 is in the Beef Straight Gulch drainage basin.
