Silver Bow Creek/Butte Area Superfund Site

### **Butte Priority Soils Operable Unit (BPSOU) Unreclaimed Sites Draft Final Field Sampling Plan (FSP) Package #7: UR-01, UR-02, UR-03, UR-04, UR-15, and UR-17**

**September 14, 2021**

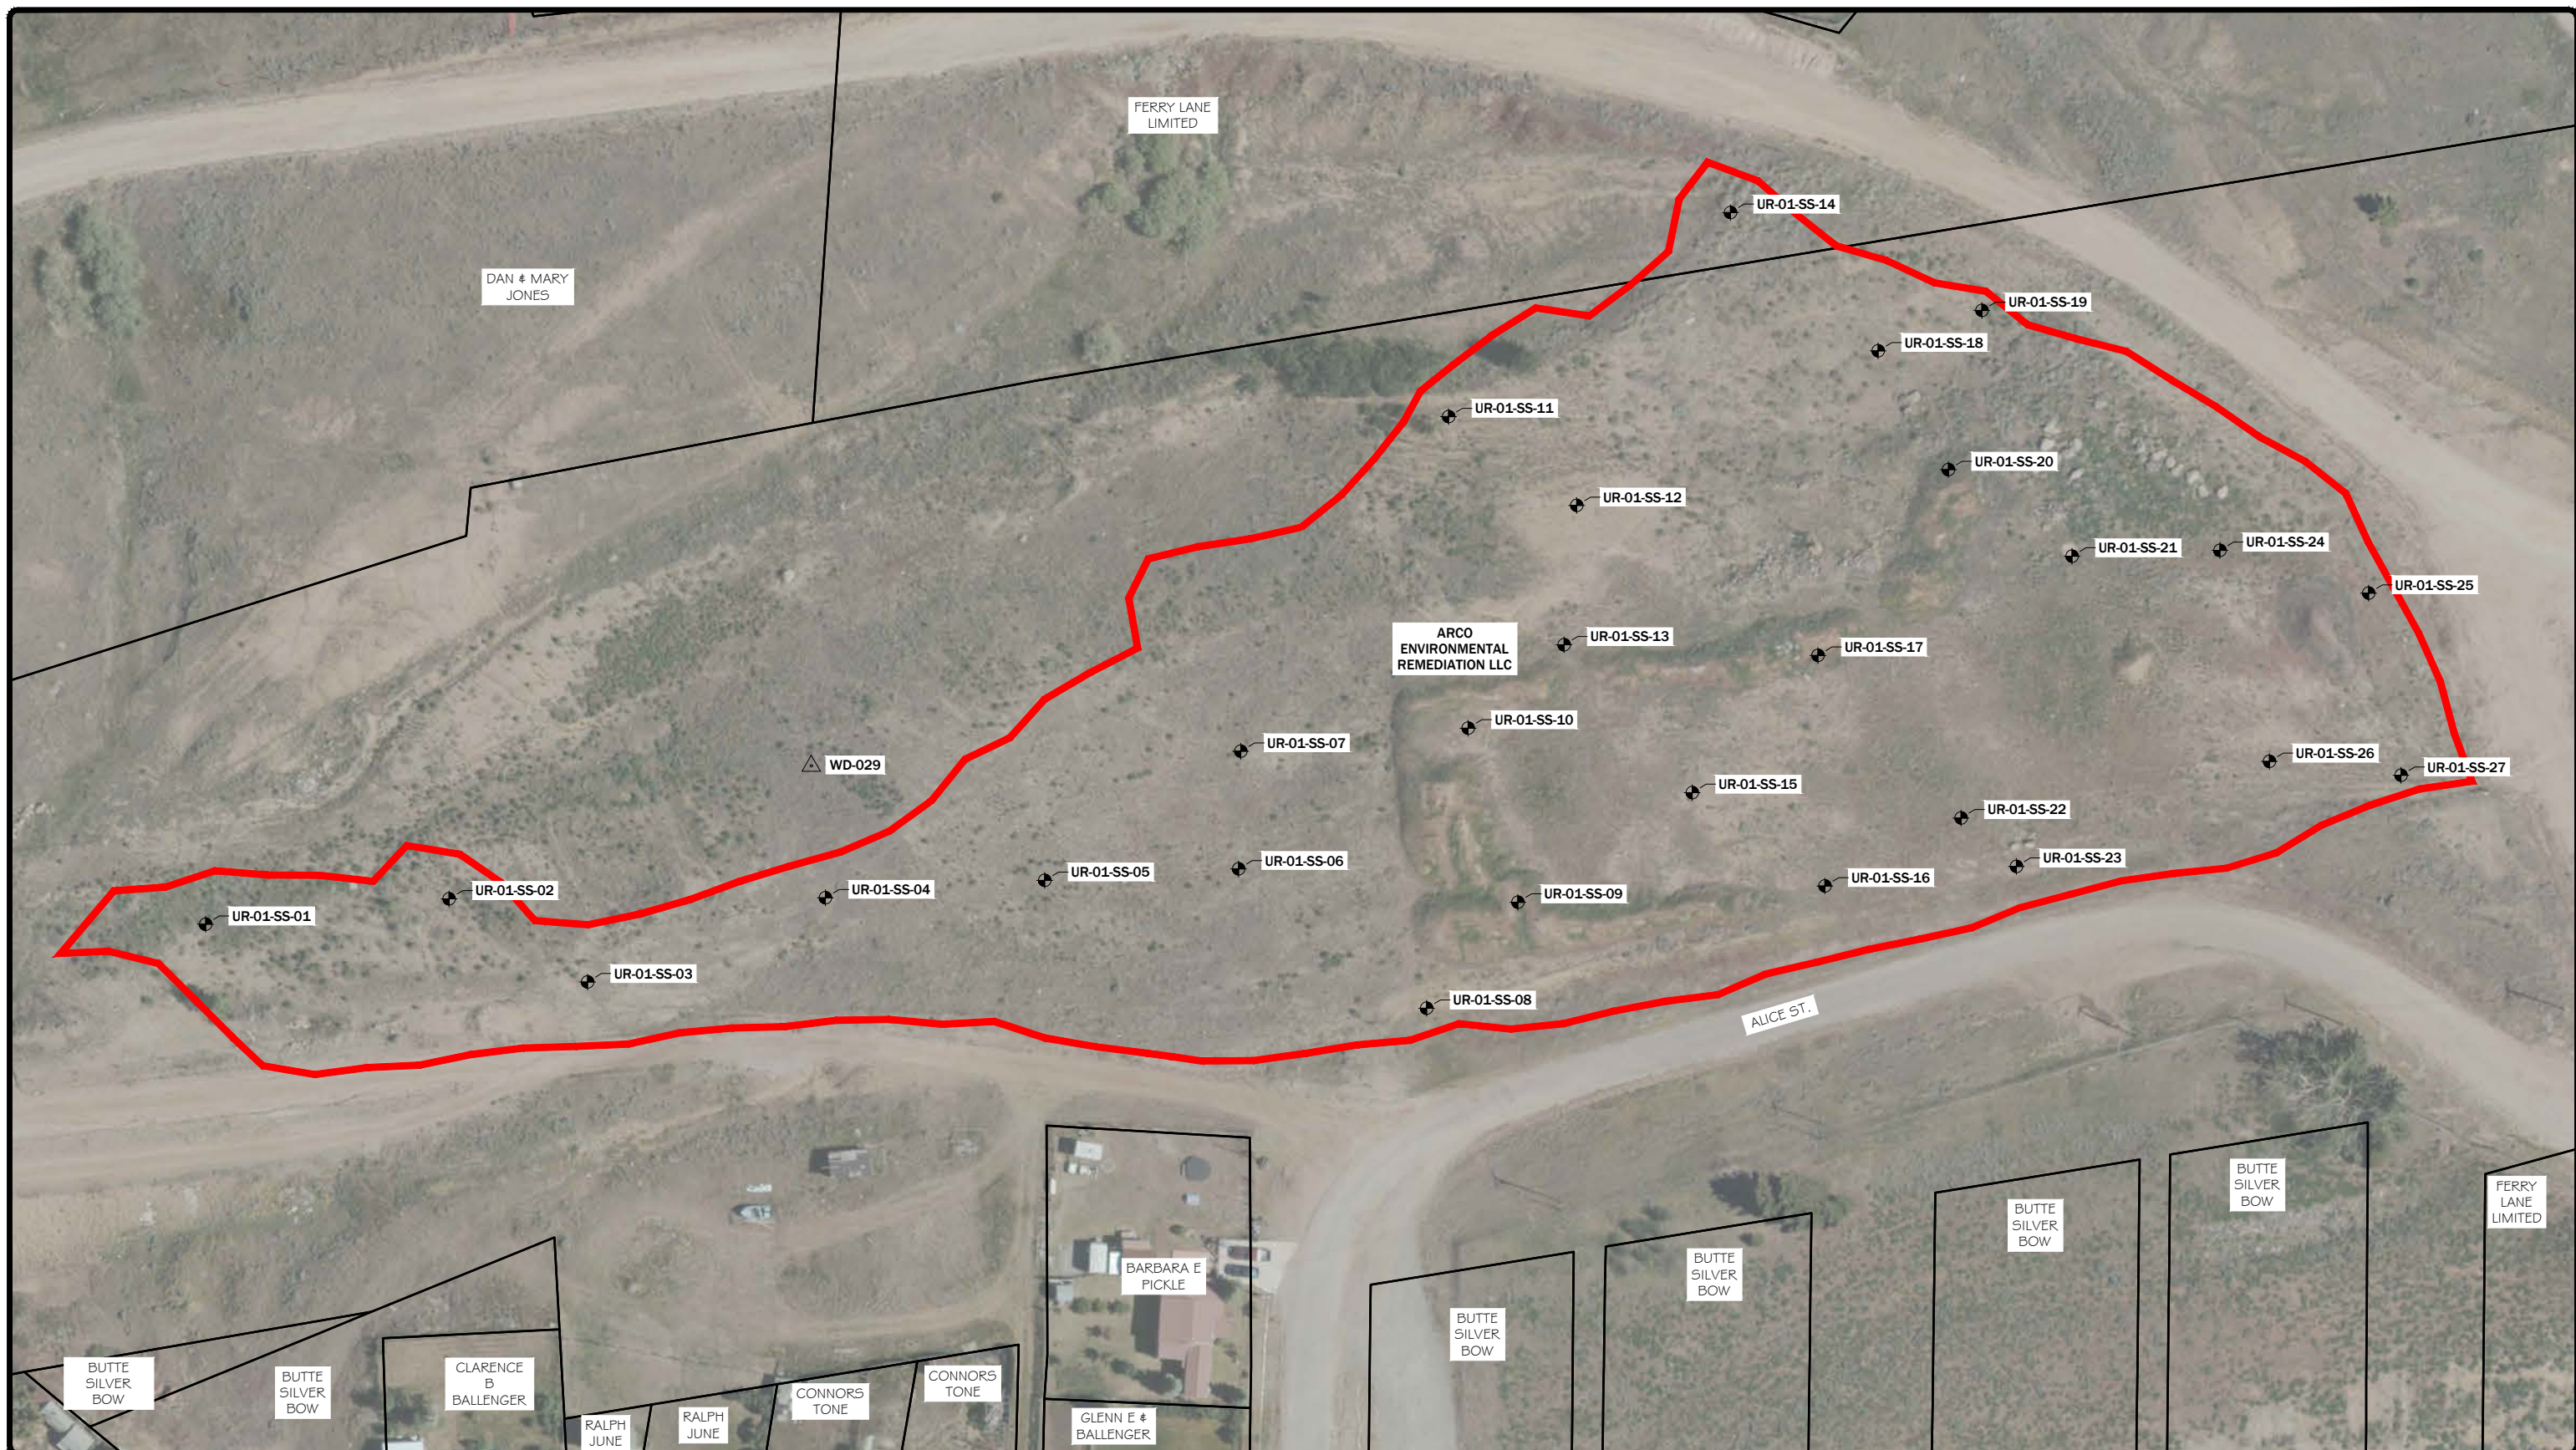
FIGURE 1 UNRECLAIMED SITE  
 UR-01  
 PROPOSED  
 SAMPLE LOCATIONS

Site UR-01 is approximately 9.2 acres and is located north of Walkerville and just north of the Alice Pit. Site UR-01 is bounded on the south by North Alice Street and on the north by Ryan Road (Figure 1). Ownership of Site UR-01 includes Atlantic Richfield Company and Ferry Lane Limited.

Data obtained from the Geocortex web-based database at <https://eis2.woodardcurran.com/Html5Viewer/index.html?viewer=BPButte.BPSOU> contain the record for one previous soil sample near Site UR-01. The approximate sample location is shown on Figure 1 with the results provided in Table 1 below. None of the results listed exceed the BPSOU action levels. The BPSOU action levels are listed in Tables 1 and 2 of the UR Sites QAPP.

Site UR-01 is vacant land with well-established vegetation and several bare areas including windrows of dumped material. The dumped material is covered with established weeds and grasses. Erosion rill starting from the middle of the site running northwest into the drainage ditch appears to have iron staining and impacted soils. There are residences within 200 feet of UR-01 in several directions. Site UR-01 is in the Beef Straight Gulch drainage basin.

All field work and soil analysis will be completed in accordance with the UR Sites QAPP. The QAPP will be reviewed annually and updated as needed on Agency review and approval. Soil sampling will be conducted at the 6 UR Sites at depth intervals of 6 to 12 inches, 2 to 6 inches, and 0 to 2 inches. Sampling will take place in that order from the deepest interval (6 to 12 inches) to the shallowest interval (0 to 2 inches). Proposed sample locations for each site are shown on Figures 1 through 6.

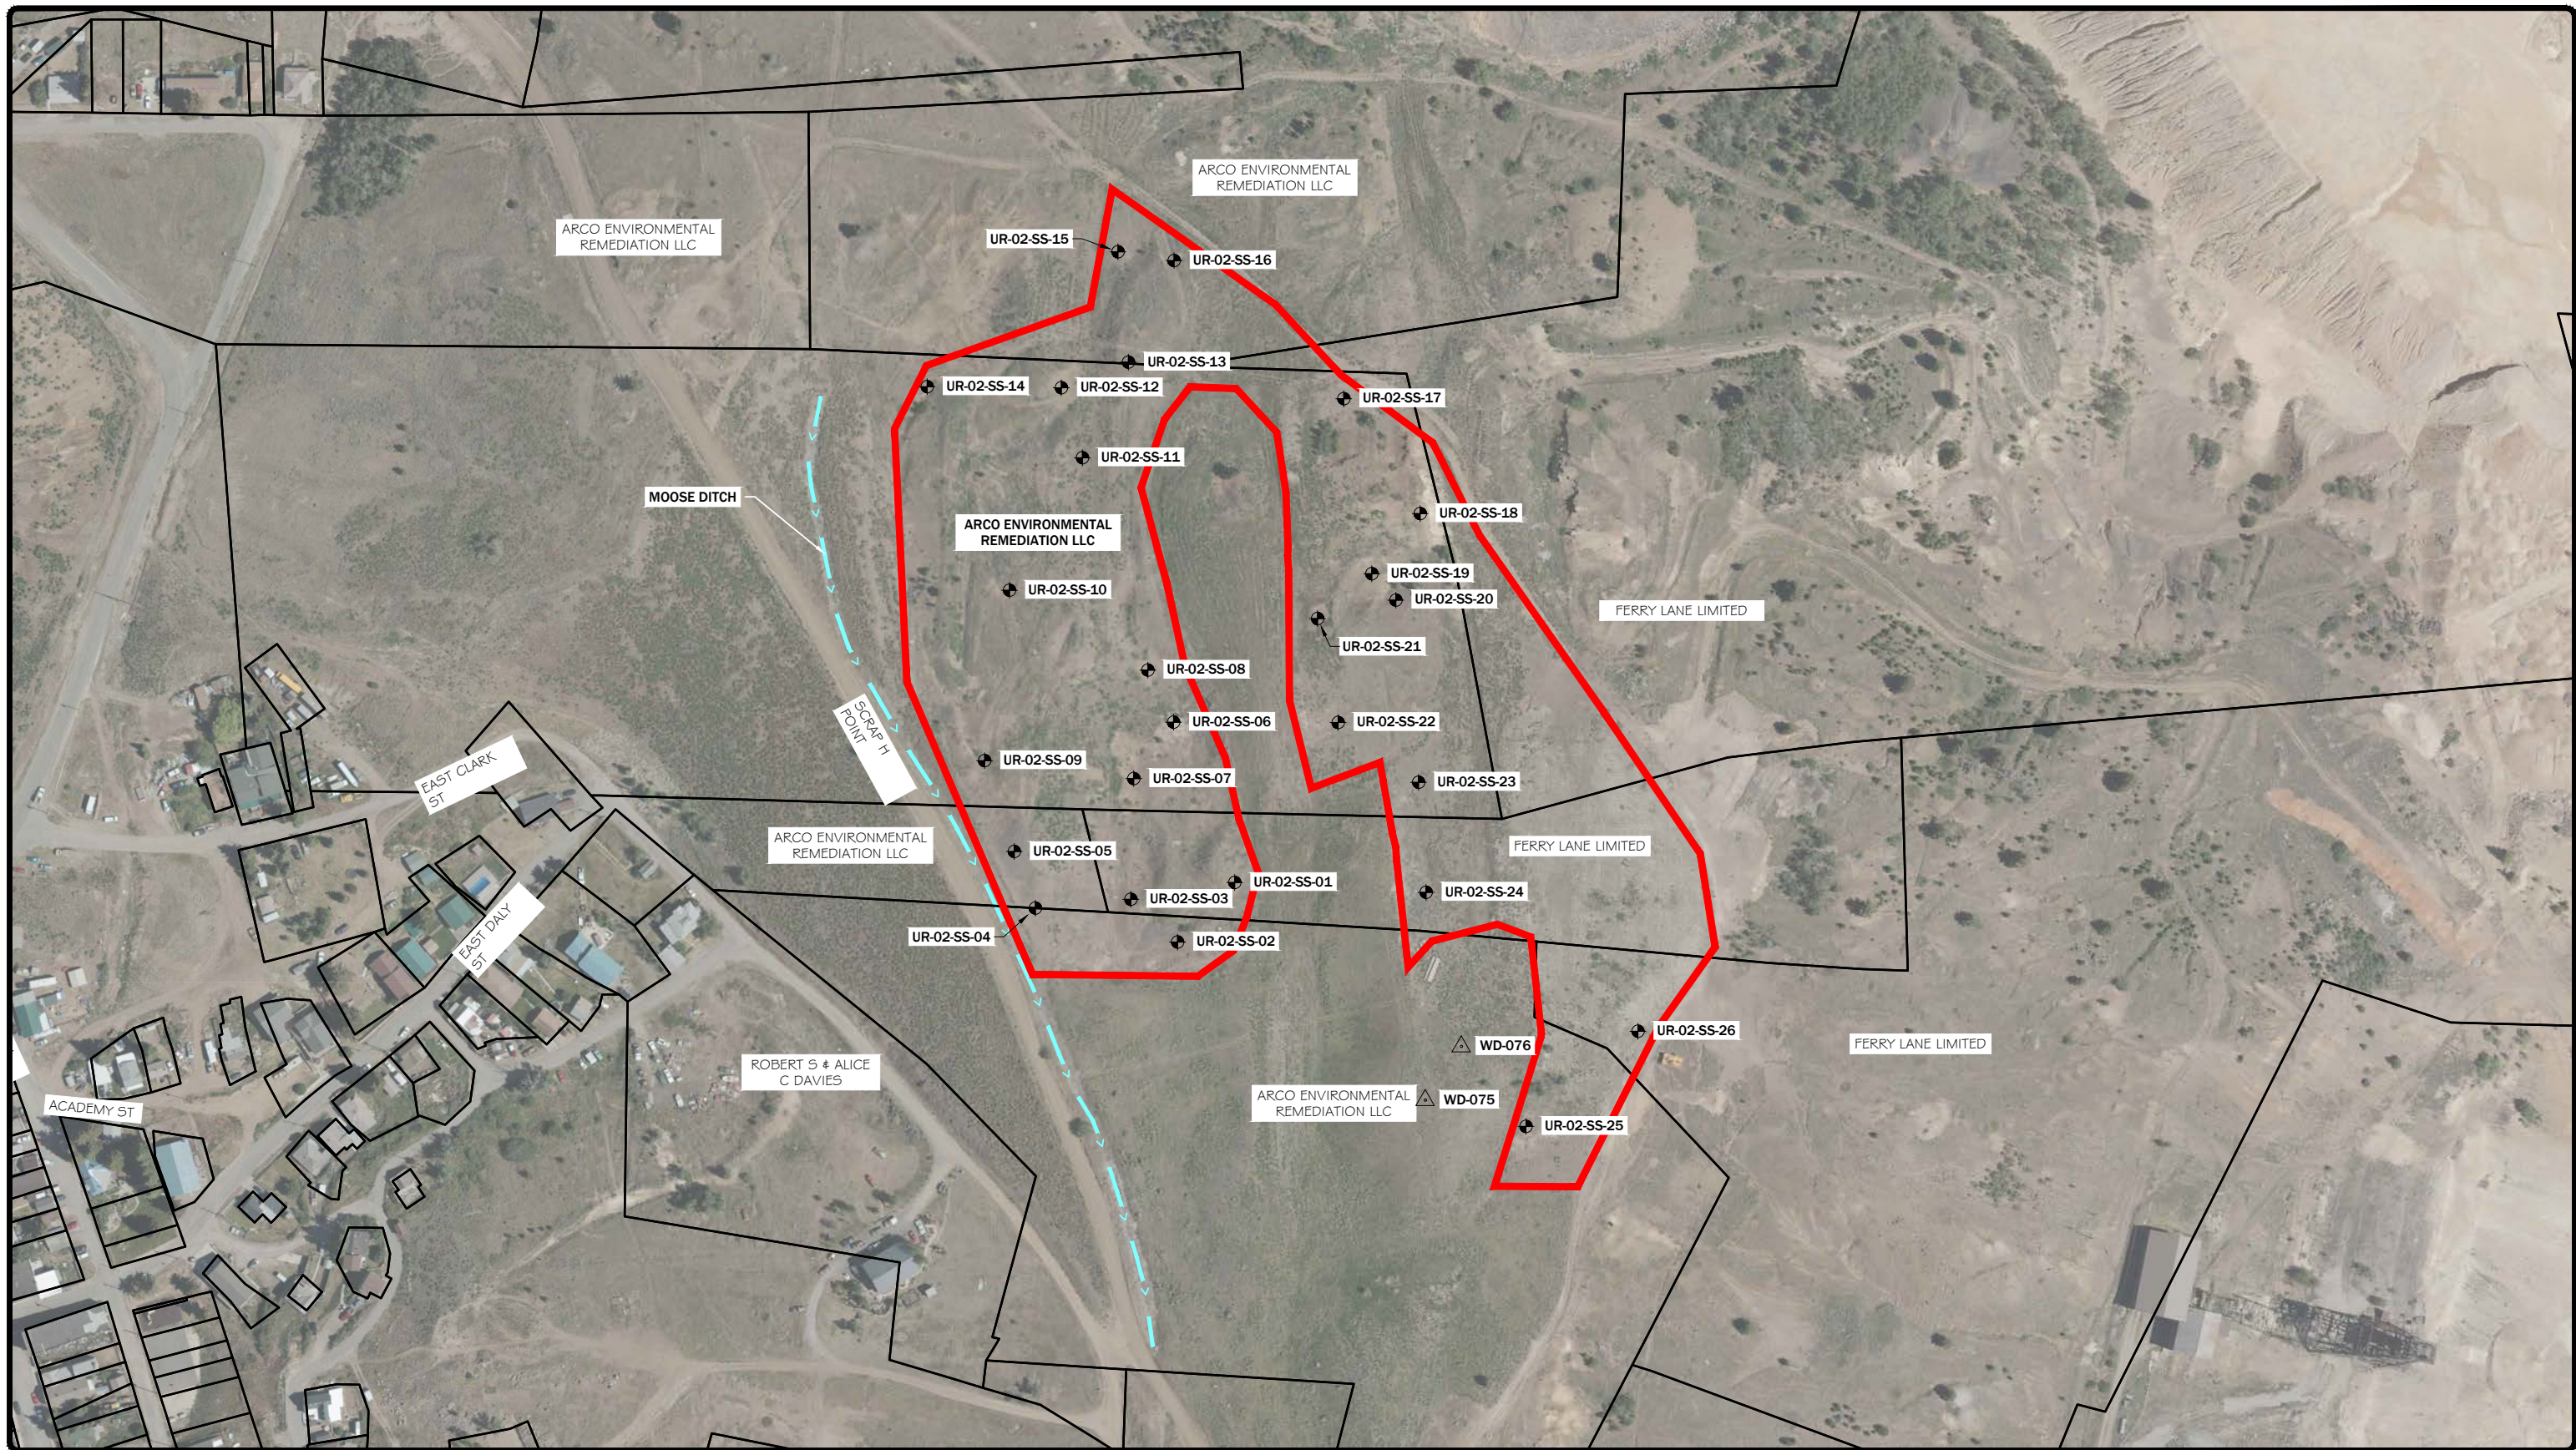
**FIGURE 2** UNRECLAIMED SITE  
UR-02  
PROPOSED  
SAMPLE LOCATIONS

Site UR-02 is approximately 12.8 acres and is located east of Scrap H Point Road in Walkerville near Moose Dump (BRES No. 12). Site UR-02 is bounded by a 4-strand barbed wire fence on the west along Scrap H Point Road (Figure 2). Site UR-02 is located on property owned by Atlantic Richfield Company and Ferry Lane Limited.

Data obtained from the Geocortex web-based database at <https://eis2.woodardcurran.com/Html5Viewer/index.html?viewer=BPButte.BPSOU> contain the records for previous soil samples near Site UR-02. The approximate sample locations are shown on Figure 2 with the results provided in Table 2 below. Results above BPSOU action levels are highlighted in Table 2. The BPSOU action levels are listed in Tables 1 and 2 of the UR Sites QAPP.

Site UR-02 is vacant land with several bare areas and heavily impacted with mining waste including debris and garbage dumps. The Moose Ditch (AB-D-S001) riprap-lined drainage channel is located between the barbed fence and Scrap H point.

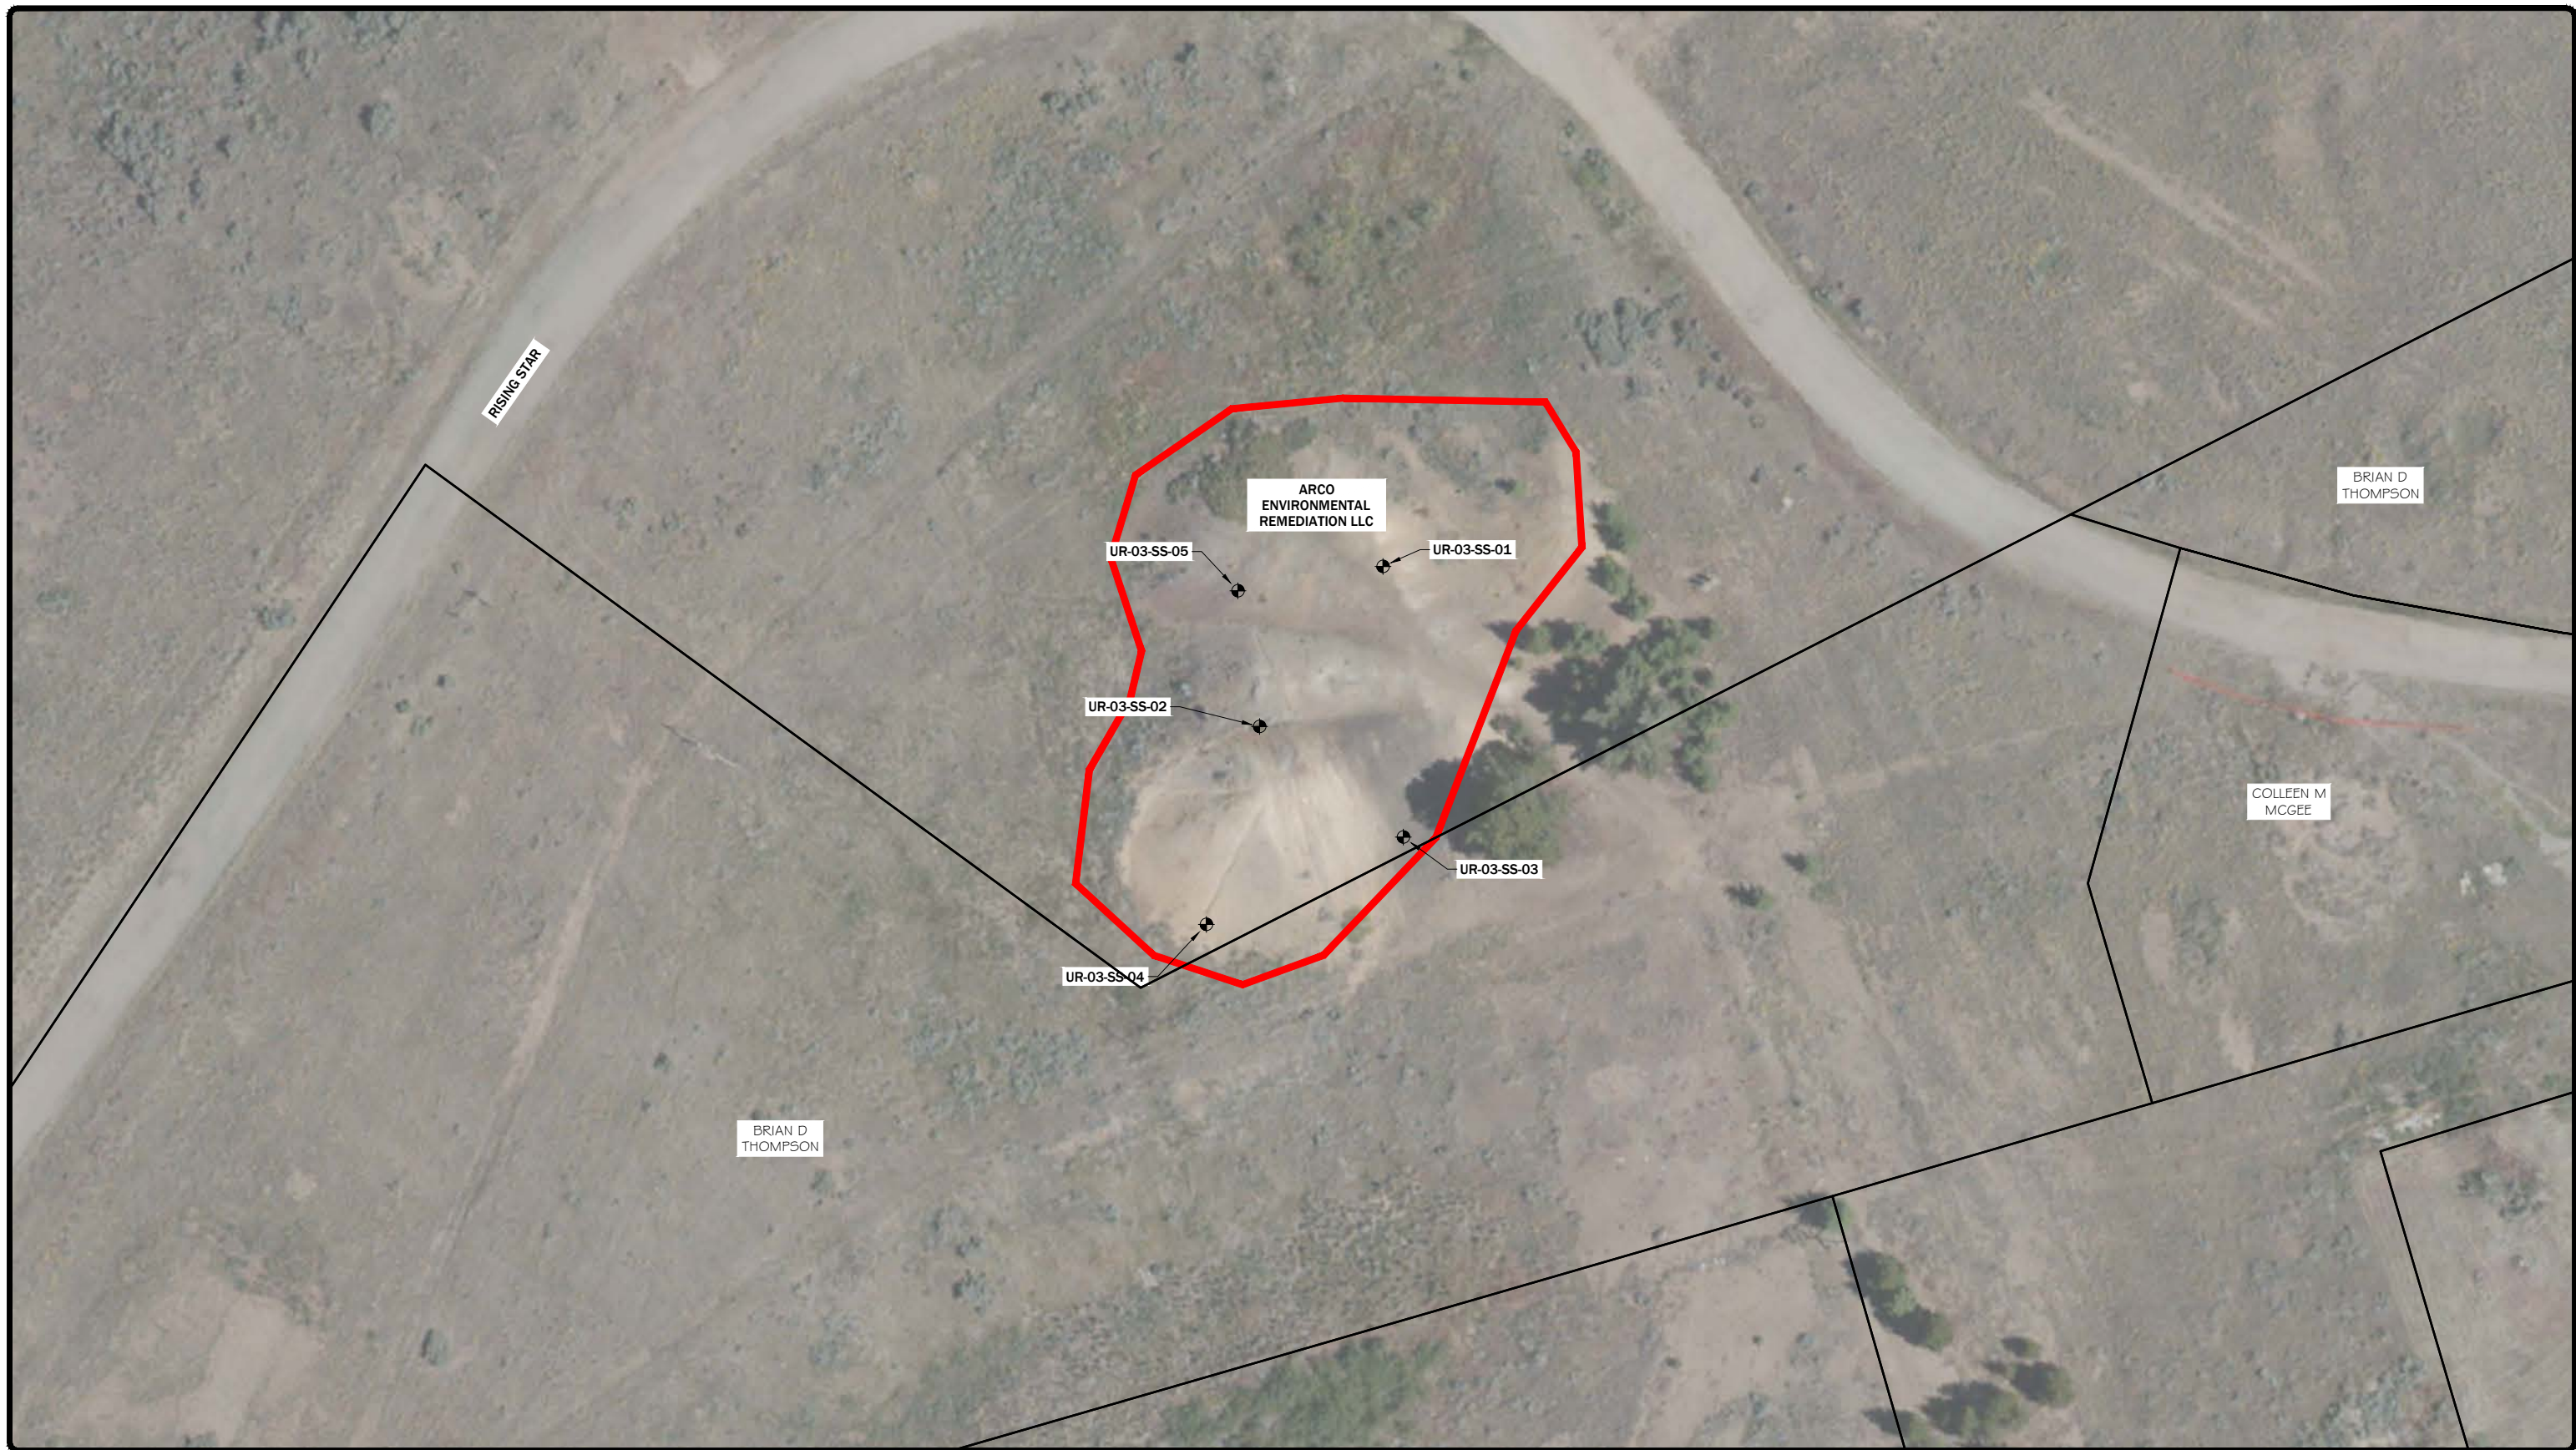
**FIGURE 3** UNRECLAIMED SITE  
UR-03  
PROPOSED  
SAMPLE LOCATIONS

Site UR-03 is approximately 0.3 acres and is located in the northwest part of Walkerville. The site is southwest of the intersection of Rising Star Road and Harrison Street (or Dewey Point Road) (Figure 3). The majority of Site UR-03 is owned by Atlantic Richfield Company. A small portion in the south part of Site UR-03 is owned by Brian Thompson.

Site UR-03 is vacant land and almost the entire site consists of several lobes of waste rock dumps. The site is mostly bare ground. On top of the piles there are approximately 3-foot diameter sink holes or small excavation activity. A residential area in Walkerville is located about 400 feet to the southeast of UR-03. Site UR-03 is in the Beef Straight Gulch drainage basin.

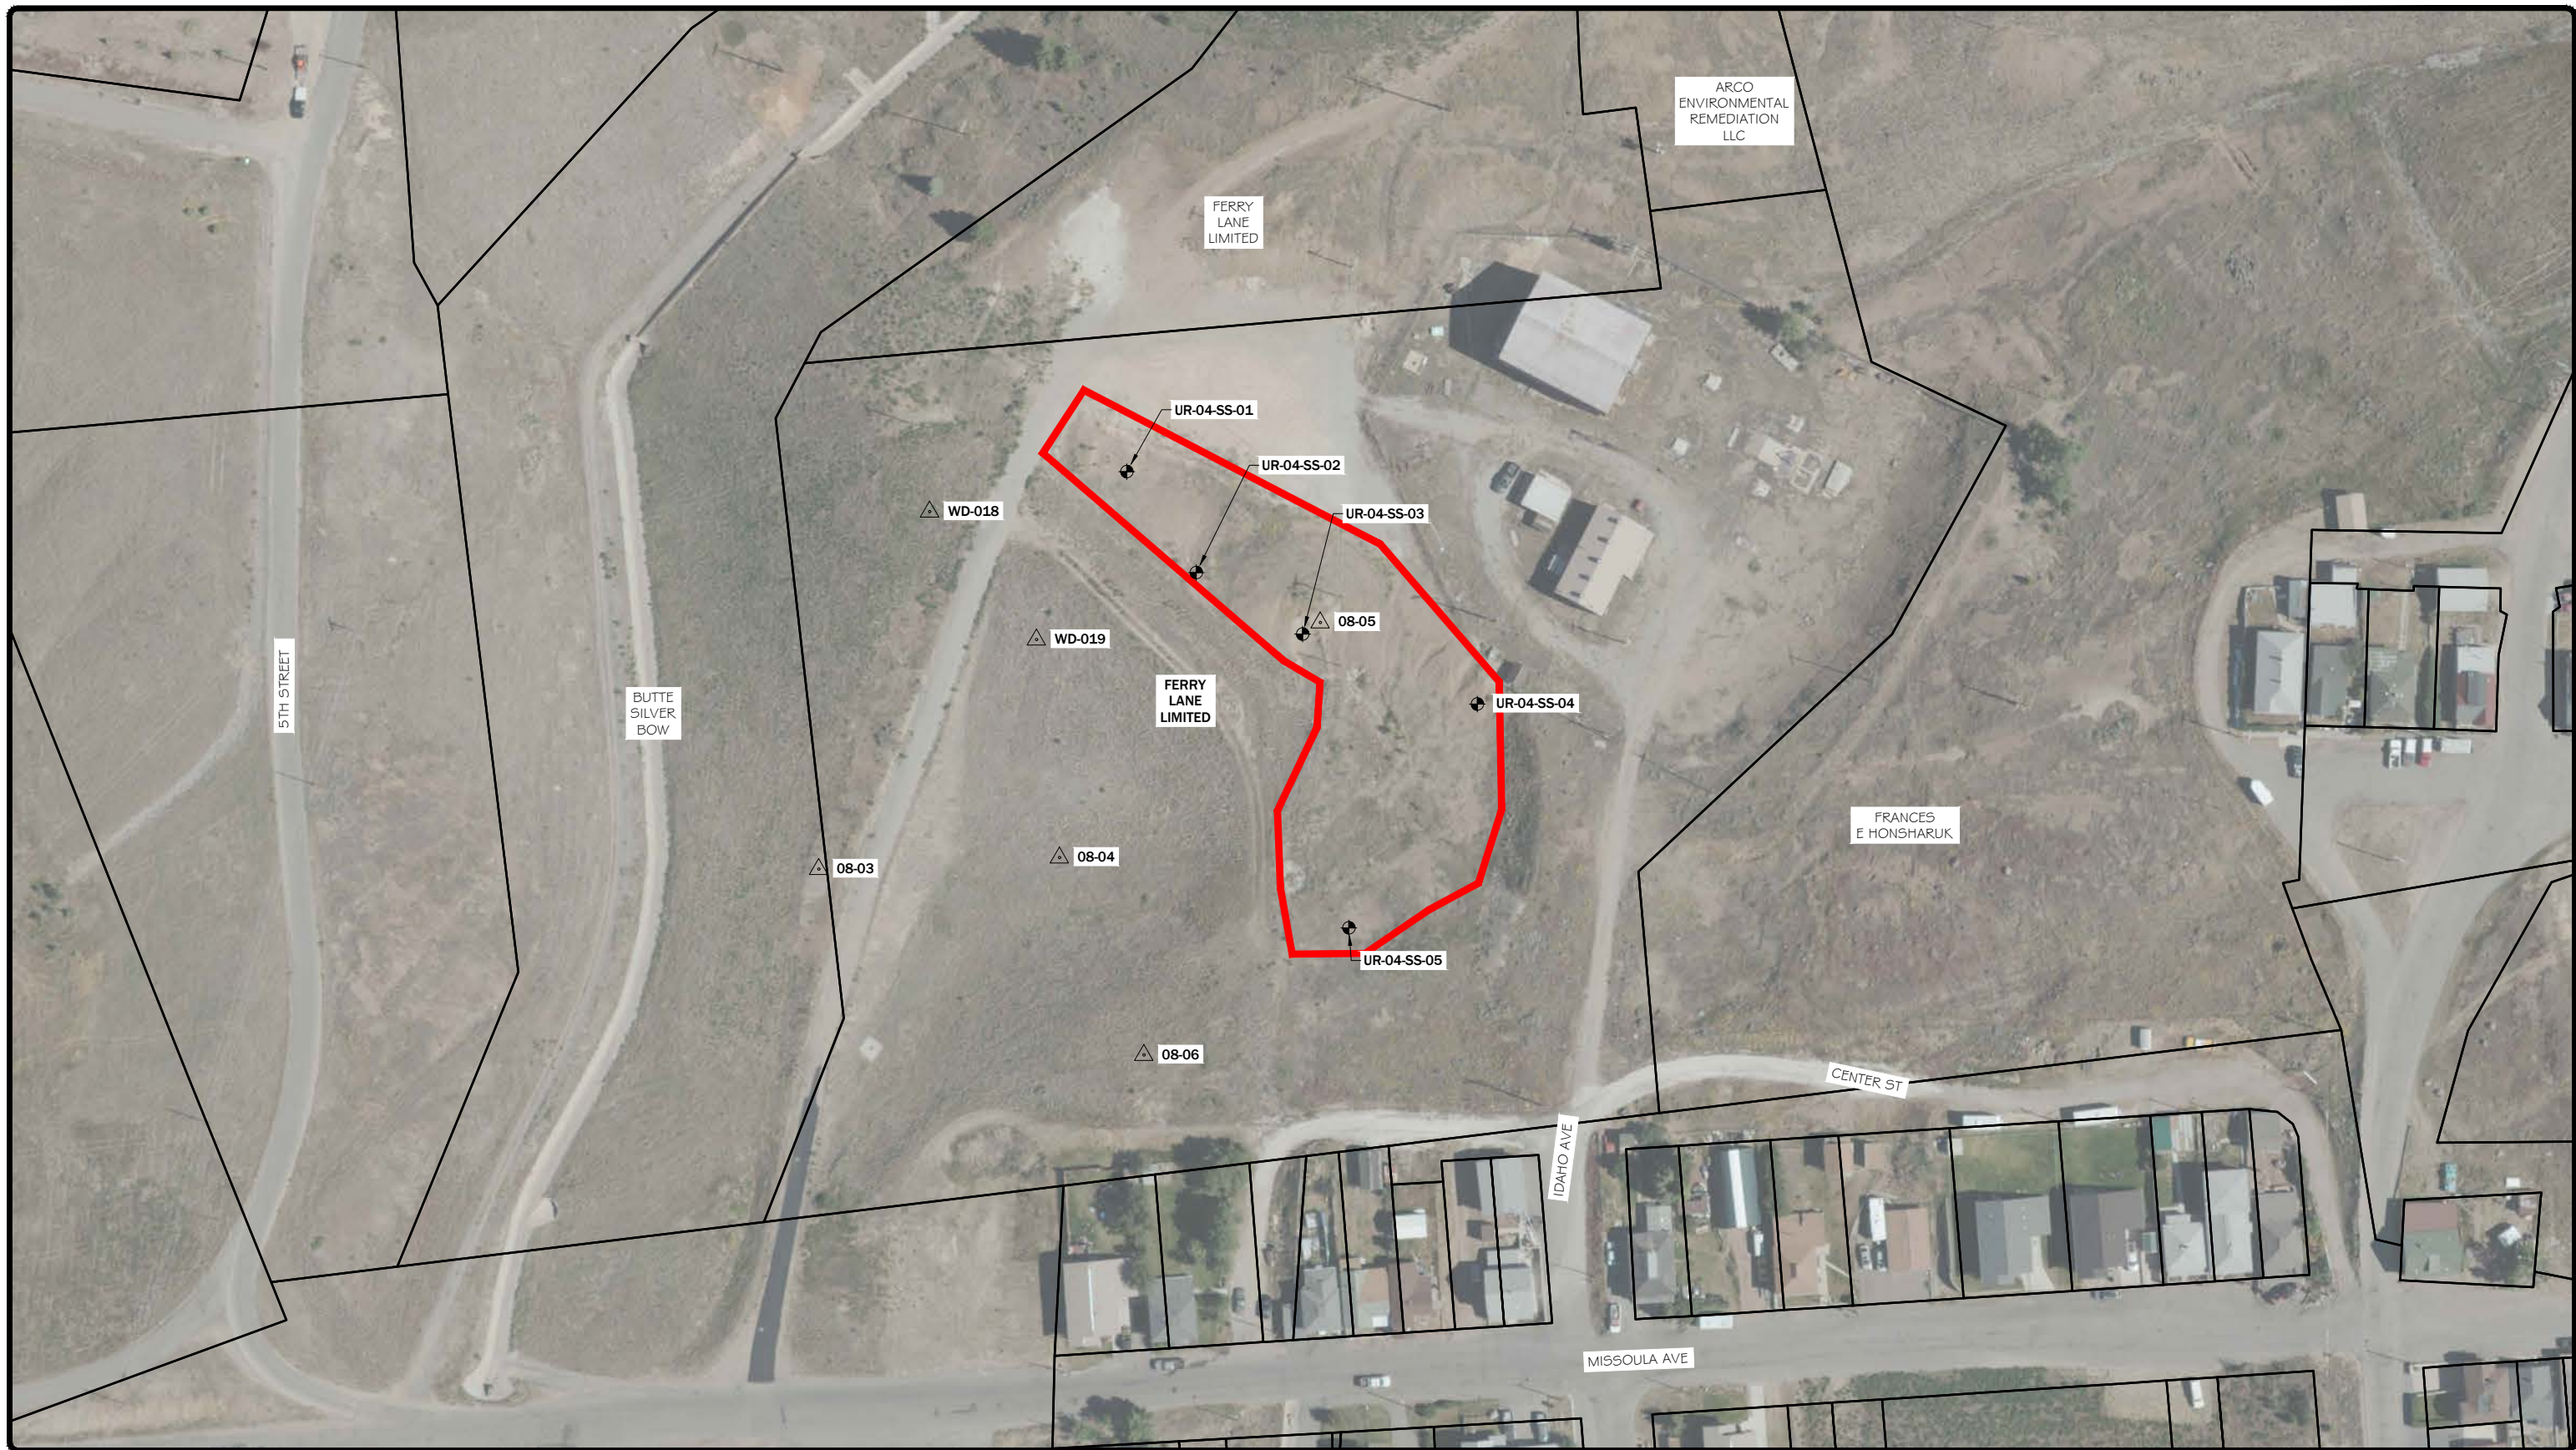
**FIGURE 4** UNRECLAIMED SITE  
UR-04  
PROPOSED  
SAMPLE LOCATIONS

Site UR-04 is approximately 0.9 acres. It is located slightly south of Walkerville and just northwest of the intersection of North Idaho and Center Streets (Figure 4), on the east side of the Missoula Gulch drainage. Site UR-04 consists of a poorly vegetated, southwest facing slope that is immediately southwest of the former Missoula Mine yard. An especially steep area in the middle of the site appears to consist of mine waste, based on yellow color and clayey texture of the soil. The south lobe of site UR-04 has better vegetation than the rest of the site, but there are still bare areas and a dump area that may contain waste rock.

Data obtained from the Geocortex web-based database at <https://eis2.woodardcurran.com/Html5Viewer/index.html?viewer=BPButte.BPSOU> contain the record for previous soil samples within or near Site UR-04. The approximate sample locations are shown on Figure 4 with the results provided in Table 3 below. Some of the results listed show exceedances of BPSOU action levels for lead and zinc (highlighted in yellow). The BPSOU action levels are listed in Tables 1 and 2 of the UR Sites QAPP.

Site UR-04 is owned by Ferry Lane Limited. Site UR-04 is vacant land in a largely open-space area. There are several residences about 150 feet south of Site UR-04 along Missoula Avenue. Site UR-04 is in the Missoula Gulch drainage basin.

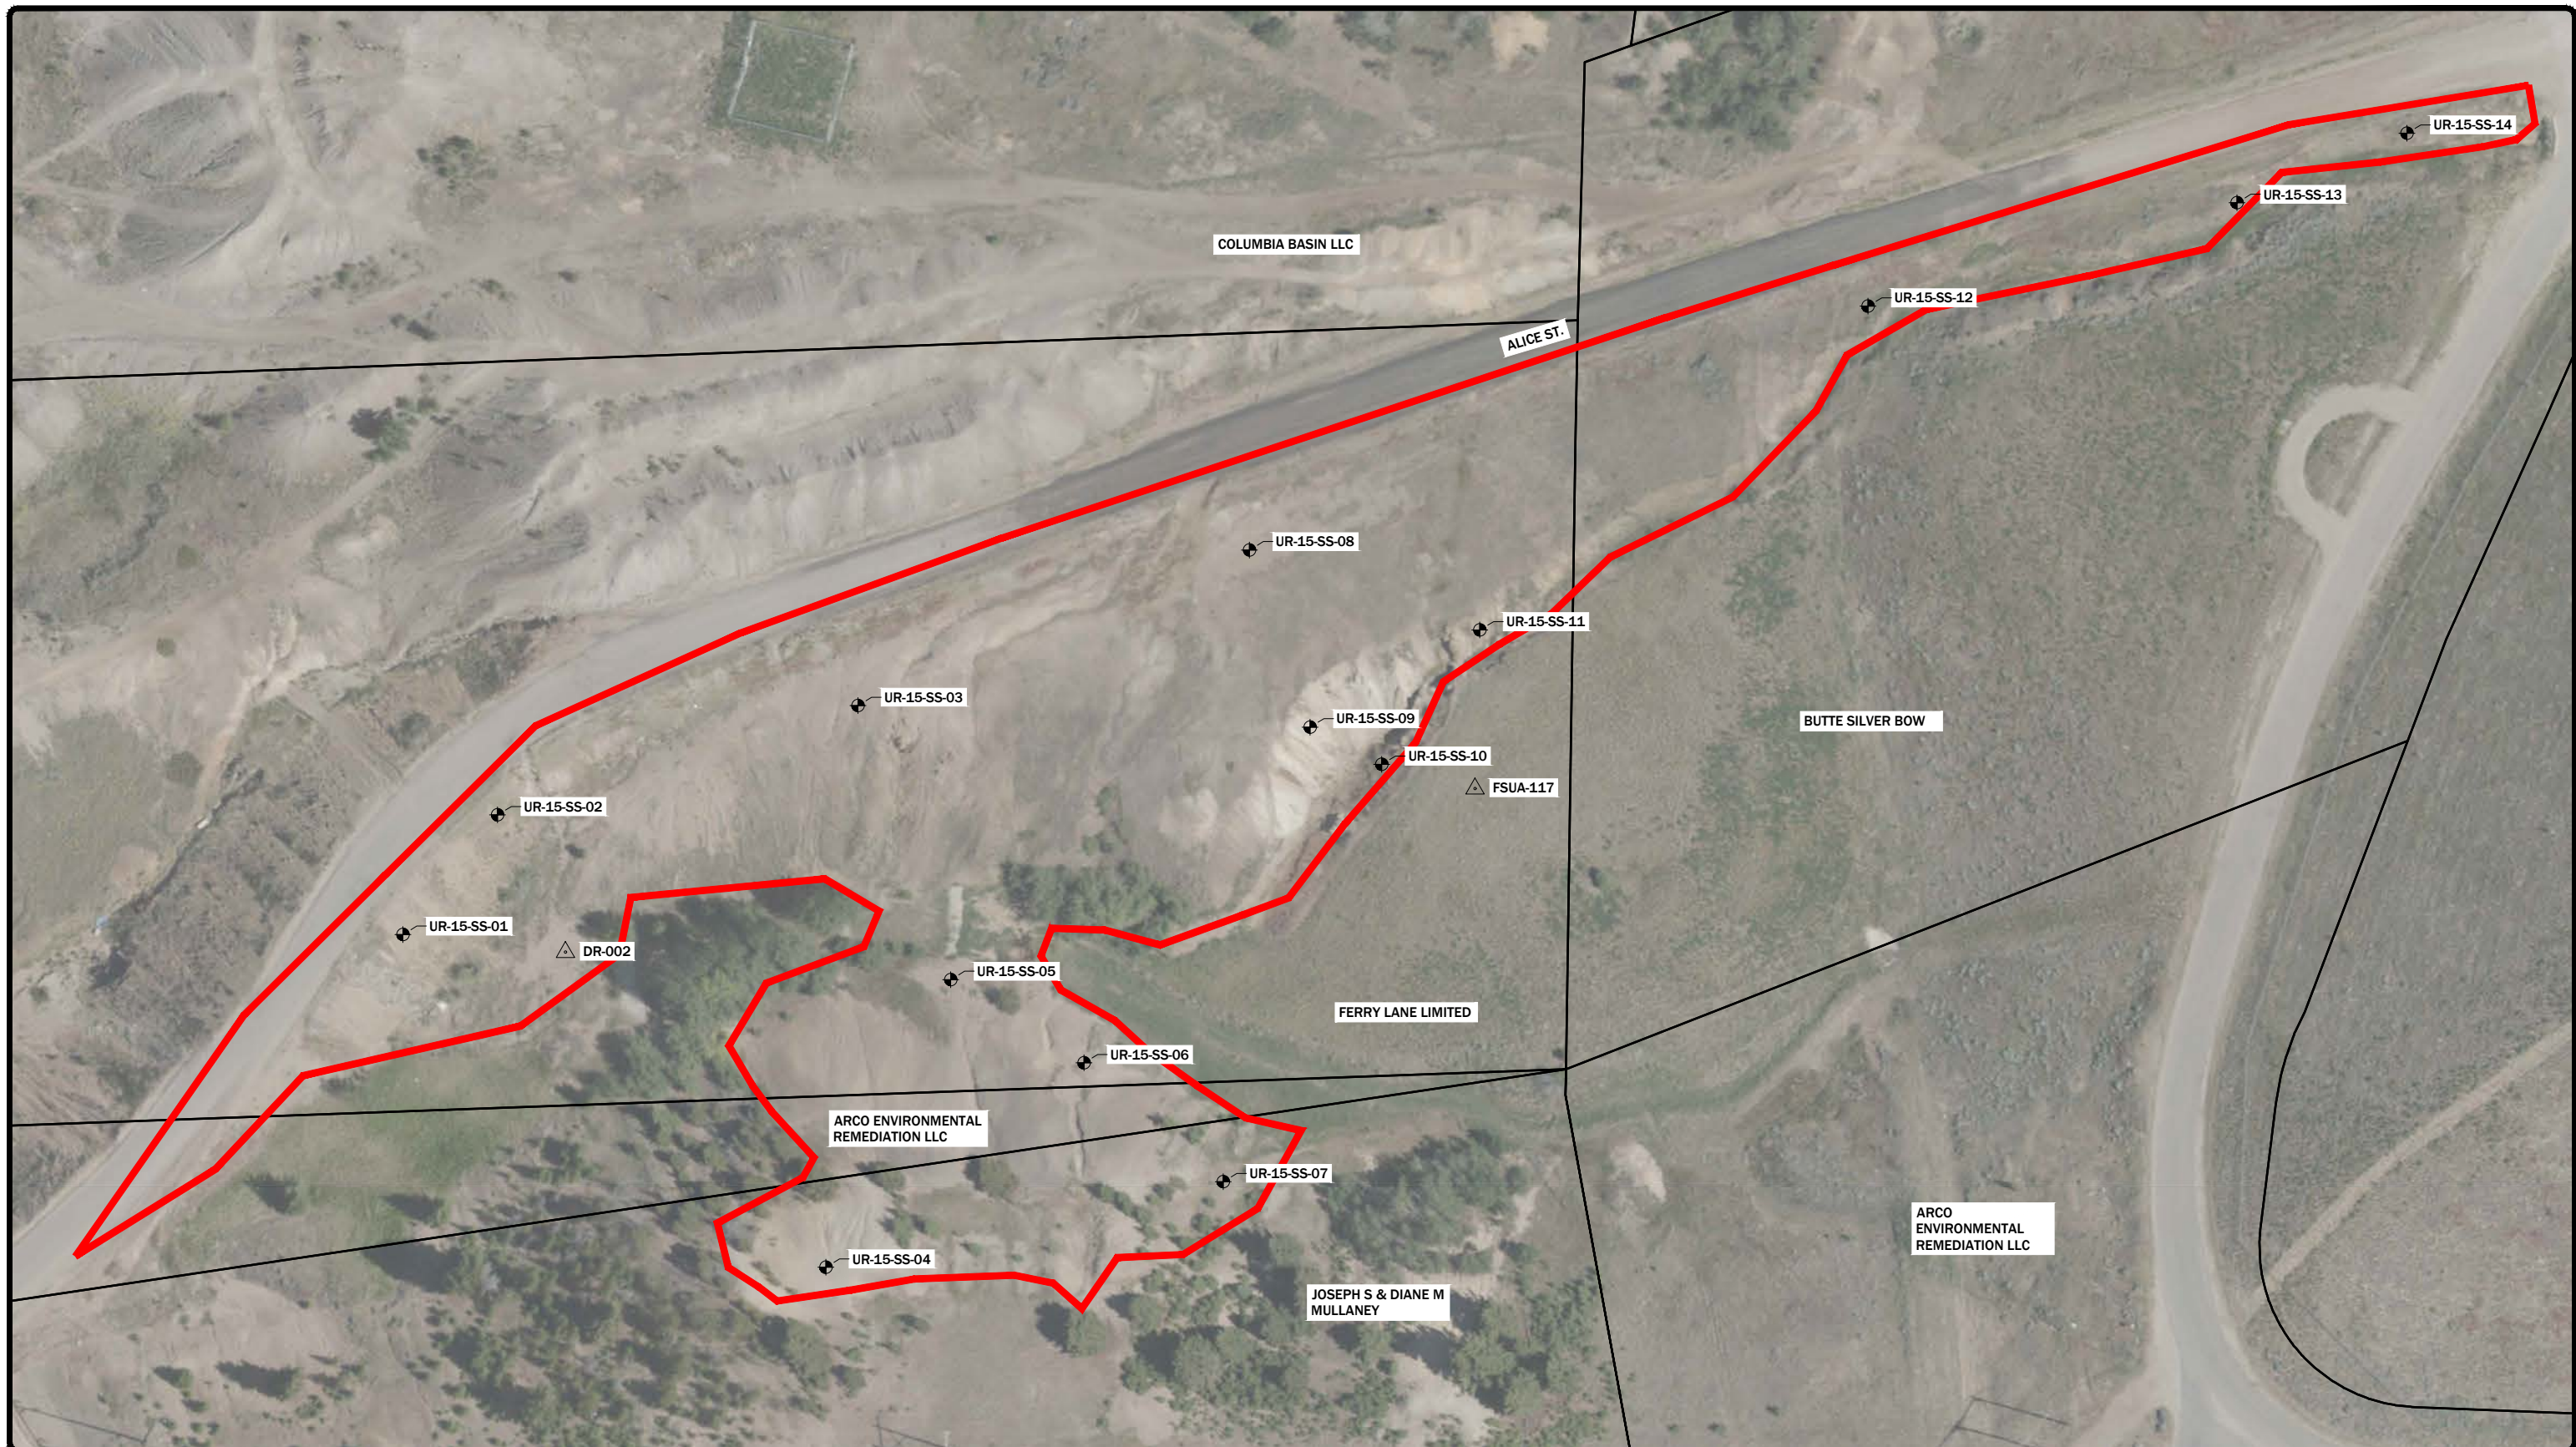
FIGURE 5 UNRECLAIMED SITE UR-15 PROPOSED SAMPLE LOCATIONS

Site UR-15 is approximately 3.8 acres and is located north of Walkerville and south of Ryan Road. The east end of Site UR-15 is at the southwest intersection of Ryan Road and Fourth Street (Figure 5). The site extends about 1,000 feet to the west of the intersection and is totally on the south side of Ryan Road. The site consists mostly of waste rock dumps that are bare. Beef Straight Creek forms part of the south border of Site UR-15 and also cuts through a portion of it. Ownership of Site UR-15 includes Ferry Lane Limited, Butte-Silver Bow, Atlantic Richfield Company, and Joseph and Diane Mullaney.

Data obtained from the Geocortex web-based database at <https://eis2.woodardcurran.com/Html5Viewer/index.html?viewer=BPButte.BPSOU> contain the records for previous soil samples within or near Site UR-15. The approximate sample locations are shown on Figure 5 with the results listed in Table 4 below. Some of the results listed show exceedances of the BPSOU action levels for lead and zinc (highlighted in yellow). The BPSOU action levels are listed in Tables 1 and 2 of the UR Sites QAPP.

Site UR-15 is vacant land that has poor vegetation. The nearest residences are about 600 feet to the north and to the south. Site UR-15 is in the Beef Straight Gulch drainage basin.
