Silver Bow Creek/Butte Area Superfund Site

### **Butte Priority Soils Operable Unit (BPSOU) Unreclaimed Sites Draft Final Field Sampling Plan (FSP) Package #7: UR-01, UR-02, UR-03, UR-04, UR-15, and UR-17**

**September 14, 2021**

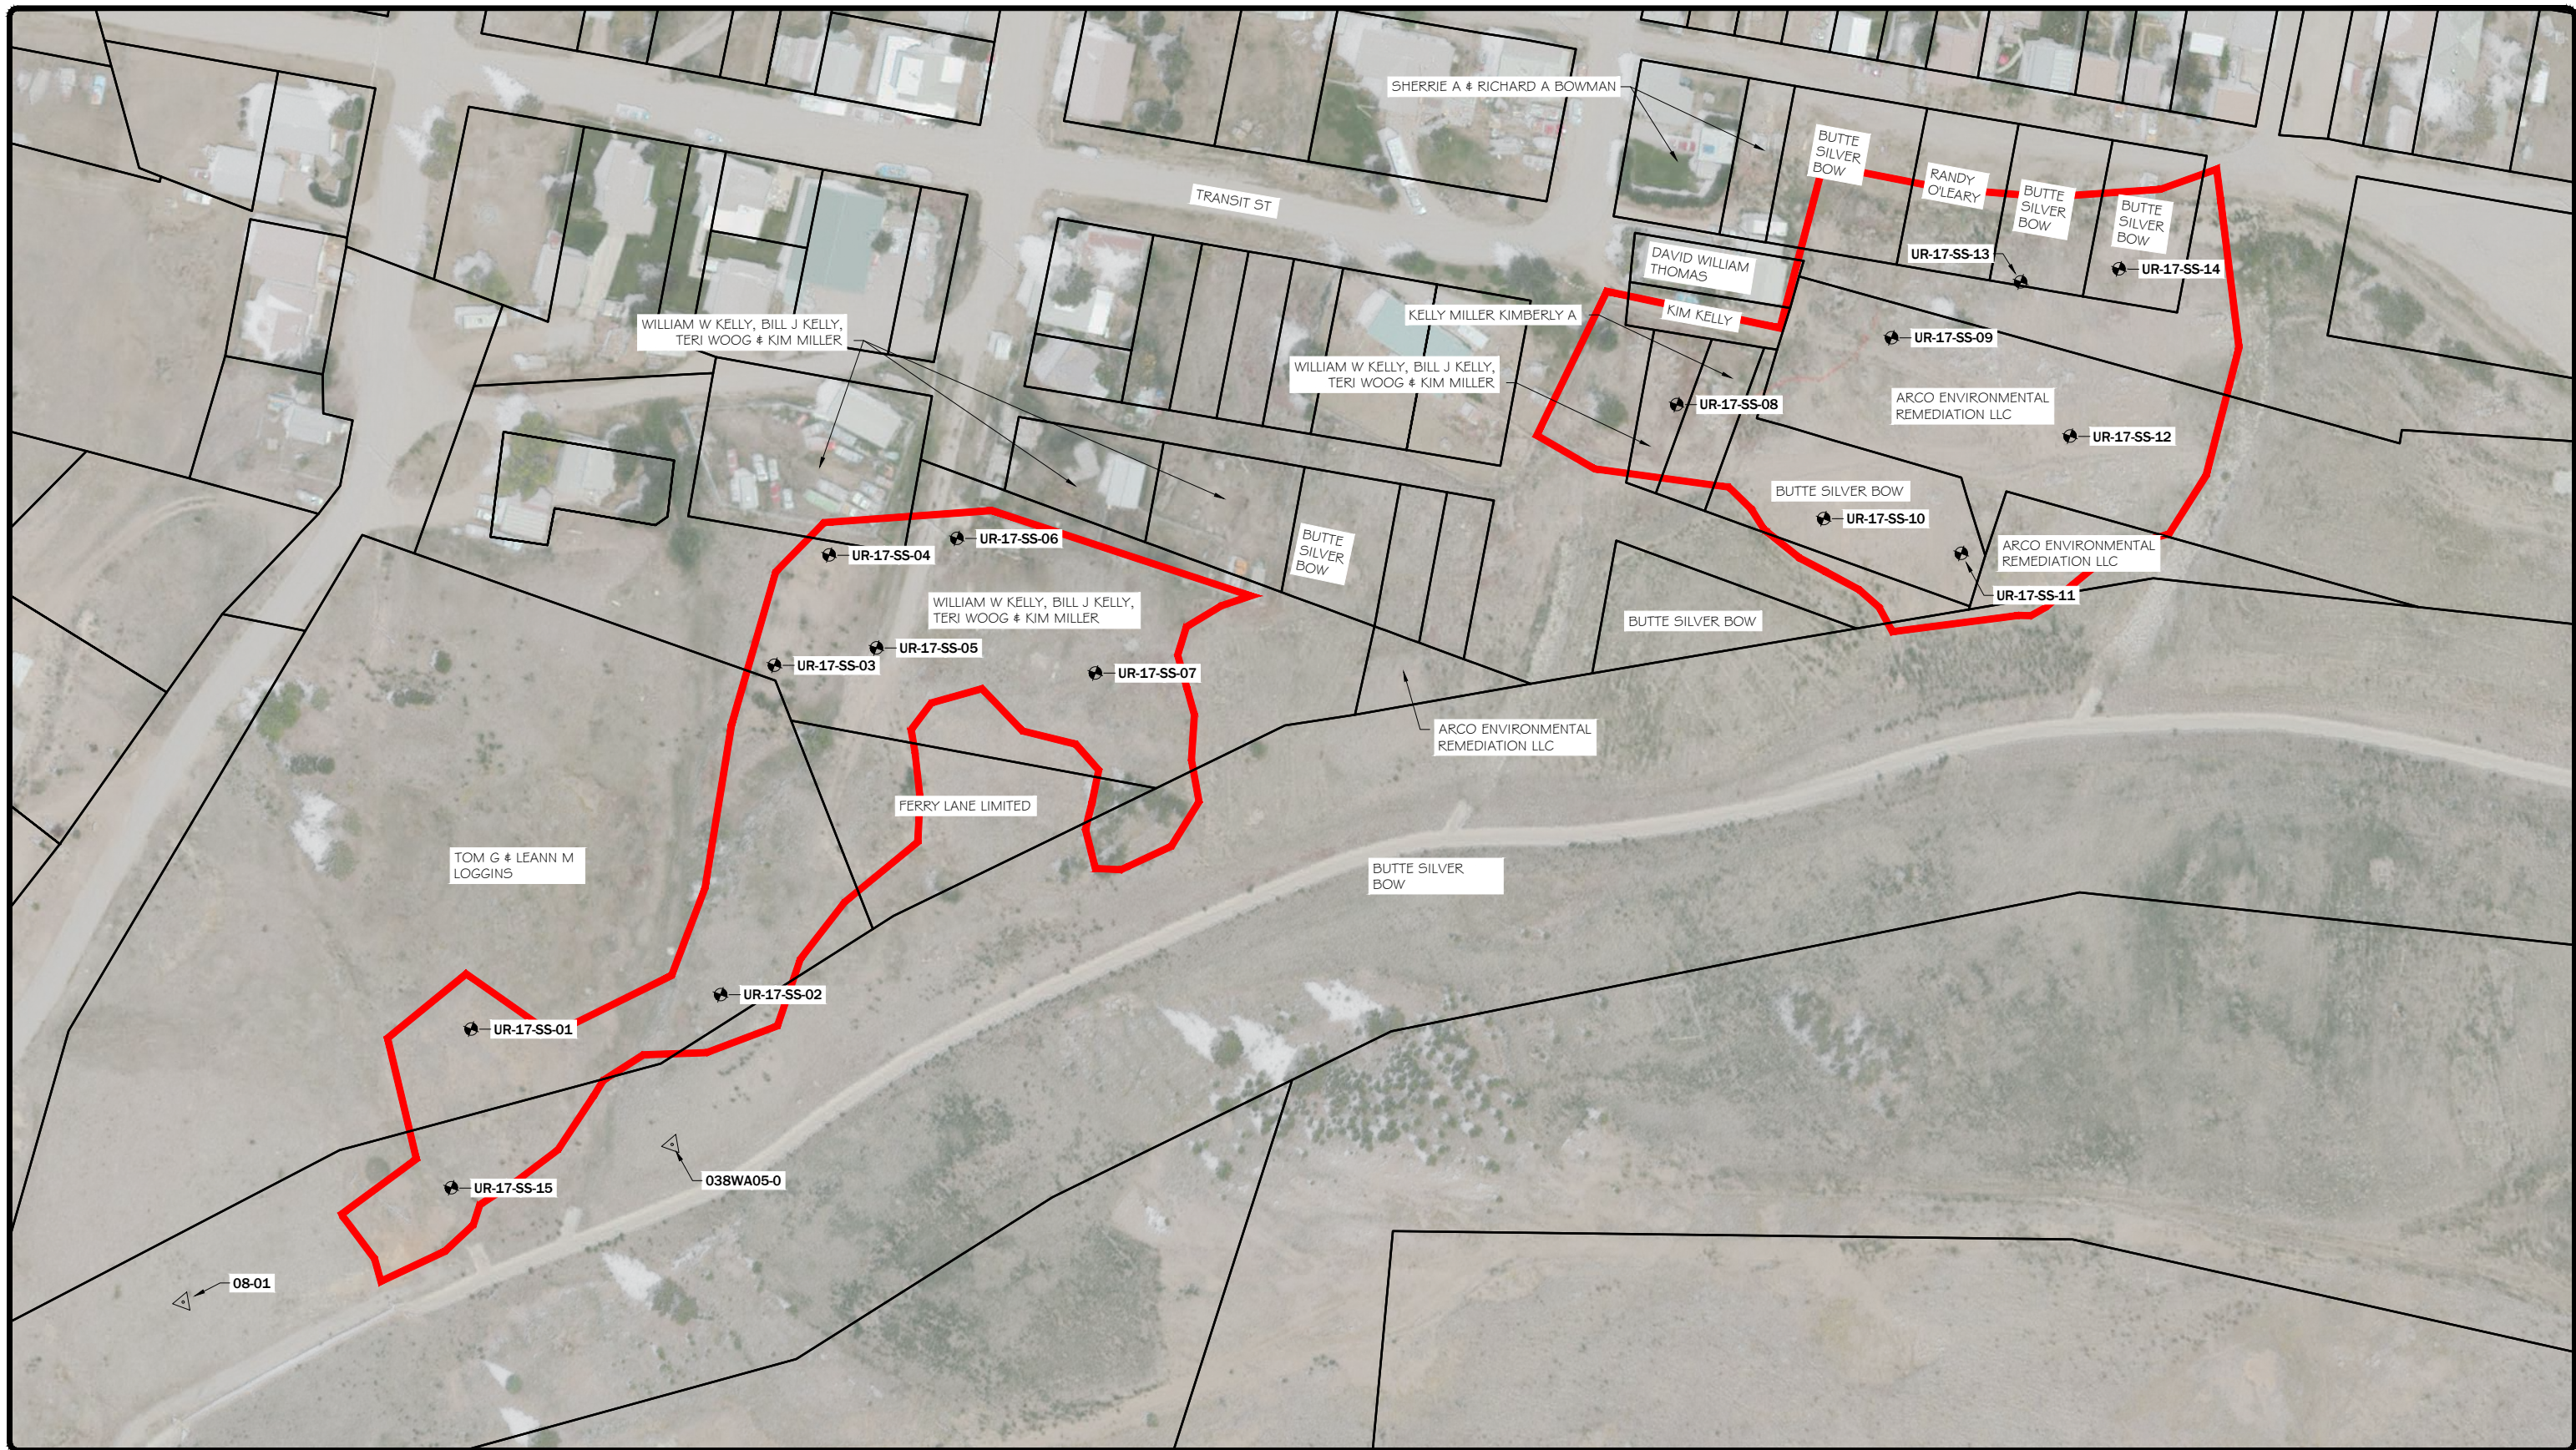
**FIGURE 6** UNRECLAIMED SITE  
 UR-17  
 PROPOSED  
 SAMPLE LOCATIONS

Site UR-17 is approximately 5.0 acres and is located in the upper reaches of the Missoula Gulch drainage on the south side of Walkerville (Figure 6) and consists of two non-contiguous UR areas to be evaluated. The site occupies a south-facing slope between a residential part of Walkerville and the bottom of Missoula Gulch. Ownership of Site UR-17 includes Atlantic Richfield Company, Butte-Silver Bow, Ferry Lane Limited, Randy and Greg O’Leary, Kimberly Kelly-Miller, William Kelly and associated parties, and Tom and Leann Loggins.

Data obtained from the Geocortex web-based database at <https://eis2.woodardcurran.com/Html5Viewer/index.html?viewer=BPButte.BPSOU> contain the records for previous soil samples within Site UR-17. The approximate sample locations are shown on Figure 6 with the results listed in Table 5 below. Some of the results listed show exceedances of the BPSOU action levels for lead and zinc (highlighted in yellow). The BPSOU action levels are listed in Tables 1 and 2 of the UR Sites QAPP.

Areas comprising Site UR-17 are vacant land near residential areas with relatively good vegetation throughout the southwest section. There is an access road from 4<sup>th</sup> Street that contains a small gully and apparent impacted soils. The northeast section of the site has large bare areas with high manganese and iron staining. There are cars on top of the steep slopes that appear to have oil leaks running down the slope. Scrap metal and glass are found through the section with variants of soil colors and erosion. Site UR-17 is in the Missoula Gulch drainage basin.
