Silver Bow Creek/Butte Area Superfund Site

Butte Priority Soils Operable Unit (BPSOU) Unreclaimed Sites - Draft Final Field Sampling Plan (FSP) #5: UR-12, UR-13, UR-33, and UR-38.

August 23, 2021

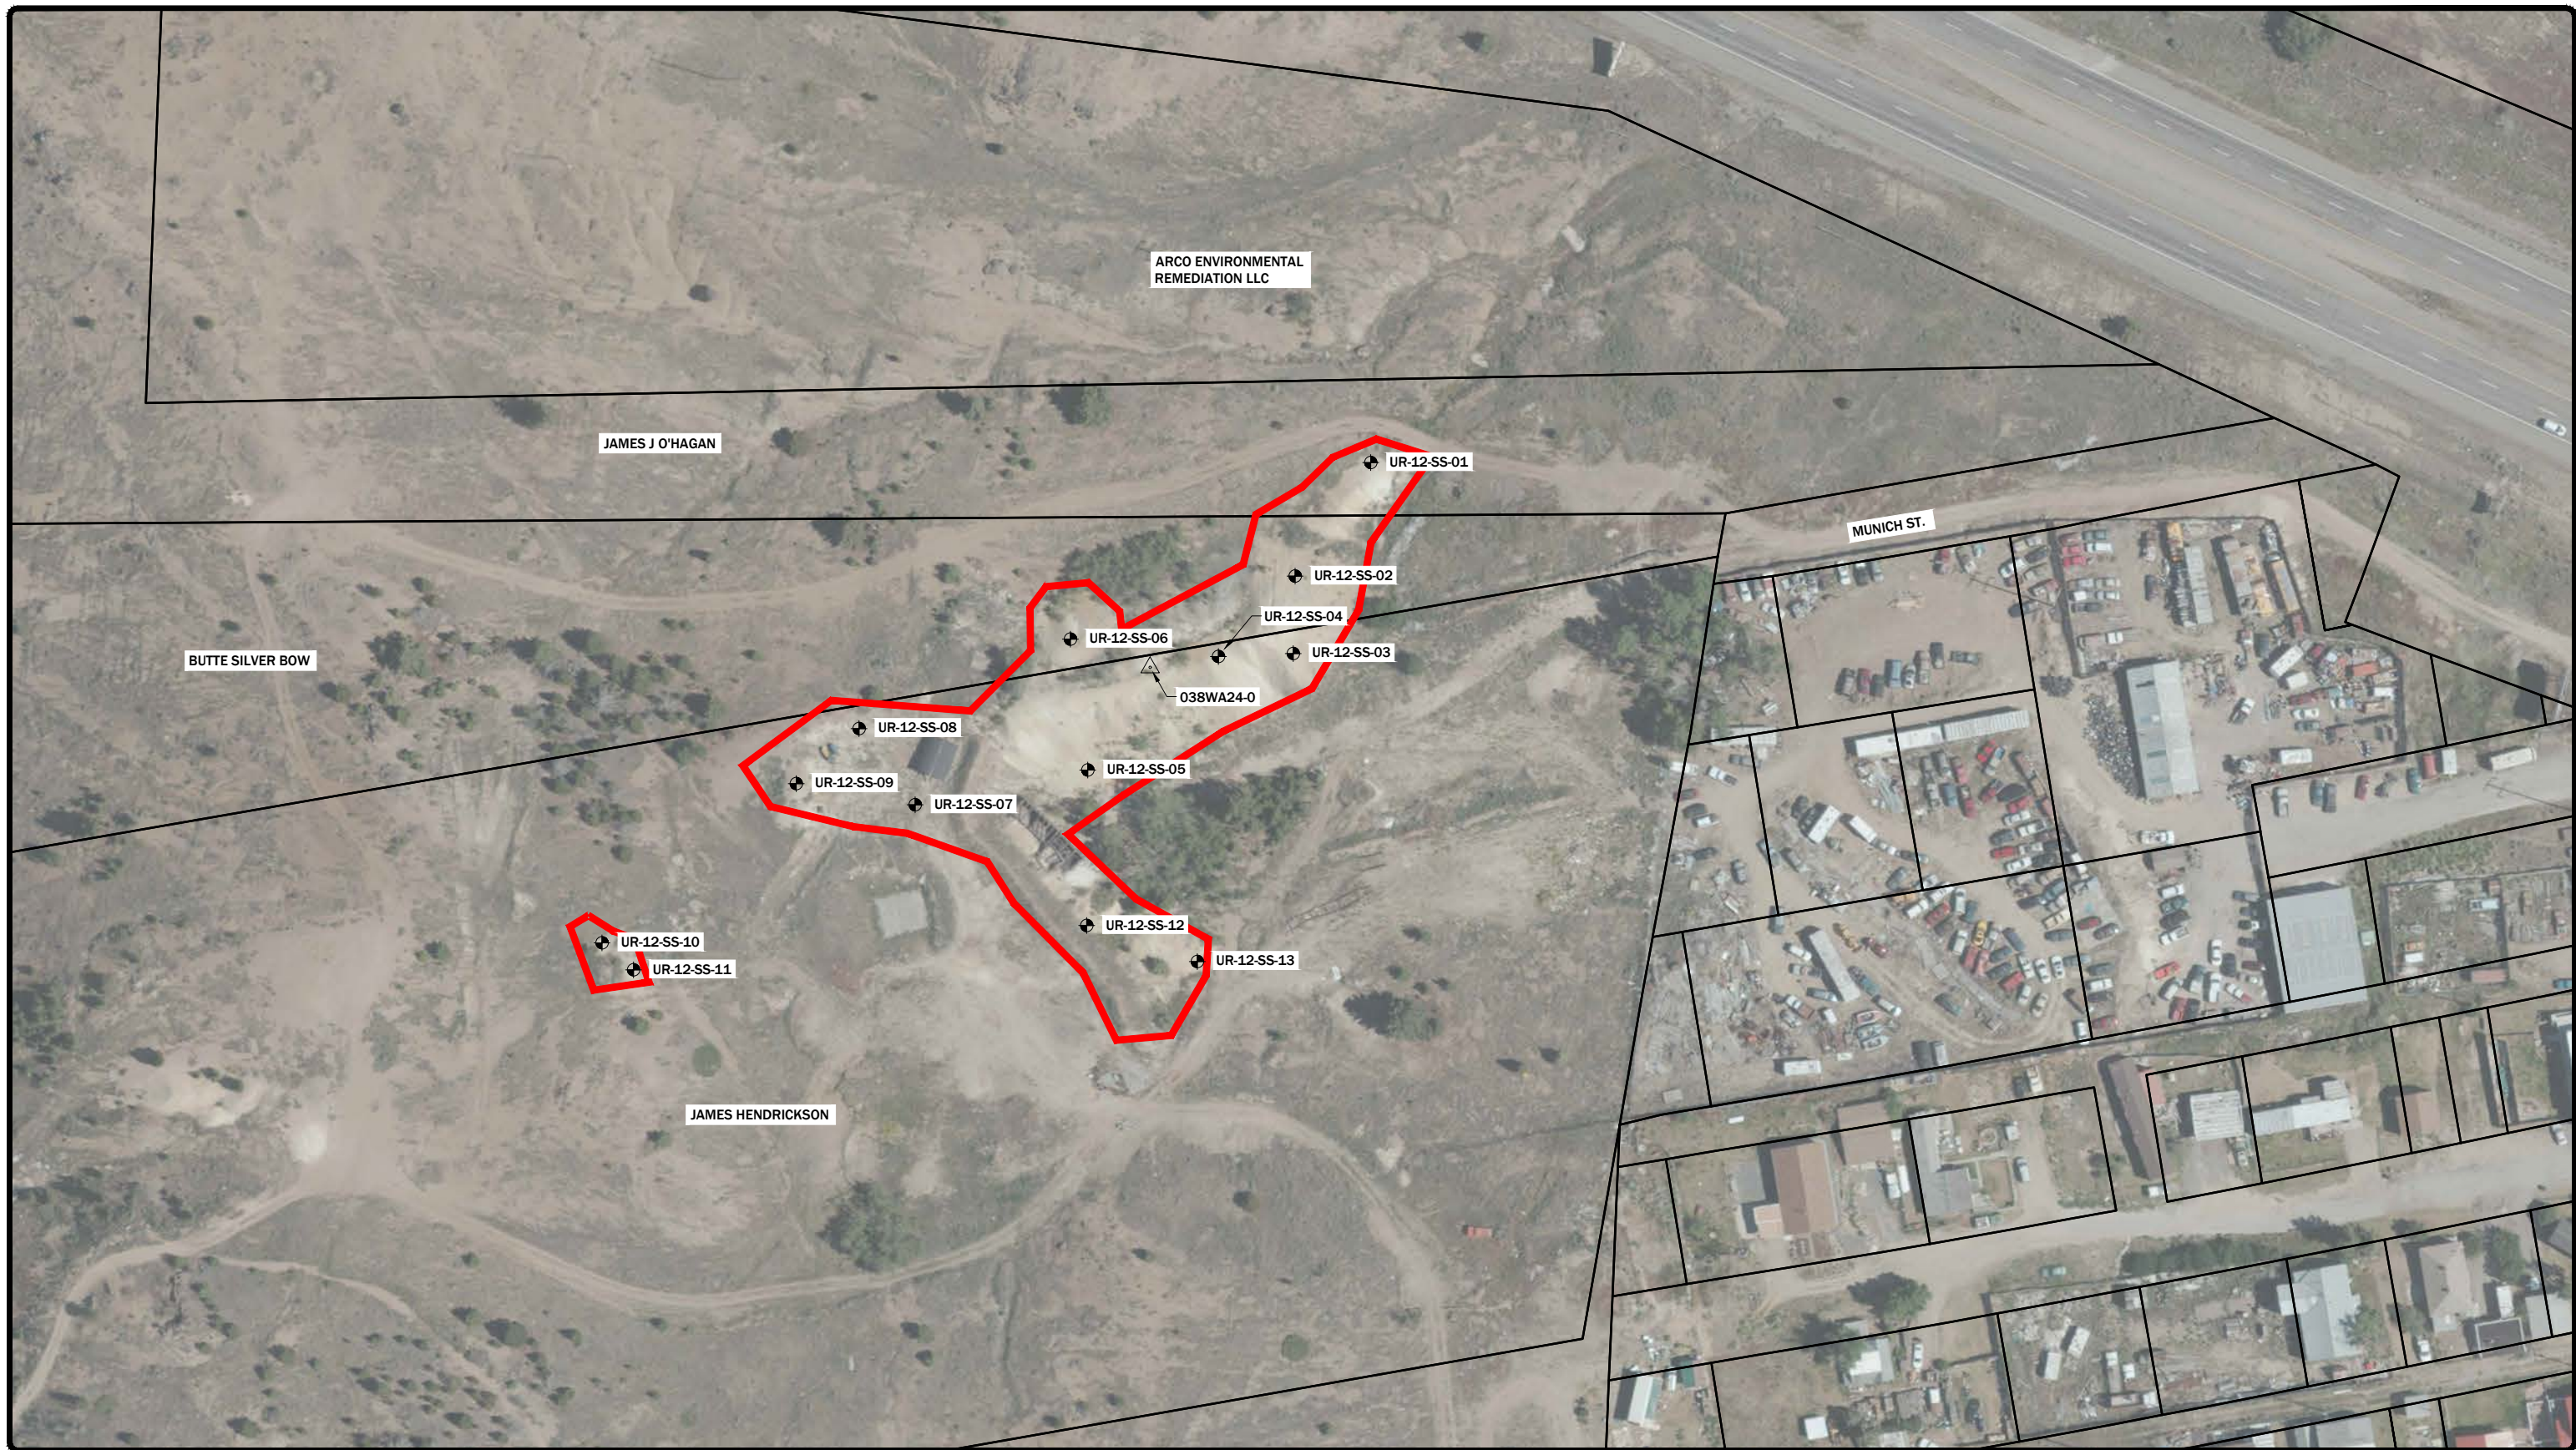
FIGURE 1 UNRECLAIMED SITE
UR-12
PROPOSED
SAMPLE LOCATIONS

Site UR-12 is approximately 1.2 acres and is located immediately west of the community of Williamsburg, south of Interstate 15/90. The site can be accessed by driving to the west end of Munich Street. A small portion of UR-12 sits isolated about 100 feet west of the main portion of the site (Figure 1). The majority of Site UR-12 is owned by James Hendrickson and located on the Highland mining claim. Other portions of UR-12 are owned by Butte-Silver Bow and James O'Hagan. Site UR-12 is vacant land and is outside of the urban area of Butte. Most of the site is bare waste rock with a few trees and sparse ground cover. There are many cars, recreational vehicles, building supplies, and scrap metals being stored on the site.

Data obtained from the Geocortex web-based database at <https://eis2.woodardcurran.com/Html5Viewer/index.html?viewer=BPButte.BPSOU> contain the records for one previous soil sample at Site UR-12. Sample 038WA24-0 was collected in November 1994 as part of a BPSOU soil sampling program and is shown on Figure 1 with results provided in Table 1 below. None of the sample results exceeded BPSOU action levels listed in the UR Sites QAPP.

Site UR-12 is in the Grove Gulch drainage basin of BPSOU, though runoff from the site will not reach Grove Gulch proper. Runoff from Site UR-12 flows to the north going through culverts beneath the interstate, then flows across UR-13, then through culverts beneath the BNSF railroad tracks directly to Silver Bow Creek.

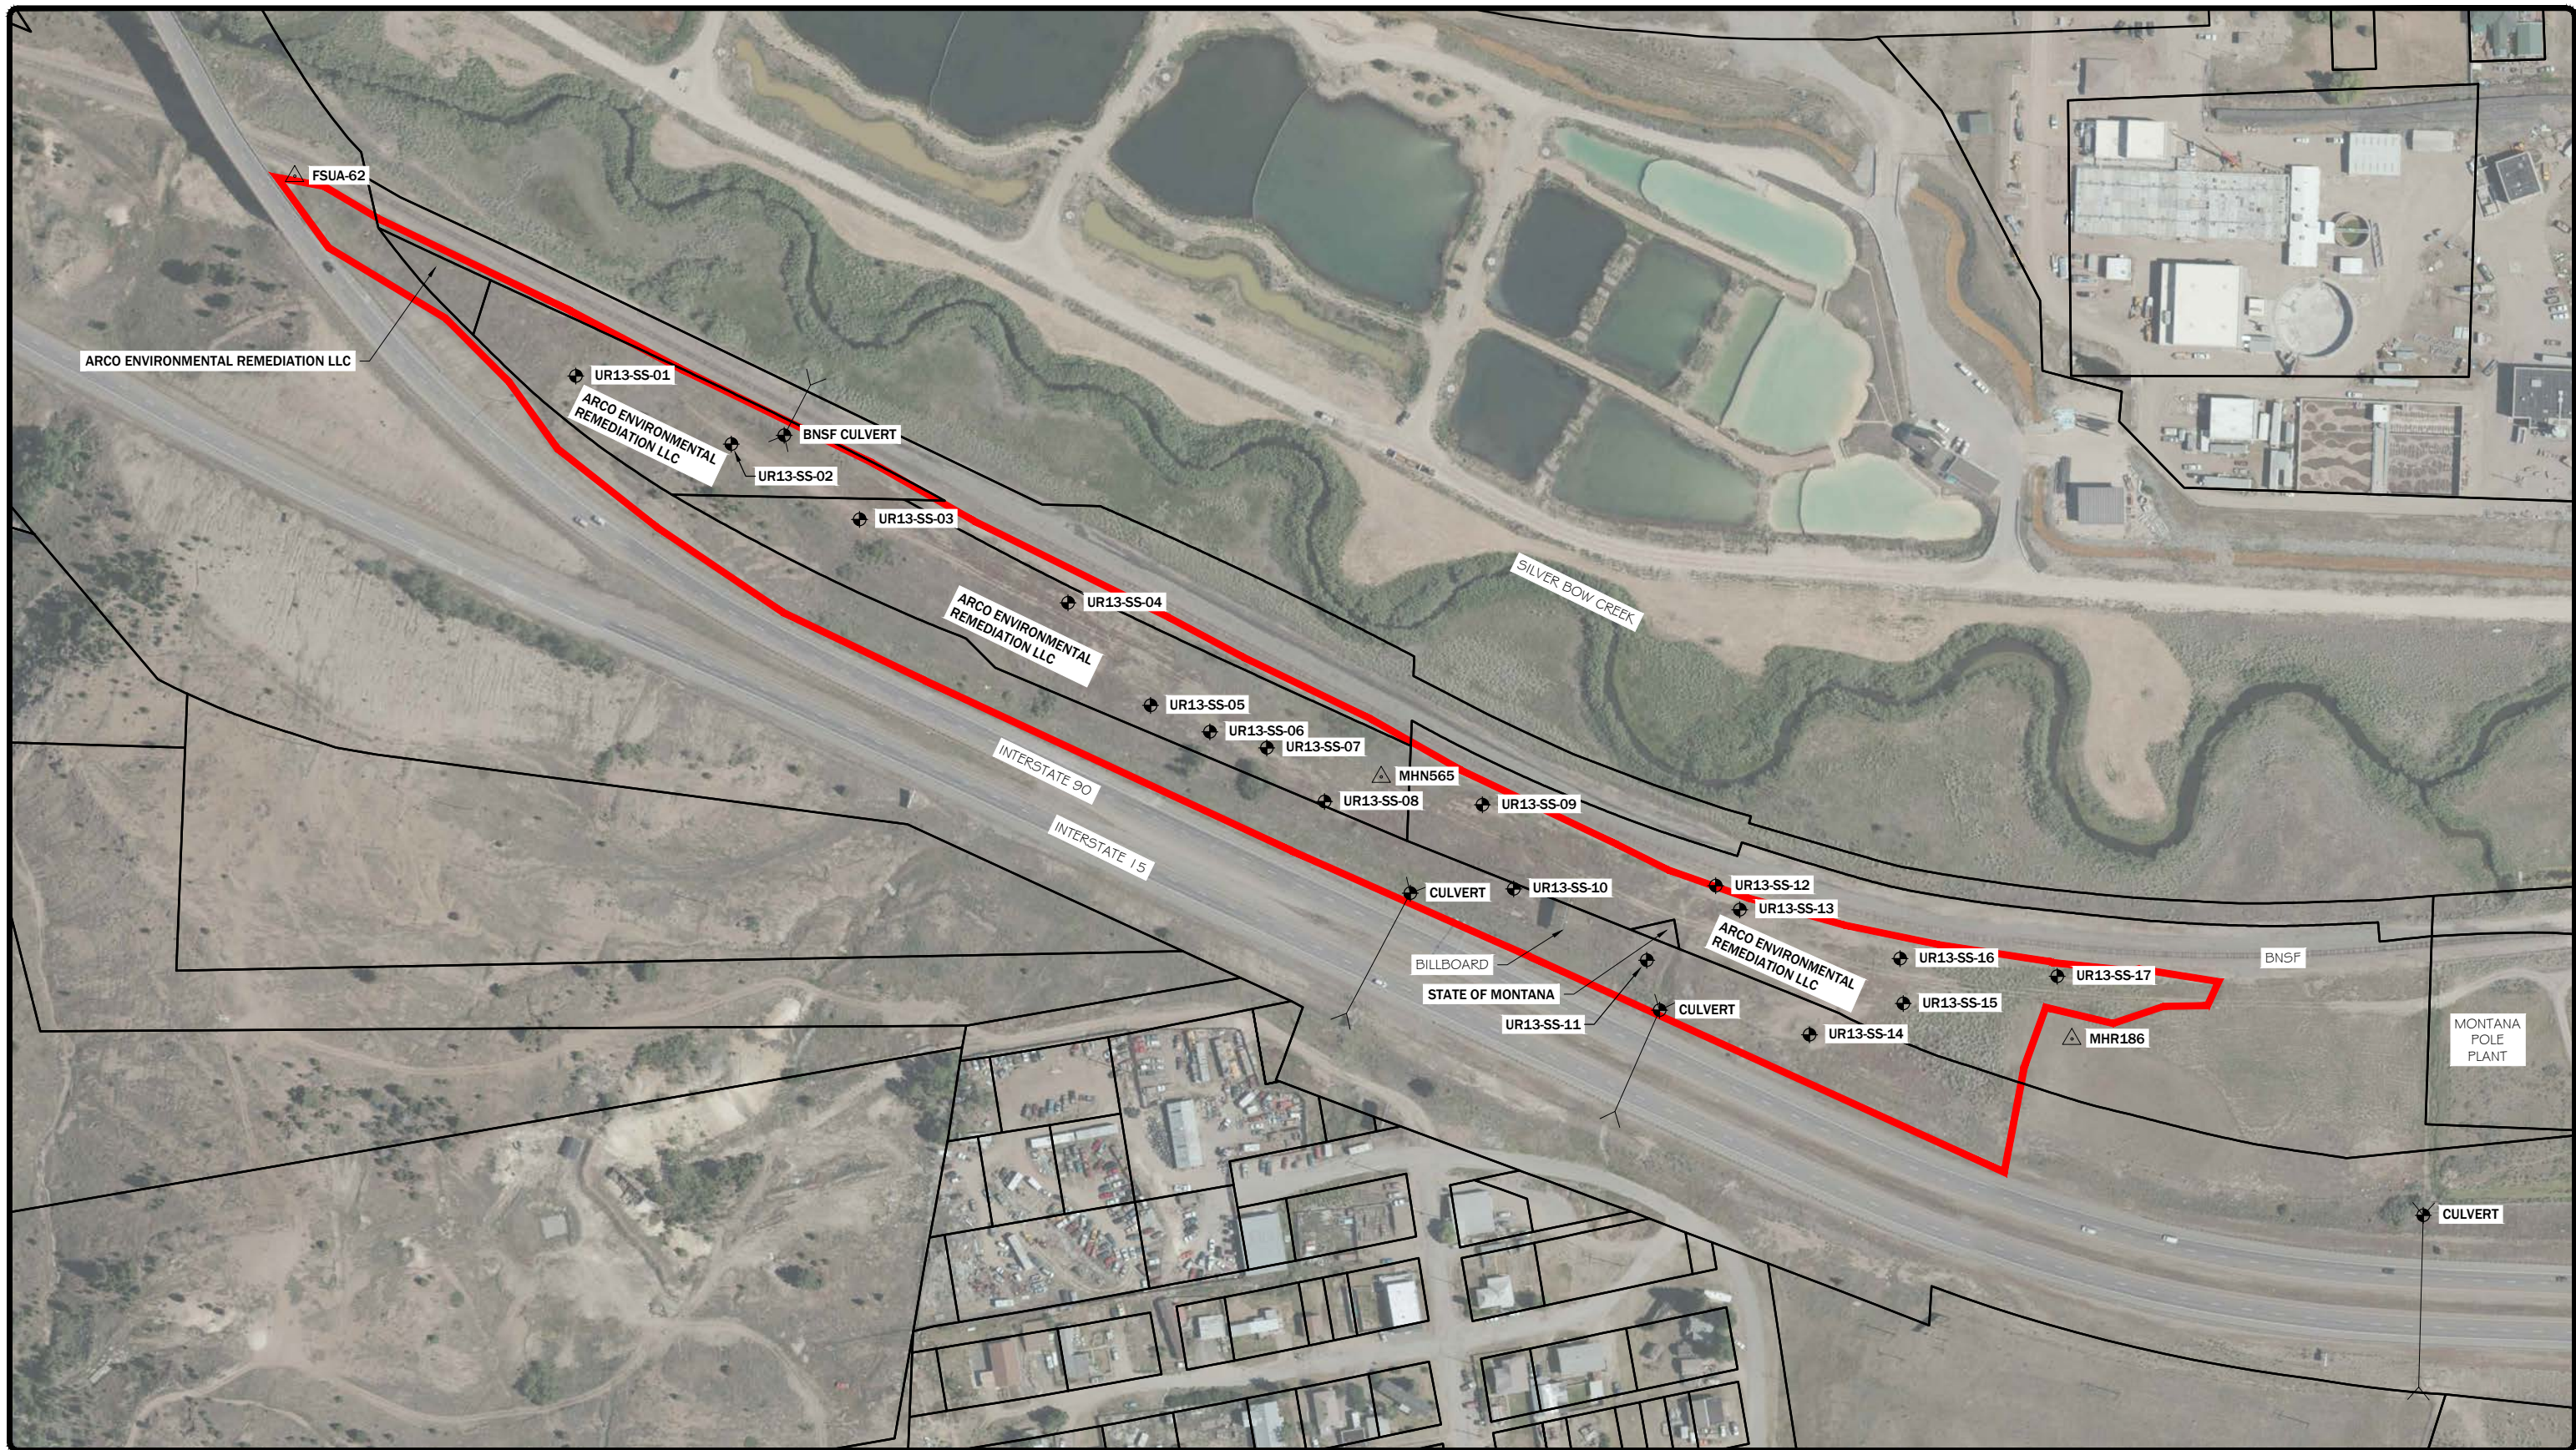
FIGURE 2 UNRECLAIMED SITE
UR 13
PROPOSED
SAMPLE LOCATIONS

Site UR-13 is approximately 10.1 acres and is located immediately north of Interstate 15/90 and south of the BNSF railroad tracks. Just north of the railroad tracks is Silver Bow Creek and the Lower Area One lagoons (Figure 2). Site UR-13 is bounded on the east by the Montana Pole Plant water treatment facility. Access to UR-13 on the east side is through a locked gate in the fence on the west edge of the pole plant site. The UR-13 site is owned by Atlantic Richfield Company and the Montana Department of Transportation (MDT). MDT owns the far western portion of Site UR-13 and a strip of the site along the south edge that is parallel to the interstate and is a portion of the MDT right-of-way (ROW). Site UR-13 is vacant land except for a billboard and power poles.

Runoff from Site UR-13 flows through culverts beneath the BNSF tracks directly to Silver Bow Creek. Culverts beneath the interstate discharge run-on to UR-13. This water either infiltrates at UR-13 or flows across the site to the BNSF culverts. The site is fenced by the MDT ROW fence along the entire south side and the Montana Pole Plant fence on the east. There is no fence along the north side of UR-13 to separate it from the BNSF ROW. Figure 2 shows the 17 proposed soil sample locations for Site UR-13 (identified as UR13-SS-01 through UR13-SS-17).

<https://eis2.woodardcurran.com/Html5Viewer/index.html?viewer=BPButte.BPSOU> contain the records for previous soil sample locations at Site UR-13. Approximate sample locations are shown on Figure 2 with results provided in Table 2 below. Some of the sample results listed (shown in highlighted text on the table) show exceedances of BPSOU action levels for arsenic, copper, lead, and zinc. The BPSOU action levels are listed in Tables 1 and 2 of the UR Sites QAPP.

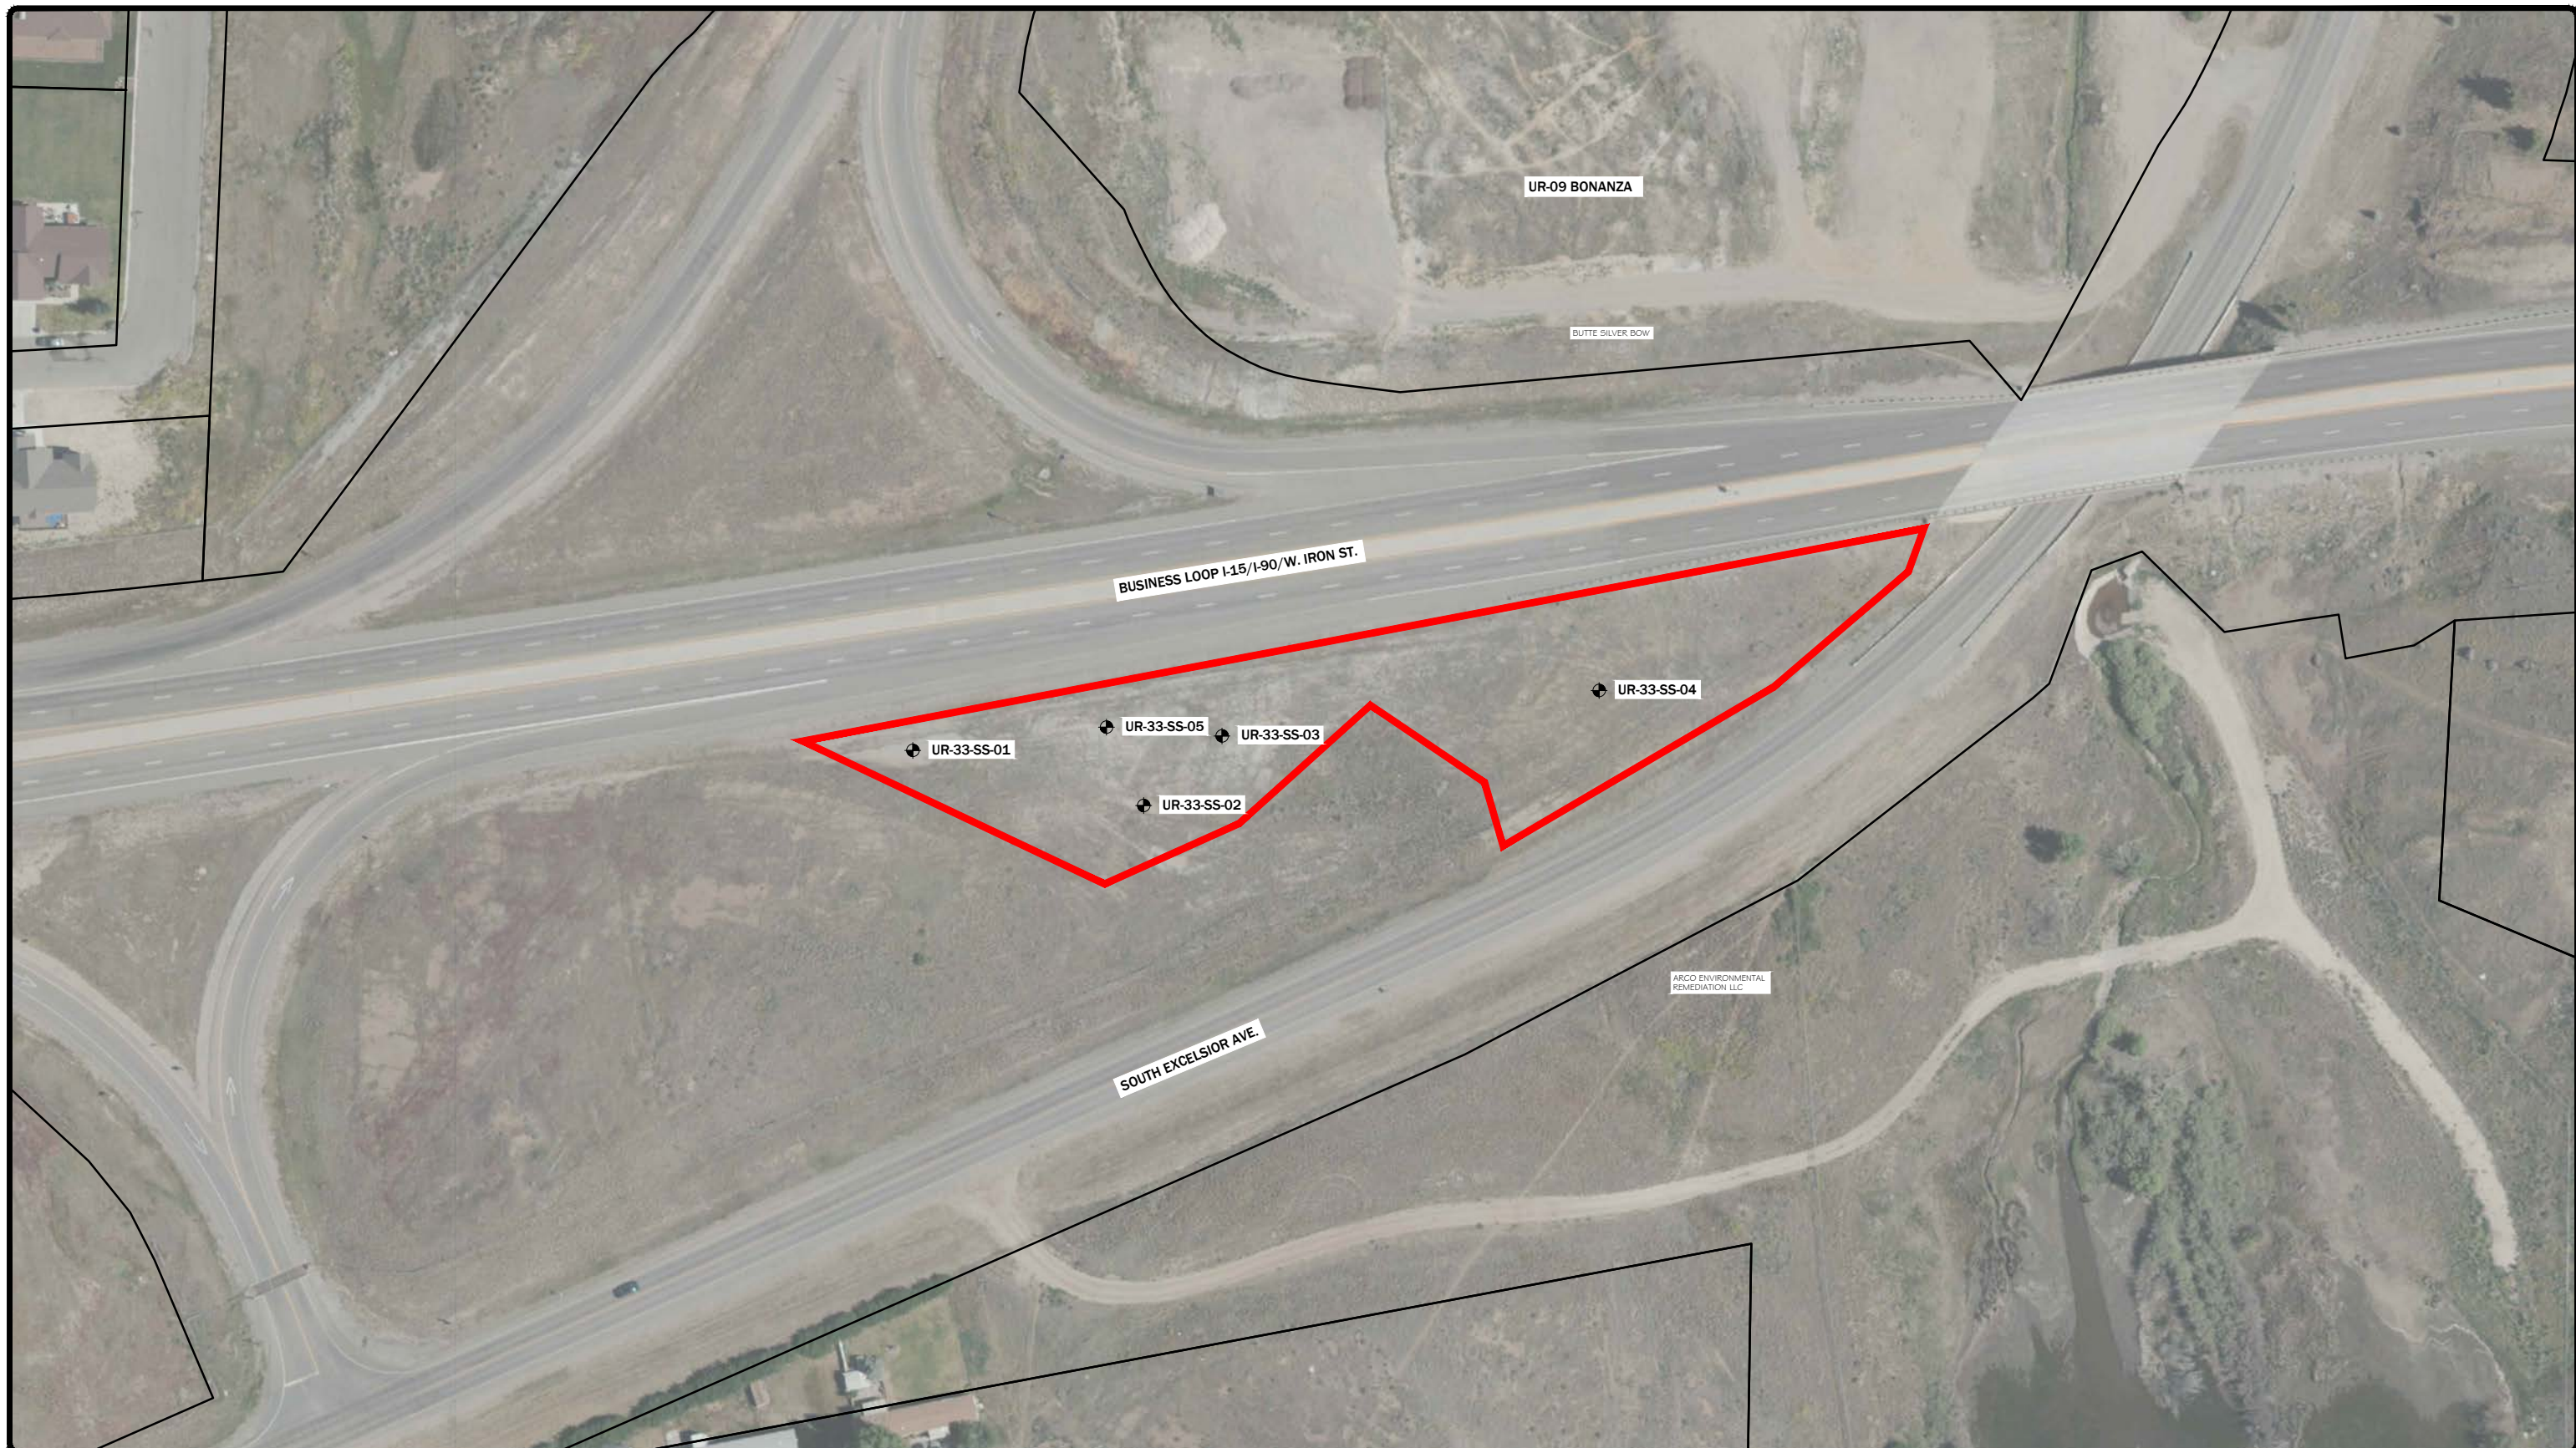
FIGURE 3 UNRECLAIMED SITE
 UR-33
 PROPOSED
 SAMPLE LOCATIONS

Site UR-33 is approximately 1.3 acres and is located south of the Interstate 15/90 Business Loop (West Iron Street) and west and north of South Excelsior Avenue as Excelsior curves to the west (Figure 3). The site is owned by MDT and is vacant ROW land designated as open space.

Site UR-33 is near the bottom of the Missoula Gulch drainage but does not appear to drain directly into Catch Basin 8, though the majority of the site slopes moderately to the south. There is a low ridge near the north edge of the Site that runs parallel to Iron Street. Thus, a small portion of the site drains northward to the ditch along the south edge of Iron Street. There is a fence in the southeast portion of the site that parallels Excelsior Avenue. The remainder of site is not fenced.

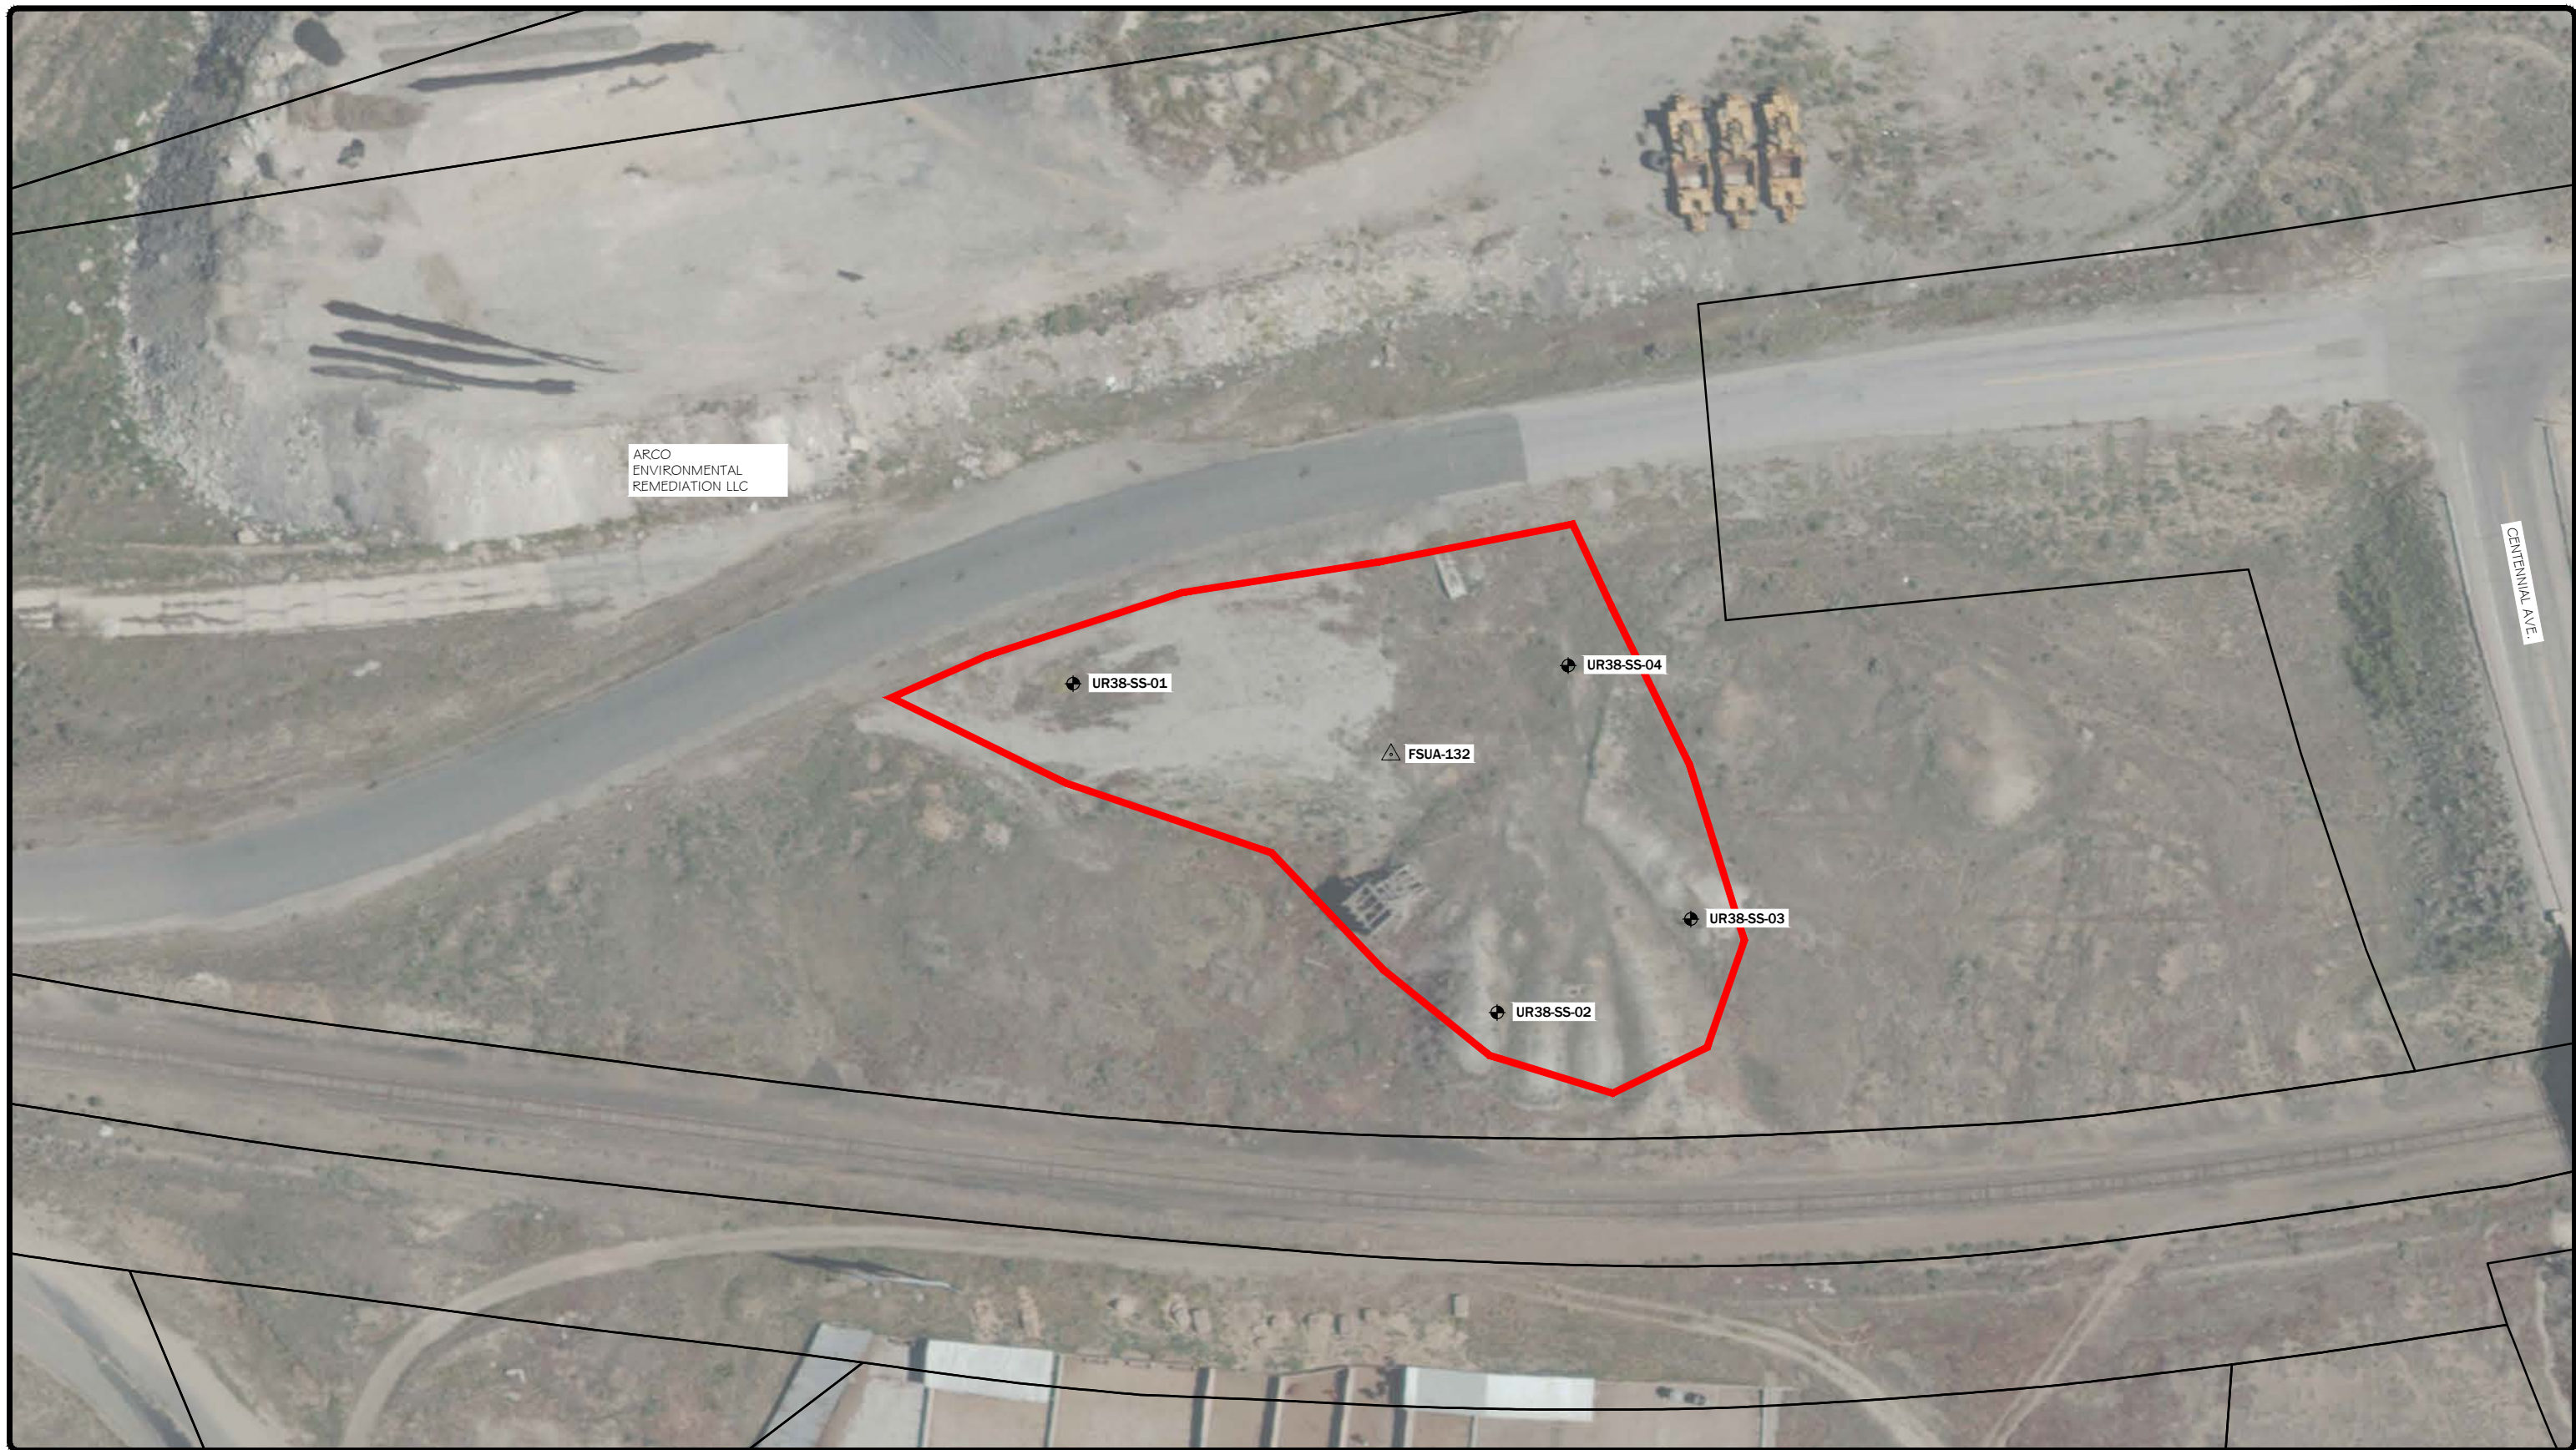
FIGURE 4 UNRECLAIMED SITE
UR 38
PROPOSED
SAMPLE LOCATIONS

Site UR-38 is approximately 0.8 acres and is located southwest of the intersection of Centennial Avenue and South Excelsior Avenue. The RARUS railroad tracks form the south border of UR-38 and south of the tracks is the Ranchland meat packing facility (Figure 4). The site is owned by Atlantic Richfield Company and the parcel is a portion of the Isele mining claim. Site UR-38 is vacant land and has no fencing. The site is easily accessed from the westward extension of South Excelsior Avenue, which is not a through street.

Site UR-38 consists mostly of poorly vegetated to bare waste rock dumps from an unknown mine opening. There is a wooden structure at the end of one of the ridges of waste rock. Runoff from Site UR-38 generally flows to the south and to the southwest. Water will either pond on the north side of the RARUS tracks or, if culverts are present, flow under the tracks. Runoff on the south side of the RARUS tracks in this area has a direct connection to Silver Bow Creek. Site UR-38 is in the Grove Gulch drainage basin of BPSOU. However, the site is north of Silver Bow Creek and runoff from this site will not reach Grove Gulch proper.

Data obtained from the Geocortex web-based database at <https://eis2.woodardcurran.com/Html5Viewer/index.html?viewer=BPButte.BPSOU> contain a record for previous soil sampling within Site UR-38. In June 1996, the sample was collected from Sample Station FSUA-132 as part of the Field Survey of UR Areas program. The approximate sample location for FSUA-132 is shown on Figure 4 with results provided in Table 3 below. None of the results listed showed exceedances of BPSOU action levels for human health, but the zinc result (highlighted below) for FSUA-132 is at the screening criteria level of 1,000 milligrams per kilogram for stormwater. The BPSOU action levels are listed in Tables 1 and 2 of the UR Sites QAPP.
