Silver Bow Creek/Butte Area Superfund Site

### **Butte Priority Soils Operable Unit (BPSOU) Unreclaimed Sites - Final Field Sampling Plan (FSP) #3: UR-06, UR-07, UR-20, UR-22, UR-35, and UR-36**

**RE: Butte Priority Soils Operable Unit (BPSOU) Unreclaimed Sites - Final Field Sampling Plan (FSP) #3: UR-06, UR-07, UR-20, UR-22, UR-35, and UR-36.**

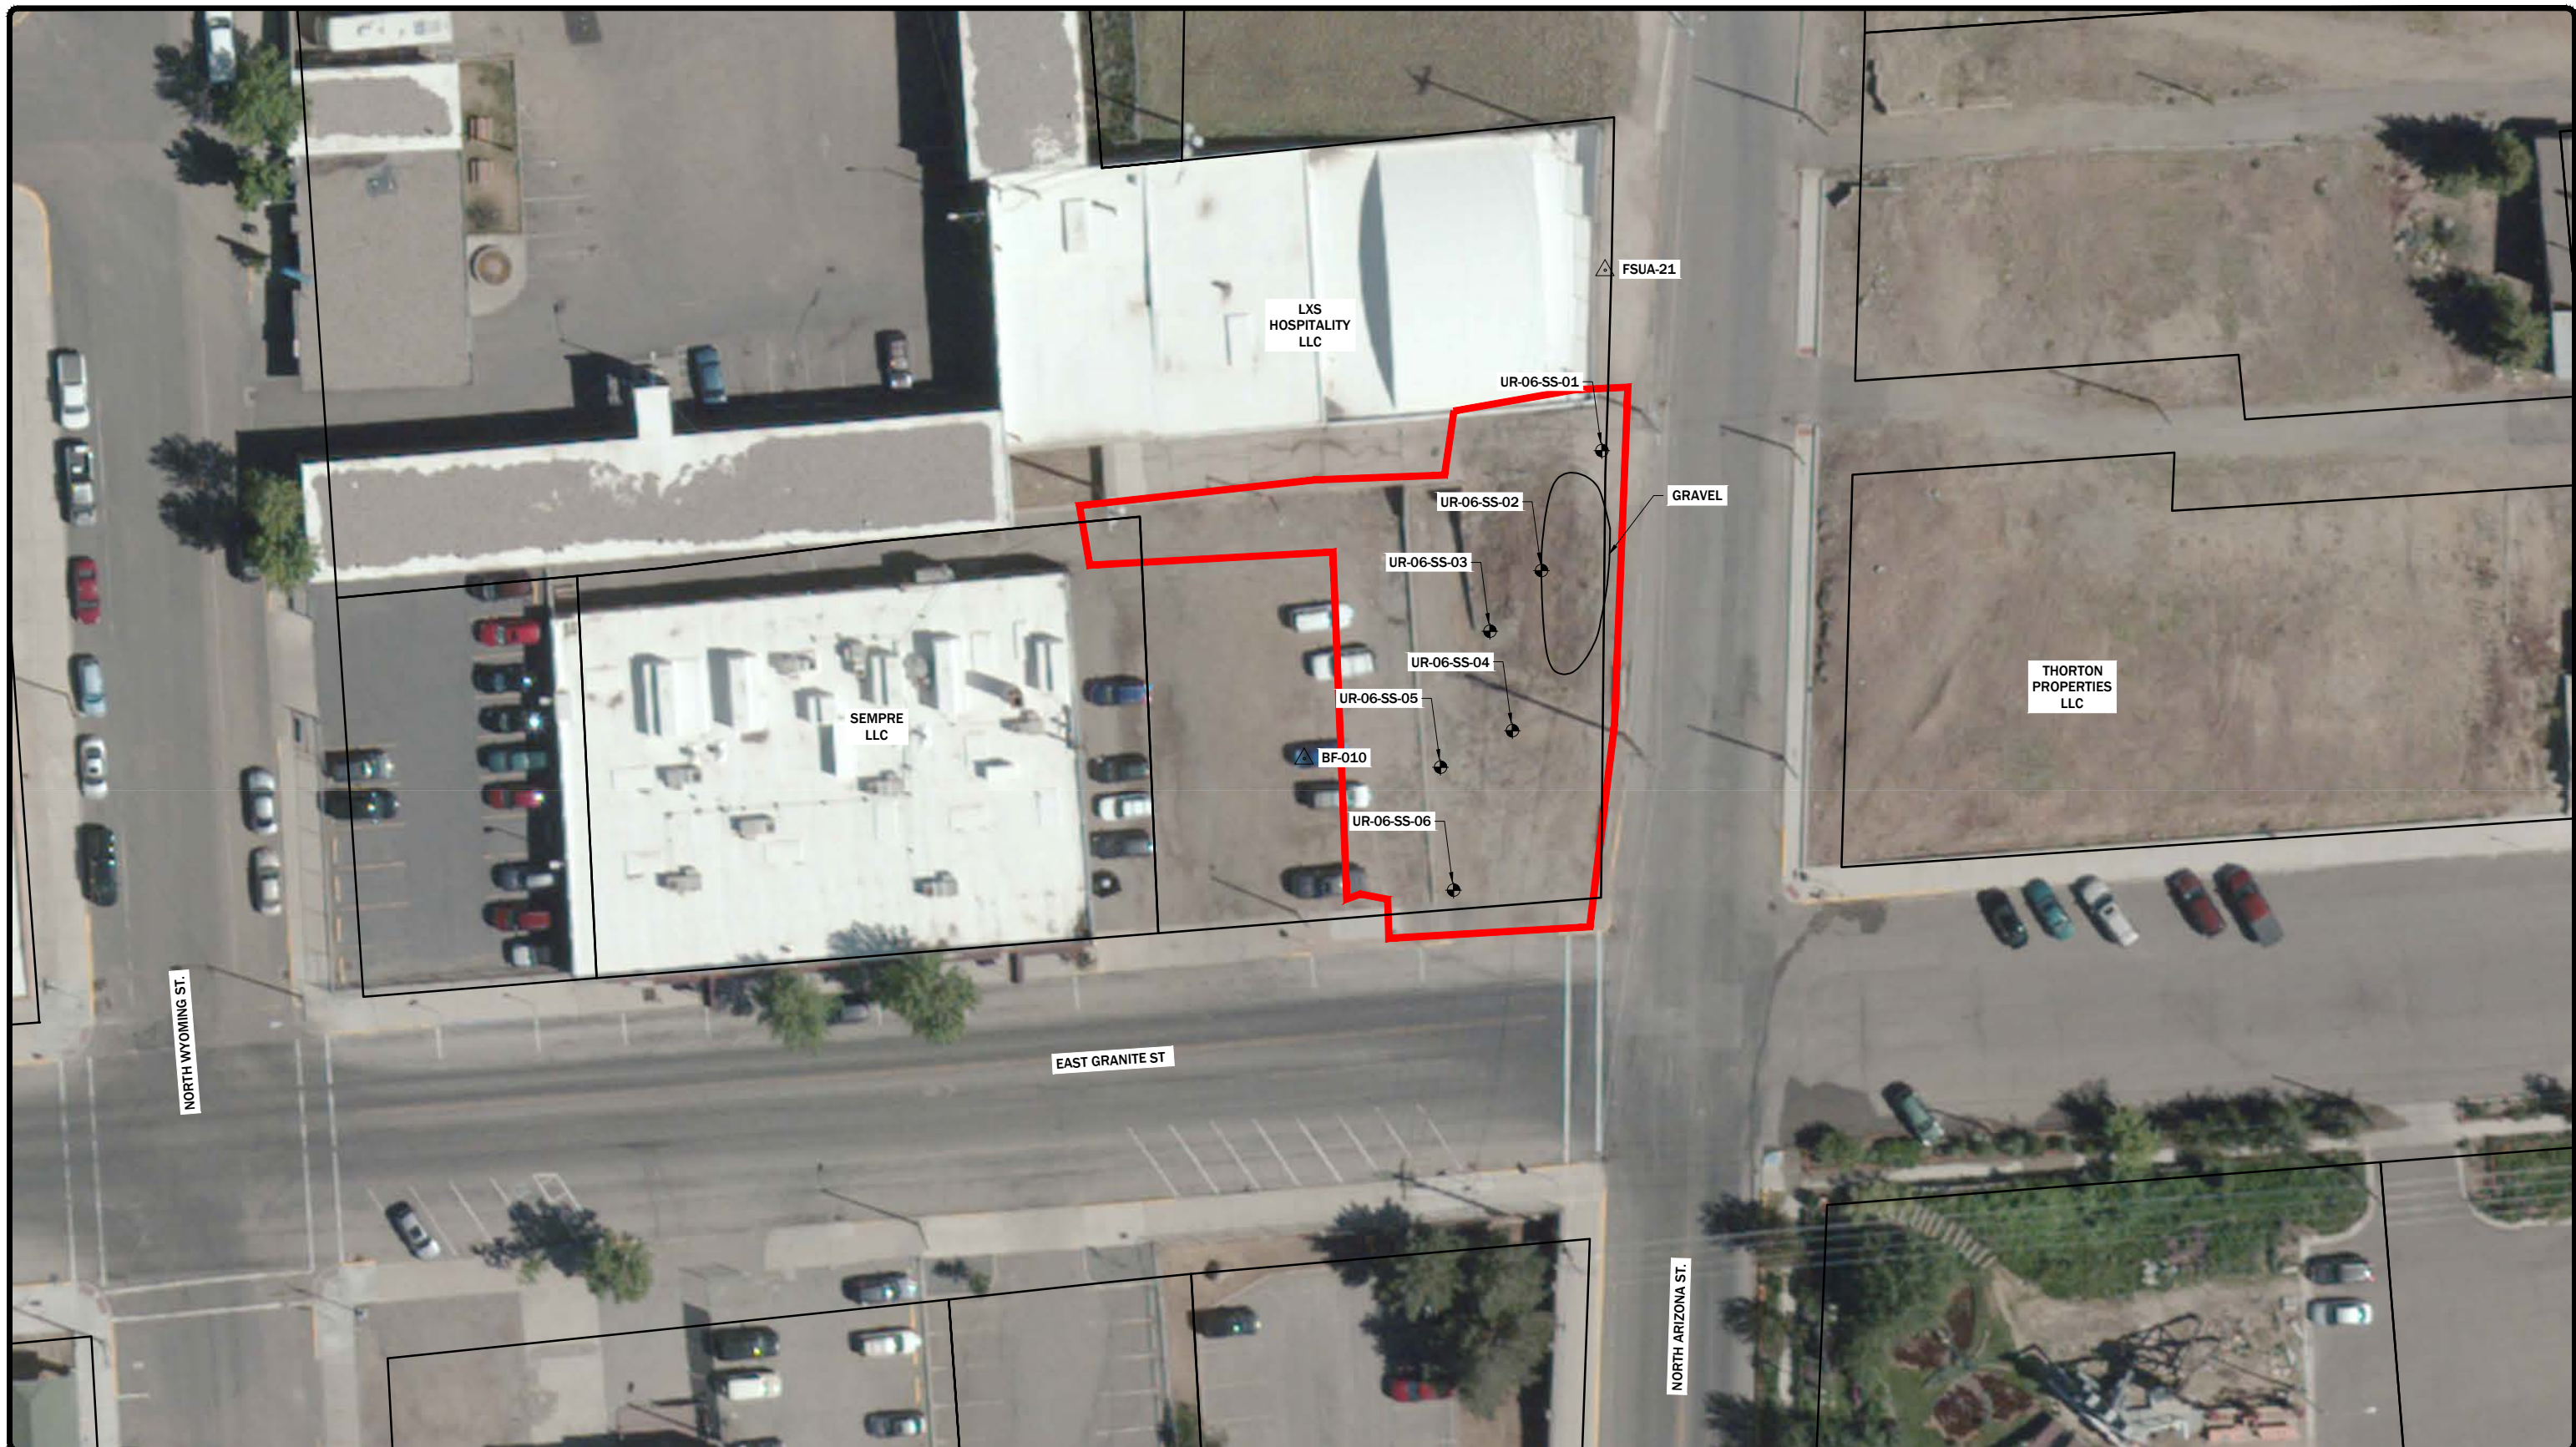
FIGURE 1 UNRECLAIMED SITE  
 UR-06  
 PROPOSED  
 SAMPLE LOCATIONS

LEGEND:  
 ● PROPOSED SOIL SAMPLE LOCATION  
 ▲ PREVIOUS SOIL SAMPLE LOCATION  
 UR-06 IS 0.22 ACRES

Site UR-06 is approximately 0.22 acres and is located at the northwest corner of East Granite and North Arizona Streets, adjacent to Capris Motel – Arctic Dump (BRES No. 100), in uptown Butte (Figure 1). It is on the east end of the uptown business district, in an area of mixed commercial and open space use. Site UR-06 is owned by LXS Hospitality, LLC. A motel is located on the same parcel where UR-06 is located. Parts of site UR-06 are sometimes used for parking and part of it is a driveway into an underground portion of the motel building (perhaps a former parking garage).

The ground surface at Site UR-06 is mostly gravel containing iron staining with very little vegetation. Currently there are engineered beams being stored along the west boundary. Runoff from Site UR-06 generally flows to the south into a storm drain (ID: AB-I-5964) located in the southeast corner outside of the boundary. Site UR-06 is in the Anaconda Road / Butte Brewery drainage basin and sits north of the Belmont Diversion structure. Storm water drainage appears to be directed to the Belmont Diversion structure, which discharges to the Berkeley Pit, and does not impact Silver Bow Creek.

Data obtained from the Geocortex web-based database at <https://eis2.woodardcurran.com/Html5Viewer/index.html?viewer=BPButte.BPSOU> contains the records for the previous soil samples near Site UR-06. The approximate sample locations are included on Figure 1 with results provided in Table 1 below. Some of the results listed, shown in highlighted cells, show exceedances of BPSOU action levels for copper, lead, and zinc. The BPSOU action levels are listed in Tables 1 and 2 of the Atlantic Richfield Company UR Sites QAPP.

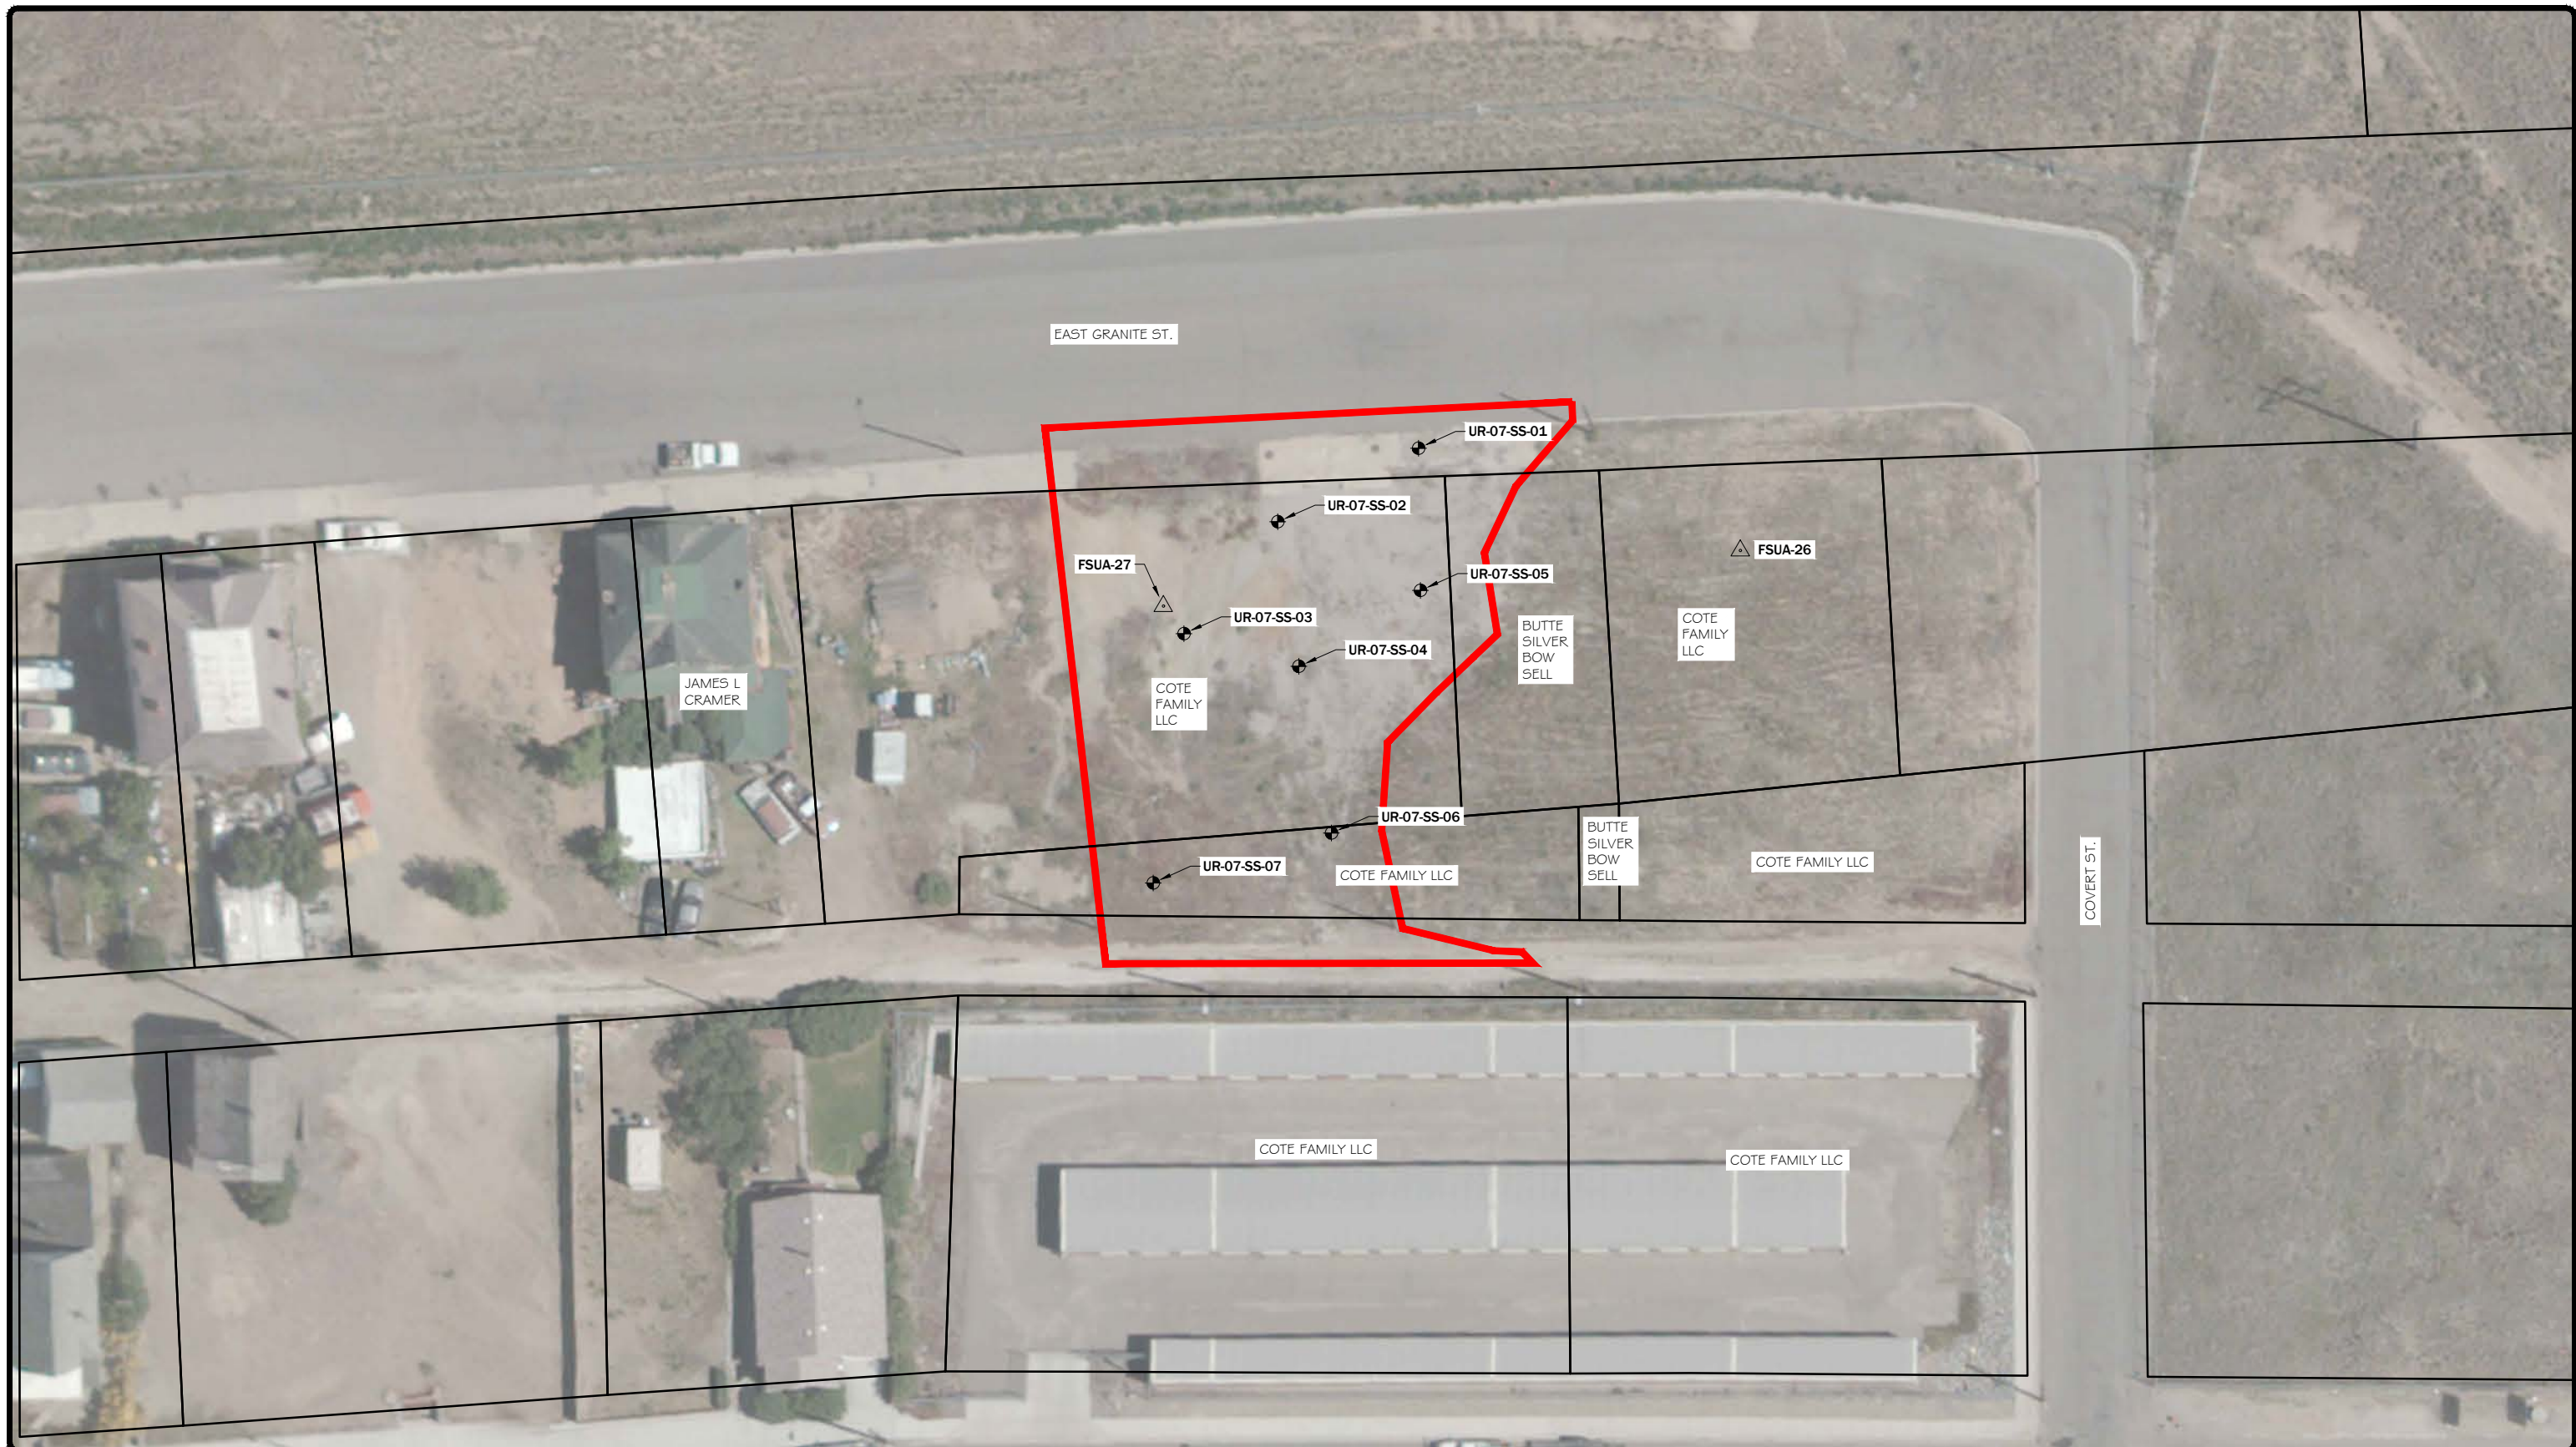
FIGURE 2 UNRECLAIMED SITE  
 UR-07  
 PROPOSED  
 SAMPLE LOCATIONS

LEGEND:  
 ● PROPOSED SOIL SAMPLE LOCATION  
 ▲ PREVIOUS SOIL SAMPLE LOCATION  
 UR-07 IS 0.3 ACRES

Site UR-07 is approximately 0.75 acres and is located at the southwest corner of East Granite and Covert Streets in uptown Butte (Figure 2). It is on the east edge of the uptown area, just west of the Berkeley Pit in an area of mixed residential and commercial use. There are many vacant lots in the area. Site UR-07 itself consists of several vacant parcels. Ownership of Site UR-07 includes Cote Family LLC, Butte-Silver Bow, and Montana Resources. Site UR-07 appears to have moderate vegetation, but the northwest one-third of the site contains a significant bare area that appears to be impacted soil.

Data obtained from the Geocortex web-based database at <https://eis2.woodardcurran.com/Html5Viewer/index.html?viewer=BPButte.BPSOU> contains the records for the previous soil samples at Site UR-07. The samples were collected in 1995 as part of the Field Survey of Unreclaimed Areas program. The approximate sample locations are included on Figure 2 with results provided in Table 2 below. Some of the results listed, shown in highlighted cells, exceeded BPSOU action levels for arsenic, copper, lead, and zinc. The BPSOU action levels are listed in Tables 1 and 2 of the UR Sites QAPP.

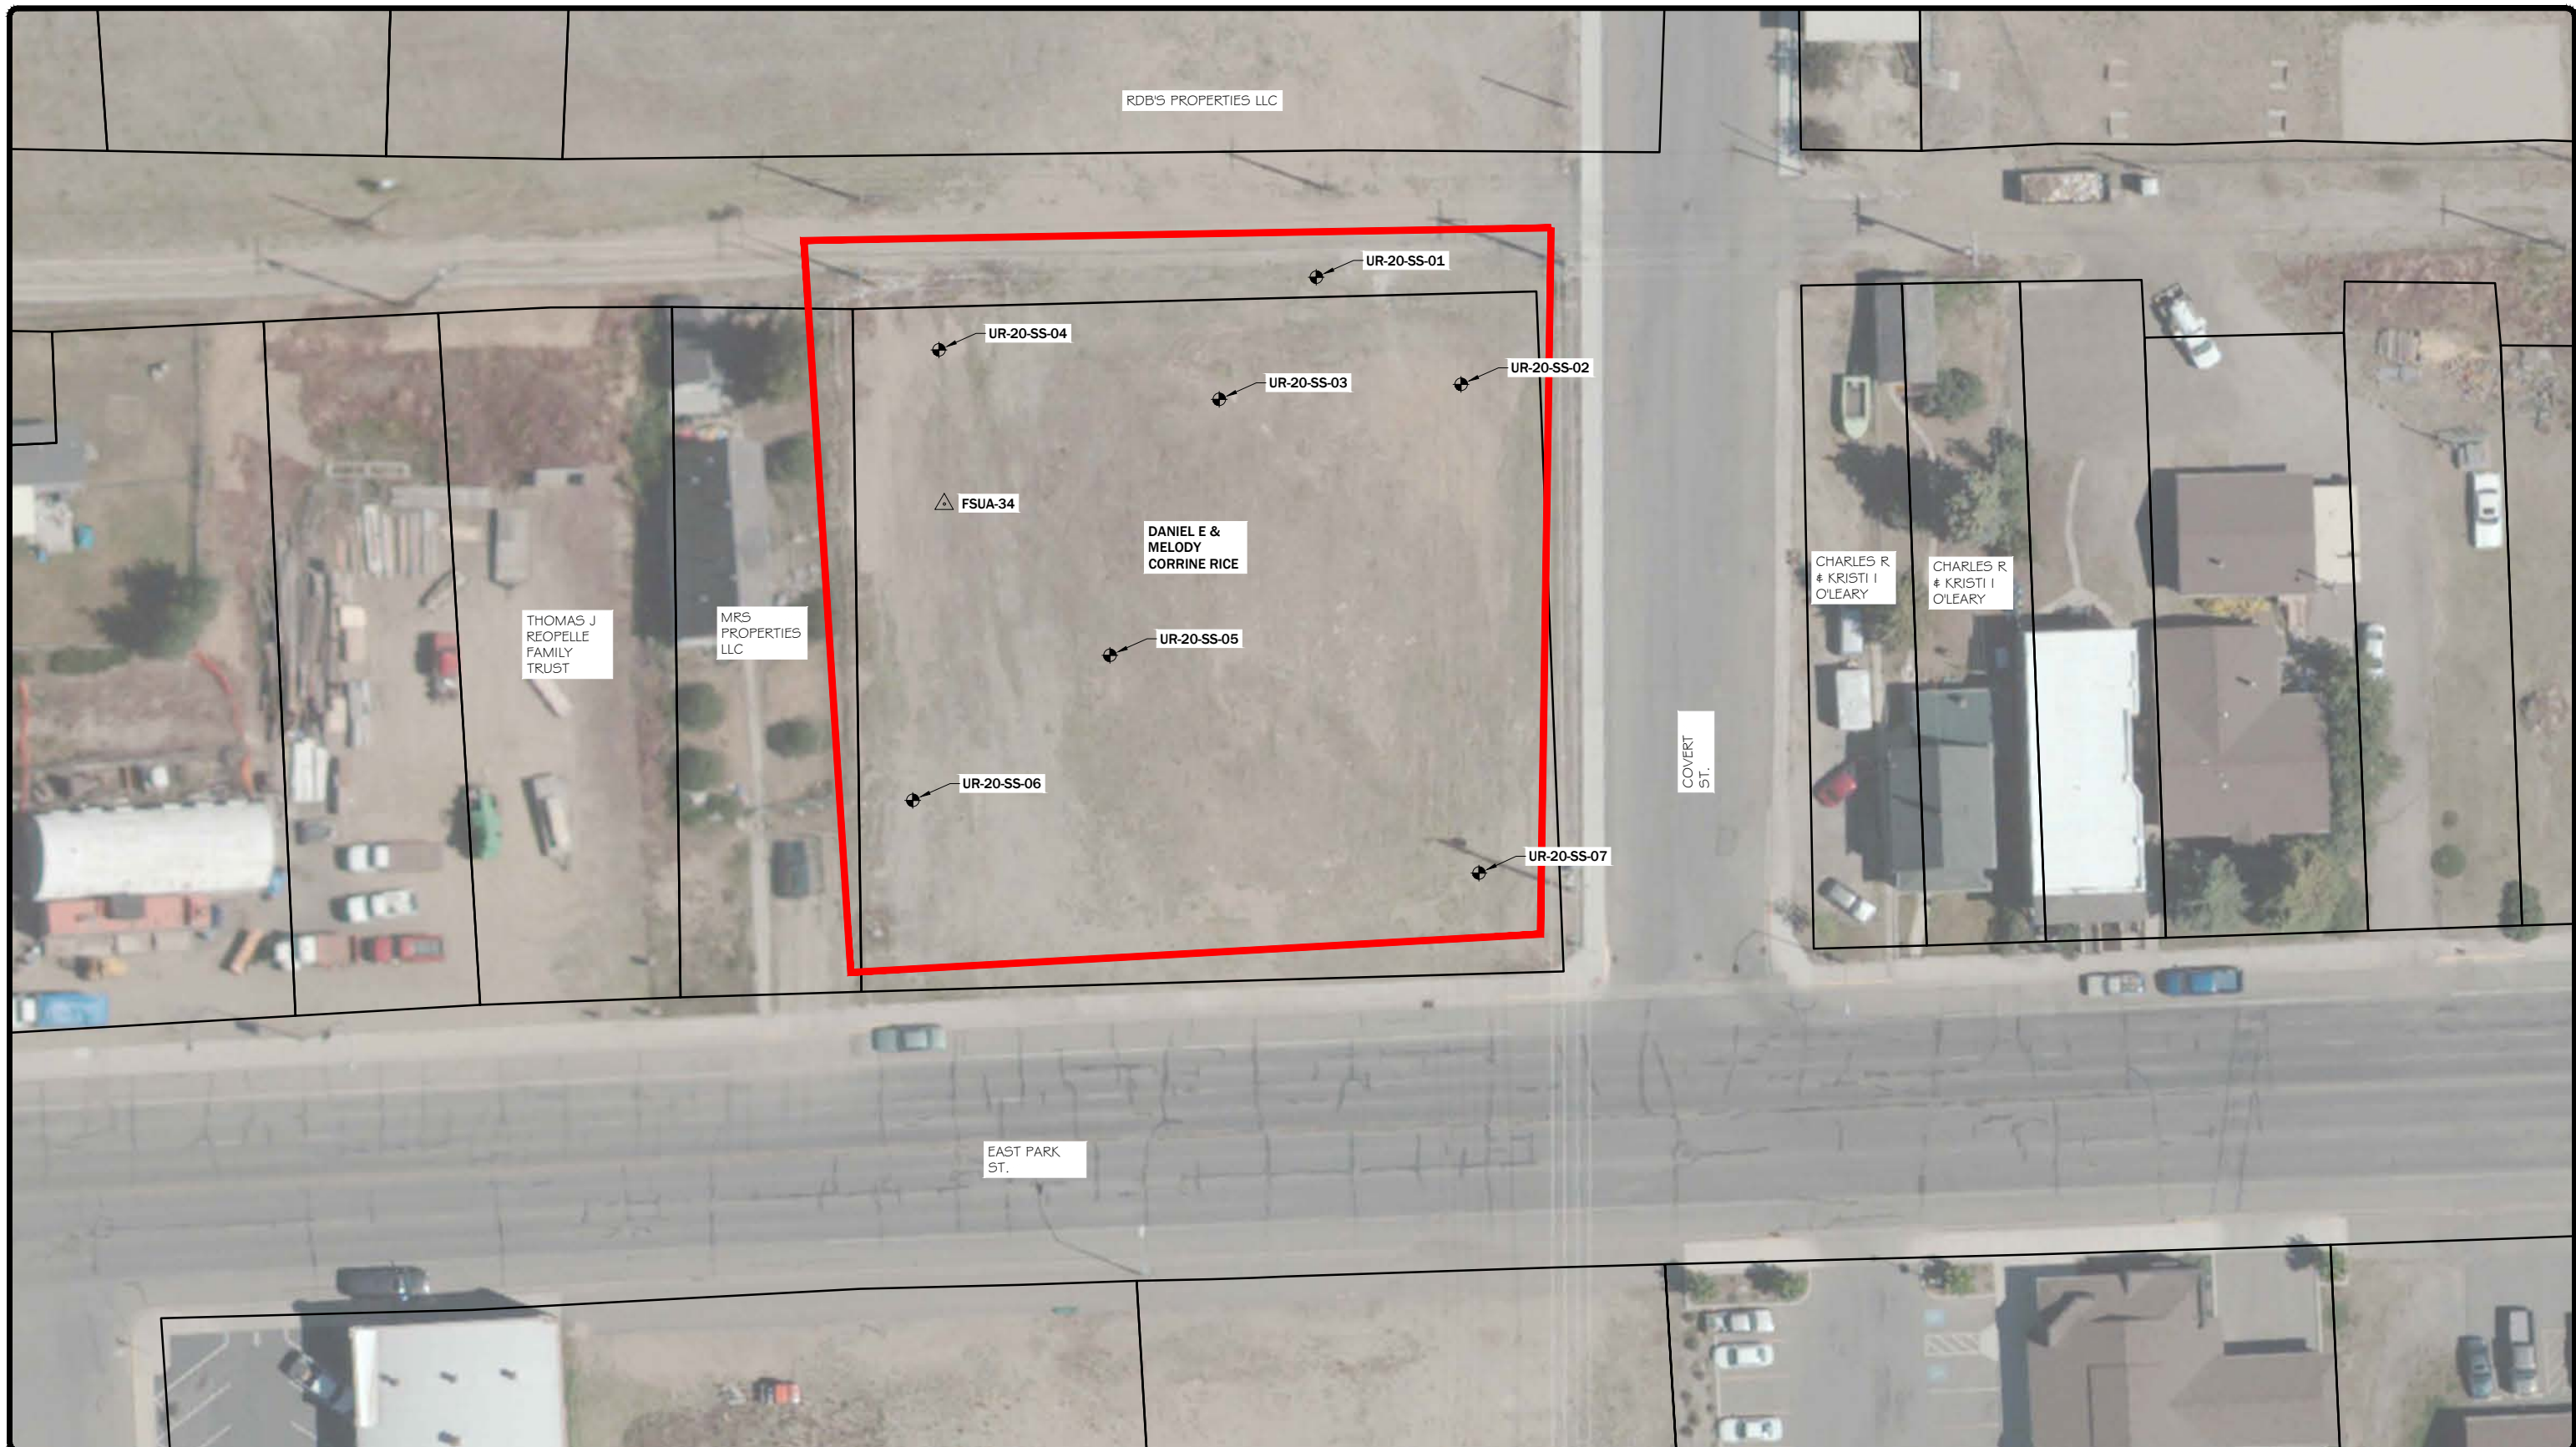
**FIGURE 3** UNRECLAIMED SITE  
UR-20  
PROPOSED  
SAMPLE LOCATIONS

UR-20 IS 0.74 ACRES

Site UR-20 is approximately 0.74 acres and is located at the northwest corner of East Park and Covert Streets in uptown Butte (Figure 3). It is on the east edge of the uptown area, just west of the Berkeley Pit in an area of mixed residential and commercial use. There are many vacant lots in the area. Site UR-20 is a vacant parcel owned by Daniel and Melody Rice. A small portion of UR-20 along the alley on the north side of the site may be owned by Butte-Silver Bow. Site UR-20 has moderate grass cover with what appears to be impacted soil along the northern boundary. There are multiple bare areas throughout the site.

Data obtained from the Geocortex web-based database at <https://eis2.woodardcurran.com/Html5Viewer/index.html?viewer=BPButte.BPSOU> contains the records for the previous soil sample within Site UR-20 collected in 1995 as part of the Field Survey of Unreclaimed Areas program. The approximate sample locations are included on Figure 3 with results provided in Table 3 below. The BPSOU action levels for human health and storm water screening criteria are listed in Tables 1 and 2 of the UR Sites QAPP. Some of the results listed, shown as highlighted cells, exceeded BPSOU storm water screening criteria for copper and zinc.

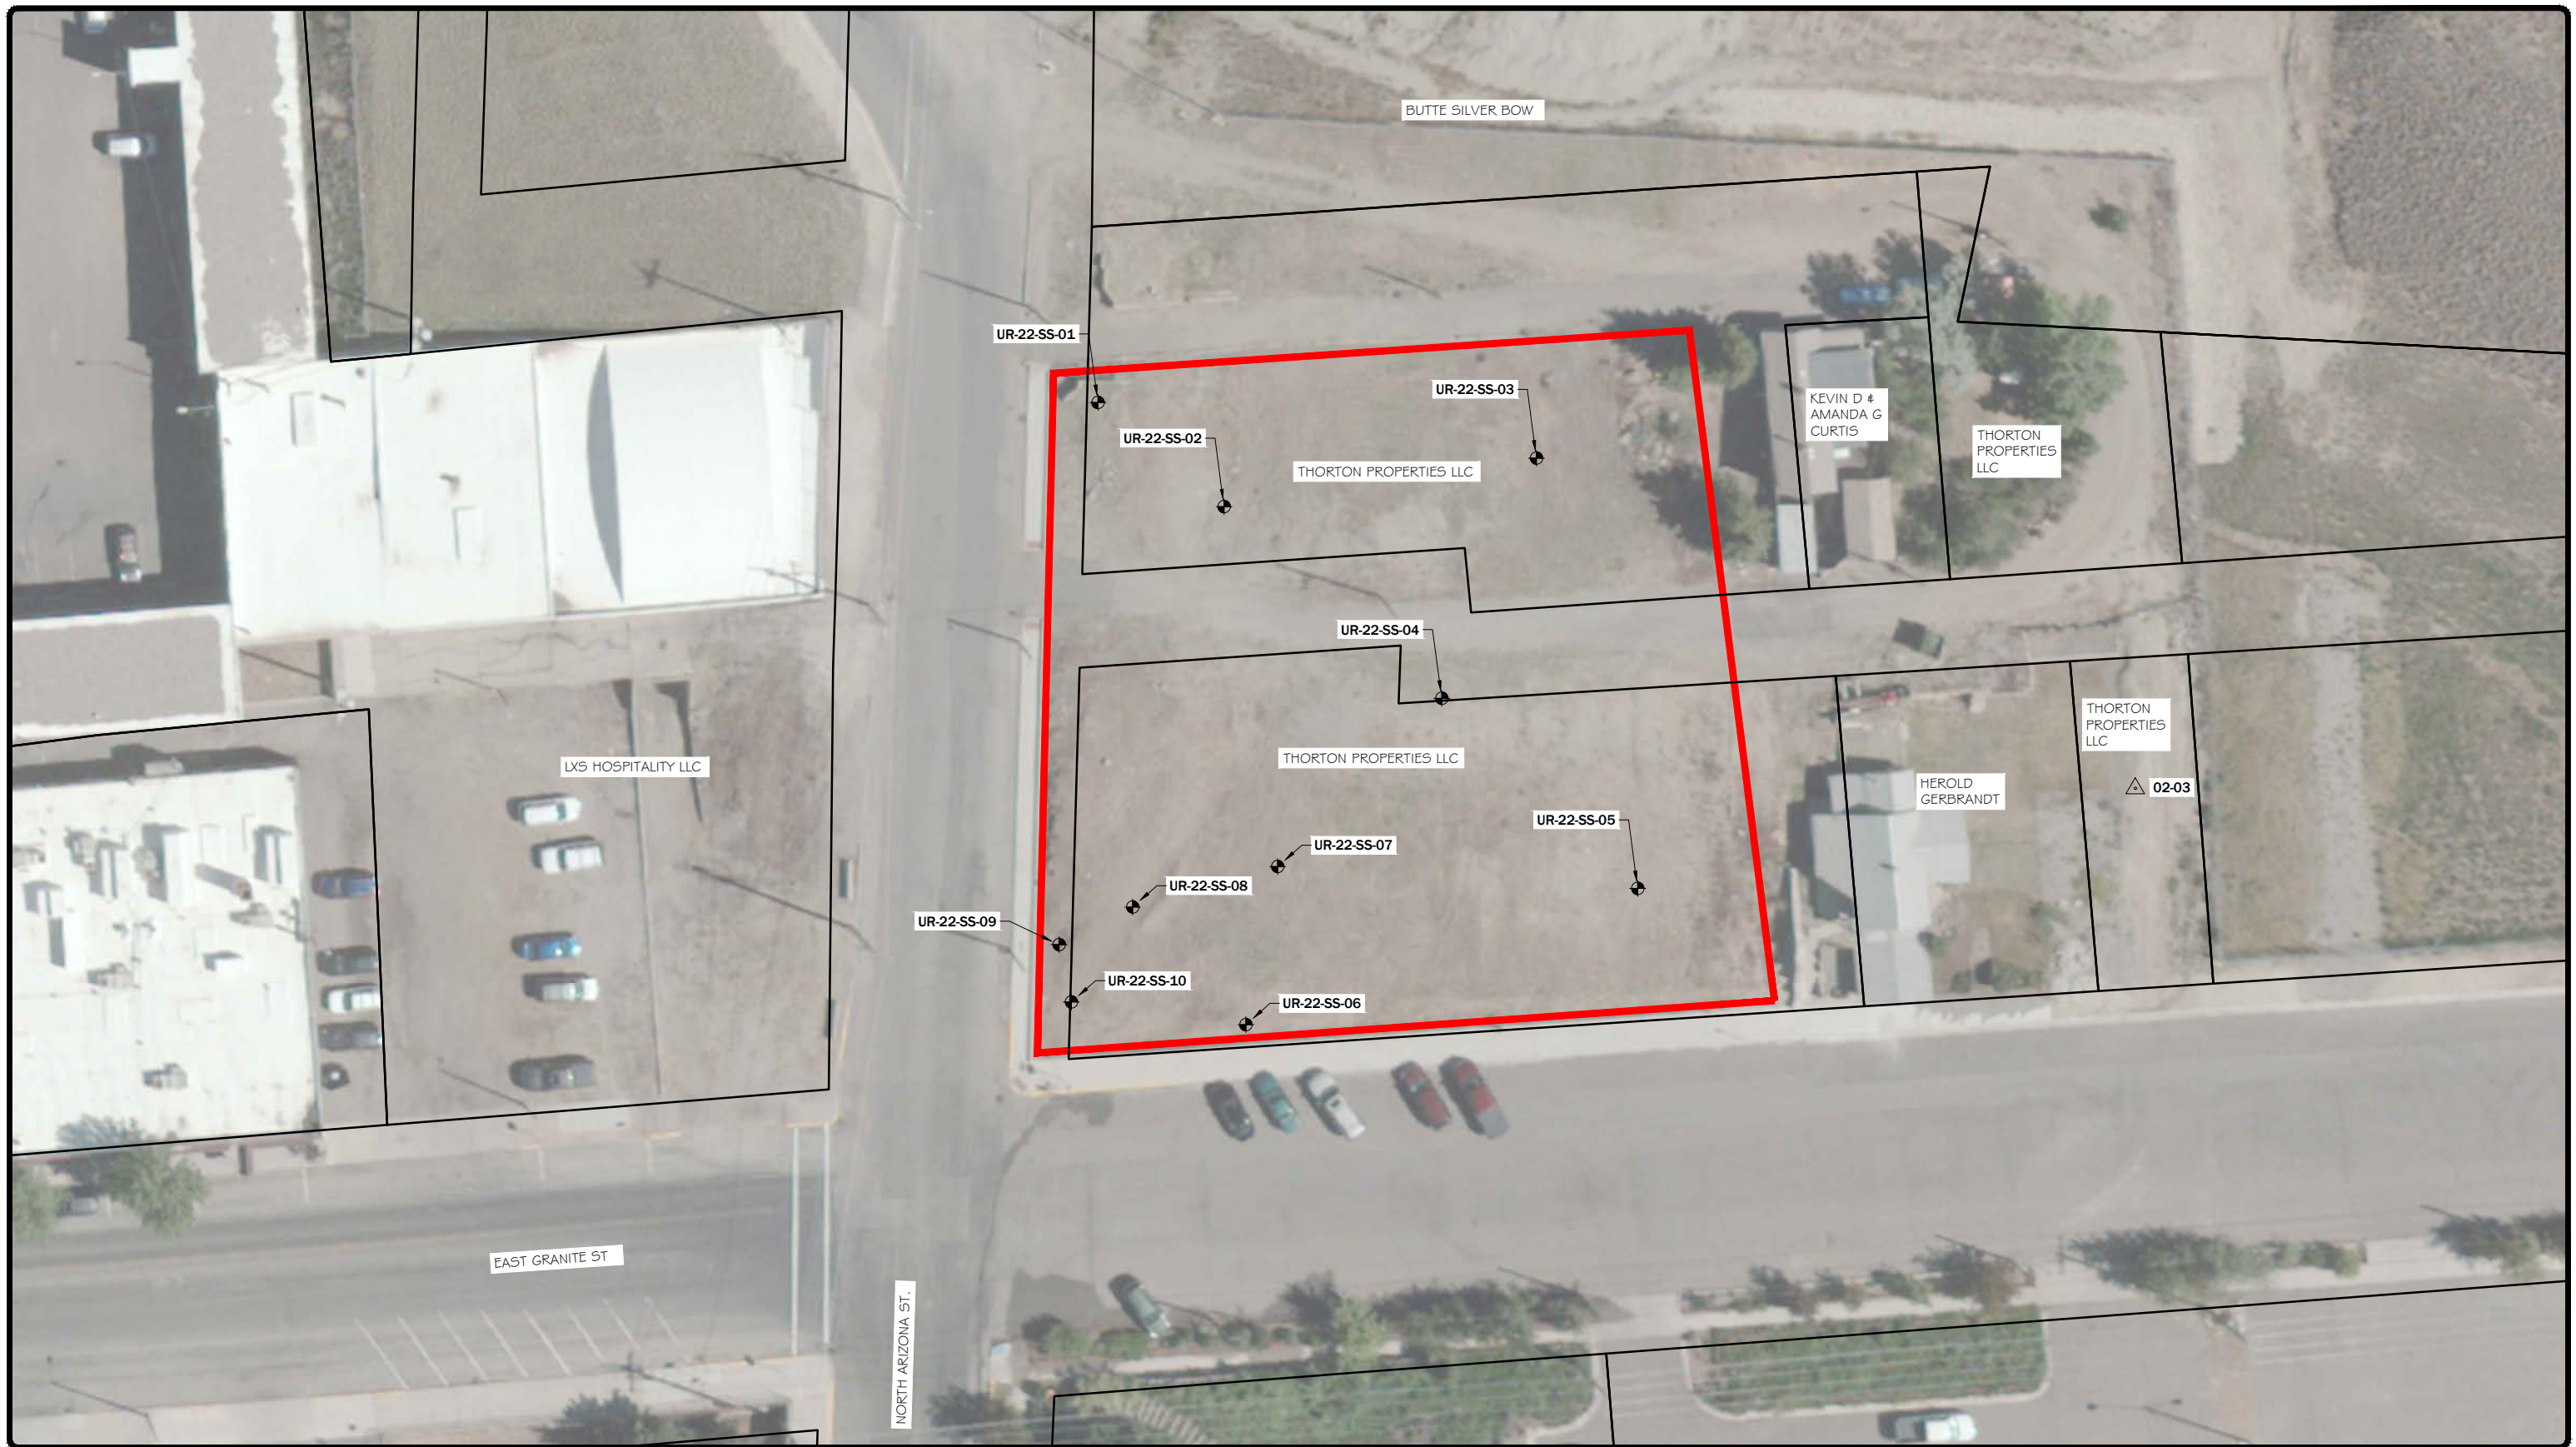
FIGURE 4 UNRECLAIMED SITE  
 UR-22  
 PROPOSED  
 SAMPLE LOCATIONS

LEGEND:  
 ● PROPOSED SOIL SAMPLE LOCATION  
 ▲ PREVIOUS SOIL SAMPLE LOCATION  
 UR-22 IS 0.67 ACRES

Site UR-22 is approximately 0.68 acres and is located at the northeast corner of East Granite and North Arizona Streets in uptown Butte (Figure 4). It is on the east end of the uptown business district, in an area of mixed commercial and open space use. Bordering UR-22 on the east are two residences. Site UR-22 is vacant land. Ownership of Site UR-22 includes Thorton Properties LLC and Butte-Silver Bow. Site UR-22 has established grasses throughout the site with scattered weeds. The southwest corner of the site has a small gully with iron and manganese staining. There are bare areas located throughout the site that contain Iron staining. There are small piles that appear to be dumped material. The portion of the site belonging to Butte-Silver Bow is an east-west trending unpaved alley that is used by the residences.

Data obtained from the Geocortex web-based database at <https://eis2.woodardcurran.com/Html5Viewer/index.html?viewer=BPButte.BPSOU> contains the records for the previous soil sample near Site UR-22. The approximate sample location is included on Figure 4 with results provided in Table 4 below. The BPSOU action levels for human health and storm water screening criteria are listed in Tables 1 and 2 of the UR Sites QAPP. Some of the results, shown as highlighted cells below, exceeded BPSOU storm water screening criteria for copper and zinc.

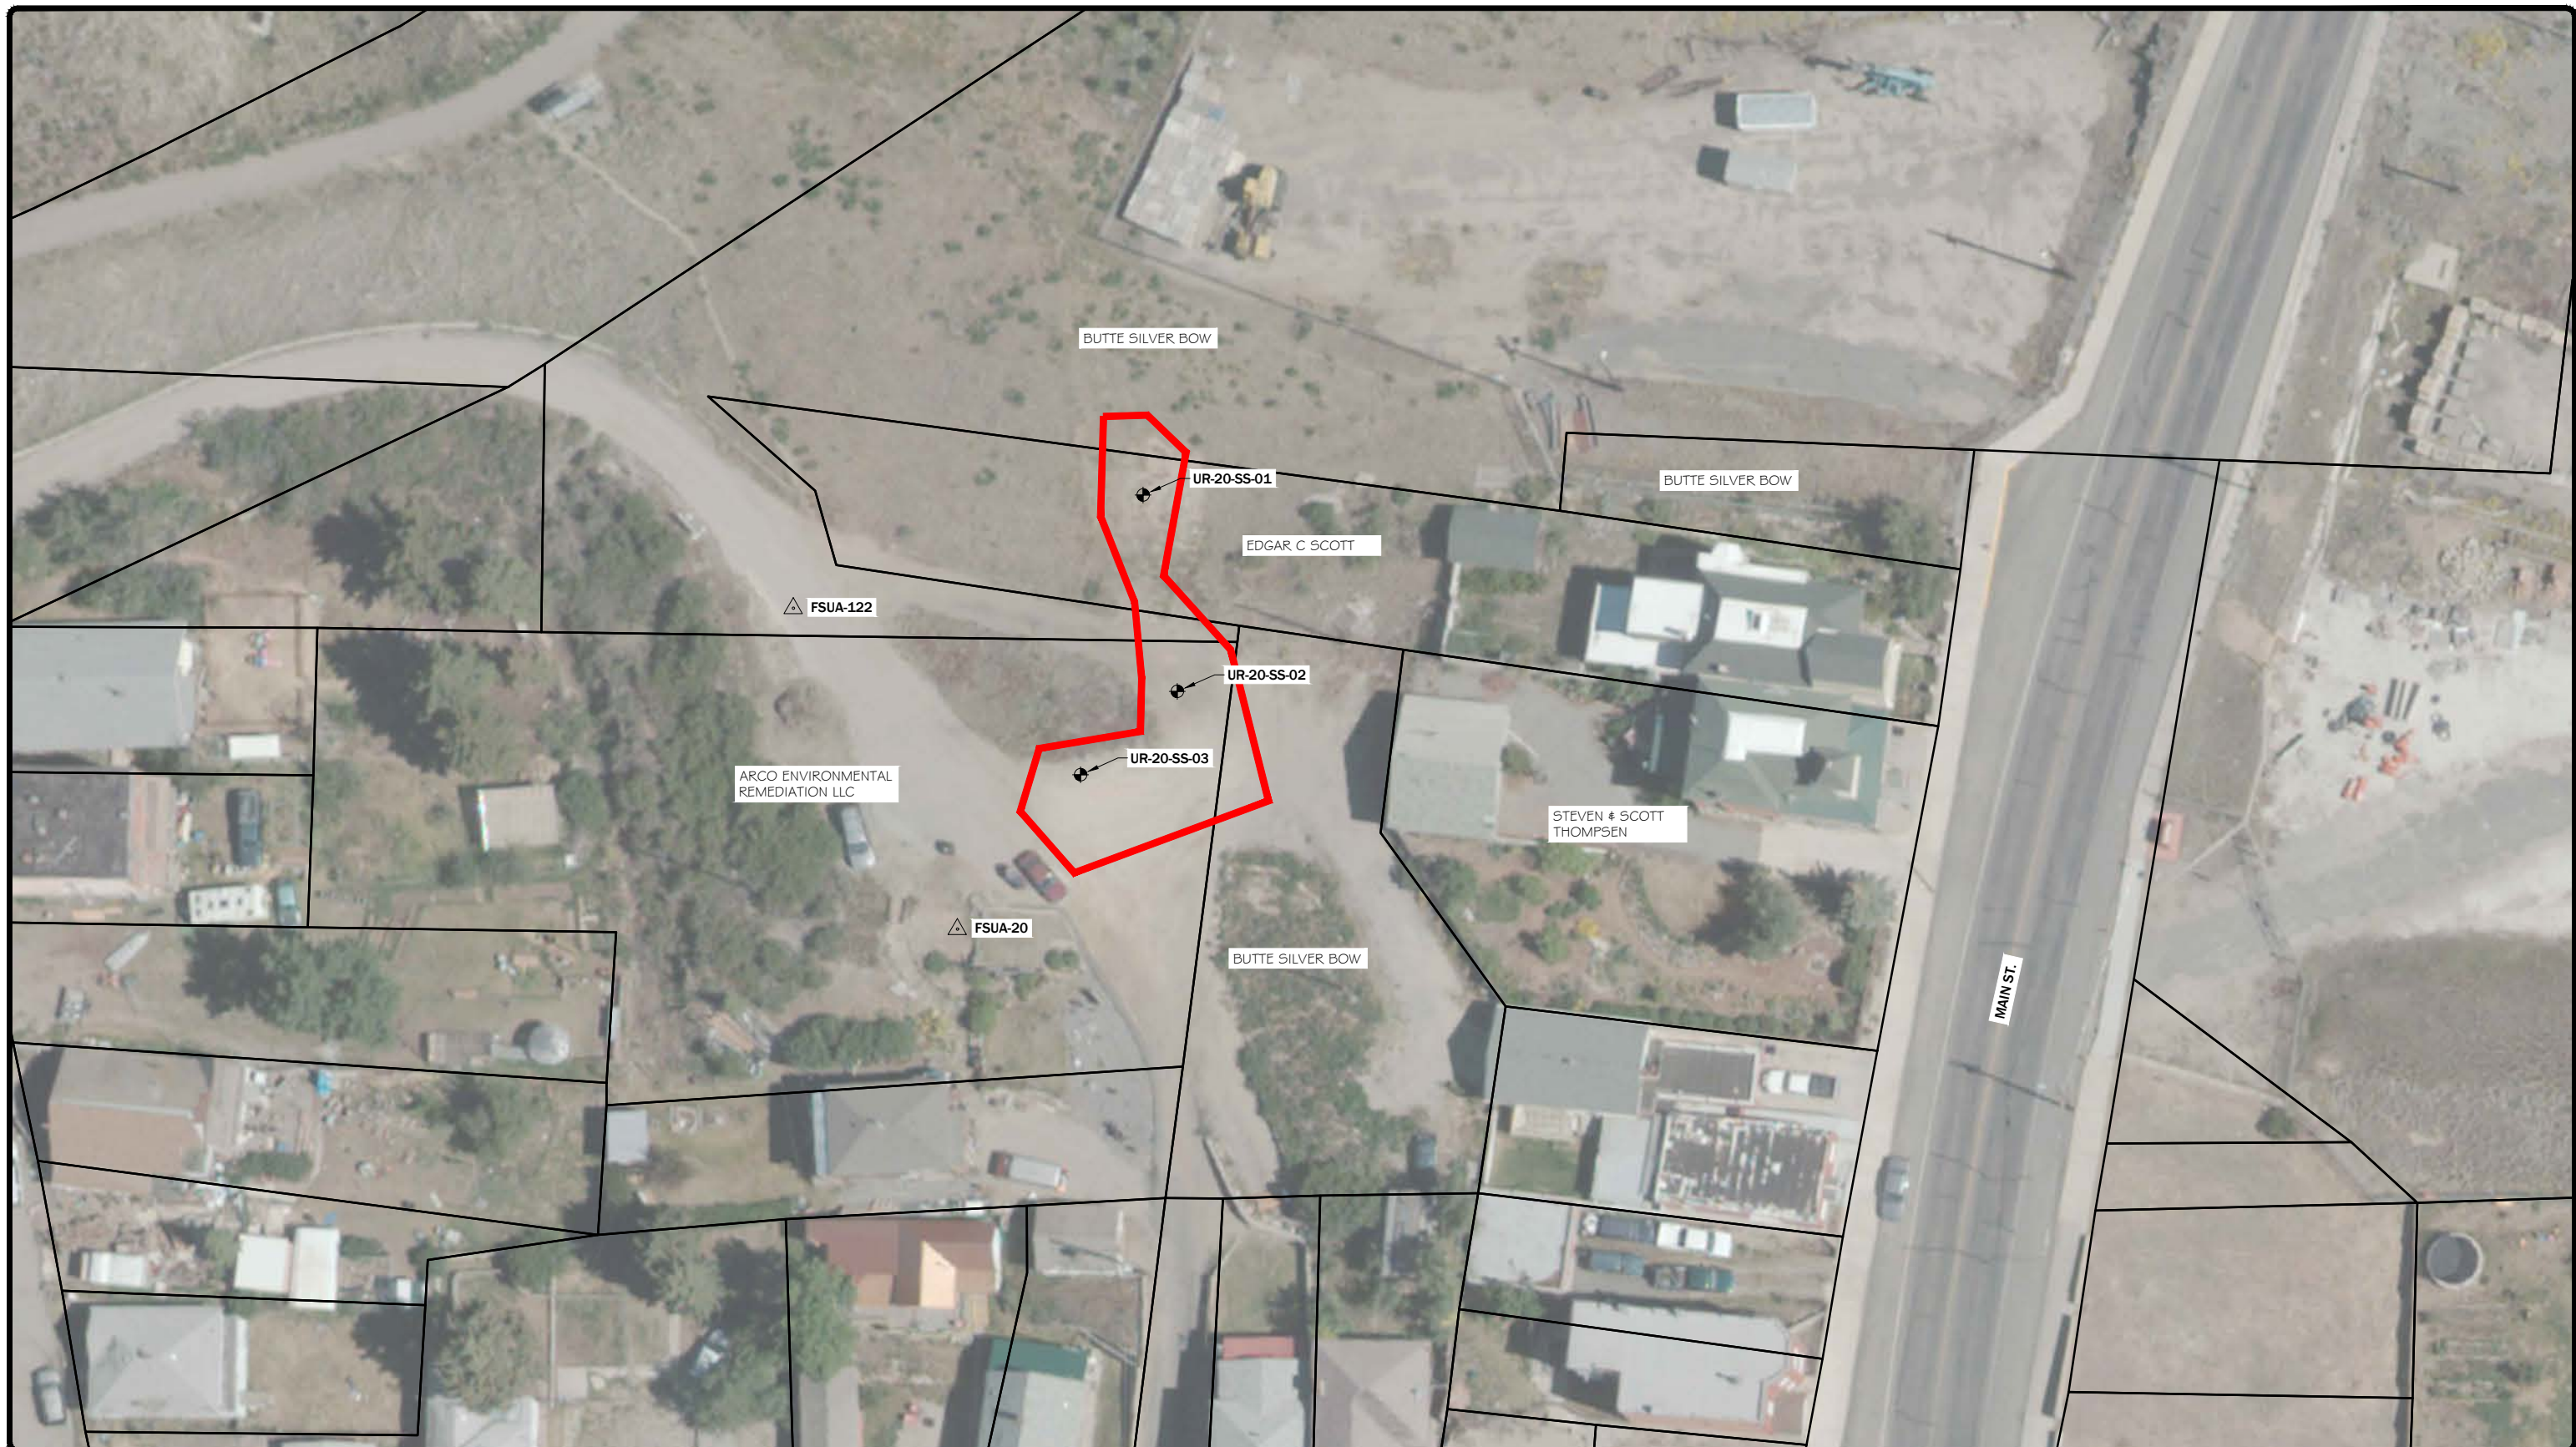
FIGURE 5 UNRECLAIMED SITE  
 UR-35  
 PROPOSED  
 SAMPLE LOCATIONS

LEGEND:  
 ● PROPOSED SOIL SAMPLE LOCATION  
 ▲ PREVIOUS SOIL SAMPLE LOCATION  
 UR-35 IS 0.07 ACRES

Site UR-35 is approximately 0.12 acres and is located 300 feet northwest of the intersection of North Main and Woolman Streets in uptown Butte (Figure 5). It is an irregular-shaped bare area, part of which is a gravel turn-around area used by local residents. It is essentially an area in the backyard of homes that face North Main Street. Ownership of site UR-35 includes Atlantic Richfield, Butte-Silver Bow, and Edgar Scott. Site UR-35 is vacant; that is, there are no structures within the boundaries of the site. However, the parcel owned by Edgar Scott has a residence and there are other residences close to UR-35. Site UR-35 is poorly vegetated with homogenous soil that is yellow in color mixed with gravel. Due to size and representation, only 3 sample locations are proposed. Storm water runoff from Site UR-35 generally flows to the south. Site UR-35 is in the Buffalo Gulch drainage basin of BPSOU.

Data obtained from the Geocortex web-based database at <https://eis2.woodardcurran.com/Html5Viewer/index.html?viewer=BPButte.BPSOU> contains the records for the previous soil samples near Site UR-35. The samples were collected in 1995 and 1996 as part of the Field Survey of Unreclaimed Areas program. The approximate sample locations are included on Figure 5 with results provided in Table 5 below. The BPSOU action levels for human health and storm water screening criteria are listed in Tables 1 and 2 of the UR Sites QAPP. Some of the results, shown as highlighted cells below, exceeded BPSOU storm water screening criteria for arsenic, lead, and zinc.
