Silver Bow Creek/Butte Area Superfund Site

### **Butte Priority Soils Operable Unit (BPSOU) Unreclaimed Sites - Final Field Sampling Plan (FSP) #3: UR-06, UR-07, UR-20, UR-22, UR-35, and UR-36**

**RE: Butte Priority Soils Operable Unit (BPSOU) Unreclaimed Sites - Final Field Sampling Plan (FSP) #3: UR-06, UR-07, UR-20, UR-22, UR-35, and UR-36.**

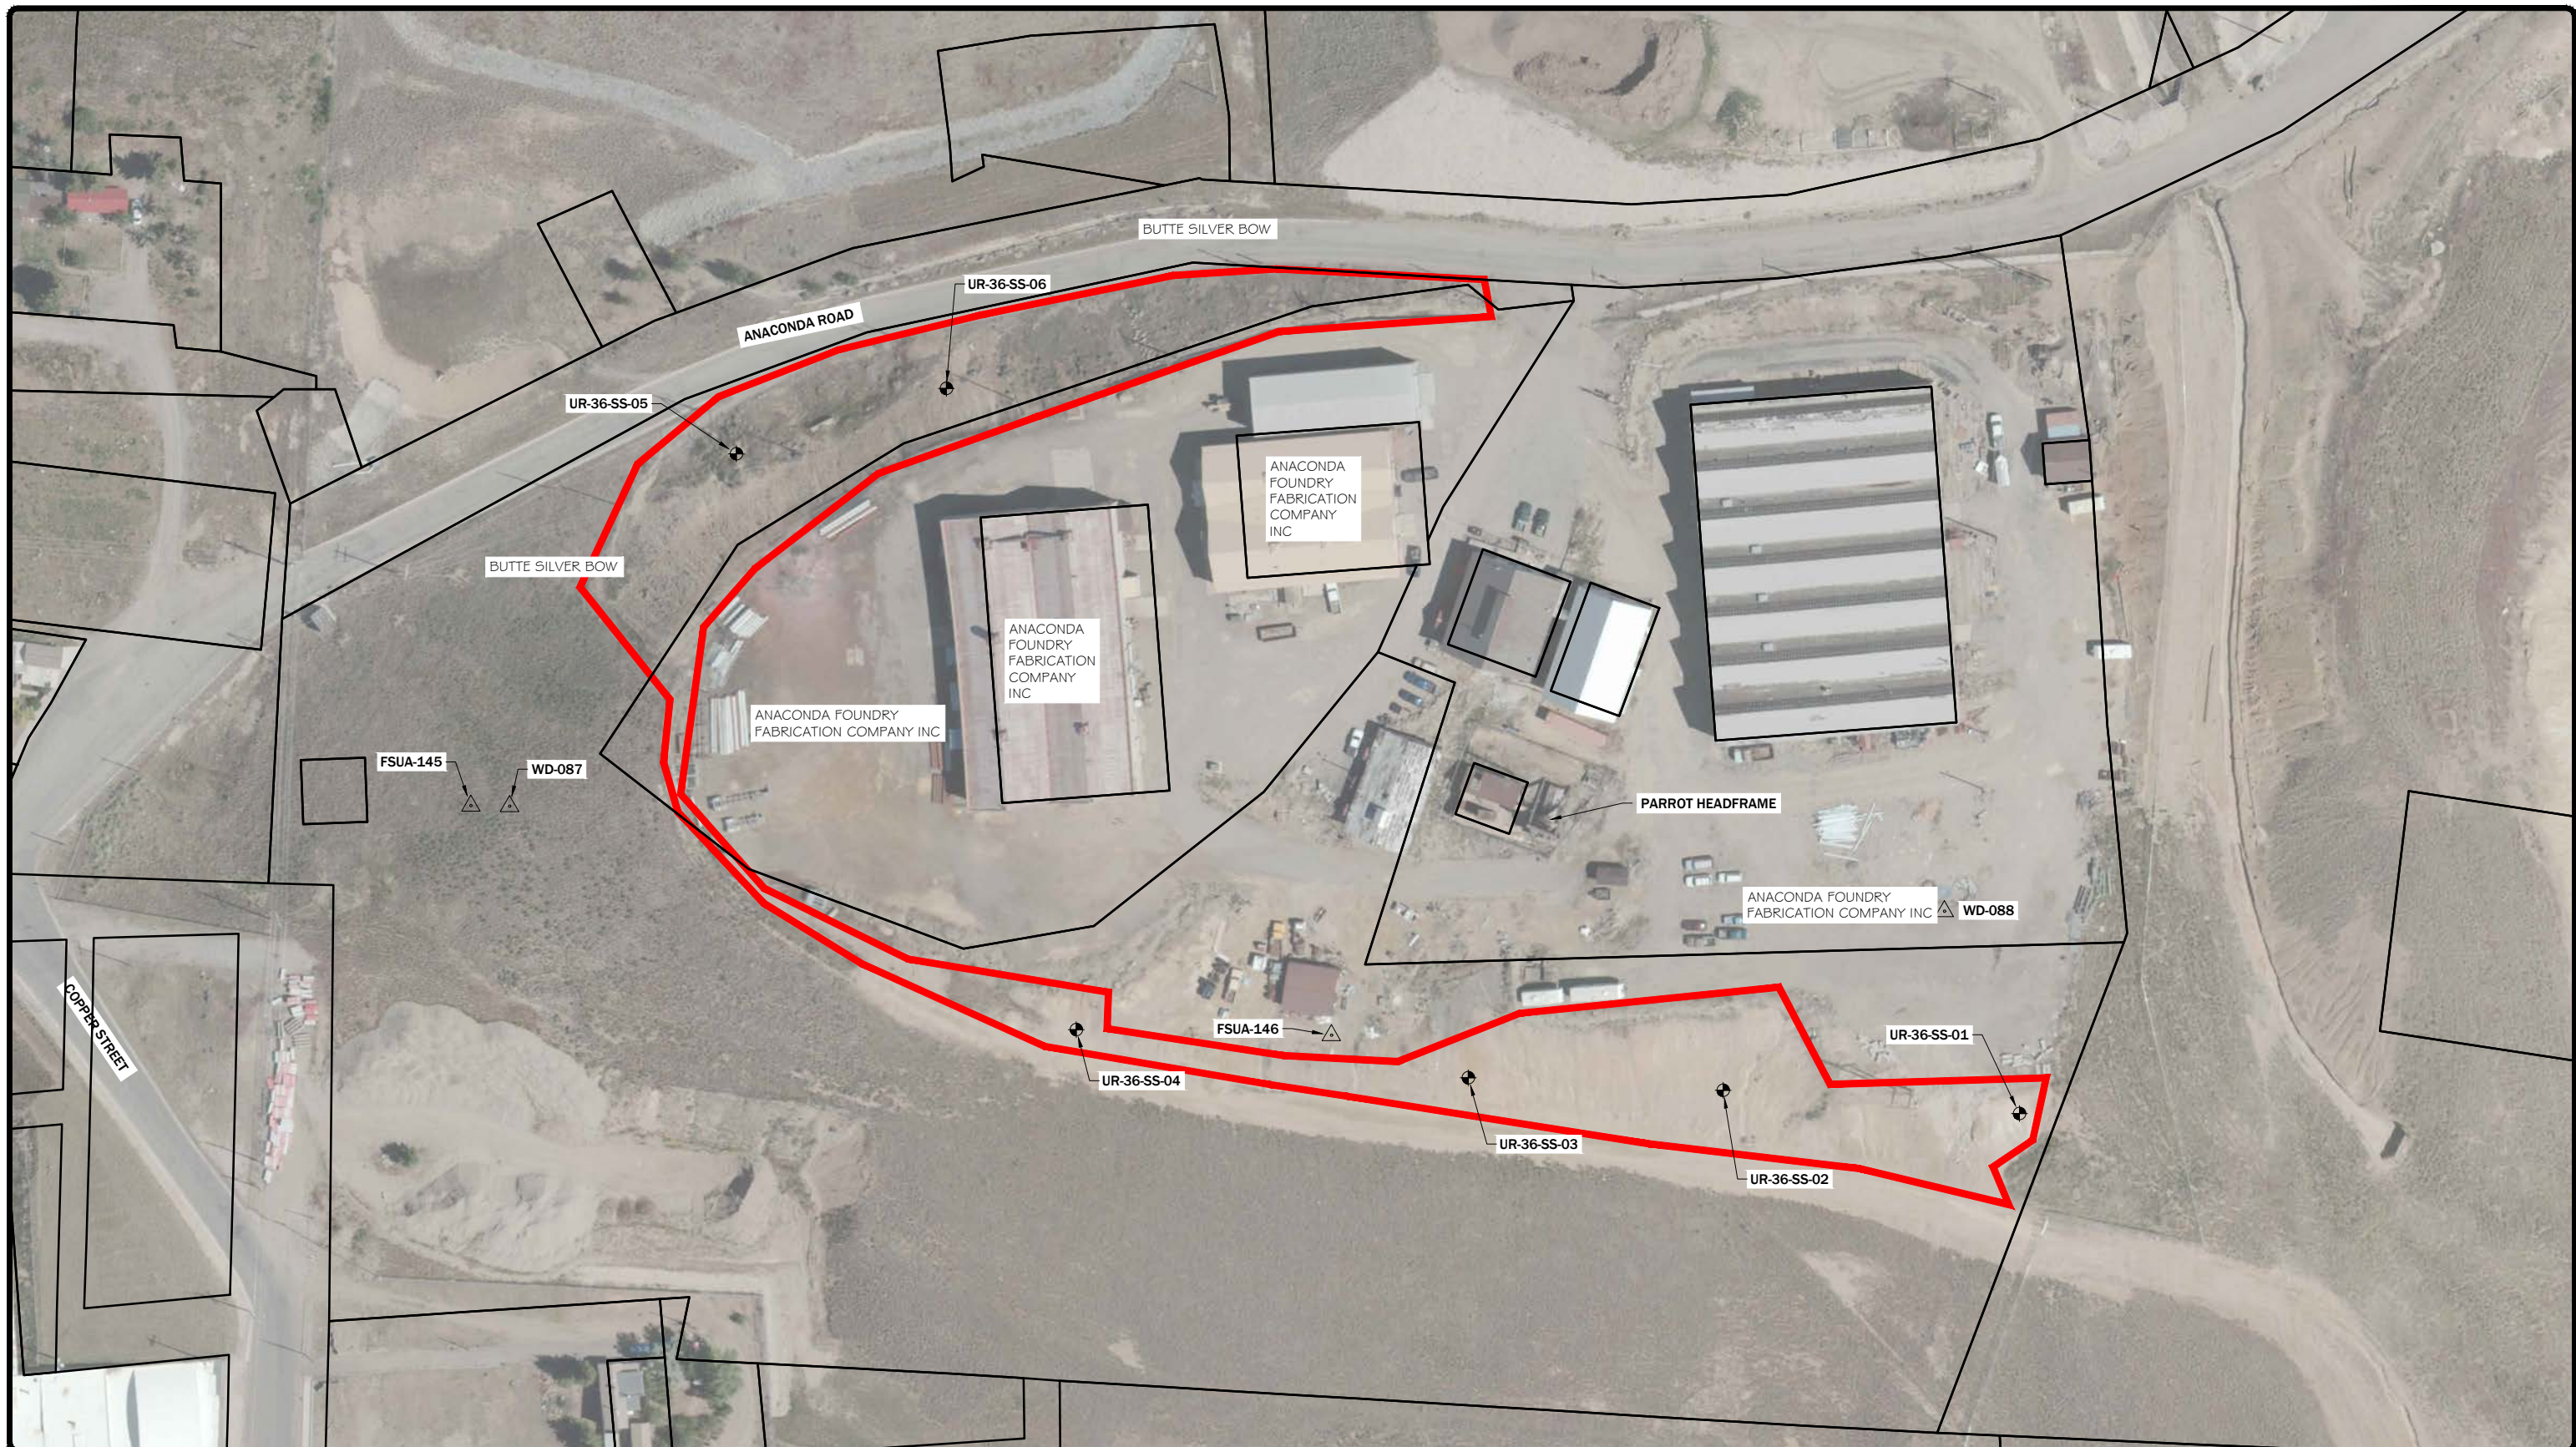
**FIGURE 6** UNRECLAIMED SITE  
 UR-36 PARROTT SLOPE  
 PROPOSED  
 SAMPLE LOCATIONS

LEGEND:  
 ● PROPOSED SOIL SAMPLE LOCATION  
 ▲ PREVIOUS SOIL SAMPLE LOCATION  
 UR-36 IS 1.8 ACRES

Site UR-36 is approximately 1.8 acres. It is located along the south side of Anaconda Road, just west of the Berkeley Pit and northeast of the uptown Butte business district (Figure 6). Site UR-36 is crescent shaped and wraps around the flat hilltop where the former Parrot mine is located. The majority of Site UR-36 is owned by Butte-Silver Bow and a minor portion is owned by AFFCO. Site UR-36 is vacant land in a light industrial area. There are a few residences located approximately 450 feet to the south.

The south-facing portion of the site is almost entirely bare and appears to consist of mine waste. The north-facing portion of the site has areas with moderate vegetation but also has very steep bare areas. There is some exposed bedrock in the north portion of UR-36. There is some fencing on the north side; it does not restrict access, but it denotes the AFFCO property boundary. Site UR-36 is in the Anaconda Road/Butte Brewery drainage basin and drains into the South Parrot Channel.

Data obtained from the Geocortex web-based database at <https://eis2.woodardcurran.com/Html5Viewer/index.html?viewer=BPButte.BPSOU> contains the records for the previous soil samples in the vicinity of Site UR-36. Approximate sample locations are included on Figure 6 with results provided in Table 6 below. The BPSOU action levels for human health and storm water screening criteria are listed in Tables 1 and 2 of the UR Sites QAPP. Some of the results, shown as highlighted cells below, exceeded BPSOU storm water screening criteria for arsenic, copper, lead, and zinc.
