Silver Bow Creek/Butte Area Superfund Site

**Butte Priority Soils Operable Unit (BPSOU) Draft Final Insufficiently Reclaimed Sites Field Sampling and Investigation Plan (FSP)
BRES No. 50 – Zelia**

Re: Butte Priority Soils Operable Unit (BPSOU) Draft Final Insufficiently Reclaimed Sites Field Sampling and Investigation Plan (FSP) BRES No. 50 – Zelia

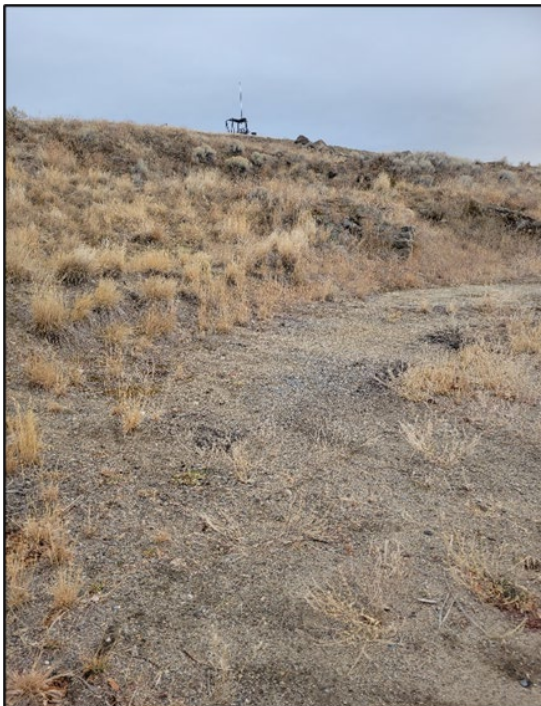
A preliminary site visit was conducted to qualify current site conditions and identify the focus areas for additional evaluation. Site photographs were taken during the preliminary site evaluation to capture site conditions. The photographs are included in this section for reference. The site consists of a barren parking area with gravel and fine material. Steep slopes appear to have bedrock outcropping throughout the slope. The site appears to exhibit weeds and undesirable species among native grasses throughout the barren areas and along the benches of the slopes. Small barren areas are located throughout the hillside, consistent with a rock outcropping.

Photograph 1: Steep Slopes and Parking Area

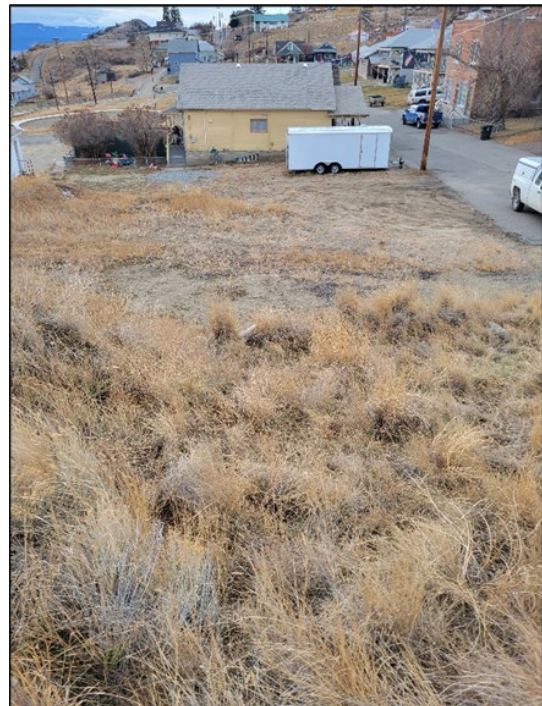
Photograph 2: Parking Area with Vehicle Traffic

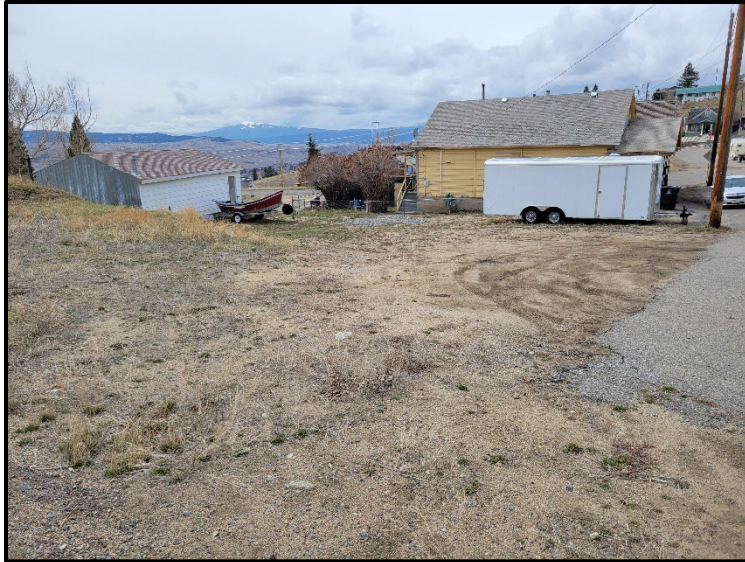
Photograph 3: Barren Area near Residential lot

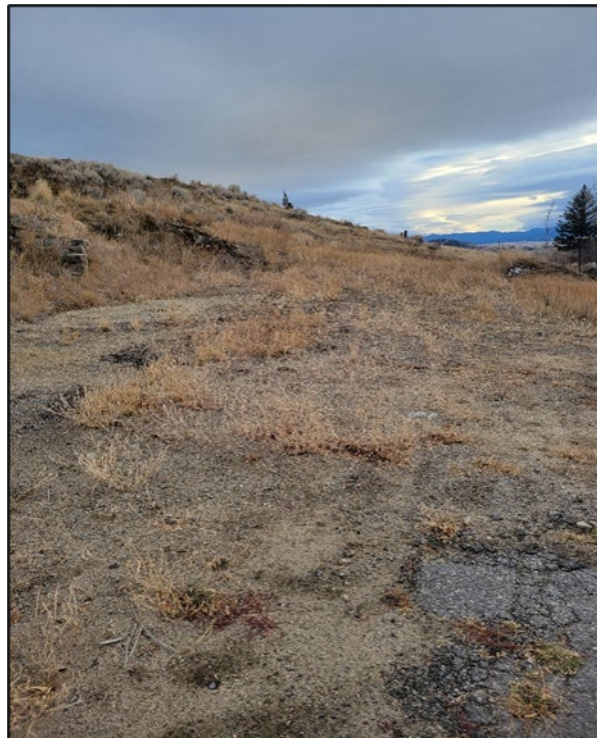
Photograph 4: Fine Material and Sediment throughout Barren Area

Existing site grading and drainages will be evaluated to determine storm water flow patterns and identify if additional storm water controls will help prevent sediment migration. The location and condition of existing storm water features will be field-verified and recorded to be used in corrective actions. Contributing sources of storm water upgradient and adjacent to the site will also be investigated.

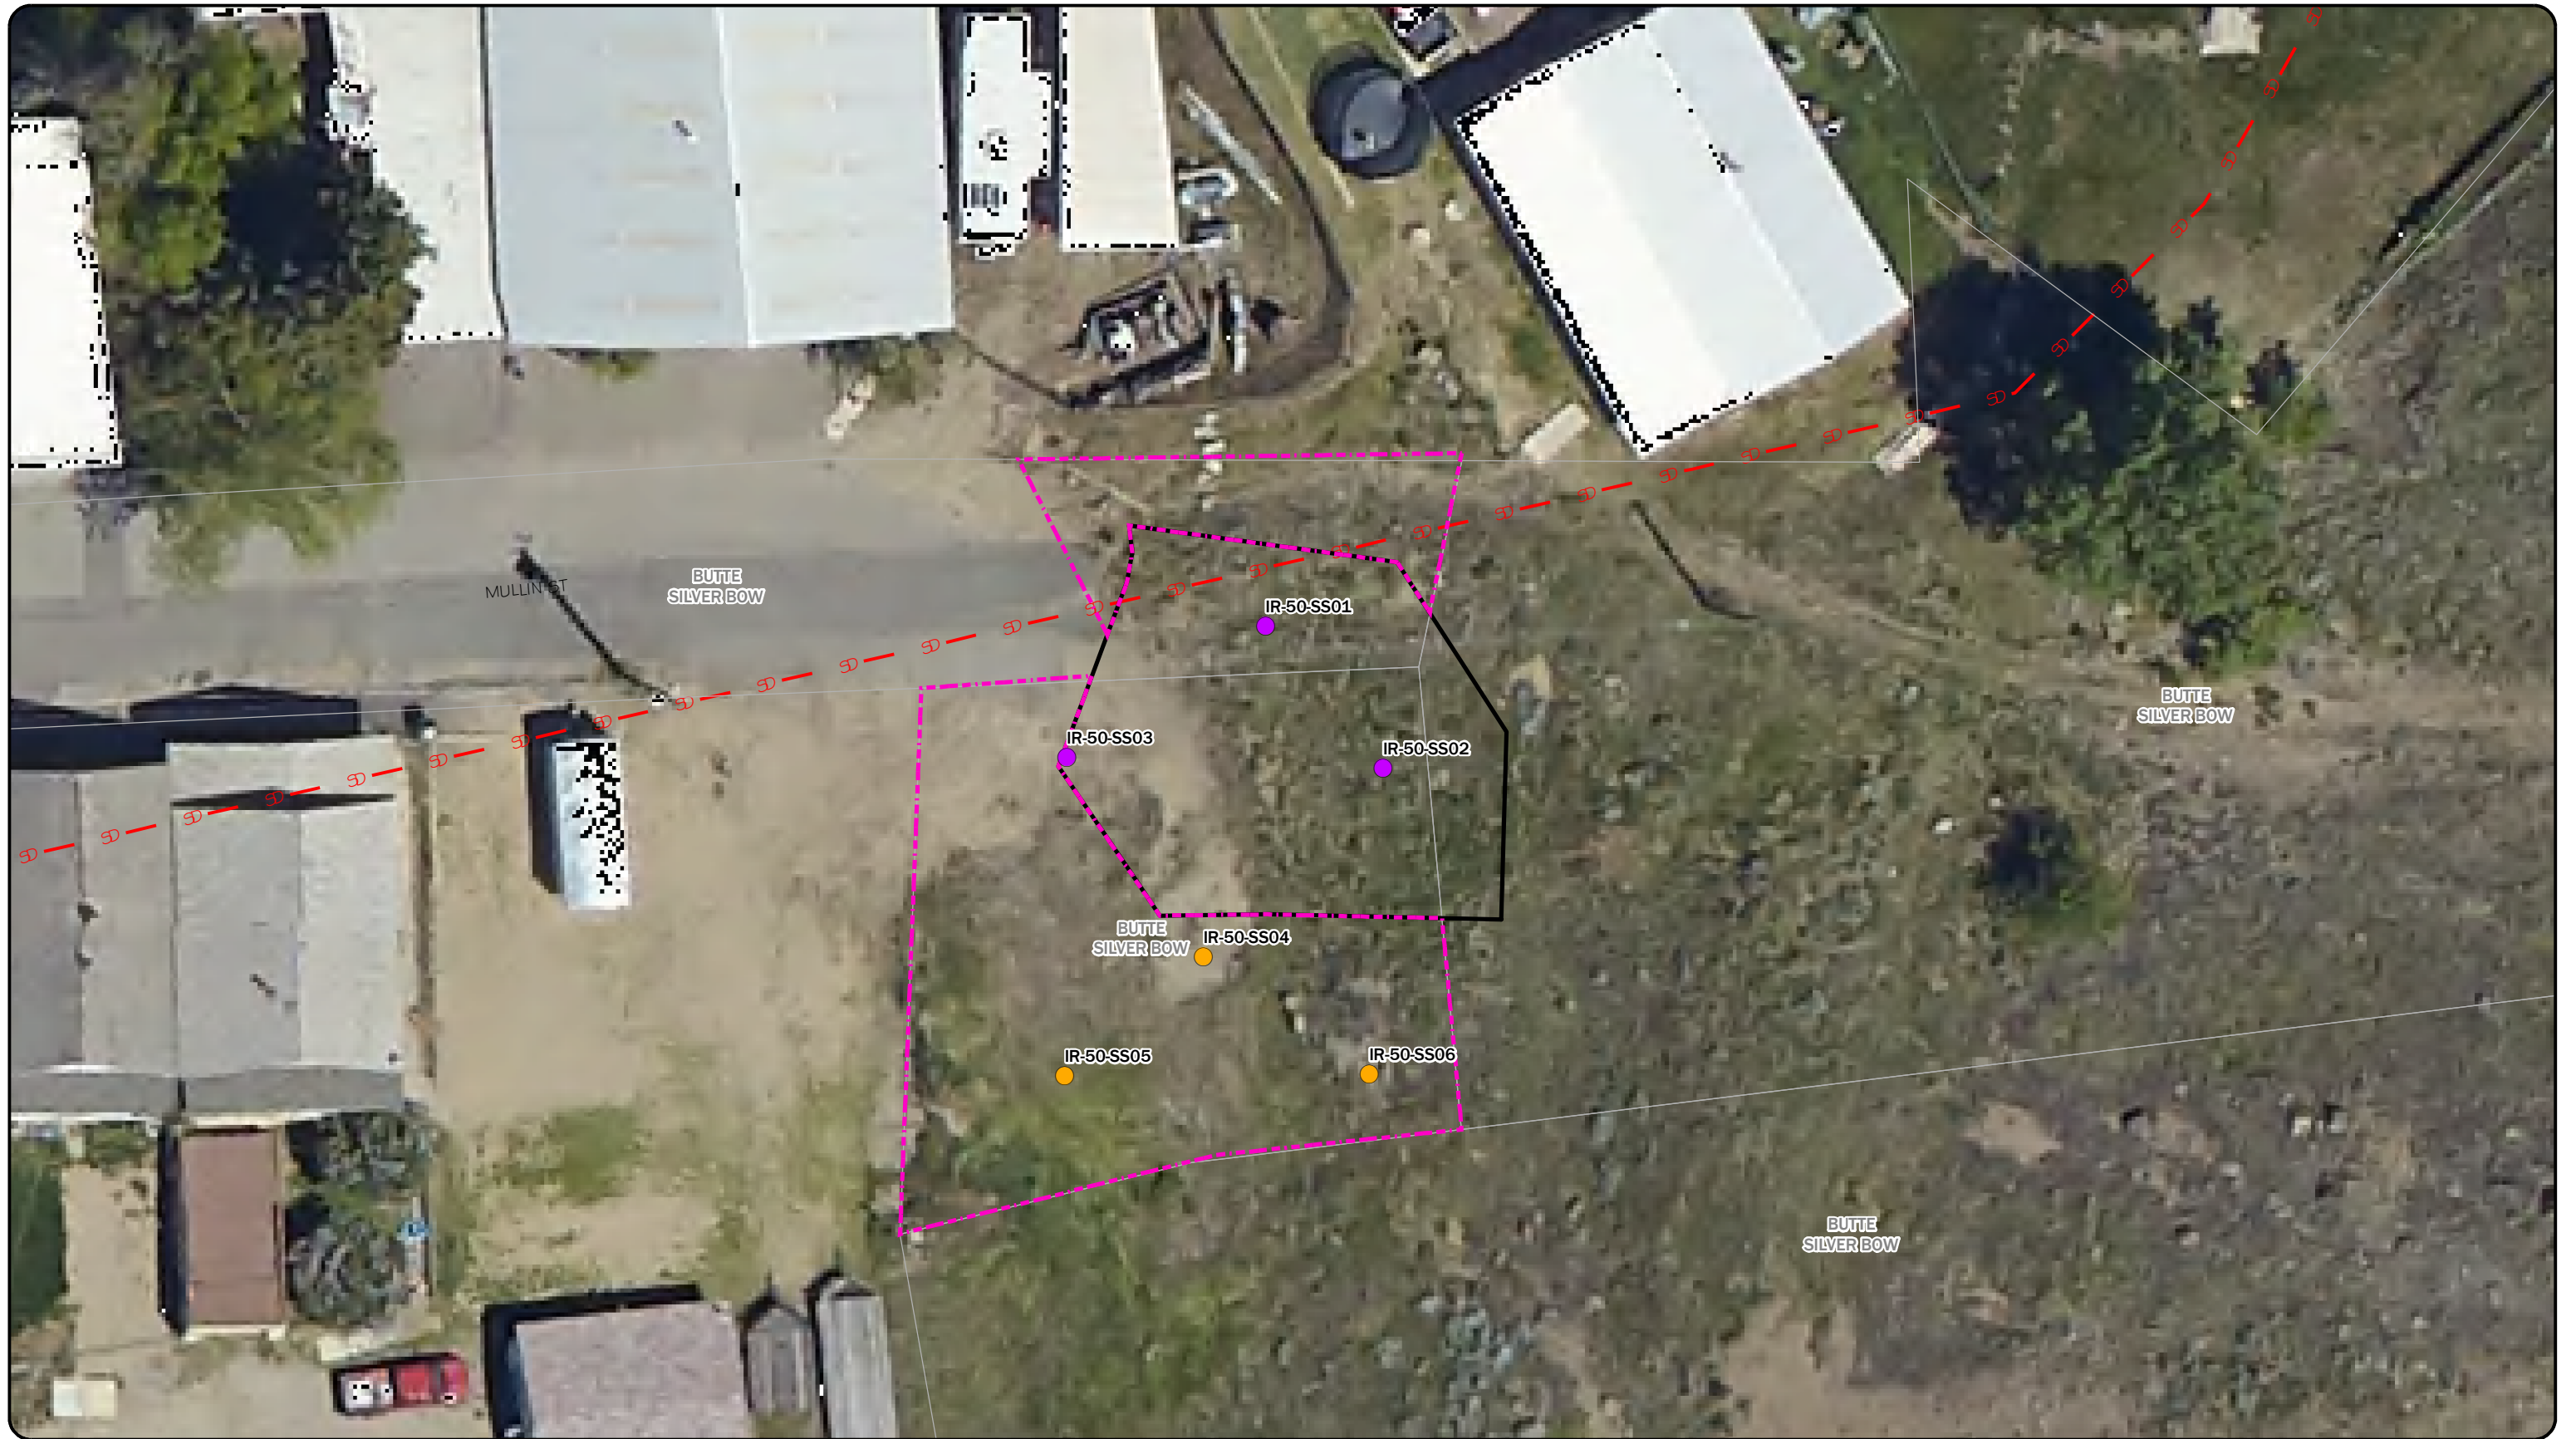
FIGURE 1

This FSP provides details related to the field evaluation of the IR Site BRES No. 50 – Zelia. Proposed soil sampling stations and areas of known deficiencies are shown on Figure 1.

Per the IR Sites QAPP, the site will be sampled at 2 depth intervals [(1) 0 to 6 inches and (2) 6 to 18 inches] to determine whether mining related waste is present and/or confirm the depth of previous reclamation efforts. Additional samples obtained outside of the existing site boundary will be obtained from 3 depth intervals [(3) 0 to 2 inches, (4) 2 to 6 inches, and (5) 6 to 12 inches] per the Unreclaimed Sites QAPP sampling protocol. Figure 1 illustrates the proposed sample stations.

INSUFFICIENTLY RECLAIMED
SITES BRES No. 50 ZELIA
PROPOSED SAMPLE STATIONS

Sample Station	2 Depth Intervals (inches)
IR-50-SS01	(1) 0-6, (2) 6-18
IR-50-SS02	(1) 0-6, (2) 6-18
IR-50-SS03	(1) 0-6, (2) 6-18

Sample Station	3 Depth Intervals (inches)
IR-50-SS04	(3) 0-2, (4) 2-6, and (5) 6-12
IR-50-SS05	(3) 0-2, (4) 2-6, and (5) 6-12
IR-50-SS06	(3) 0-2, (4) 2-6, and (5) 6-12
