Silver Bow Creek/Butte Area Superfund Site

# Draft Final 2023 Residential Metals Abatement Program (RMAP) Clark Park Soil Remedial Action Work Plan (RAWP)

Pioneer Technical Services, Inc.

May 8, 2023

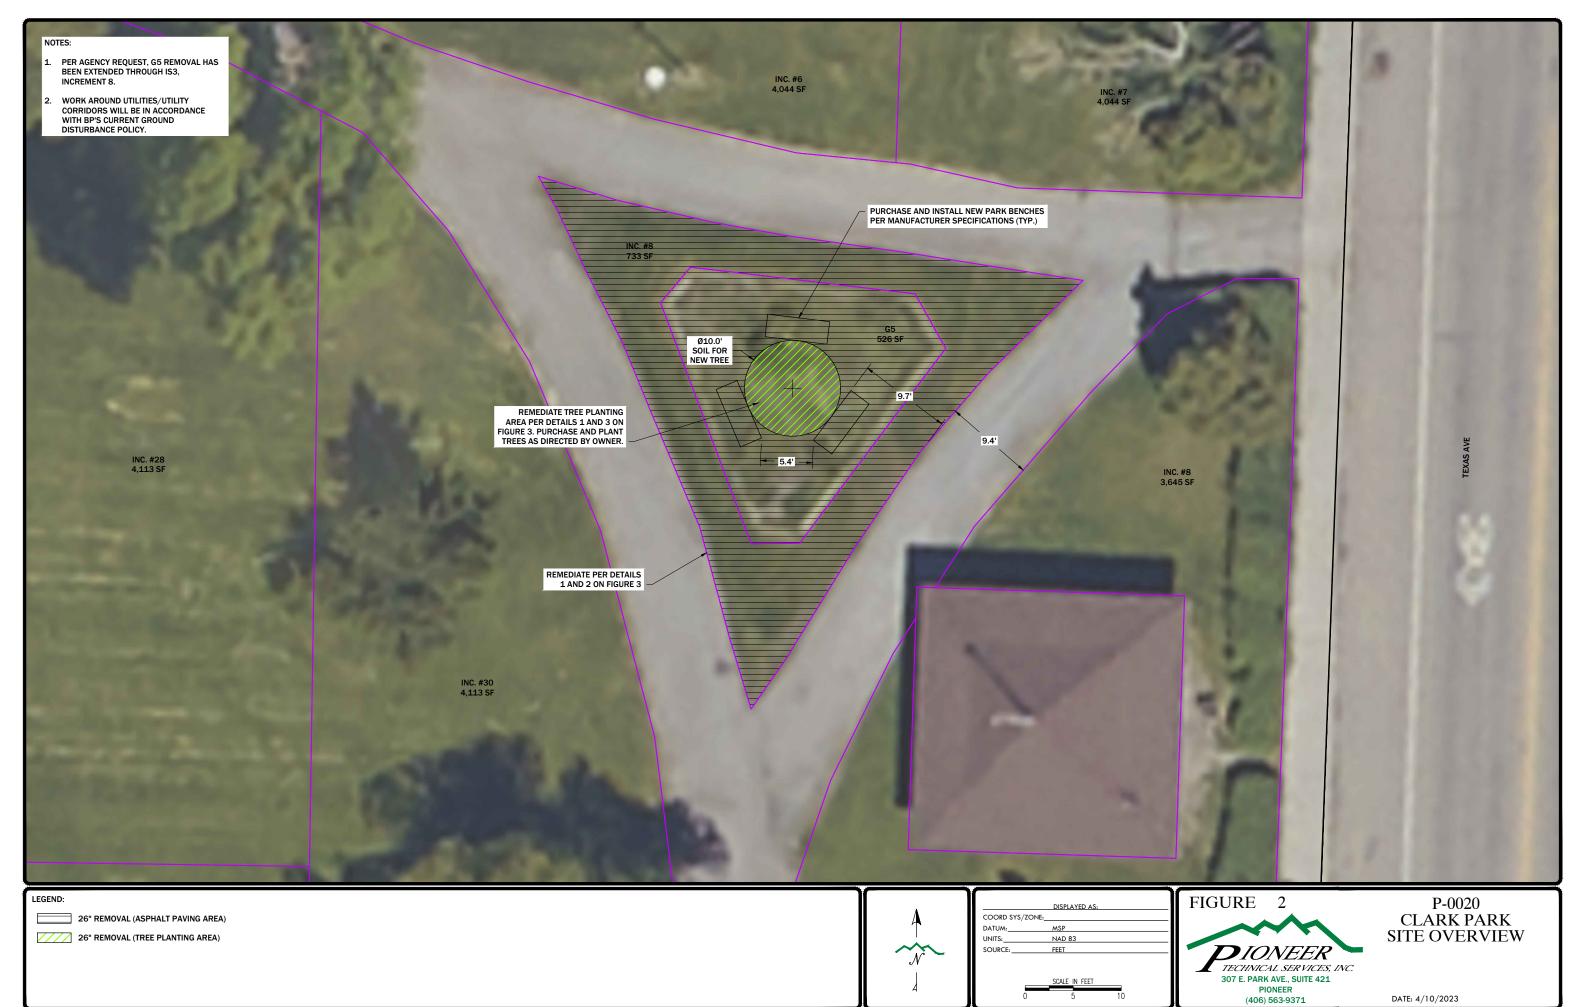
#### **26" REMOVAL DETAIL**

NOTE: EXCAVATOIN DEPTH BELOW EXISTING GROUND SURFACE = 26" (MIN) (+0.1' OR -0.0')

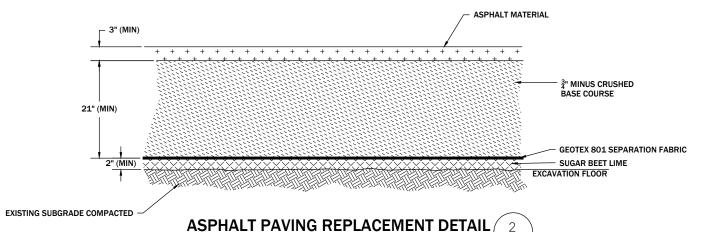
#### 26" TREE PLANTING AREA REPLACEMENT DETAIL

- CRUSHED BASE COURSE SECTION SHALL BE COMPACTED TO 95% OF THE STANDARD PROCTOR.
- 2. ASPHALT SHALL BE TYPE B WITH PG 58-28 BINDER.

NOTE: 26" OF NATIVE SOIL TO BE REMOVED. IT WILL BE REPLACED WITH 2" OF LIME, A SEPARATION FABRIC, AND 24" OF TYPE A KAW AVENUE STOCKPILE GROWTH MEDIUM.

Once the separation fabric is installed, backfill materials including Type A growth medium (see Section 5.3, Attachment D, Attachment D-1, and Attachment D-2), ¾-inch minus crushed base course (see Section 5.4, Attachment E, and Attachment E-1), and asphalt will be placed according to Details 2 and 3 on Figure 3. The Type A backfill materials will not be compacted to attain a specific density and moisture content but will be slightly compacted to impede future settling of the backfill material.
