Butte Priority Soils Operable Unit (BPSOU) Final Insufficiently Reclaimed Sites – Field Sampling Plan (FSP) BRES No. 84 – Mandan Park Play Area

Re: Butte Priority Soils Operable Unit (BPSOU) Final Insufficiently Reclaimed Sites – Field Sampling Plan (FSP) BRES No. 84 – Mandan Park Play Area.

This FSP describes field evaluation of the IR Site, BRES No. 84 – Mandan Park Play Area. Note, “Mandan Park Play Area” is consistent with the site identification nomenclature provided on the 94ARCO68 map. Sampling associated with the functional park and play area located northeast of the IR site will be addressed as described in the *Final 2023 RMAP Parks Soil Sampling FSP Submittal #7*². The IR sampling boundary, proposed soil sampling stations of the open space area, and site deficiencies identified during previous BRES evaluations are shown on Figure 1.

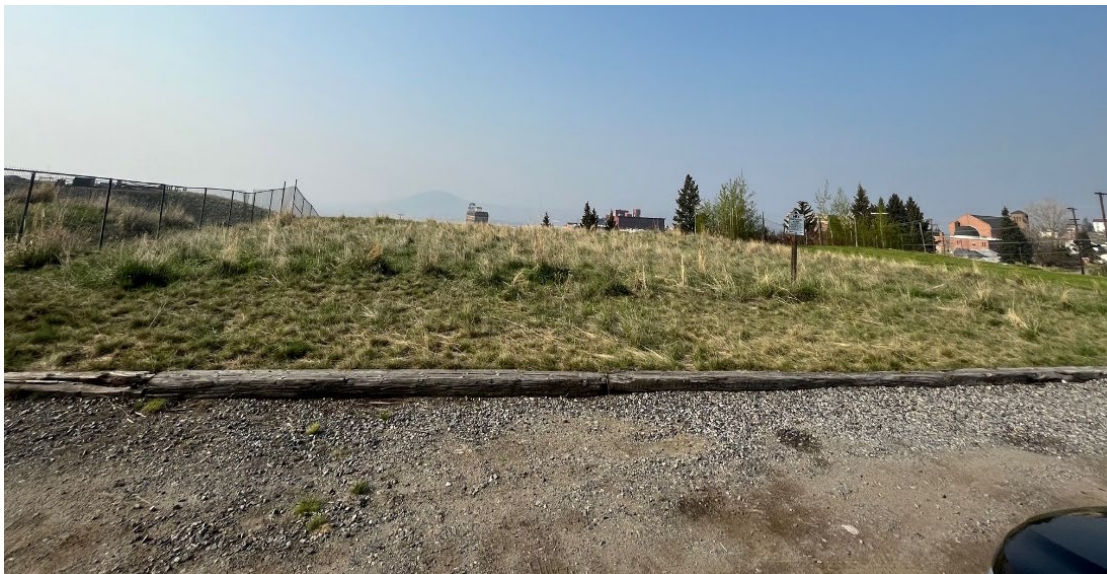
A preliminary site evaluation was conducted during the development of this sampling plan to inspect current site conditions and identify focus areas for further investigation. Photograph 1 through Photograph 3 show current site conditions. The investigation found the site to have good vegetation cover throughout the site with some weeds present. The south and west portions of the site have steep slopes, but the area near Mandan Park is flat. Aspen trees are located on the site and are encased in a tall fence. The west portion of this fence is seeing some damage; however, this portion of the site is maintained by BSB and is excluded from the proposed boundary adjustments.

Photograph 1: Overview facing south from the Mandan Park Parking Lot.

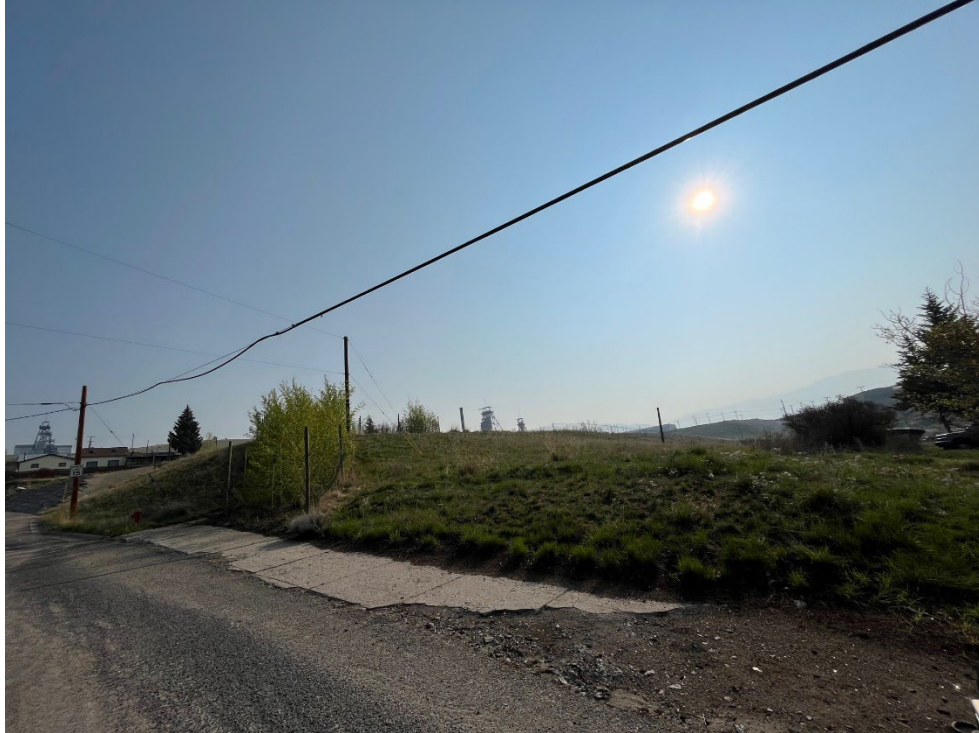
Photograph 2: Overview of the west and south portions of the site facing northeast.

Plant litter is migrating from the site on the west side along North Wyoming Street. No sediment migration was observed from the site. The sidewalk along North Wyoming Street is found to be in deteriorating condition. Overall, the site is in good condition with good vegetation growth.

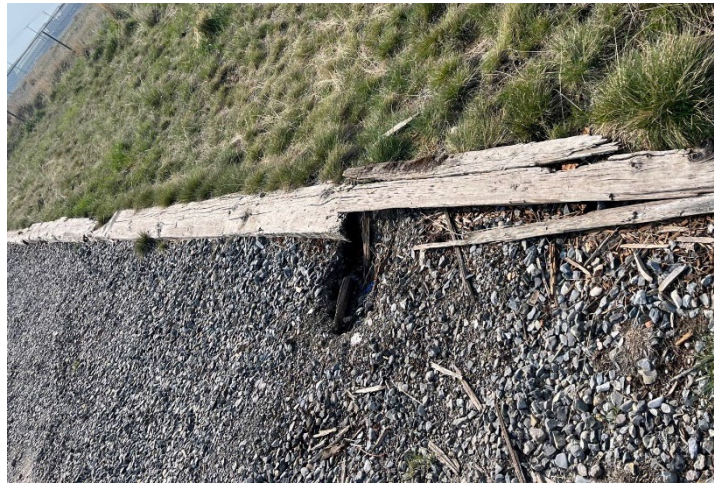
Photograph 3: Hole found near the site.

A small hole was found during the site evaluation. This hole is located in the parking lot of Mandan Park; however, it is on the boundary line with the UR portion of site. Wooden borders, as seen on Photograph 3, surround the north portion of the site that border Mandan Park. Figure 1 illustrates

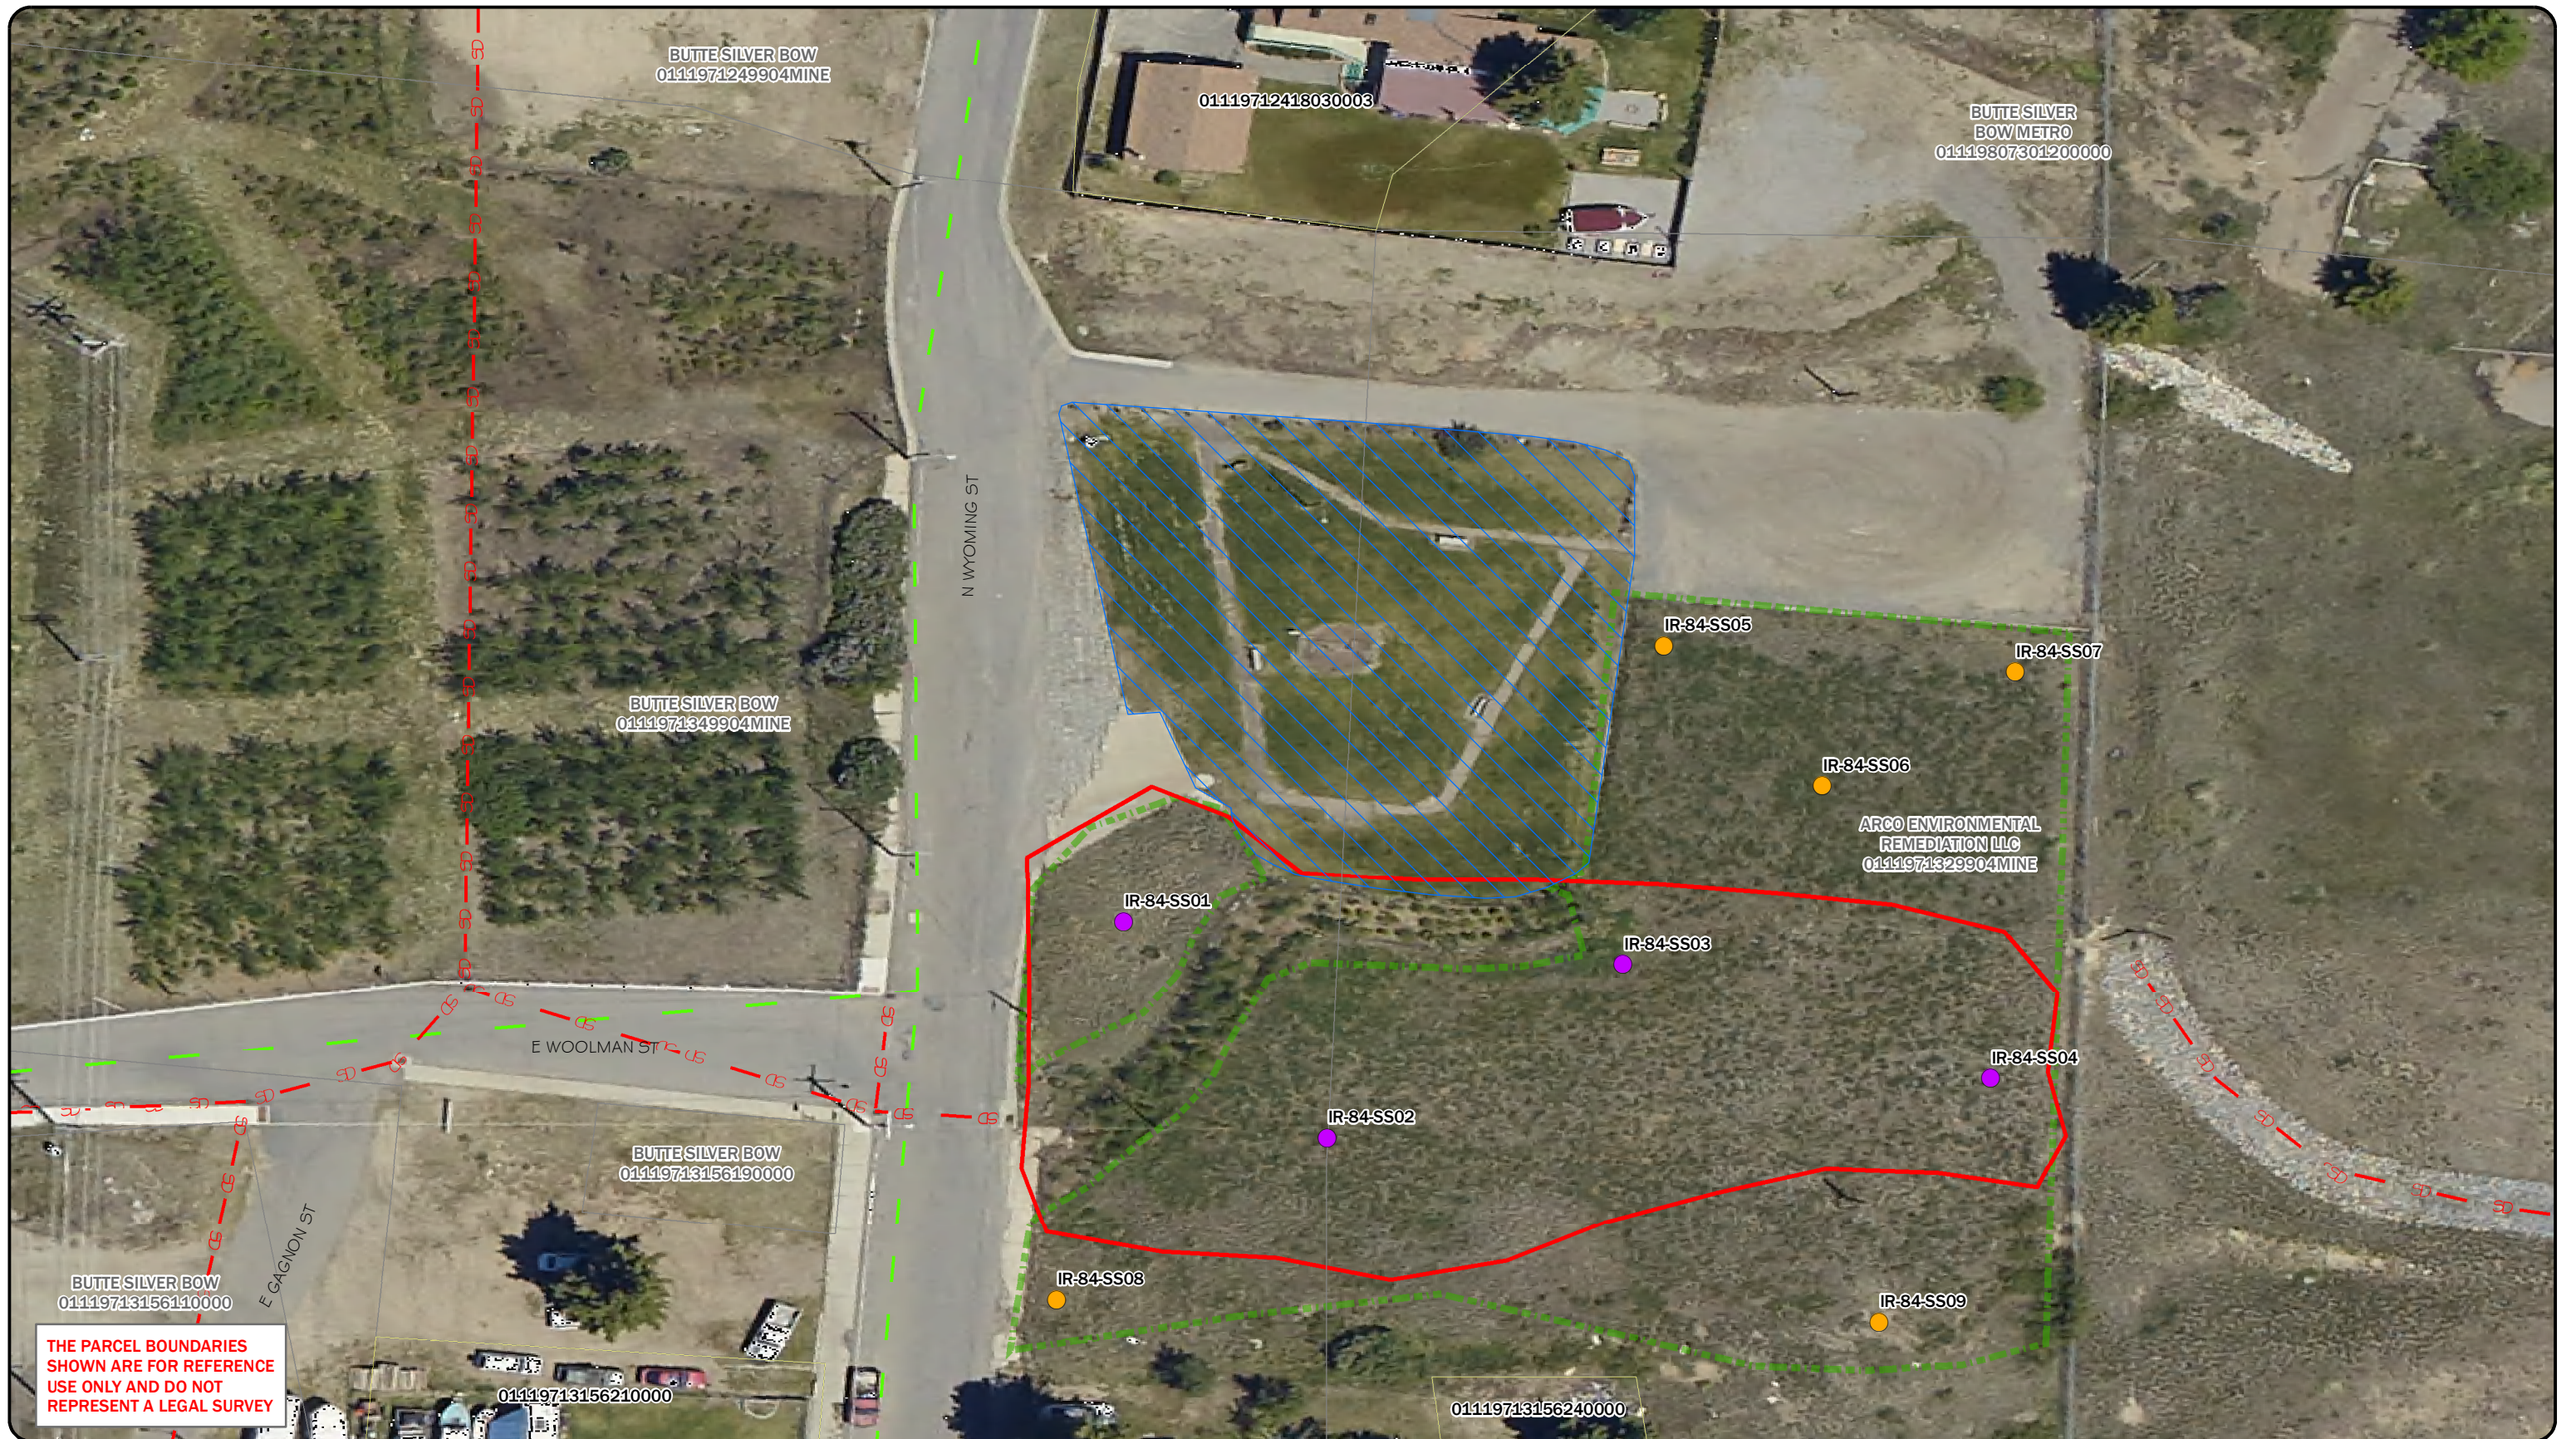
FIGURE 1
 INSUFFICIENTLY RECLAIMED
 SITE BRES No.84 MANDAN PARK

the proposed sample stations as sited during the preliminary site evaluation. Adjusted boundary lines, previous sample locations, and other previous findings are included on Figure 1.

Figure 1 – Insufficiently Reclaimed Sites BRES No. 84 – Mandan Park Play Area Proposed Sample Stations

Sample Station	Two Depth Intervals (inches)
IR-84-SS01	(1) 0-6, (2) 6-18
IR-84-SS02	(1) 0-6, (2) 6-18
IR-84-SS03	(1) 0-6, (2) 6-18
IR-84-SS04	(1) 0-6, (2) 6-18

Sample Station	Three Depth Intervals (inches)
IR-84-SS05	(3) 0-2, (4) 2-6, (5) 6-12
IR-84-SS06	(3) 0-2, (4) 2-6, (5) 6-12
IR-84-SS07	(3) 0-2, (4) 2-6, (5) 6-12
IR-84-SS08	(3) 0-2, (4) 2-6, (5) 6-12
IR-84-SS09	(3) 0-2, (4) 2-6, (5) 6-12
