Final Butte Priority Soils Operable Unit (BPSOU) 2021 Unreclaimed Sites Sampling – UR-35 Site Evaluation Summary Report

**SILVER BOW CREEK/BUTTE AREA NPL SITE
BUTTE PRIORITY SOILS OPERABLE UNIT**

*2021 Unreclaimed Sites Sampling UR-35
Site Evaluation Summary Report*

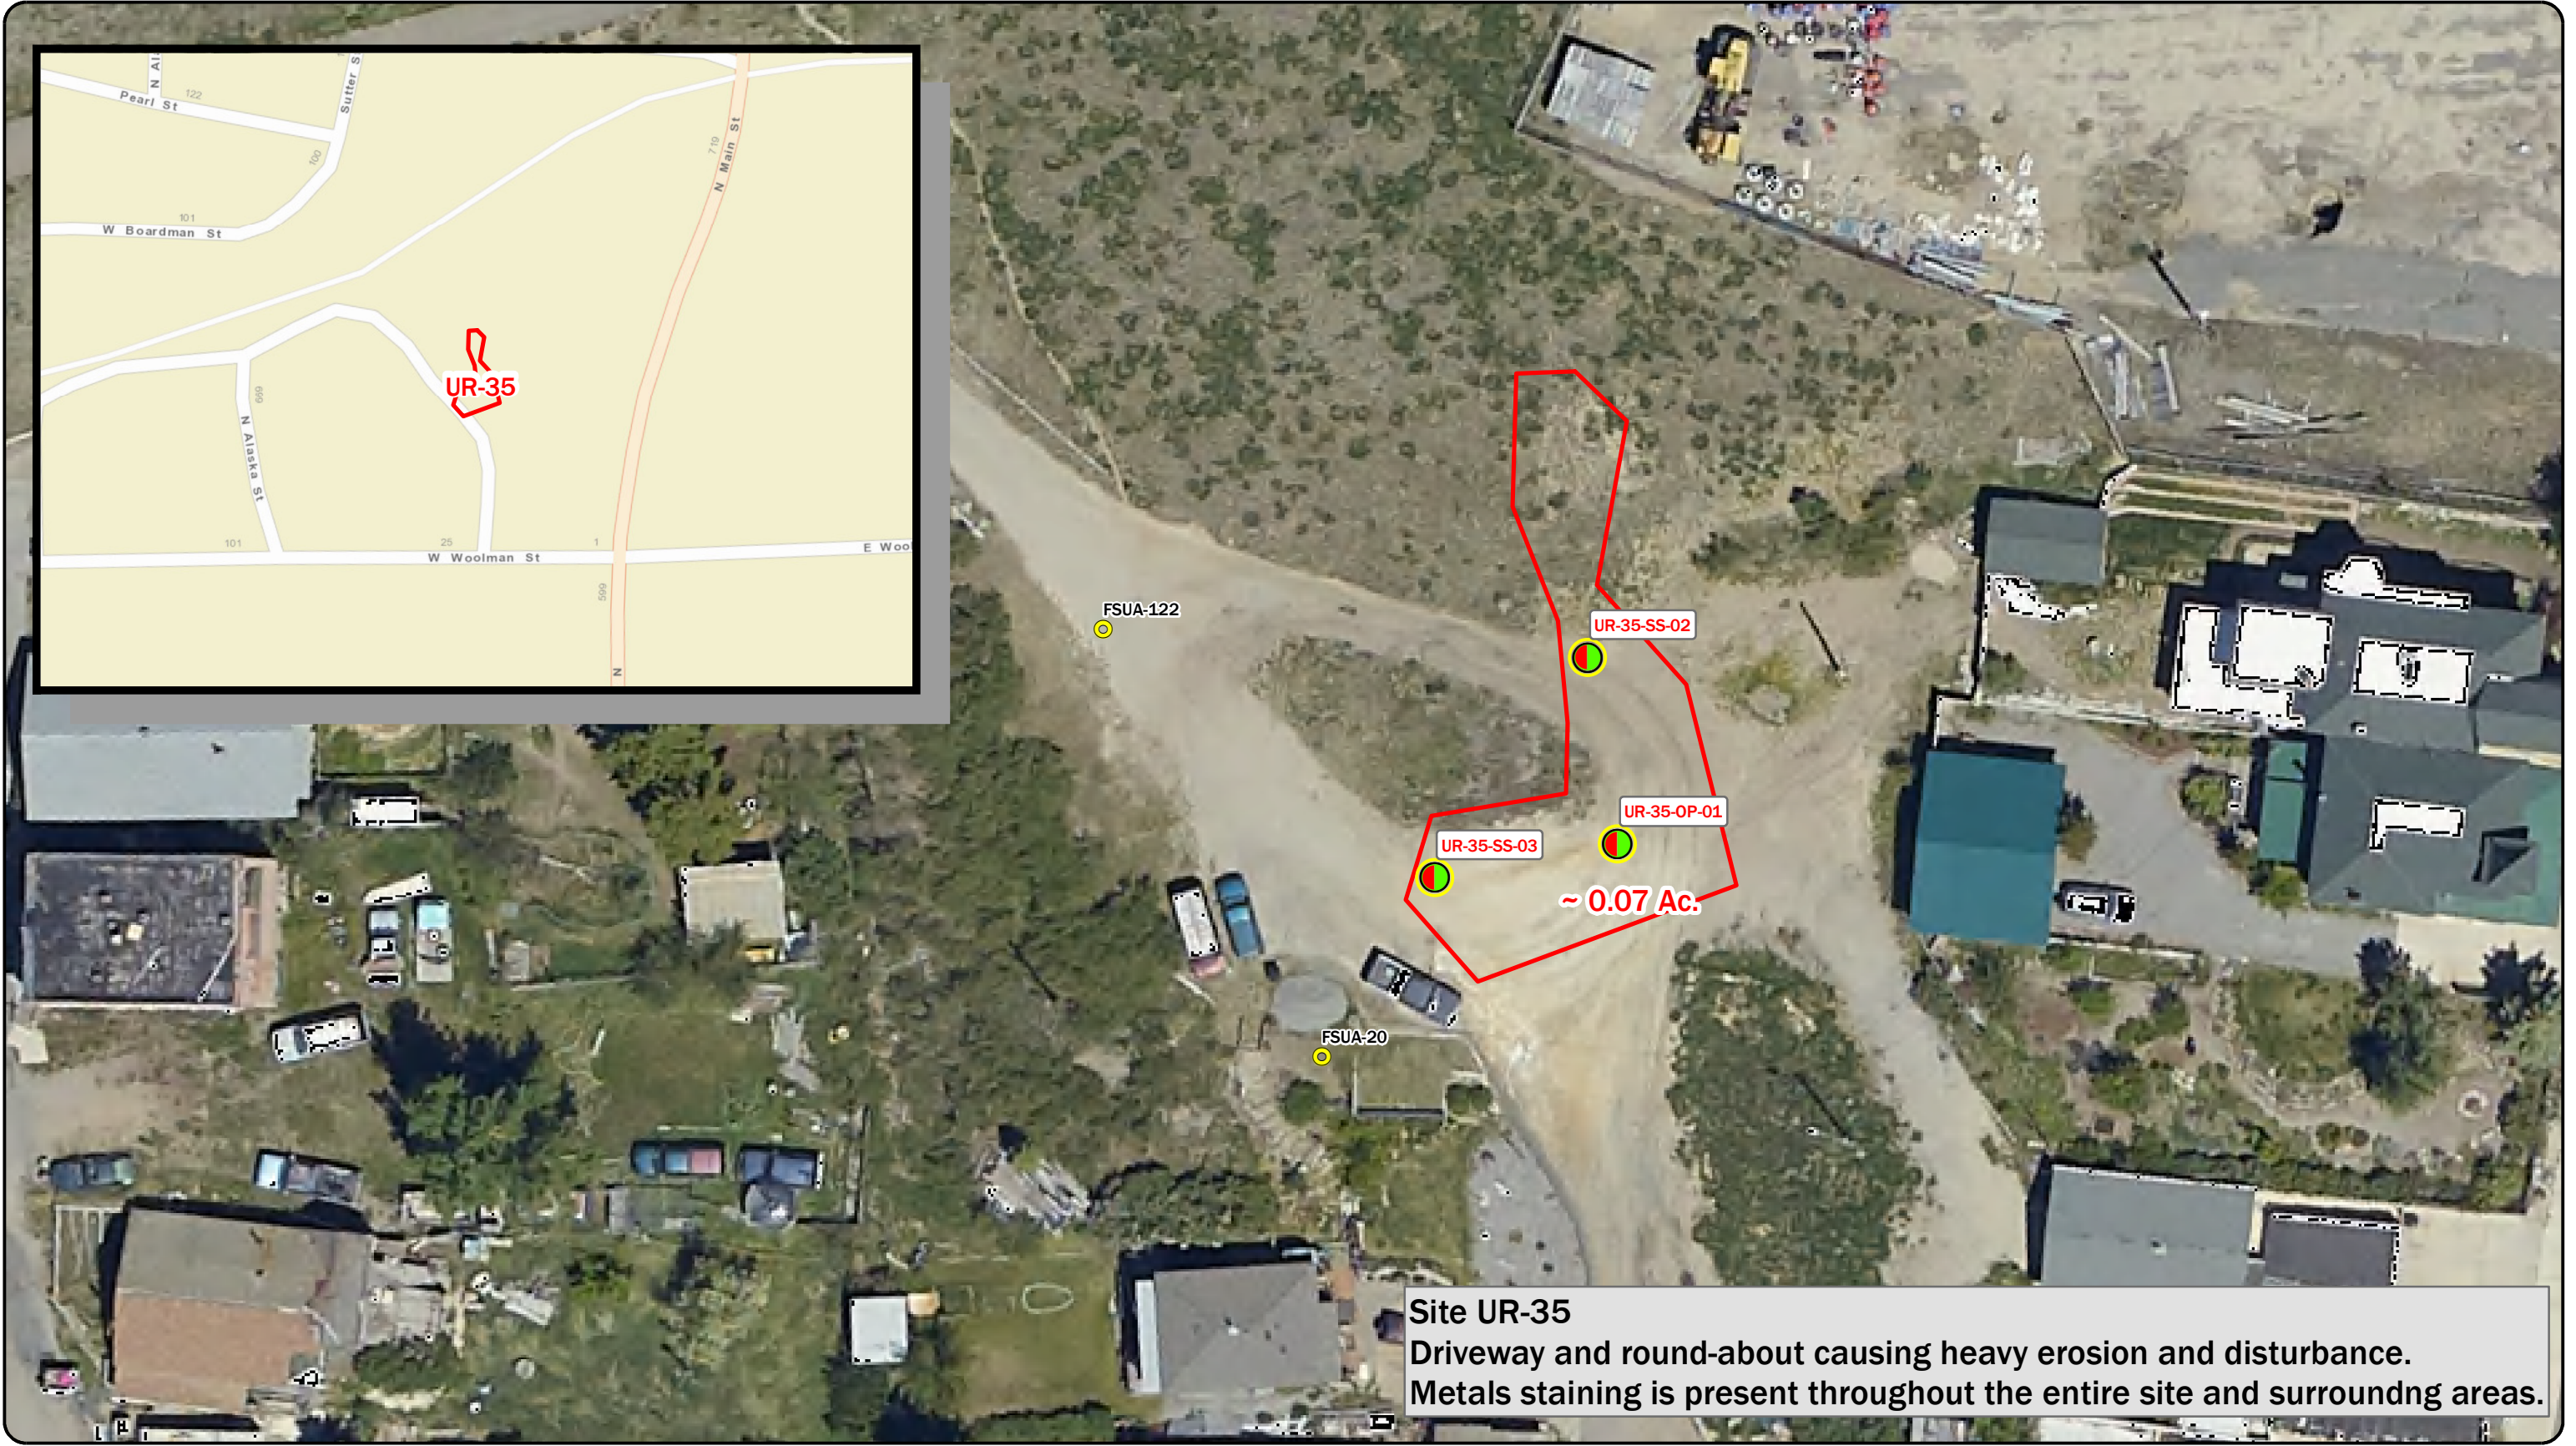
UR-35
 2021 UR SITES
 SAMPLING AND
 EXCEEDANCES

Figure 1. Unreclaimed Sites UR-35 2021 Samples and Exceedances

Site UR-35
 Driveway and round-about causing heavy erosion and disturbance.
 Metals staining is present throughout the entire site and surrounding areas.

The Site has a partially complete pathway to SBC through the Buffalo Gulch drainage; evidence of metals-impacted sediment from Site UR-35 shows it may be contributing to surface water degradation at the confluence of SBC and Blacktail Creek. Sediment is captured by the Superfund storm water HDD; however, there is potential for metals-impacted storm water to reach SBC if the structure is not maintained properly. Based on the criteria identified in the QAPP, localized remedial action is anticipated. Methods described in the 2022 *UR Sites QAPP* (Atlantic Richfield Company, 2022) Request for Information (RFI)-01 may be implemented to further delineate the extent of the remedial boundary.

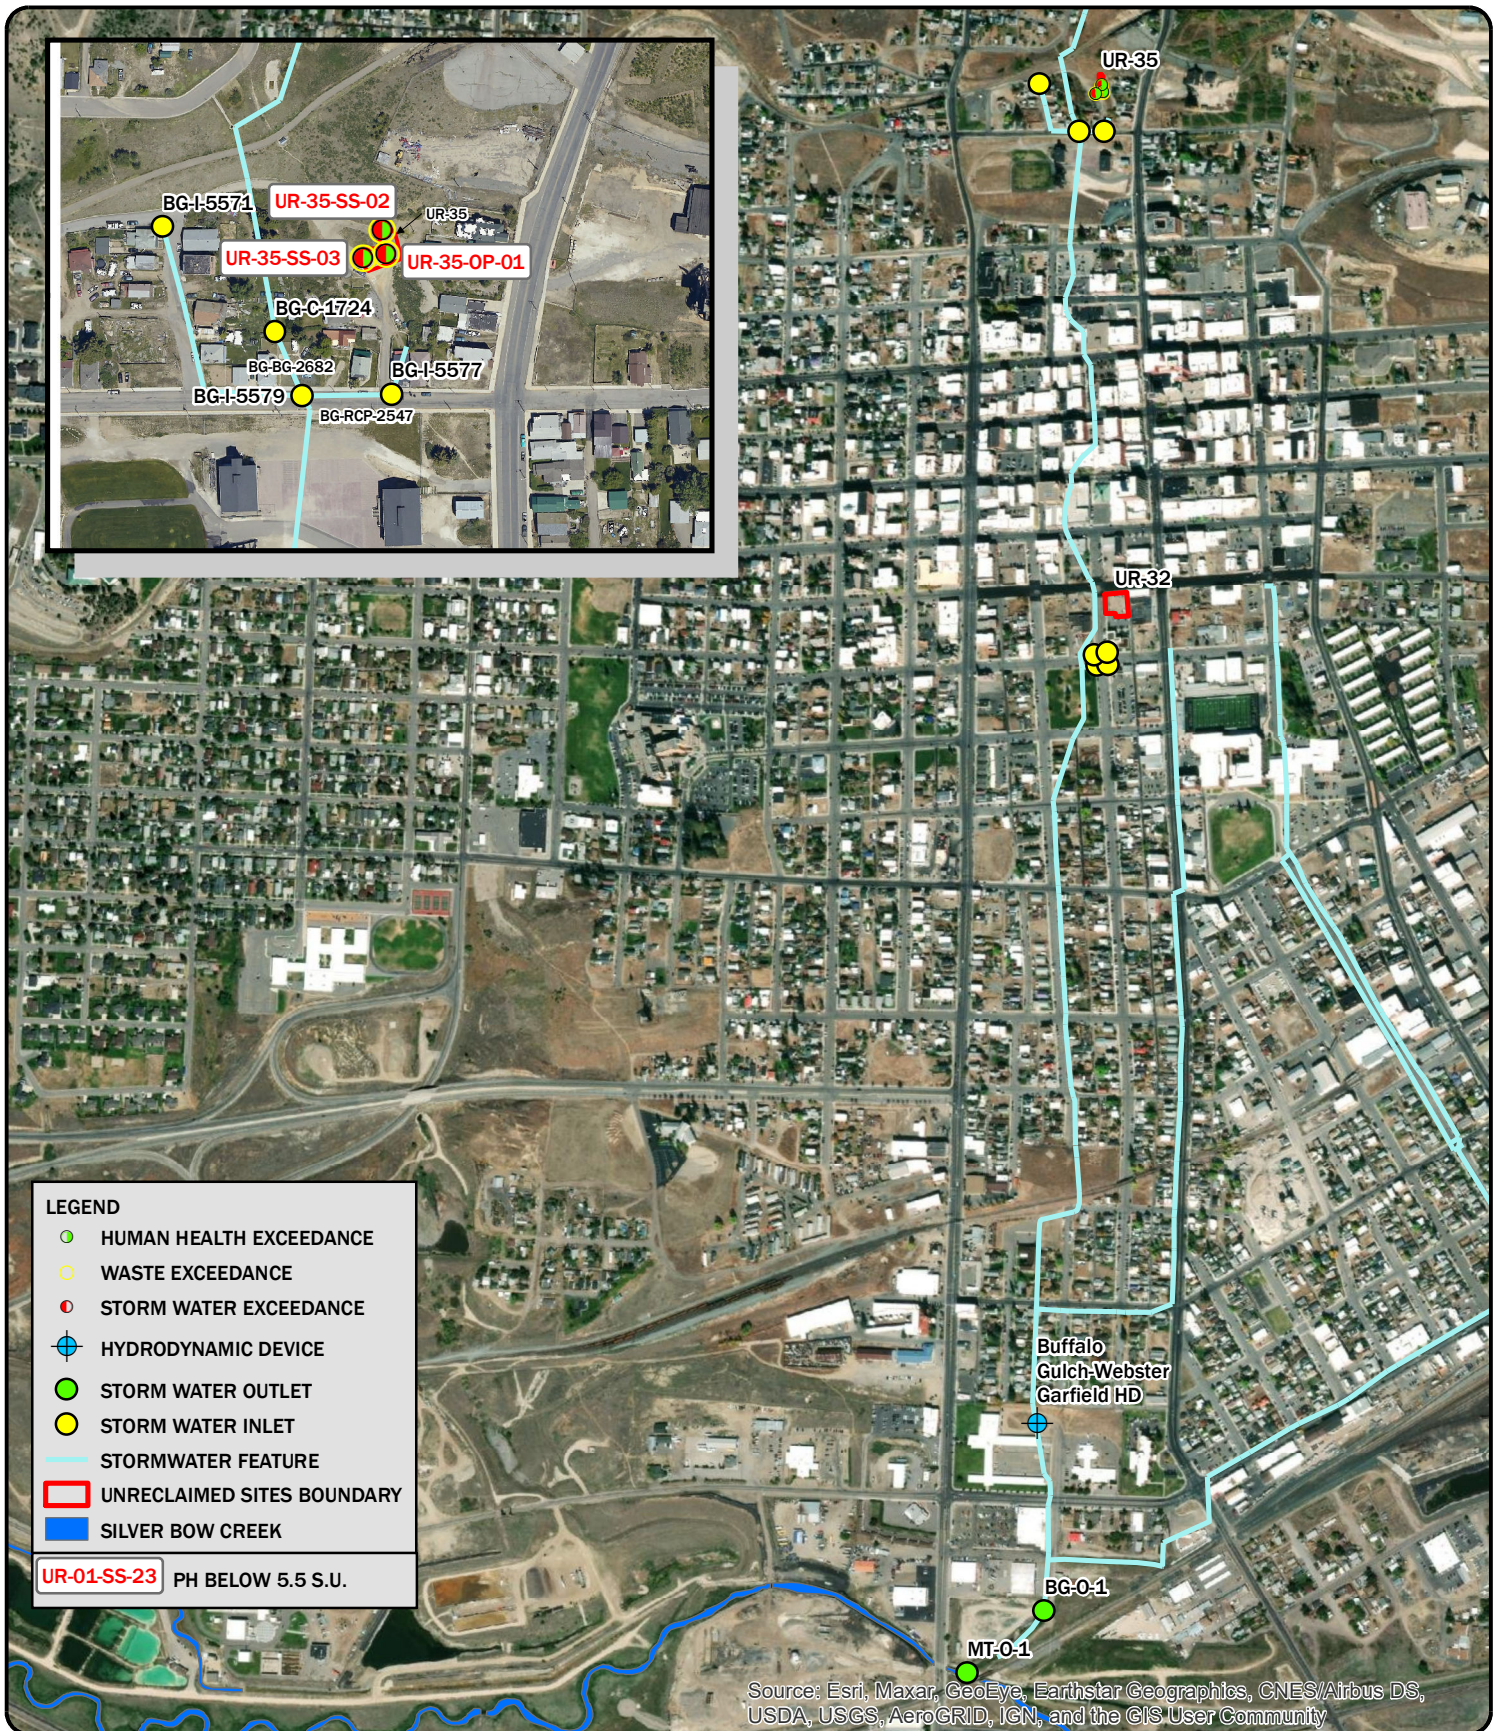
**Unreclaimed Sites
 UR-35
 Storm Water Features**

Contribution to degradation of surface water quality or metals-impacted sediment is determined by evaluating the presence of rills, concentrated outflow, and metals-impacted sediment in downstream infrastructure; determining sediment contribution loading upgradient of the Site; and connection to surface water features (Figure 2).

Figure 2. Unreclaimed Sites UR-35 Storm Water Features

- Documentation of active rills and soil loss from the Site.
- Evidence of current metals-impacted sediment within the UR Site boundary translocating off Site.
- Existing downstream infrastructure, Buffalo Gulch Webster Garfield HDD, captures potentially impacted sediment and is designed to retain sediment migration from Buffalo Gulch drainage mitigating potential surface water degradation from metals-impacted sediment.

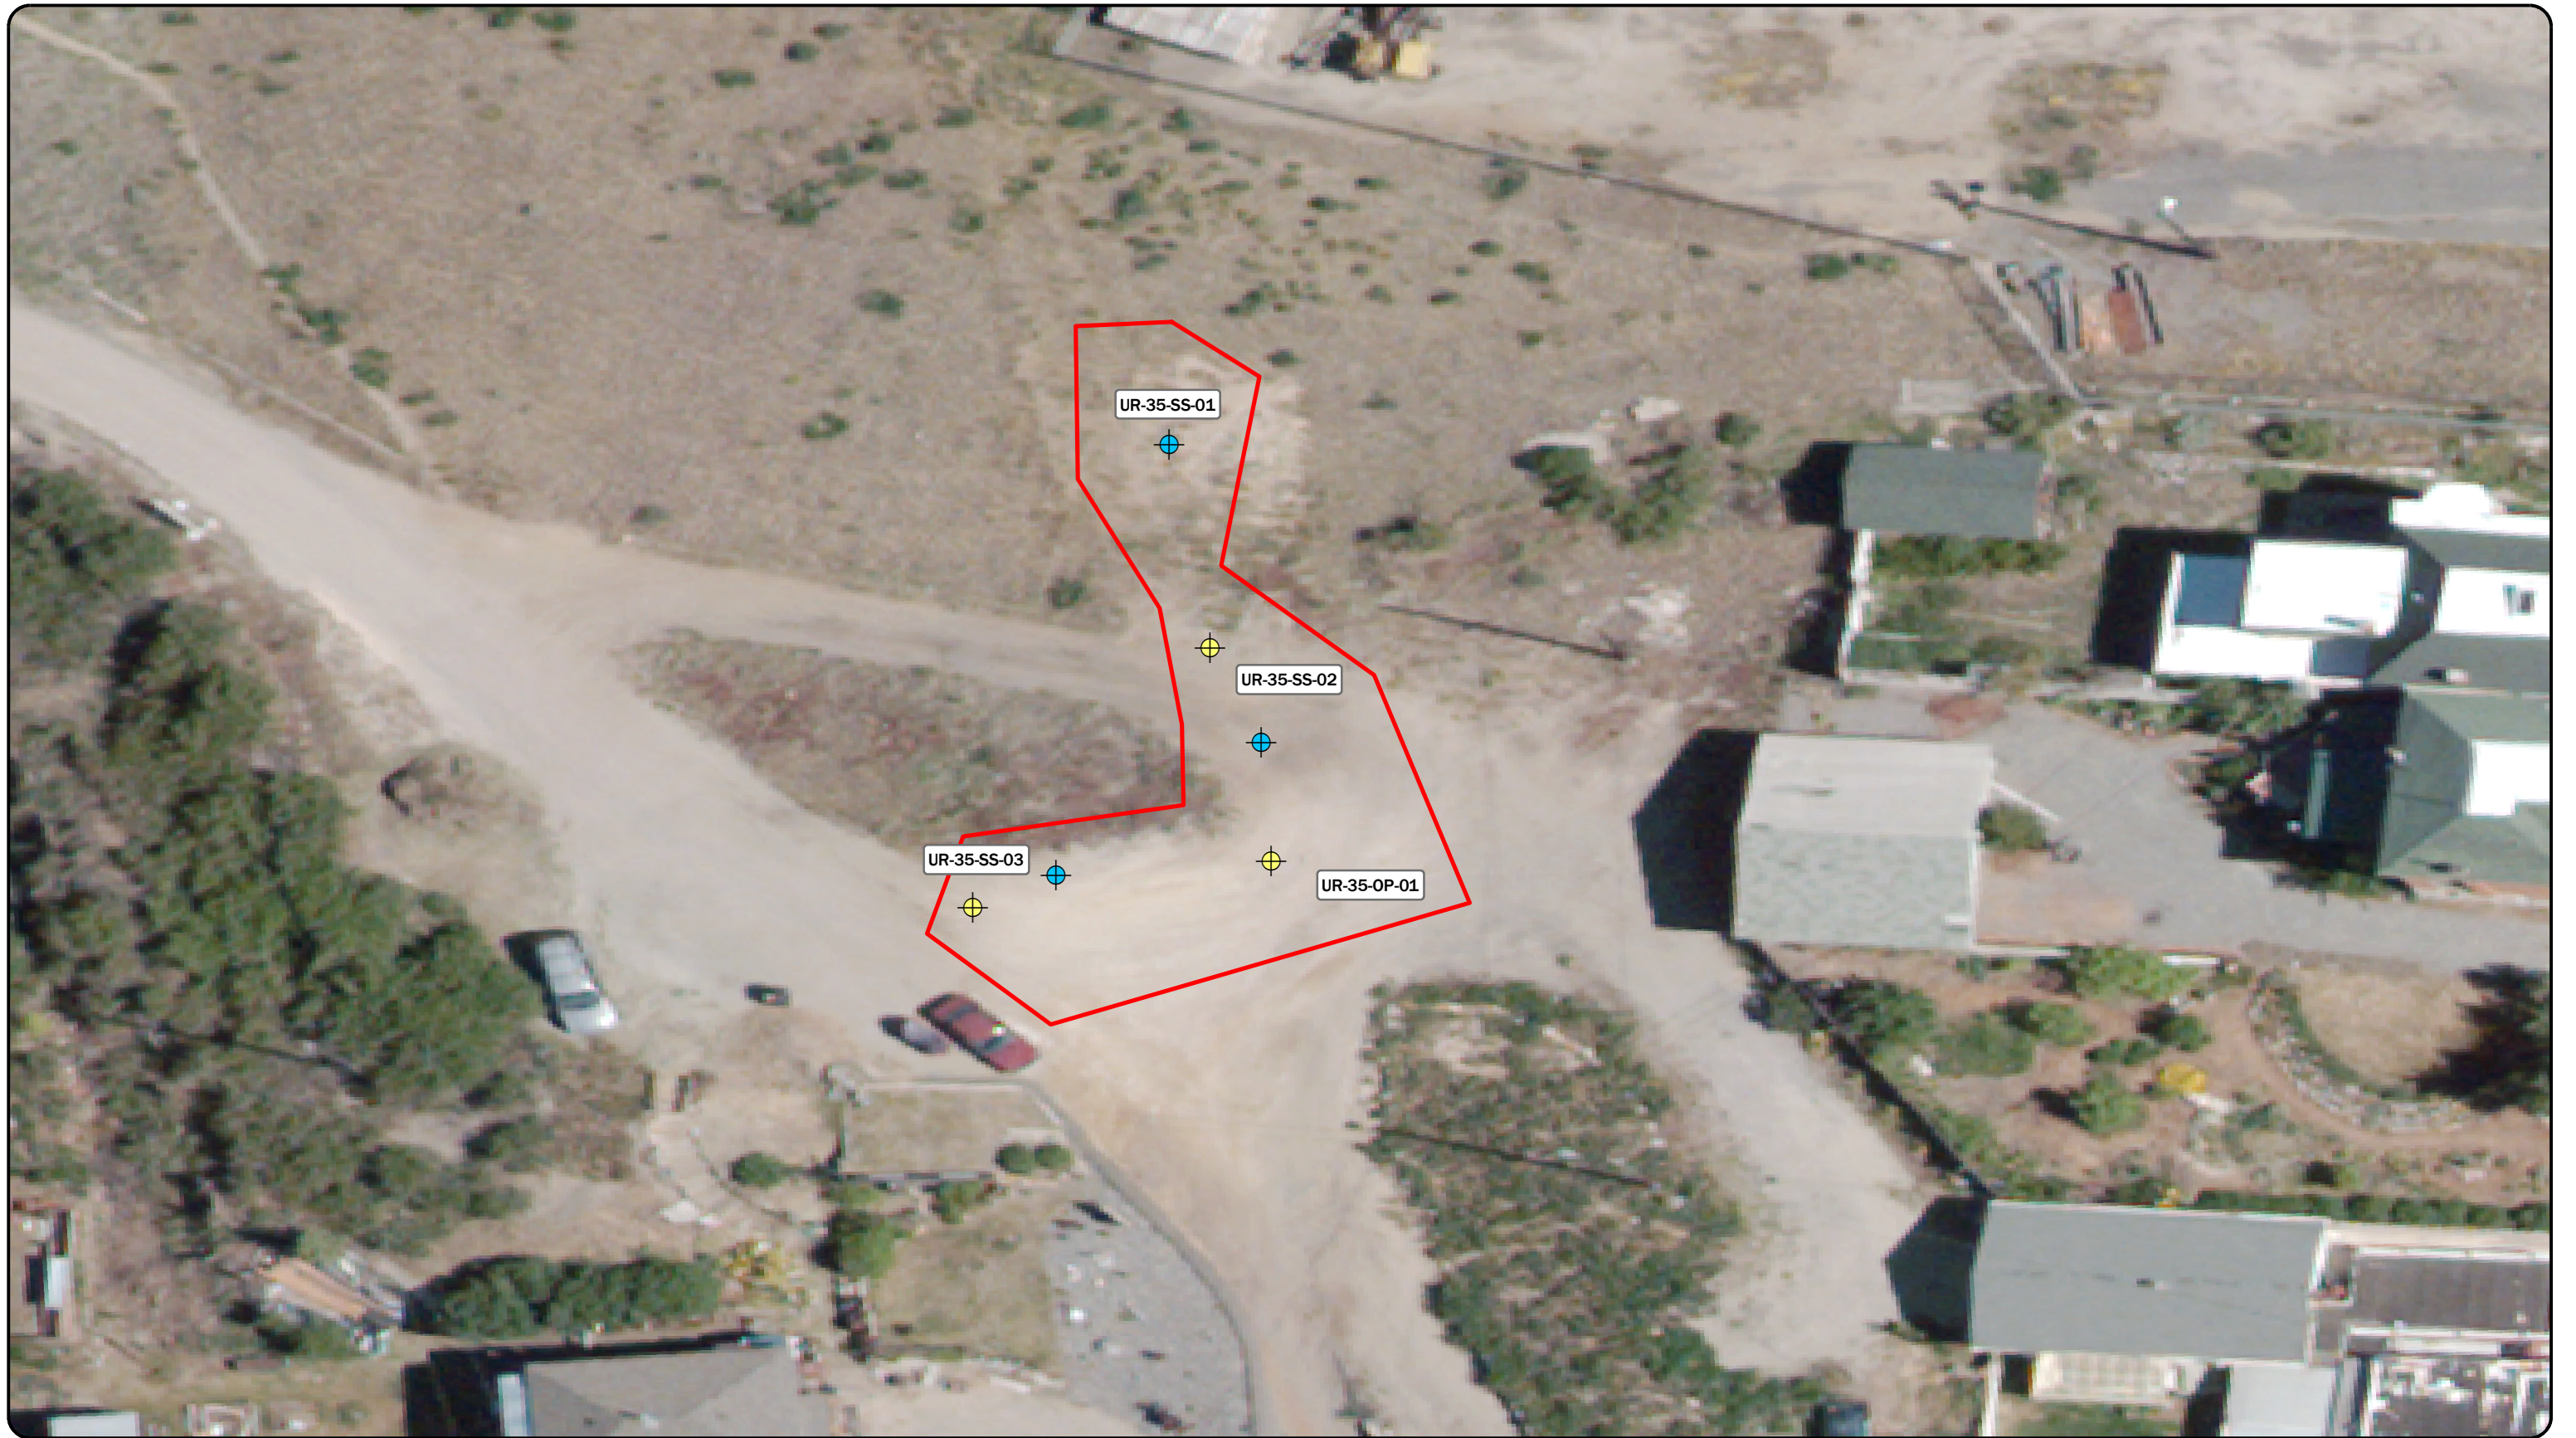
Figure 1. Unreclaimed Sites UR-35 Sample Stations

Sample stations were determined based on preliminary Site investigations and the Agency-approved *BPSOU UR Sites Final Field Sampling Plan Package #3: UR-06, UR-07, UR-20, UR-22, UR-35, and UR-36* (Atlantic Richfield Company, 2021a). Field personnel and representatives from the Agencies (when present) made decisions regarding collection of additional “opportunistic” samples to characterize the Site conditions and characteristics accurately. A minimum of five combination samples (15 subsamples) were collected at smaller sites (1 acre or less), and a minimum of 3 combination samples were collected per acre at larger sites (greater than 1 acre). Subsamples were collected in a three-point (triangular) pattern. At each point, a subsample of predetermined depth was collected. As a rule, the diagonal distance between the points was 10 feet, depending on the area of soil homogeneity. The diagonal distance could be adjusted in the field to account for soil differences and the presence of obstacles. Three discrete aliquots of equal amounts of soil from each designated subsample location were composited into one sample. Material such as plant matter, debris, and large rocks was removed, to a reasonable extent, prior to placing the sample in the sample container for laboratory analyses. A portion of the natural sample was placed into a #10 (2 millimeter) disposable sieve screen prior to running the XRF analyses and a portion was used for pH analysis. After XRF analyses were complete, the sample was archived in the Pioneer office in Butte, Montana. Samples were collected from the 0- to 12-inch depth at 0- to 2-inch, 2- to 6-inch, and 6- to 12-inch intervals.

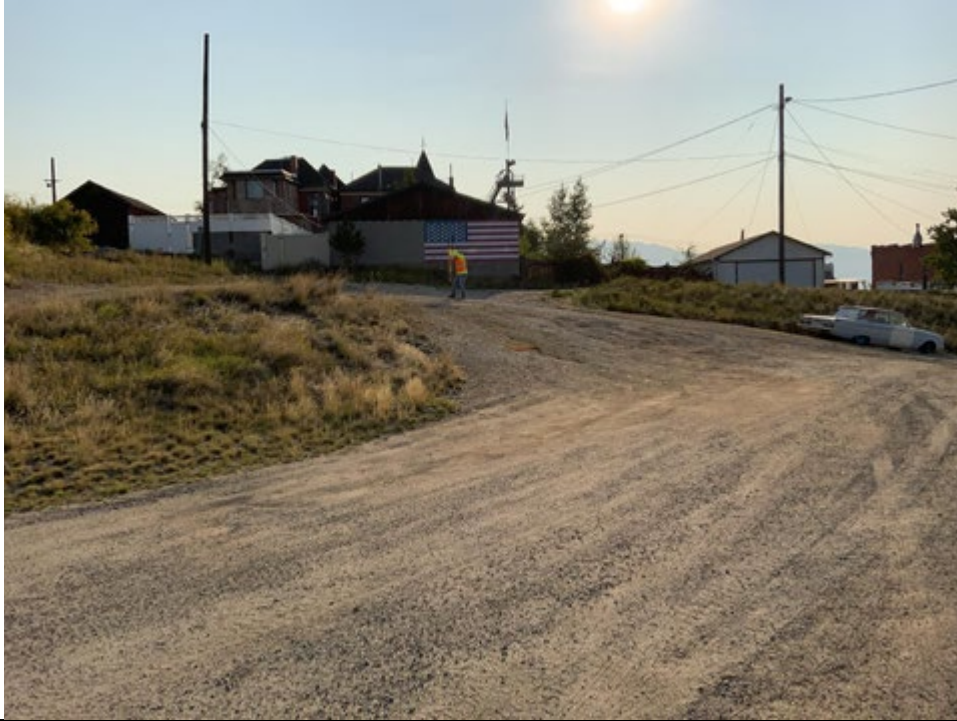
PhotoNumber: UR35-1	Photographer: JLS
Date: 09/08/2021 09:07	Photo Direction: North
Description: General area.	
Project: BPSOU Unreclaimed Sites 2021

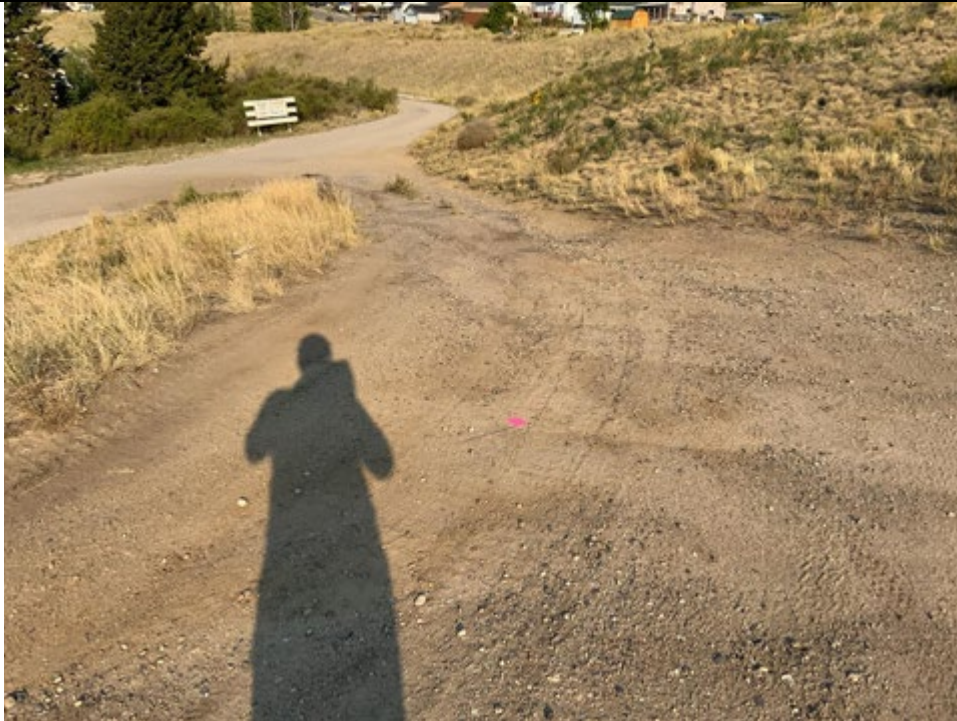
PhotoNumber: UR35-2	Photographer: JLS
Date: 09/08/2021	Photo Direction: South
Description: SS02 has active motor vehicle impact. Ground is being disturbed and conveyed throughout the site.	
Project: BPSOU Unreclaimed Sites 2021

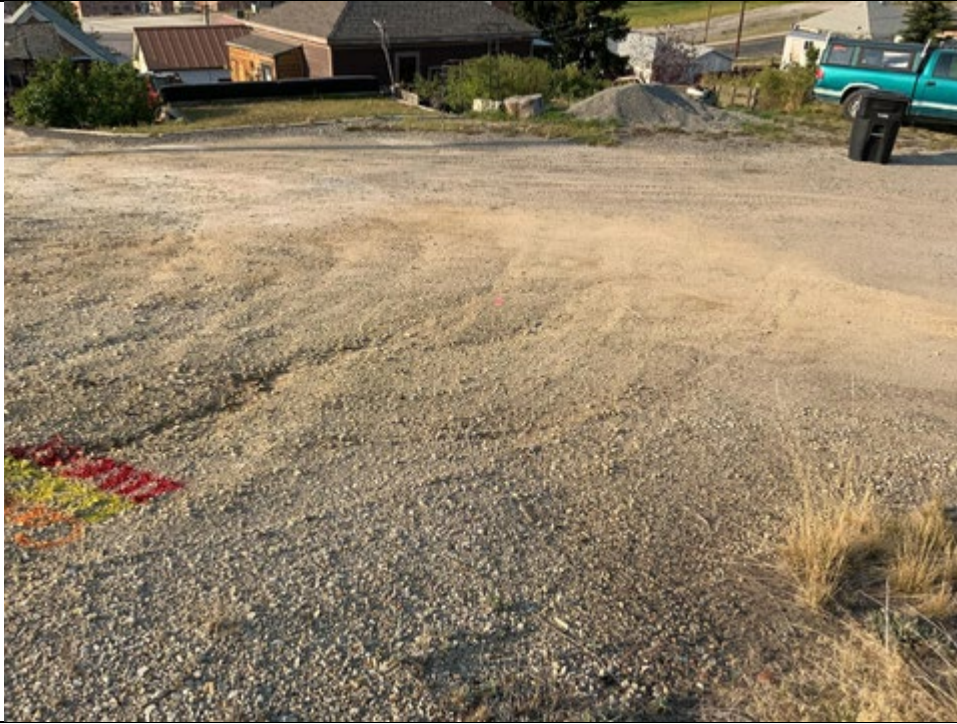
PhotoNumber: UR35-3	Photographer: JLS
Date: 09/08/2021	Photo Direction: South East
Description: SS03 has different colors of material. Active erosion is depositing where sub locations are located.	
Project: BPSOU Unreclaimed Sites 2021

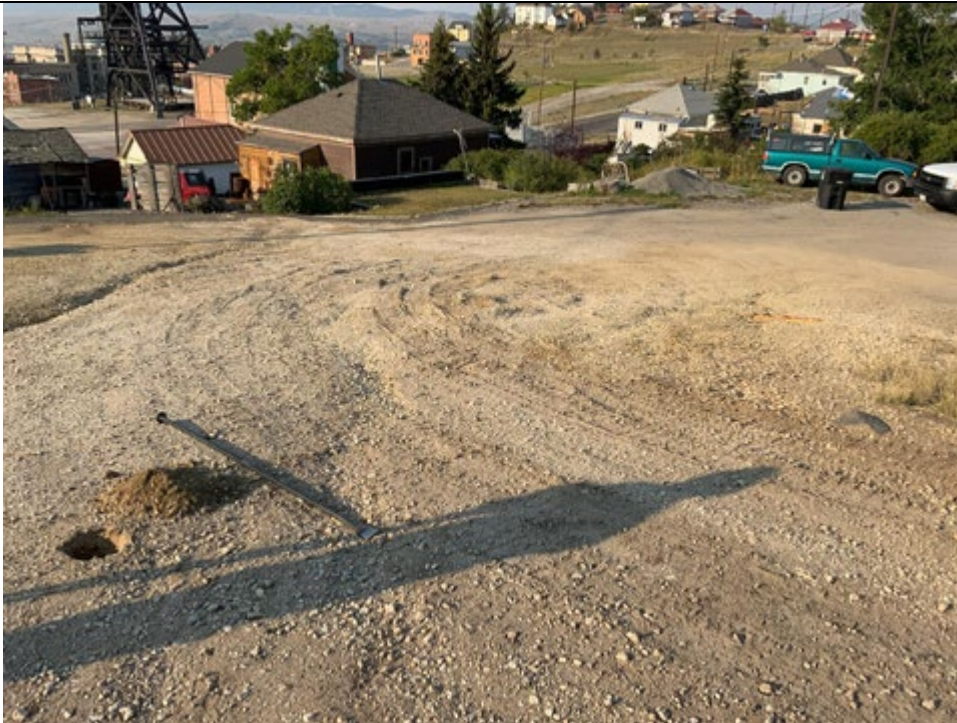
PhotoNumber: UR35-4	Photographer: JLS
Date: 09/08/2021	Photo Direction: South East
Description: OP01 was determined to be collected due to lack of access on North area. Some sub locations contain different colored material and active erosion and motor vehicle disturbance.	
Project: BPSOU Unreclaimed Sites 2021
