Silver Bow Creek Conservation Area Repository Data Gap Quality Assurance Project Plan Request for Change to Install Additional Test Pits and Perform Material Characterization

SUBJECT: Additional Test Pit Soils Investigation and Material Characterization to Support a Soil-Water Slurry System Design

MAJOR WORK TASKS: Install Additional Test Pits for Material Characterization

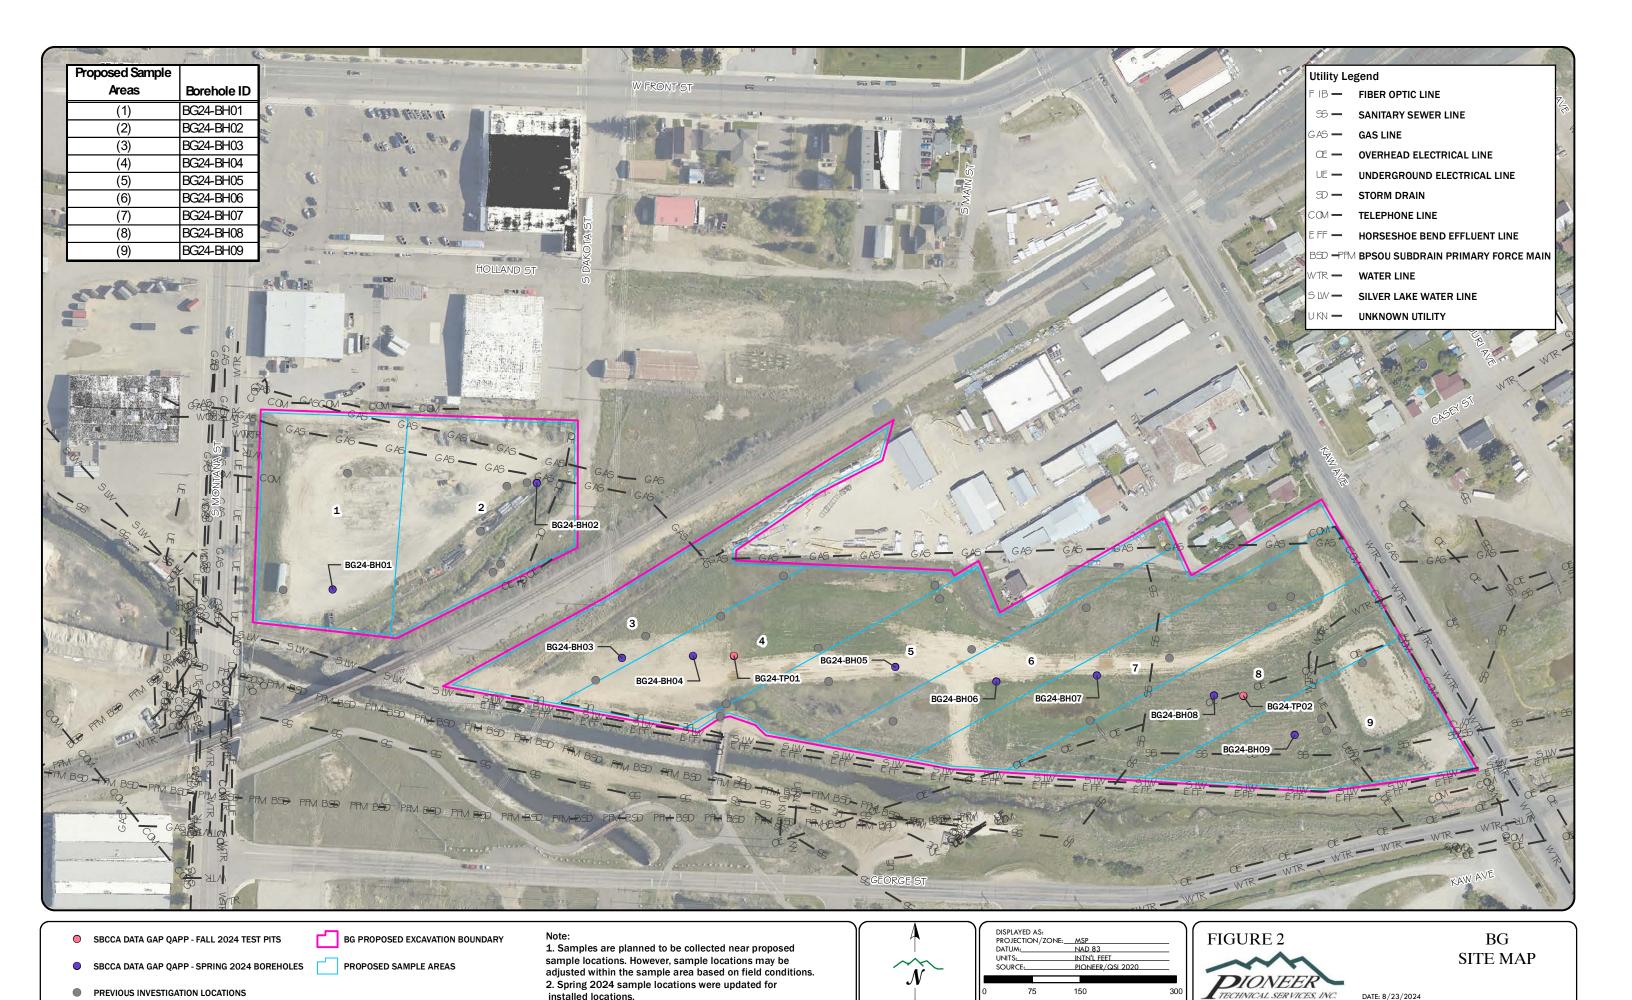
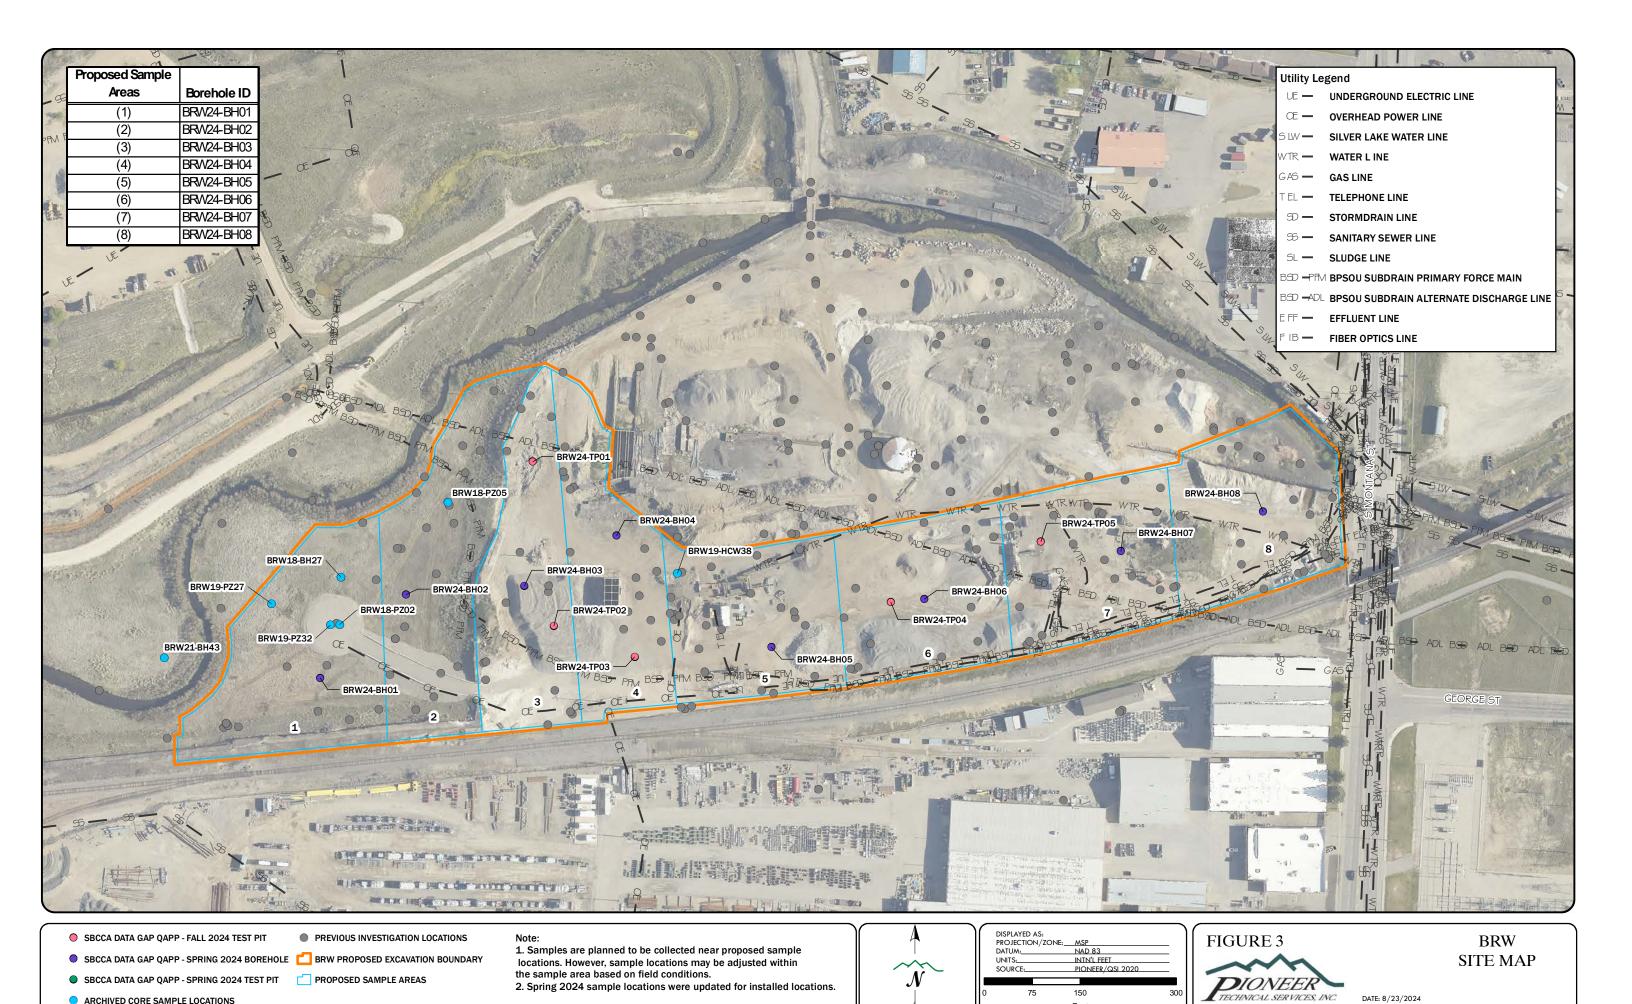
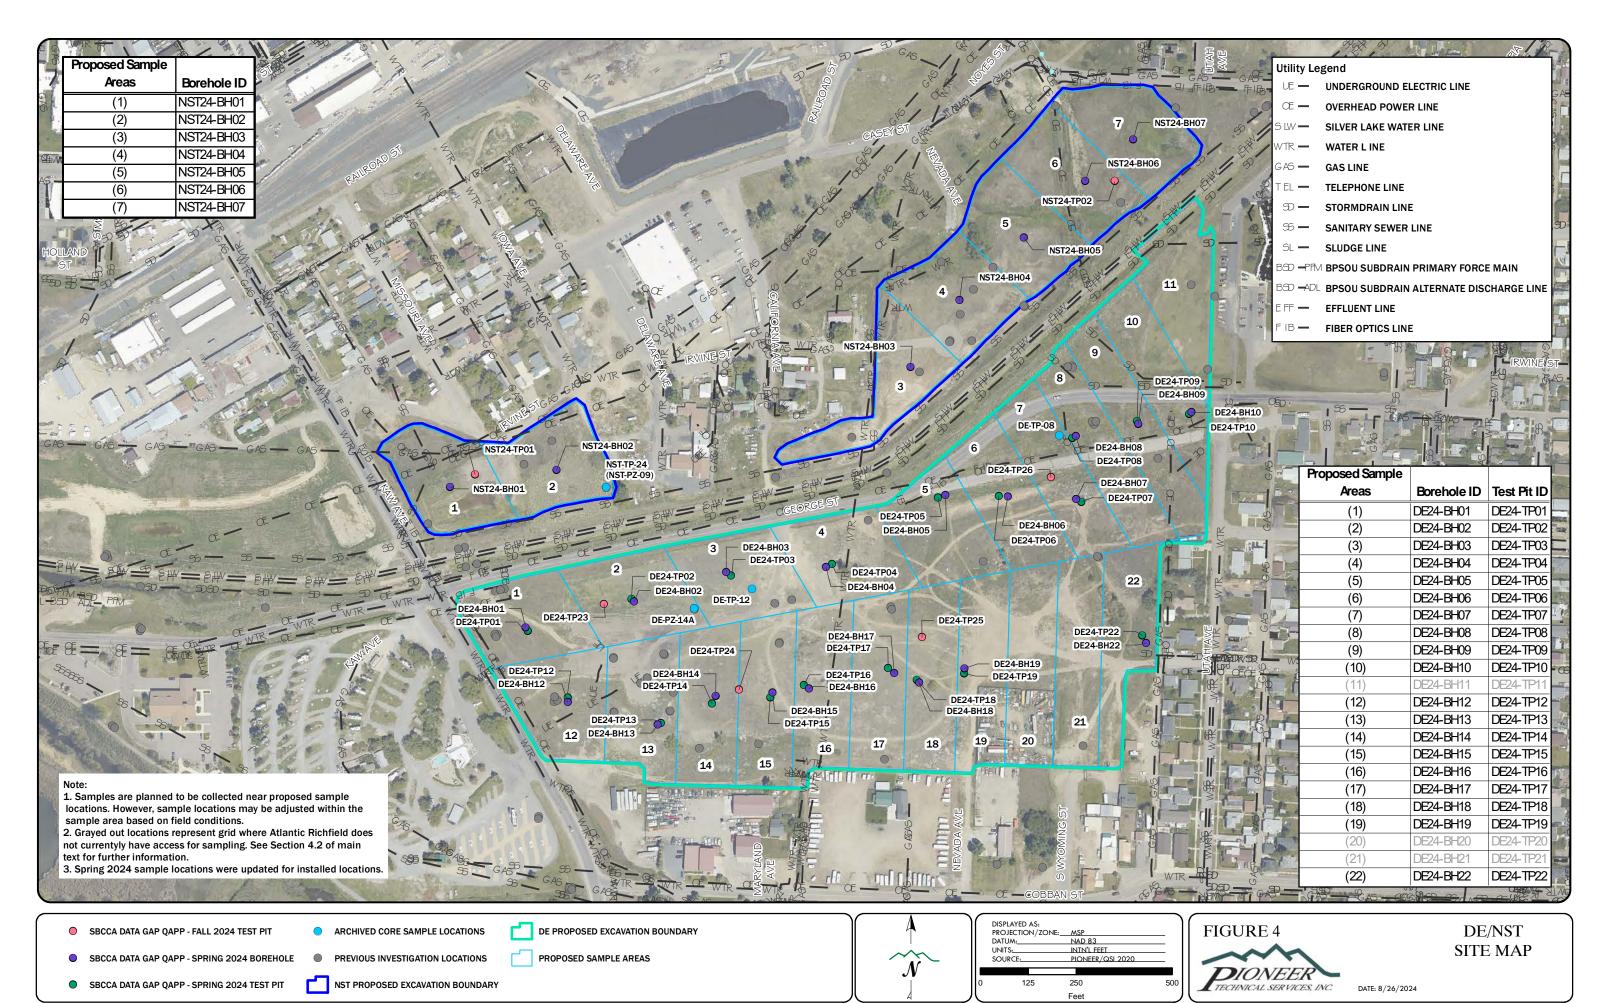
- Two to five test pits will be excavated at each RA site as shown on revised Figures 2, 3, and 4.
- Each test pit will be excavated to the depth identified in Table 6. All excavated material will be placed at least 3 feet from the excavated test pit's edge.

Atlantic Richfield plans to excavate a total of 13 test pits, with 2 to 5 test pits installed at each RA site (BRW, BG, DE, and NST). Material collected from test pits at each site will be composited into one representative bulk sample (approximately 10-cubic yards) for each RA site for material characterization testing and analysis (Table 5). The additional test pit locations are shown on revised Figures 2, 3, and 4. The locations shown on Figures 2, 3, and 4 are approximate, and the number of and pit locations may be modified as determined by the Field Team Leader in consultation with the Contractor Project Manager and Contractor Quality Assurance Officer. The test pits will be excavated to the depth of the proposed RA excavation (Table 6). The total depth of each test pit may vary depending on field conditions encountered and/or equipment limitations. Most specifically, test pits may be stopped in any scenario that may result in risk to the field team staff, equipment operators, or others associated with performance of the work.
